status report

Jeep Renegade S Plug-In-Hybrid 4xe

Vehicle identification number	1C4BU0000LP006342	mileage read:	39252 km
..			
First Registration / construction year:	16.06.2021 / 2020	Visit Date / place of birth:	12.09.2025 Dahlwitz- Hoppegarten
Bodywork:	SUV	Re - import:	no
Body type:	Road /	KBA no. :	1726//ACP
Fuel / emission class:	Petrol / hybrid / € 6	transmission type:	automatic
Displacement / power:	1332 ccm / 132 kW (179 PS)	Engine:	four-wheel
paint:	COLORADO RED CLEAR COAT	Number of previous owners:	Unbekannt
Doors / seats:	5 / 5	number keys:	2
Next HU / AU:	- / -	cushion type:	substance
Service book available:	yes	Interior Color:	black
smoking vehicle:	no	Last service km / on the:	37790 / 23.09.2024
Vehicle roadworthy:	yes	Vehicle roadworthy:	yes
Submitted vehicle documents:	For example, I (Fzg.Schein)	state outside:	2 - Good
visit condition:	-	condition inside:	2 - Good
state general:	2 - Good

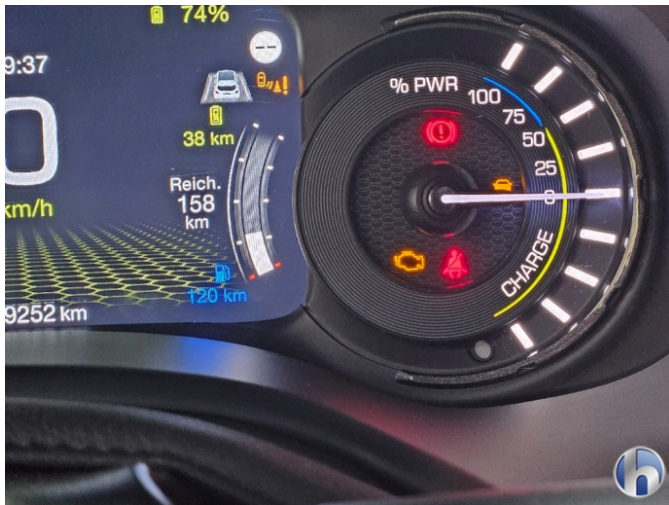
component	Damage	Rep kind
1. maintenance	Due	Replace
2. motor	Error message	Carry out a fault diagnosis
3. Reifendrucküberwachung	Error message	Carry out a fault diagnosis
4. tailgate	Deformed (slightly)	Smart repair
5. Rear bumper	Scratch(es)	Smart repair
6.	Scratch(es)	Paint
7. tire front - right	Damaged	Replace
8.	Scratch(es)	Paint
9. exterior body	Sticker	
10. battery	Empty battery	Replace

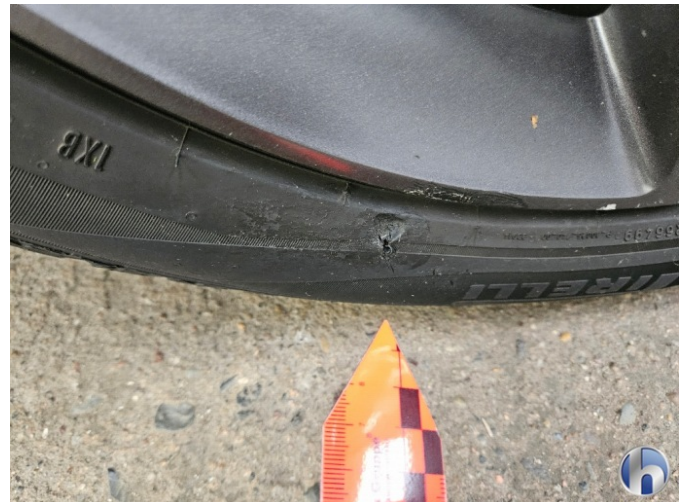
7. tire front - right

Tyre / wheel type:	All season tires	aluminum
1st axis - Left / states .	Pirelli	235/45/R19/99Y 6 mm
1st axis - right / states .	Pirelli	235/45/R19/99Y 6 mm
2nd axis - Left / states .	Pirelli	235/45/R19/99Y 6 mm
2nd axis - right / states .	Pirelli	235/45/R19/99Y 6 mm
traffic Safety:	not roadworthy	
spare wheel:	Tirefit	
state spare wheel:	-
