## status report

#### Jeep Grand Cherokee 3.0 CRD Overland

| Vehicle identification number | 1C4RJFCM8JC435290 | mileage read: | 147299 km |

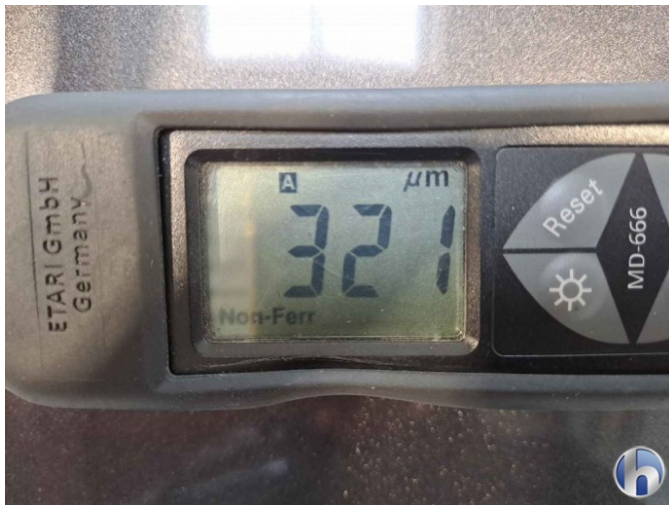
| component | Damage | Rep kind |
|---|---|---|
| 1. hood | Subsequently painted | acceptable |

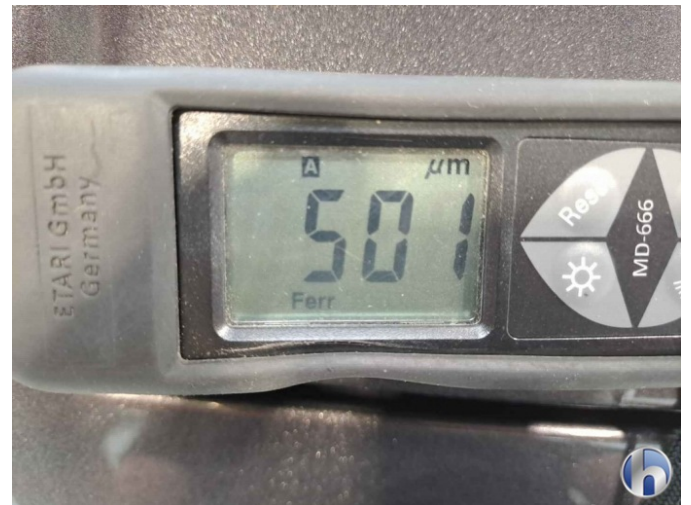
| component | Damage | Rep kind |
|---|---|---|
| 2. Front fender - right | Subsequently painted | acceptable |

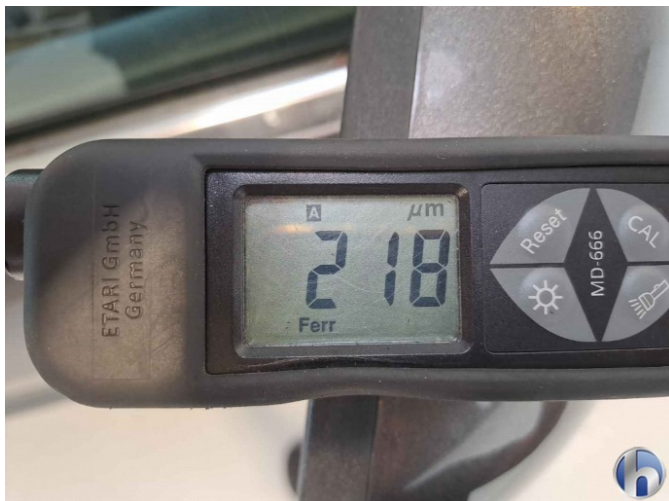
| component | Damage | Rep kind |
|---|---|---|
| 3. A-pillar Front - right | Subsequently painted | acceptable |

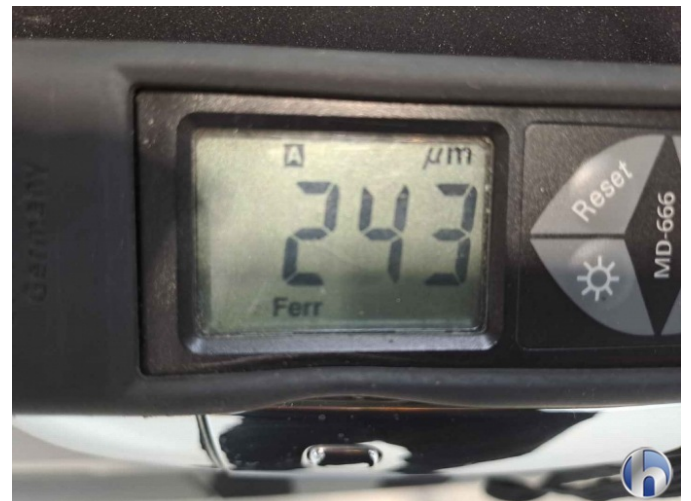
| component | Damage | Rep kind |
|---|---|---|
| 4. Front door - right | Subsequently painted | acceptable |

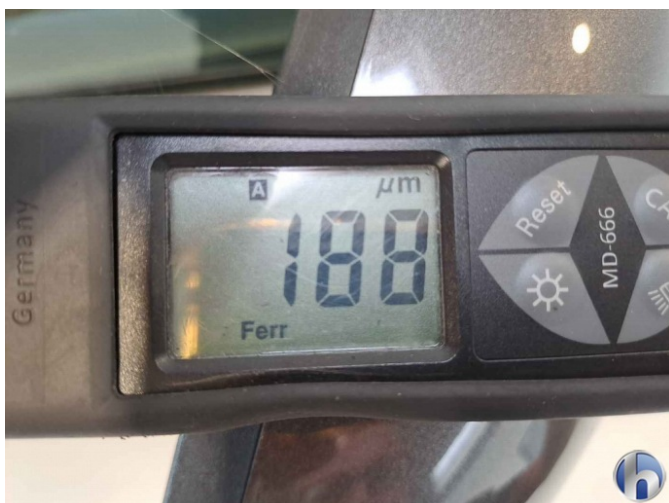
| component | Damage | Rep kind |
|---|---|---|
| 5. roof | Subsequently painted | acceptable |

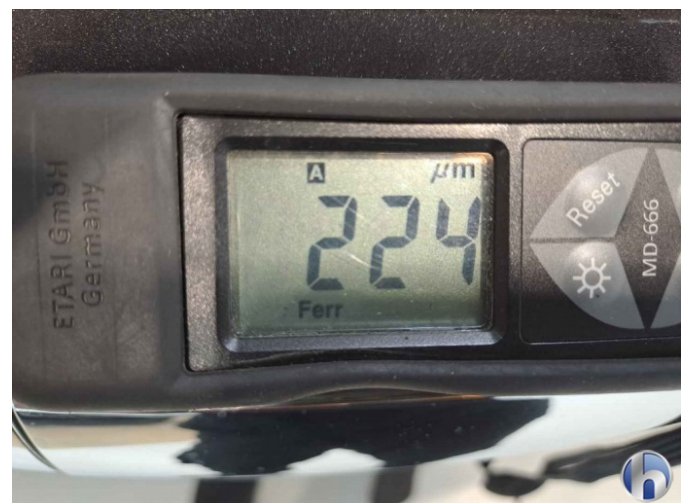
| component | Damage | Rep kind |
|---|---|---|
| 6. Door Rear - right | Subsequently painted | acceptable |

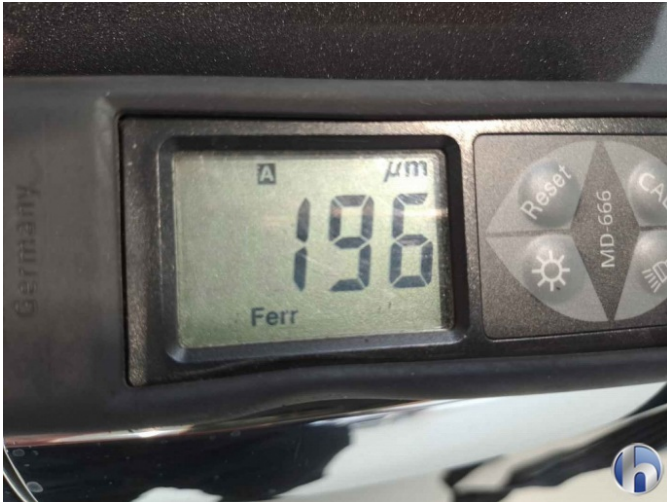
| component | Damage | Rep kind |
|---|---|---|
| 7. Roof frame - right | Subsequently painted | acceptable |

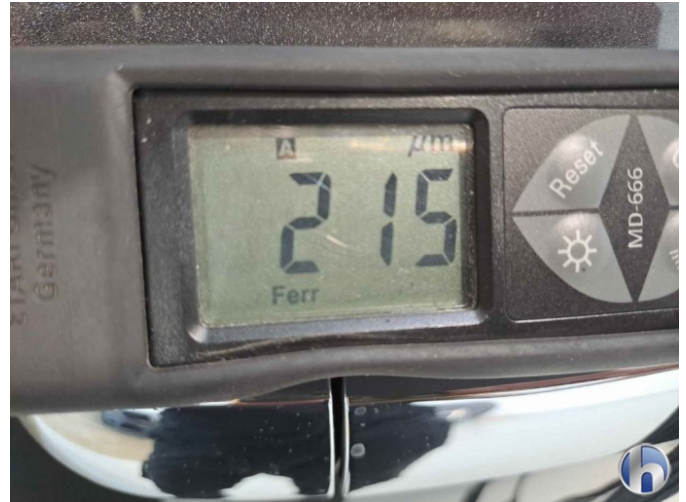
| component | Damage | Rep kind |
|---|---|---|
| 8. Sidewall - Rear - right | Subsequently painted | acceptable |

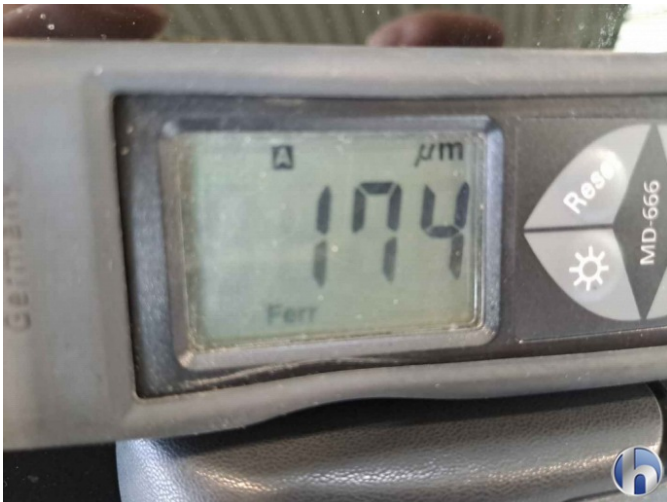
| component | Damage | Rep kind |
|---|---|---|
| 9. tailgate | Subsequently painted | acceptable |

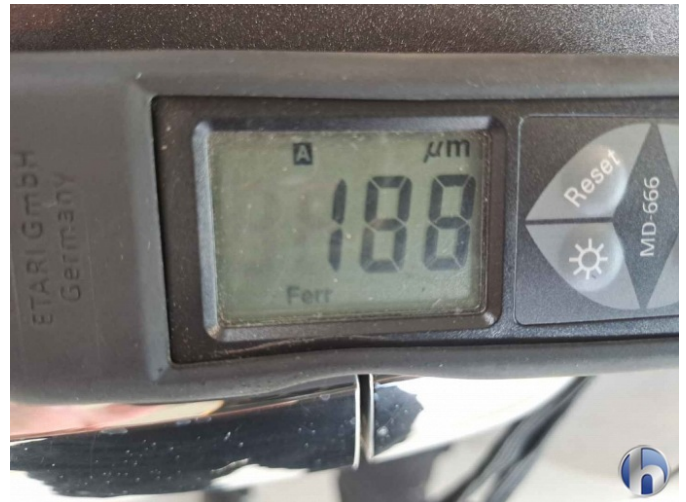
| component | Damage | Rep kind |
|---|---|---|
| 10. Sidewall - Rear - Left | Subsequently painted | acceptable |

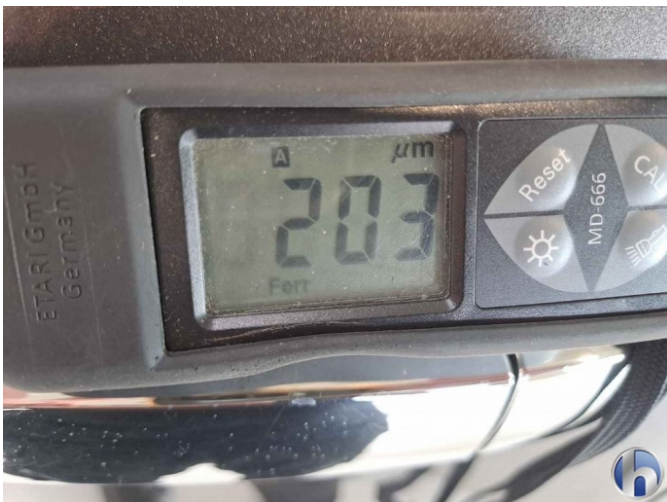
| component | Damage | Rep kind |
|---|---|---|
| 11. Roof frame - left | Subsequently painted | acceptable |

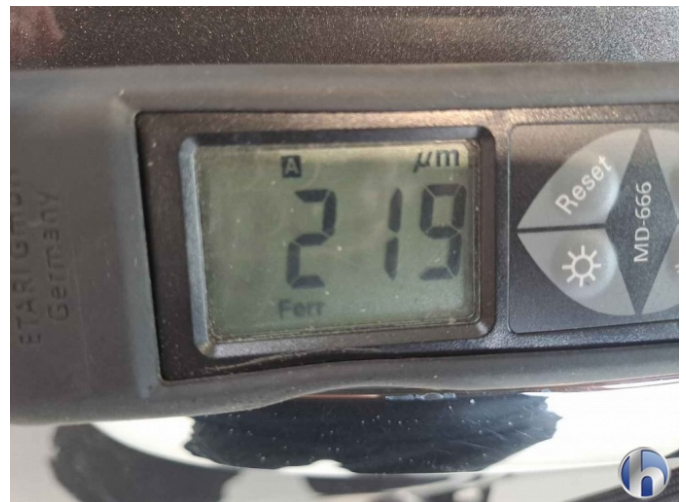
| component | Damage | Rep kind |
|---|---|---|
| 12. Rear door - left | Subsequently painted | acceptable |

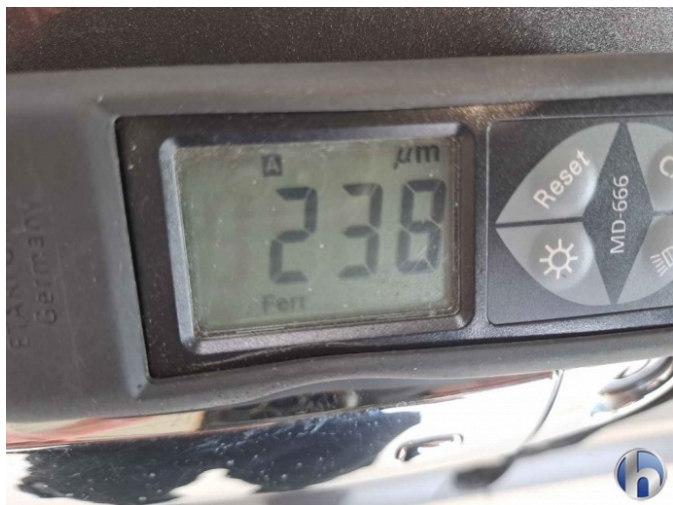
| component | Damage | Rep kind |
|---|---|---|
| 13. Front door - left | Subsequently painted | acceptable |

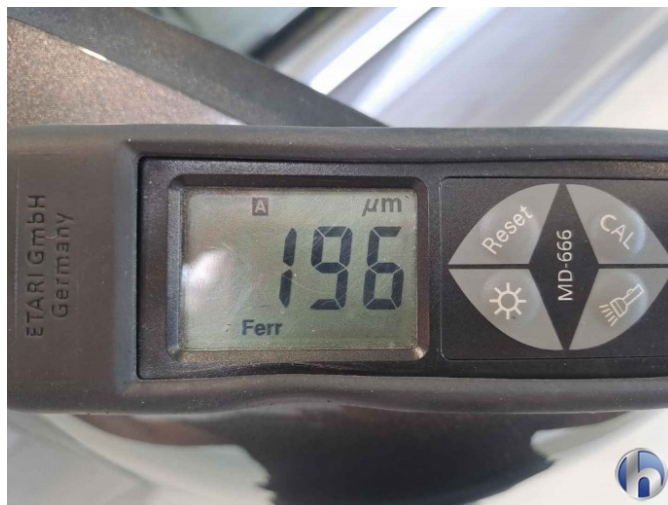
| component | Damage | Rep kind |
|---|---|---|
| 14. A-pillar Front - Left | Subsequently painted | acceptable |

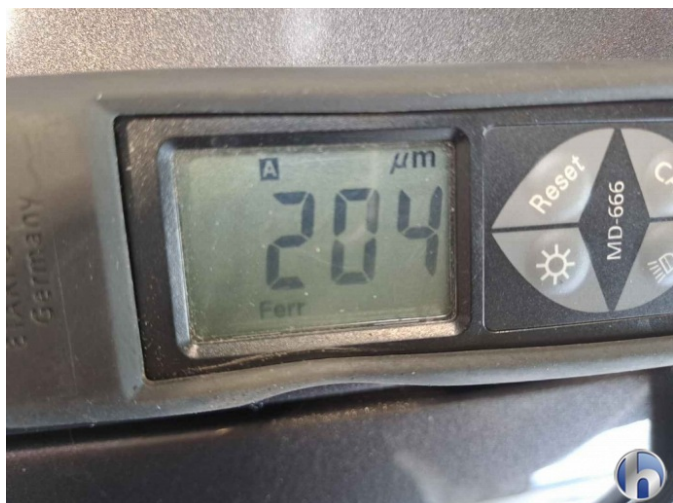
| component | Damage | Rep kind |
|---|---|---|
| 15. Front fender - left | Subsequently painted | acceptable |

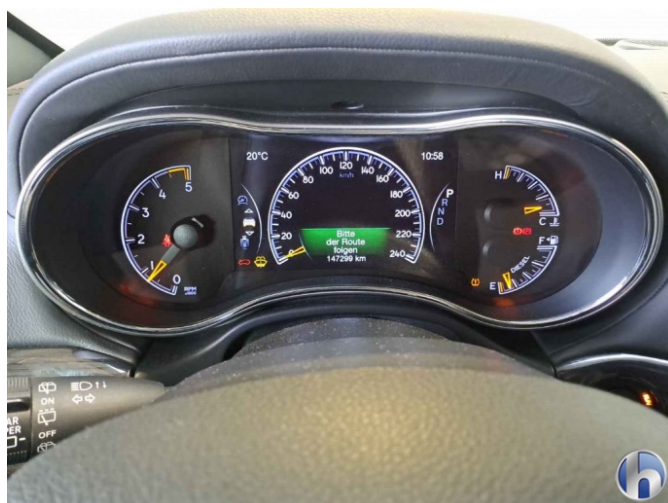
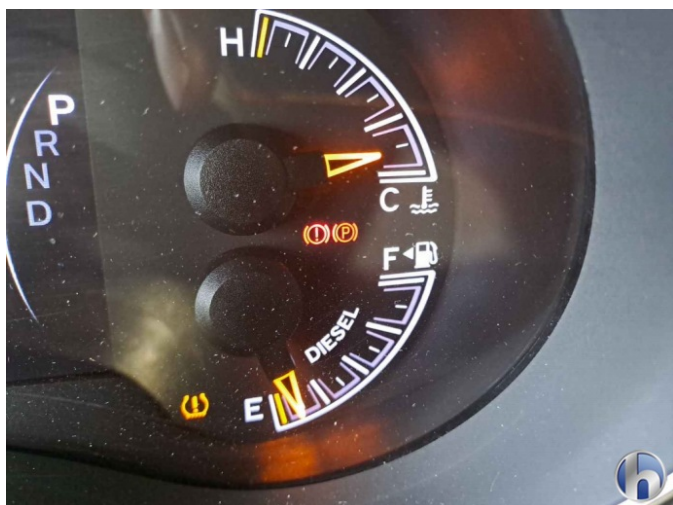
| General examination | |
|---|---|
| <b>Note Road Safe:</b> | Parkbremse Fehlermeldung |

| component | Damage | Rep kind |
|---|---|---|
| 17. Parkbremse | Error message | Carry out a fault diagnosis |

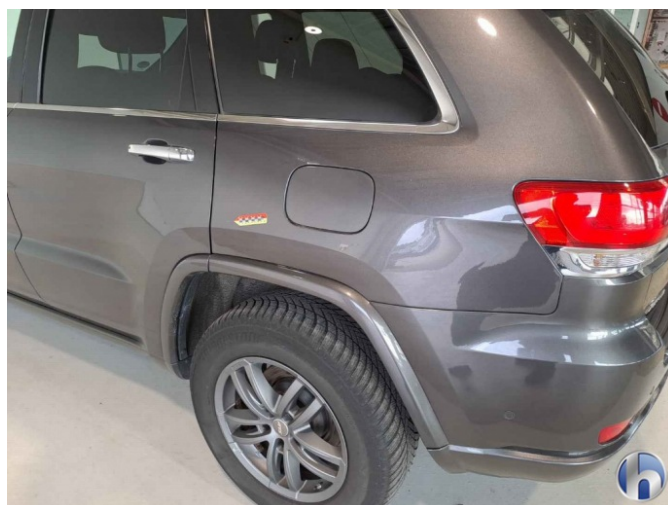
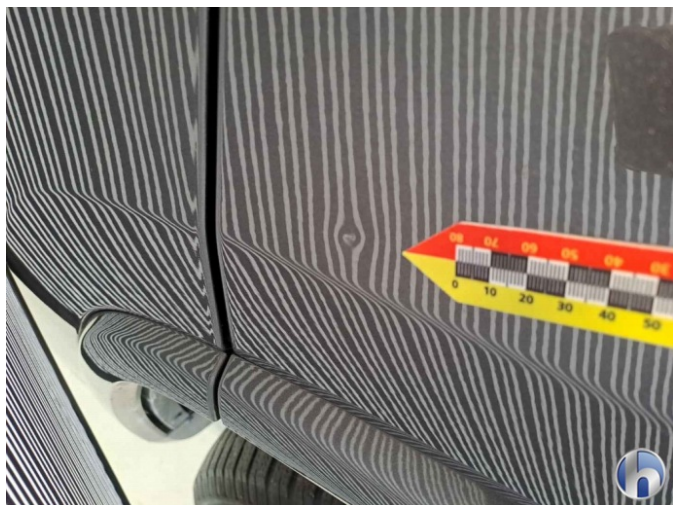
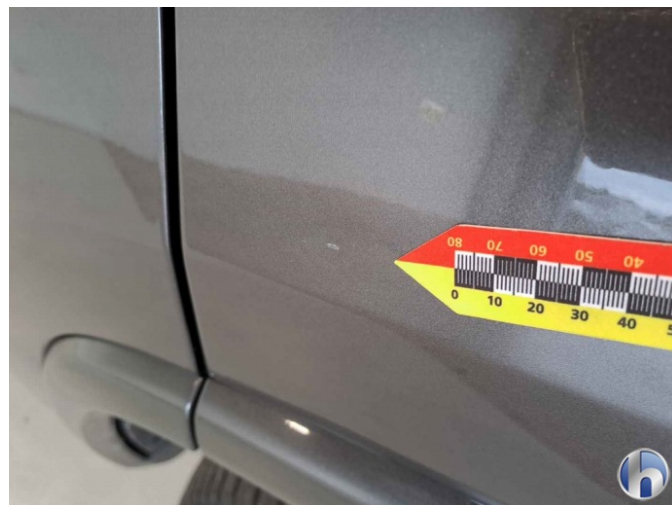
| component | Damage | Rep kind |
|---|---|---|
| 18. Sidewall - Rear - Left | | Refurbish and paint |

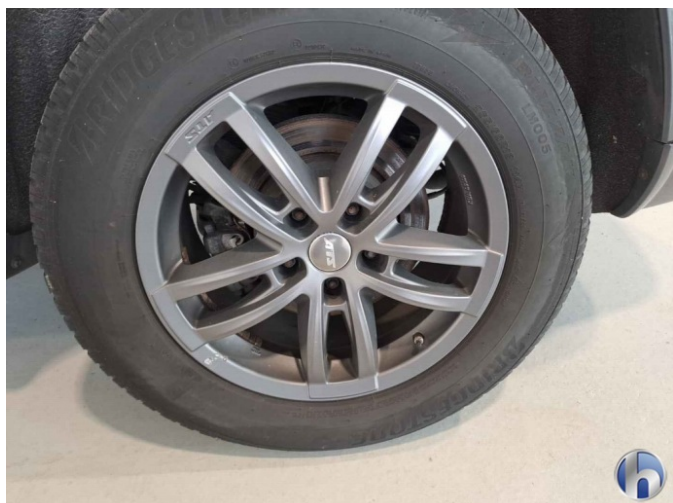
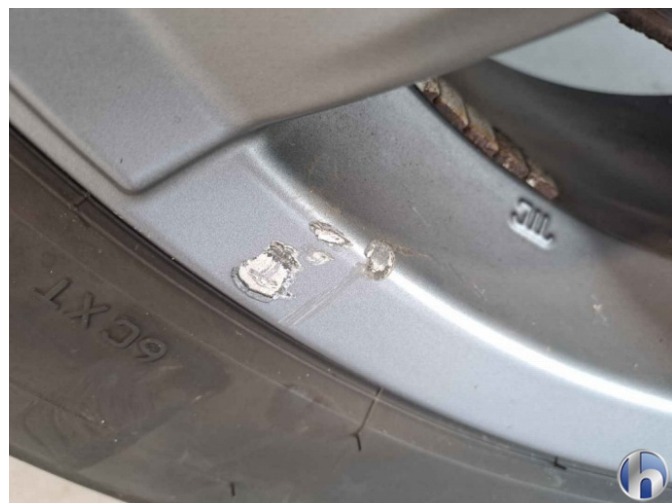
| component | Damage | Rep kind |
|---|---|---|
| 19. Felge (Aluminium) hinten links | Scratch(es) | Paint |

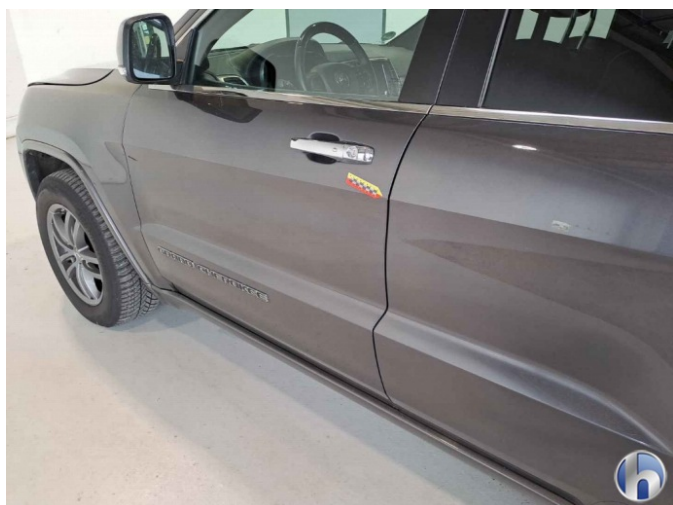
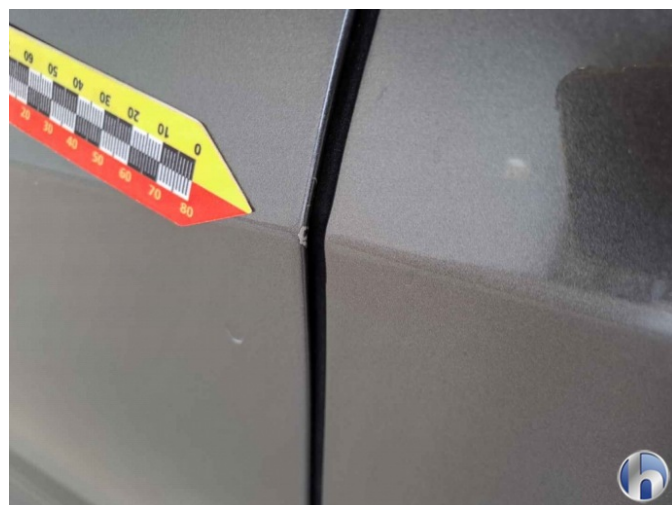
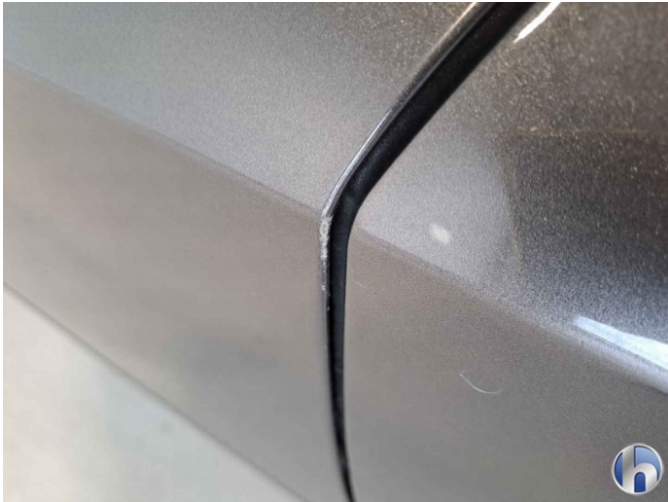
| component | Damage | Rep kind |
|---|---|---|
| 20. Front door - left | Scrape | Smart repair |

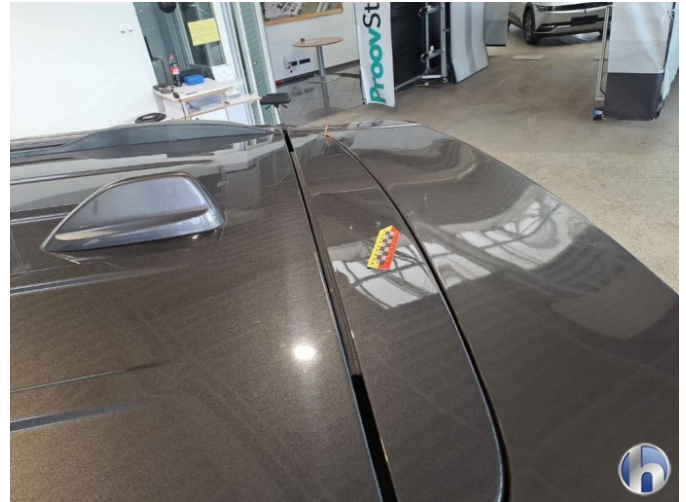
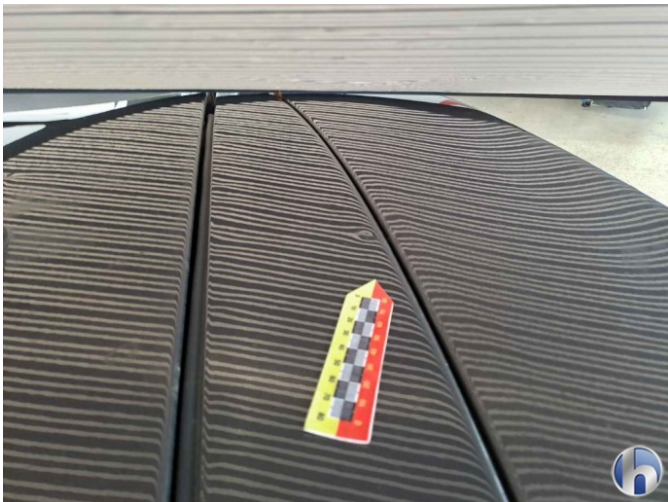
| component | Damage | Rep kind |
|---|---|---|
| 21. tailgate | Delle | Smart repair |

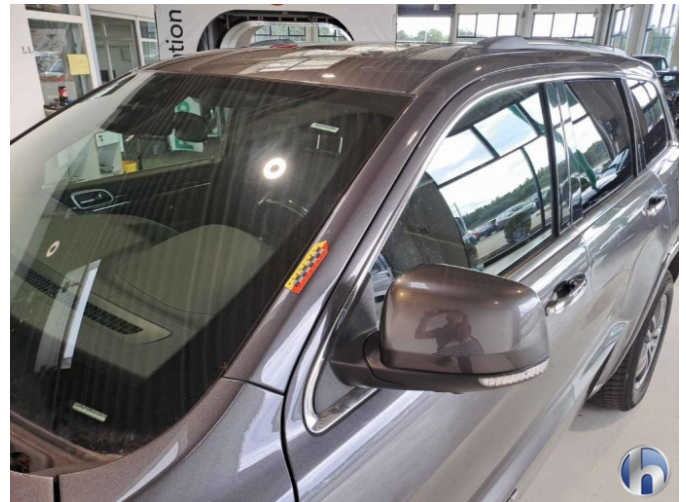
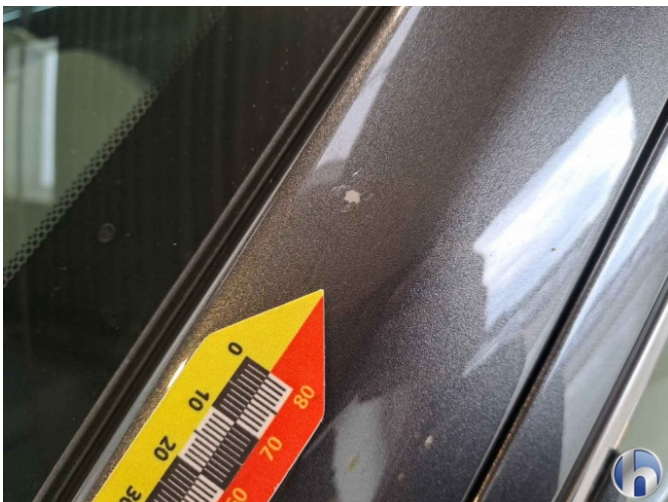
| component | Damage | Rep kind |
|---|---|---|
| 22. A-pillar Front - Left | Chipping from stones | Smart repair |

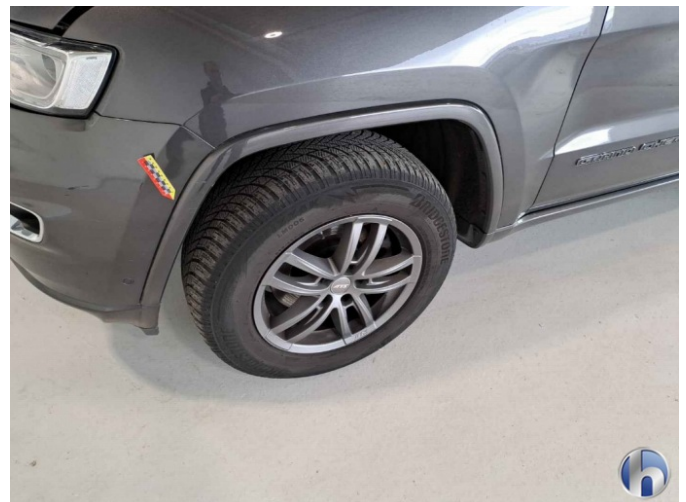
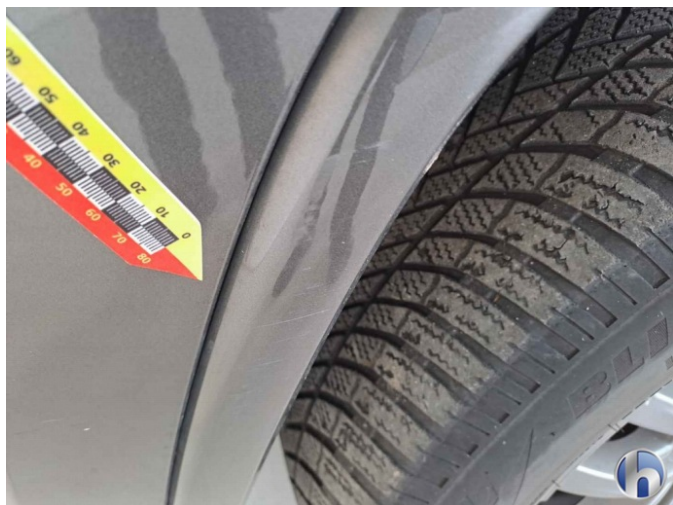
| component | Damage | Rep kind |
|---|---|---|
| 23. | Scrape | Smart repair |

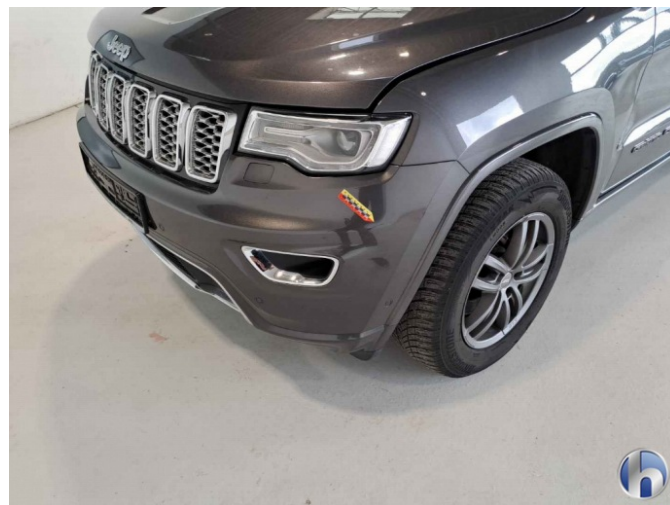
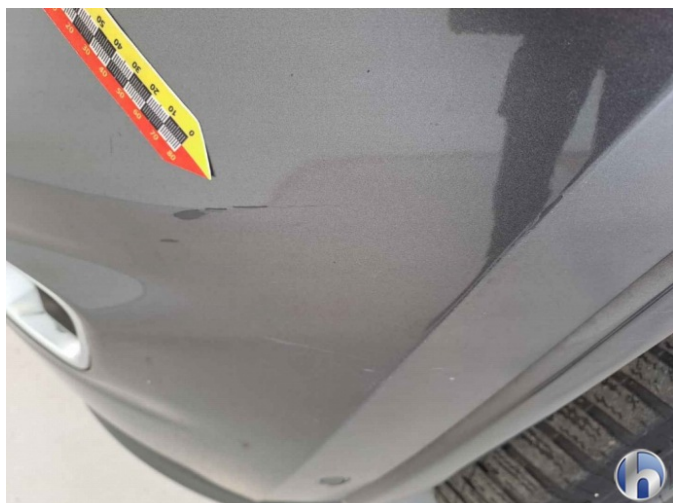
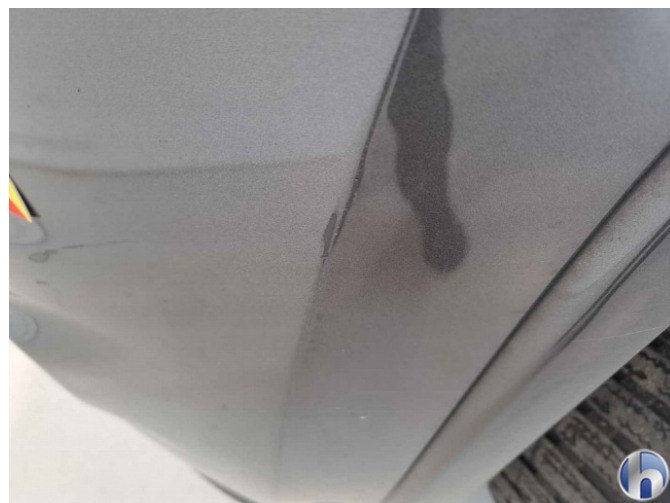
| component | Damage | Rep kind |
|---|---|---|
| 24. Front bumper | Scrape | Smart repair |

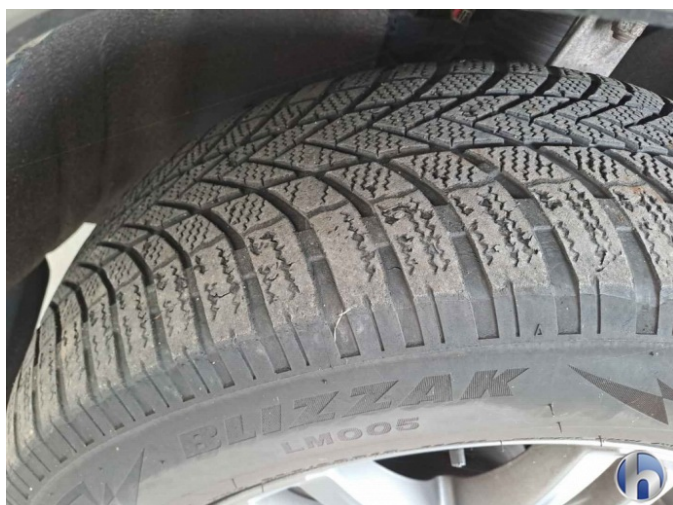
| component | Damage | Rep kind |
|---|---|---|
| 25. | Worn | Replace |

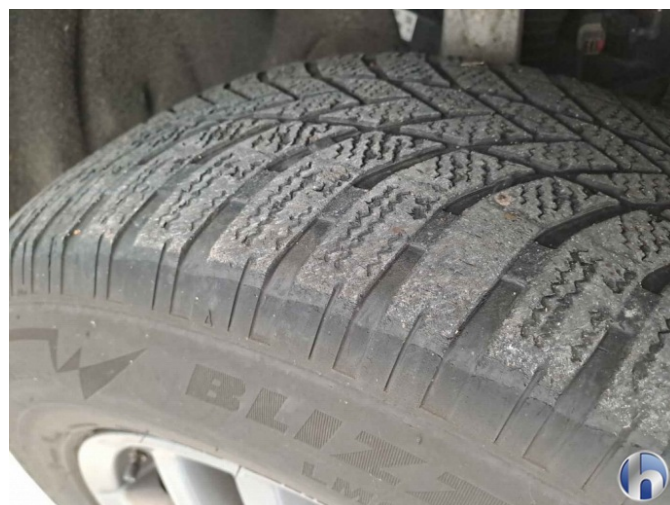
| component | Damage | Rep kind |
|---|---|---|
| 26. | Worn | Replace |

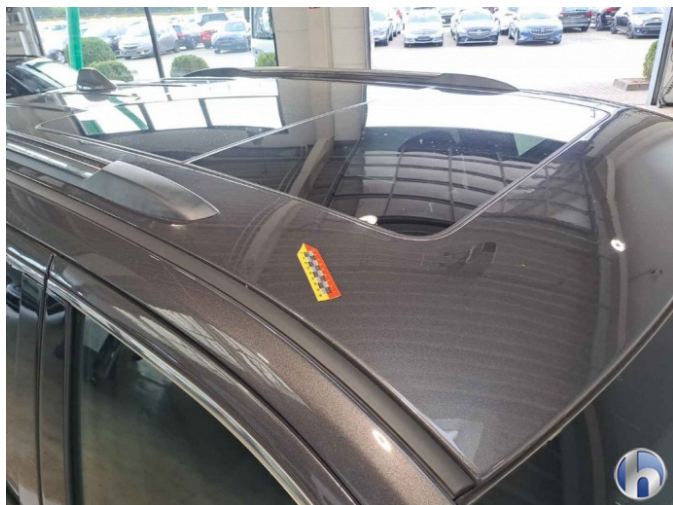
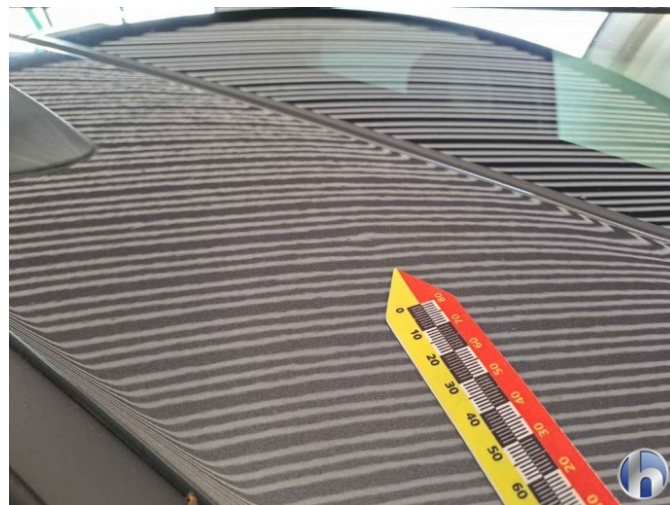
| component | Damage | Rep kind |
|---|---|---|
| 27. roof | Delle | Smart repair |

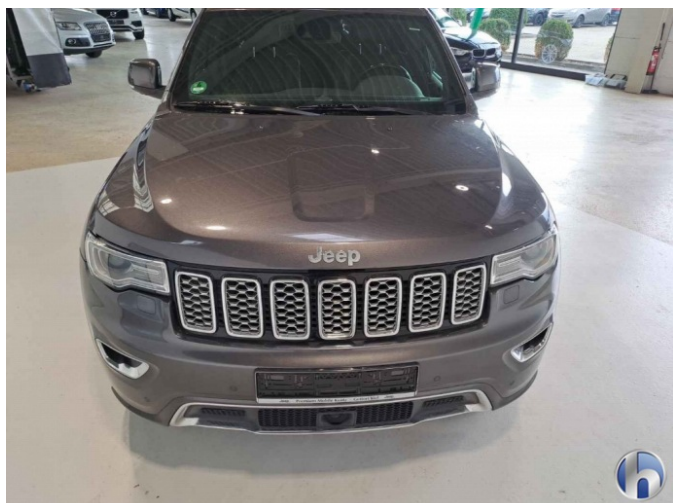
| component | Damage | Rep kind |
|---|---|---|
| 28. exterior body | Surface scratch(es) | |

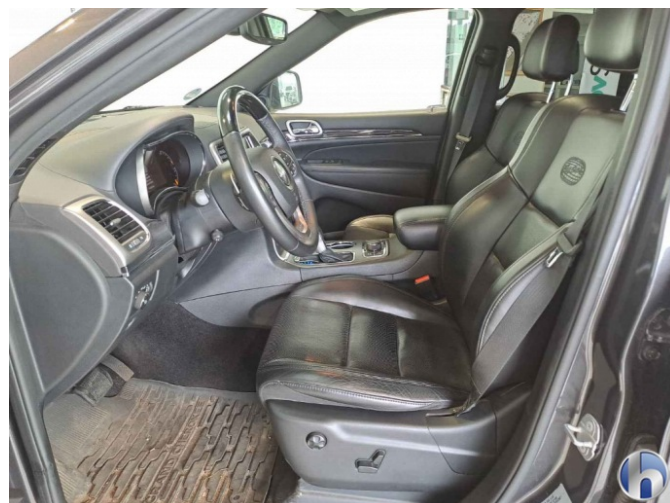
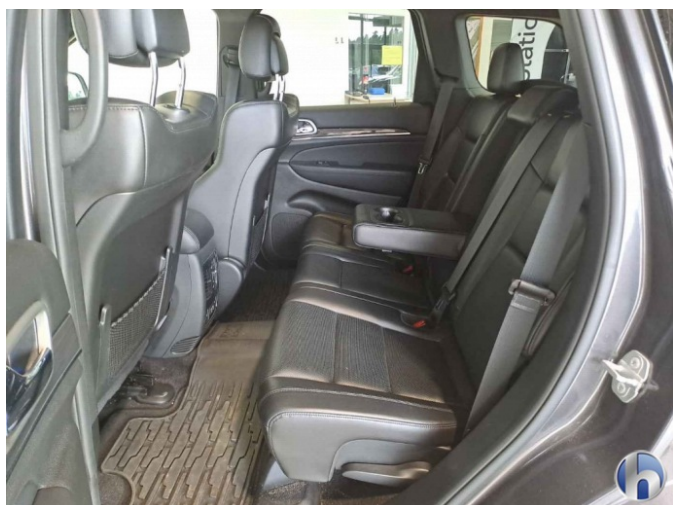
| component | Damage | Rep kind |
|---|---|---|
| 29. | Wear and tear | acceptable |

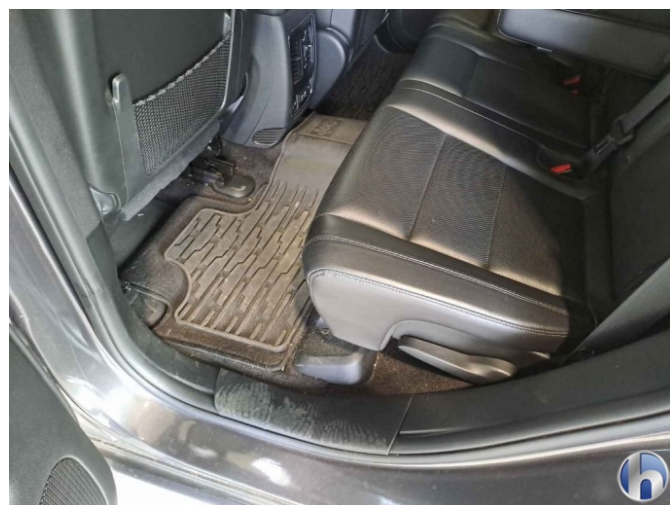
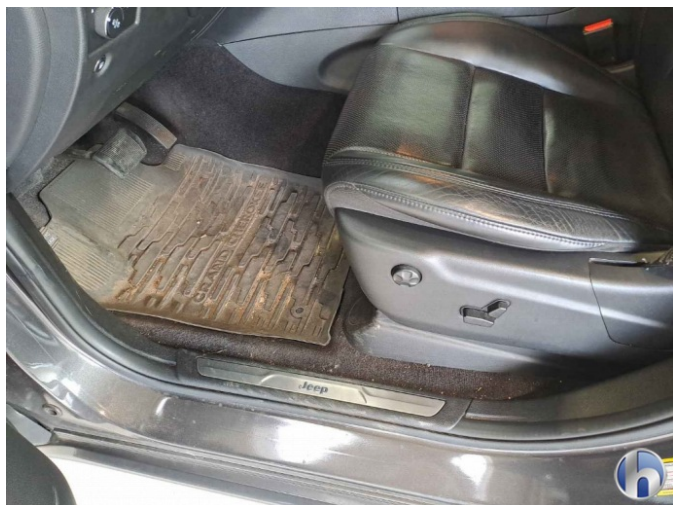
| component | Damage | Rep kind |
|---|---|---|
| 30. | Dirty | |

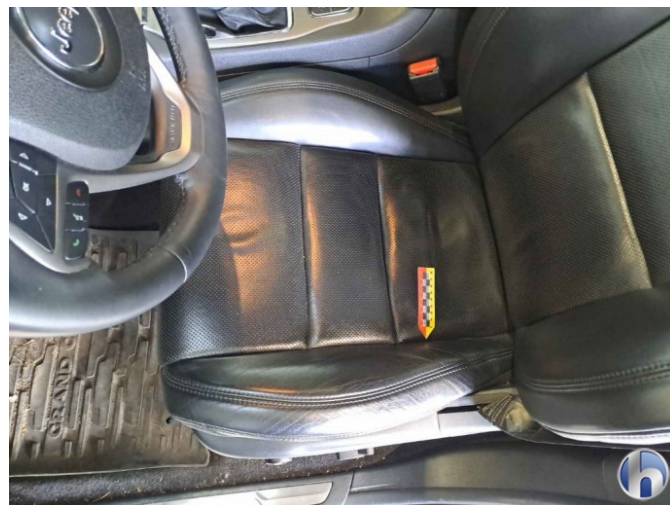
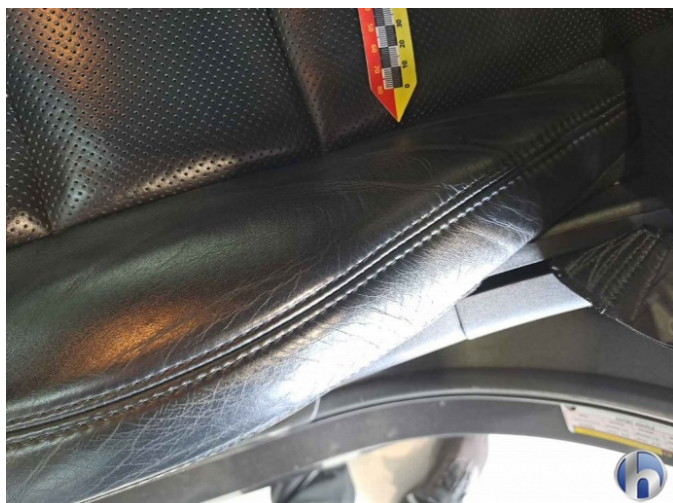
| component | Damage | Rep kind |
|---|---|---|
| 31. | Damaged | Replace |

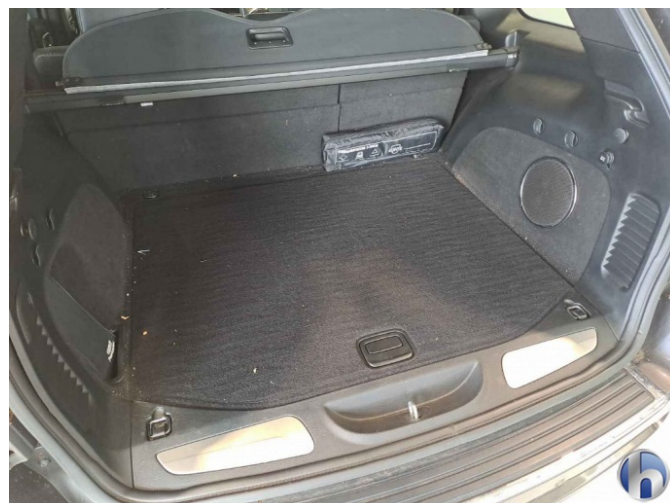
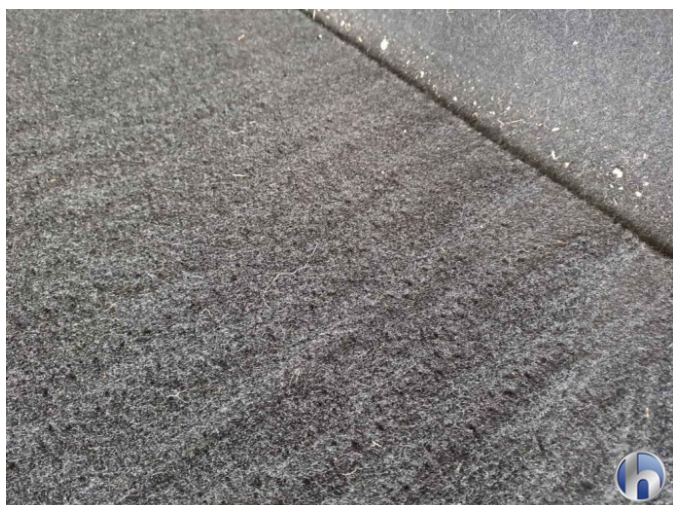
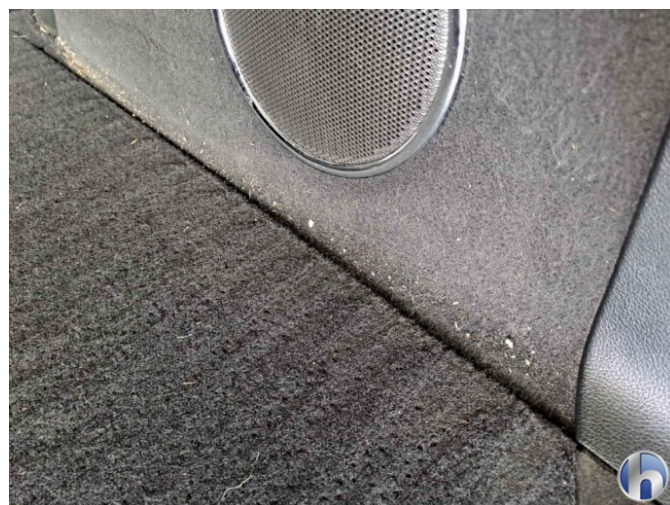
| component | Damage | Rep kind |
|---|---|---|
| 32. | Dirty (animal hair) | |

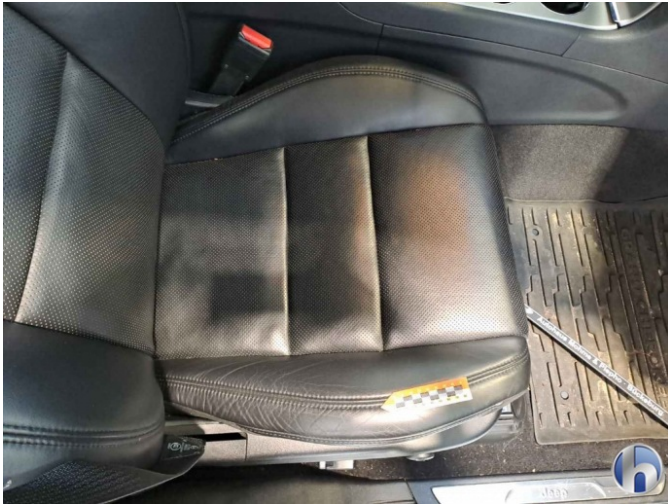
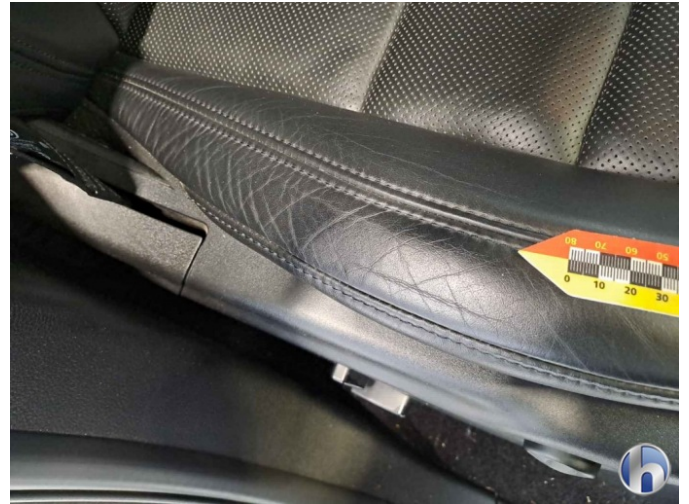
| component | Damage | Rep kind |
|---|---|---|
| 34. | Damaged | Replace |
