## status report

**customer:** Bank 11, Neuss  
**contract number:** 903930931  
**reference:**

#### Dodge Ram 1500

| Vehicle identification number | <b>1C6RR7LG3MS589304</b> | mileage read: | <b>50389 km</b> |

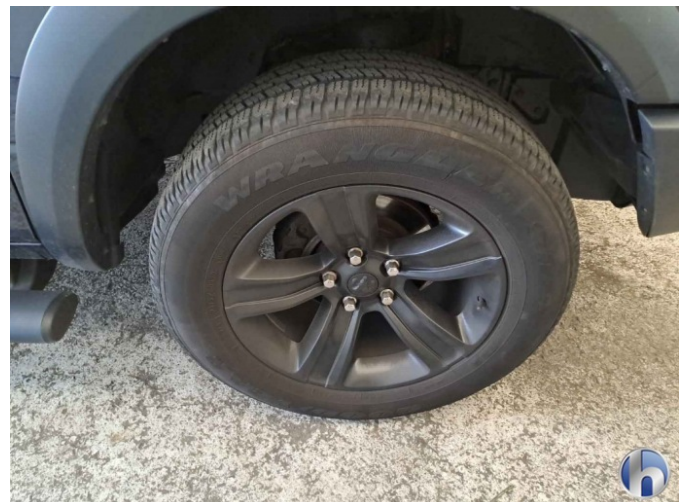
| component | Damage | Rep kind |
|---|---|---|
| 15. Rim rear - left | Scratch(es) | Paint |

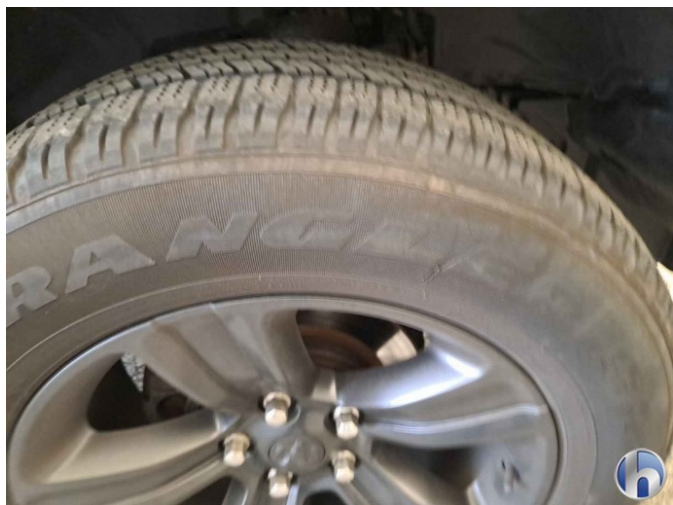
| component | Damage | Rep kind |
|---|---|---|
| 16. tire front - right | Damaged | Replace |

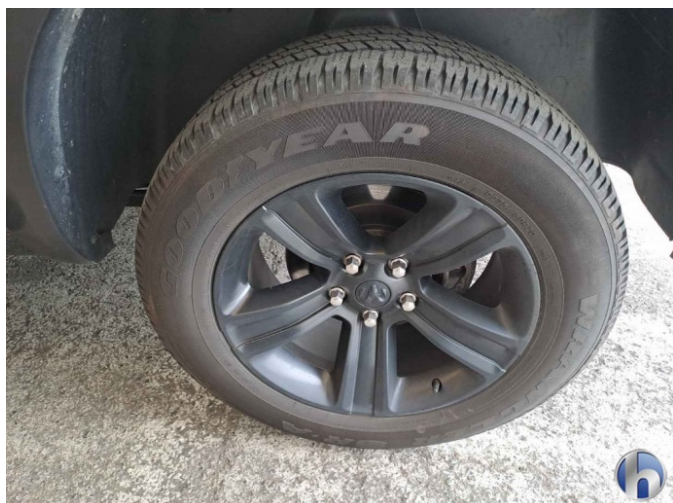
| component | Damage | Rep kind |
|---|---|---|
| 18. tire rear - left | Not safe for road traffic | Replace |

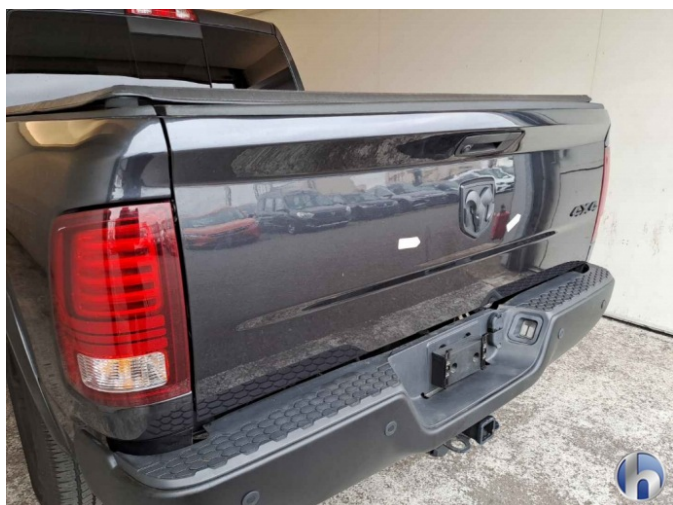
| component | Damage | Rep kind |
|---|---|---|
| 20. tailgate | Execution defect | Paint |

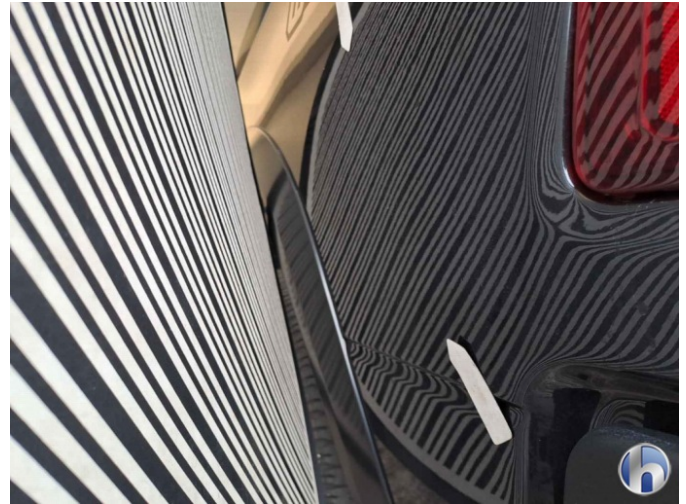
| component | Damage | Rep kind |
|---|---|---|
| 22. Sidewall - Rear - Left | Execution defect | Refurbish and paint |

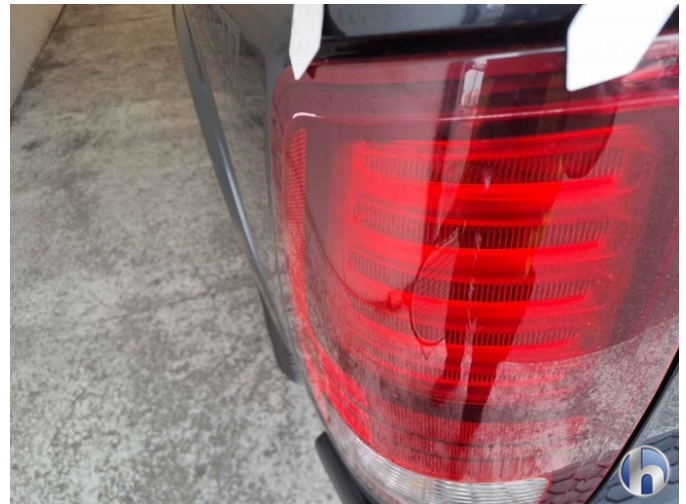
| component | Damage | Rep kind |
|---|---|---|
| 23. Taillight left | Scratch(es) | Replace |

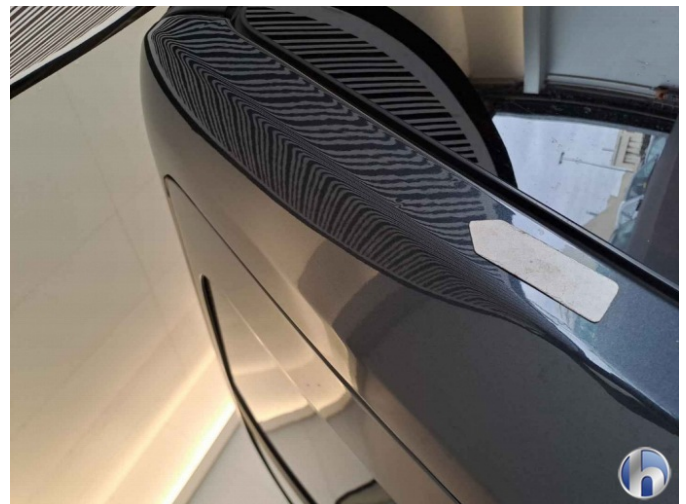
| component | Damage | Rep kind |
|---|---|---|
| 24. C-pillar back - left | Execution defect | Refurbish and paint |

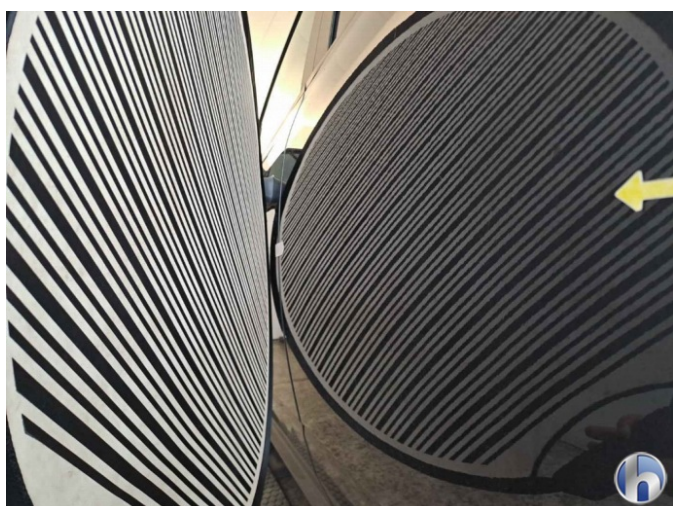
| component | Damage | Rep kind |
|---|---|---|
| 25. Rear door - left | Execution defect | Refurbish and paint |

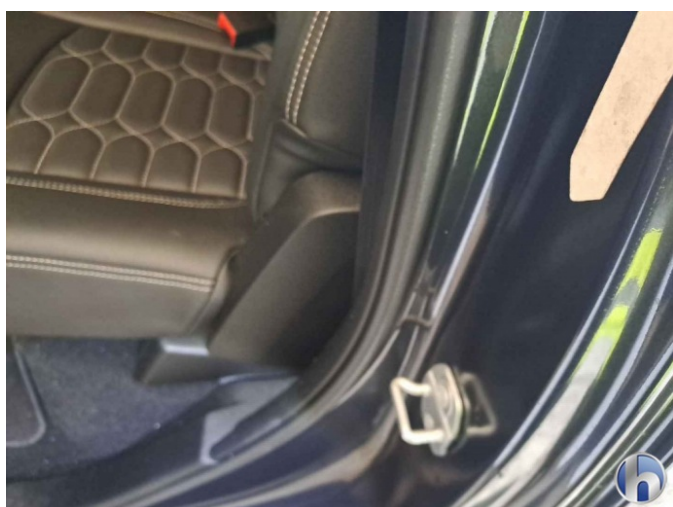
| component | Damage | Rep kind |
|---|---|---|
| 26. Türeinstieg Hinten - Links | Execution defect | Paint |

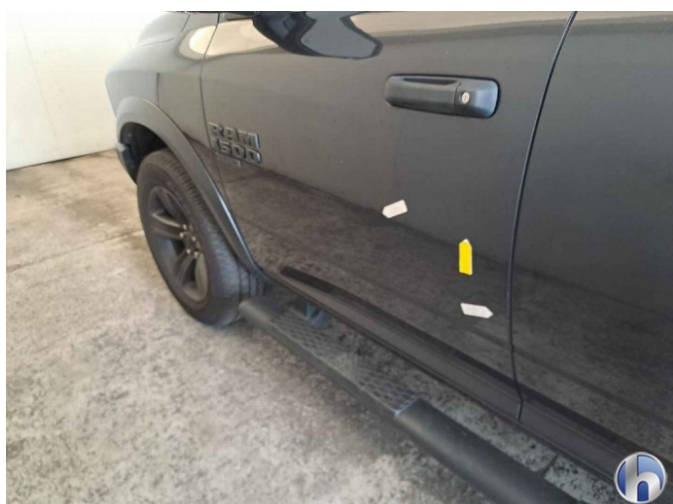
| component | Damage | Rep kind |
|---|---|---|
| 28. Front door - left | Execution defect | Refurbish and paint |

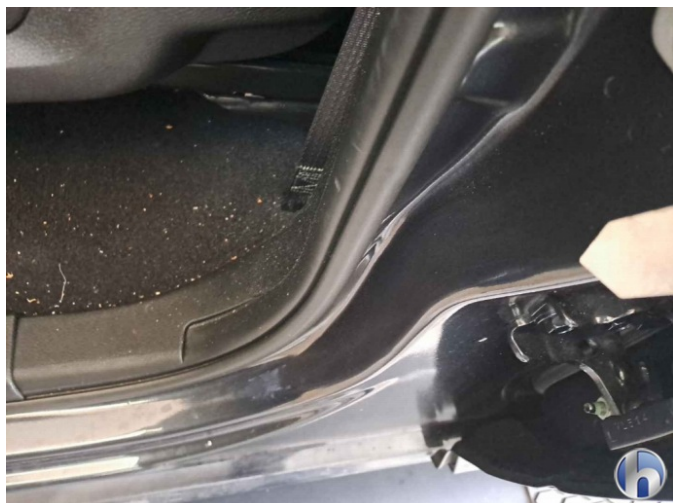
| component | Damage | Rep kind |
|---|---|---|
| 29. Türeinstieg Vorne - Links | Execution defect | Paint |

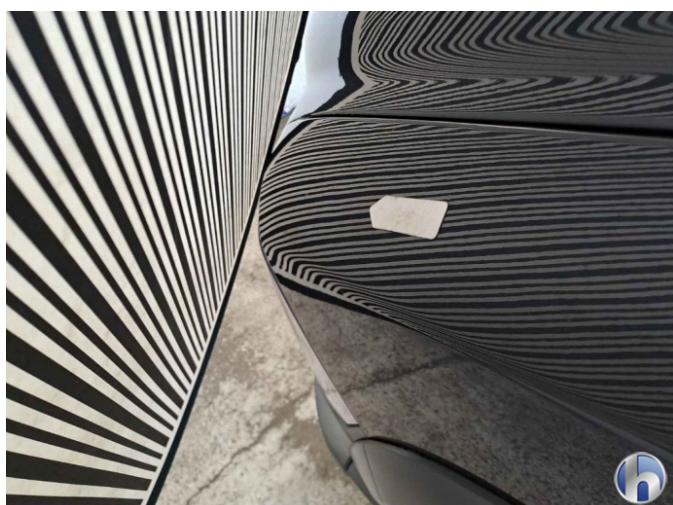
| component | Damage | Rep kind |
|---|---|---|
| 30. Front fender - left | Execution defect | Refurbish and paint |

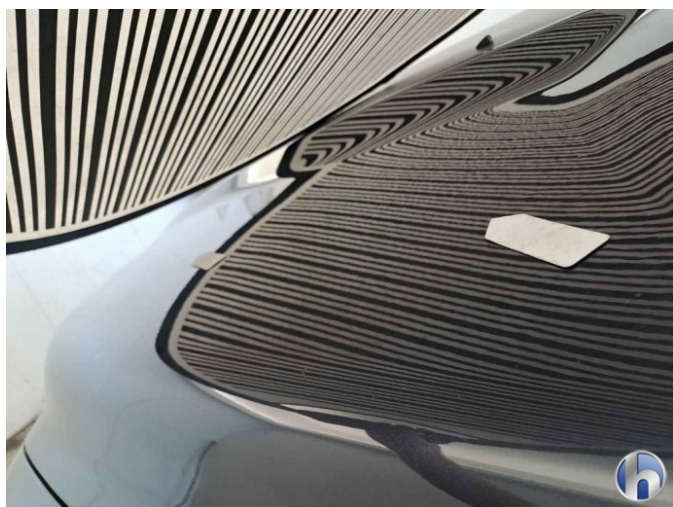
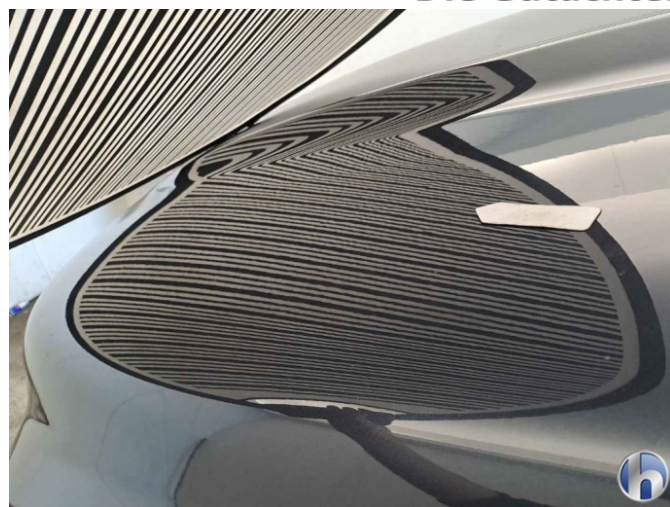
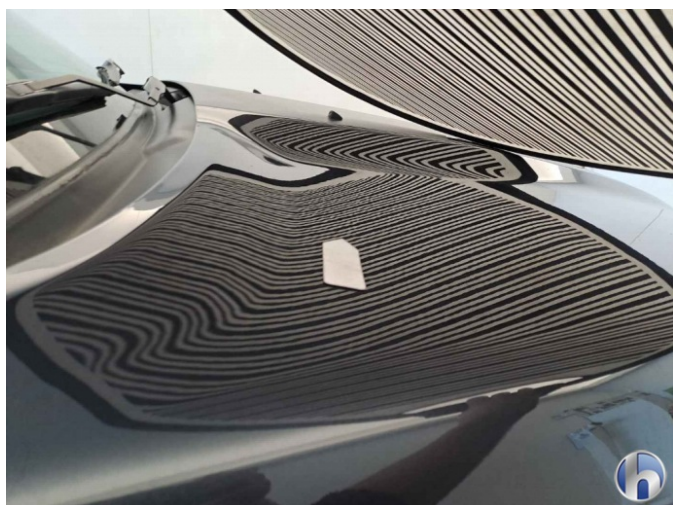
| component | Damage | Rep kind |
|---|---|---|
| 31. hood | Execution defect | Refurbish and paint |

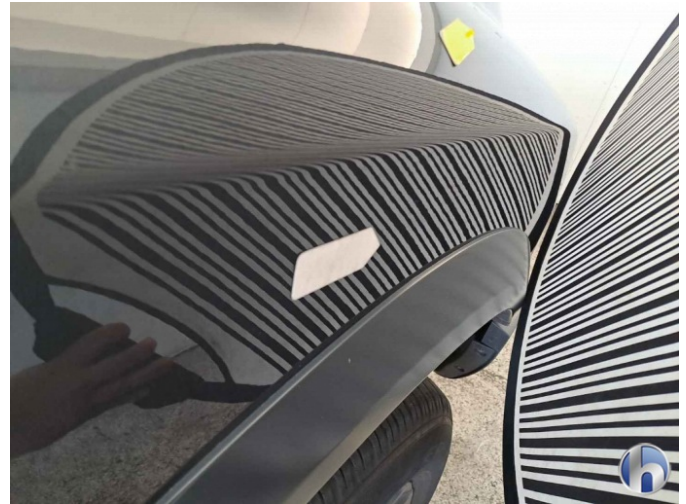
| component | Damage | Rep kind |
|---|---|---|
| 32. Front fender - right | Execution defect | Refurbish and paint |

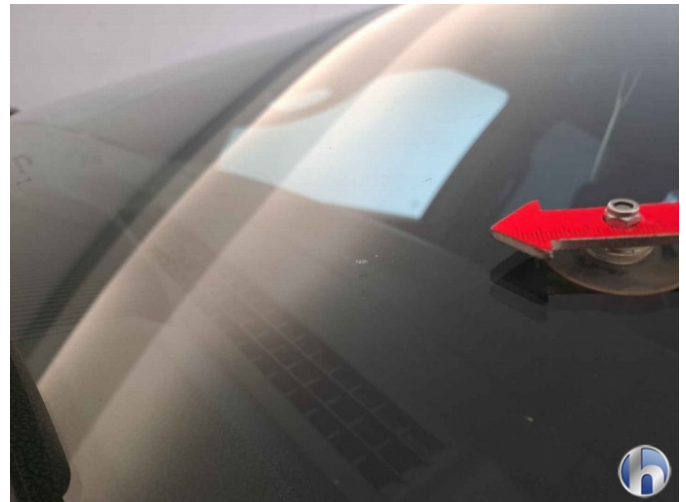
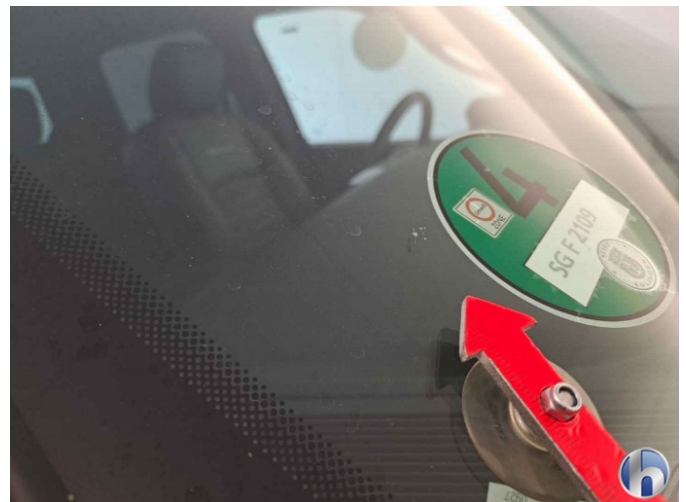
| component | Damage | Rep kind |
|---|---|---|
| 33. Windshield | Chipping from stones in field of view | Replace |

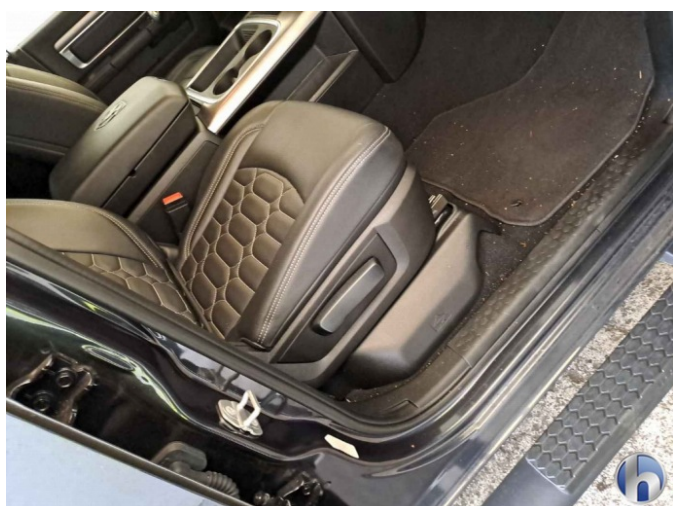
| component | Damage | Rep kind |
|---|---|---|
| 35. Türeinstieg Vorne - Rechts | Execution defect | Paint |

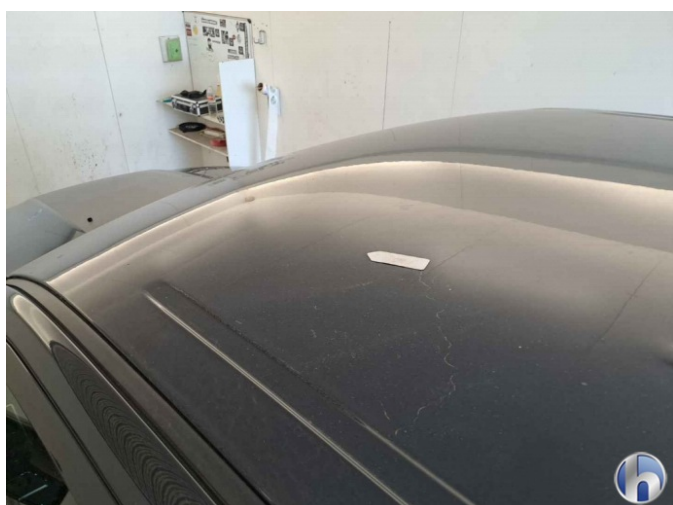
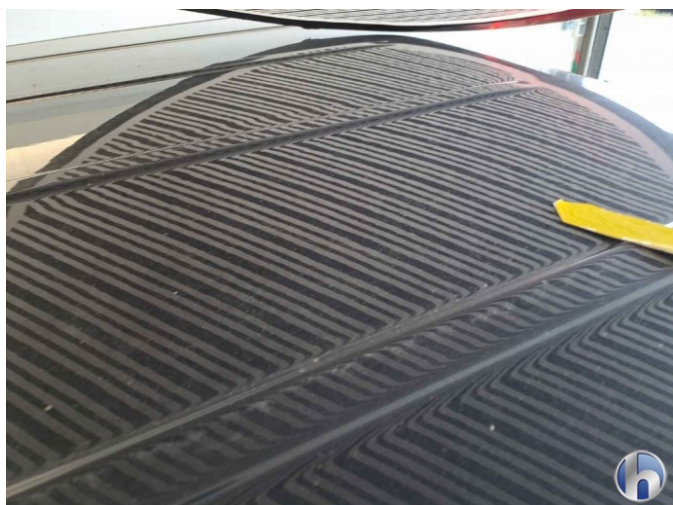
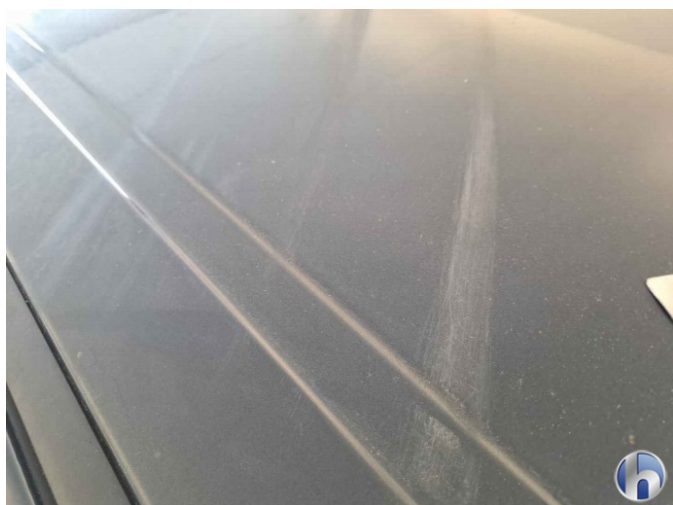
| component | Damage | Rep kind |
|---|---|---|
| 36. roof | Execution defect | Refurbish and paint |

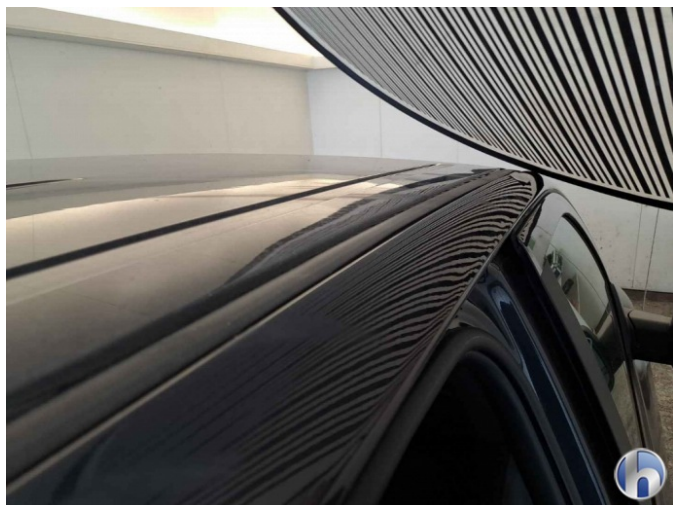
| component | Damage | Rep kind |
|---|---|---|
| 37. Roof frame - right | Execution defect | Refurbish and paint |

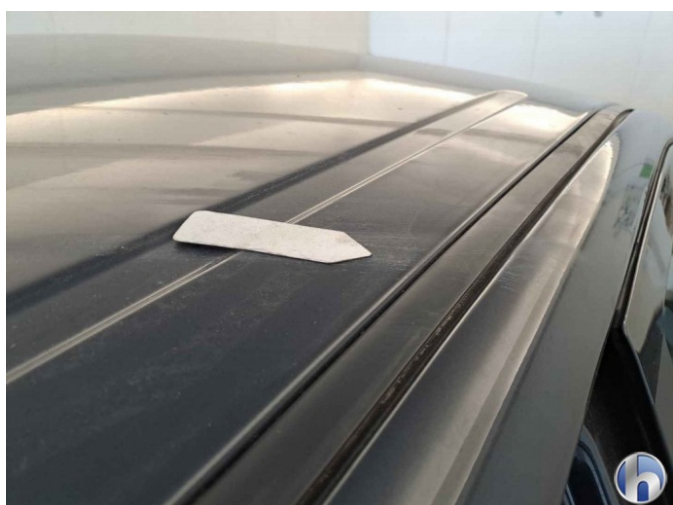
| component | Damage | Rep kind |
|---|---|---|
| 38. Dachleiste Rechts | Scrape | Replace |

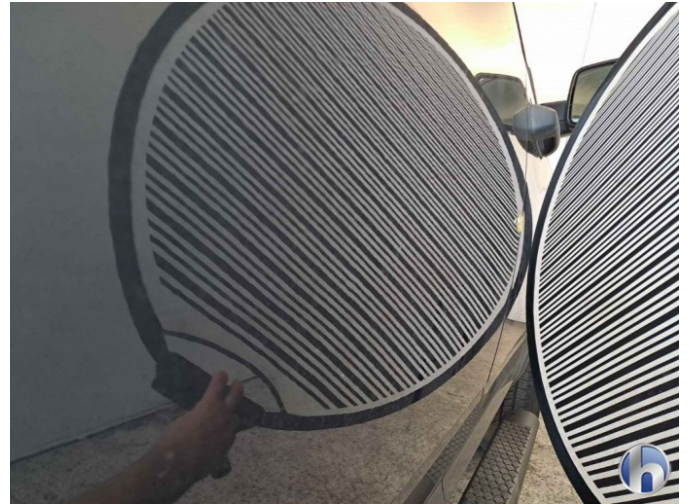
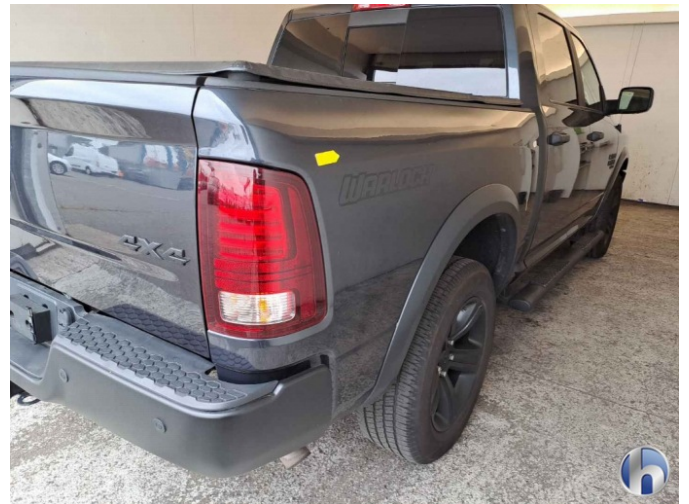
40. Door Rear - right

| 40. | Door Rear - right | Execution defect | Refurbish and paint |

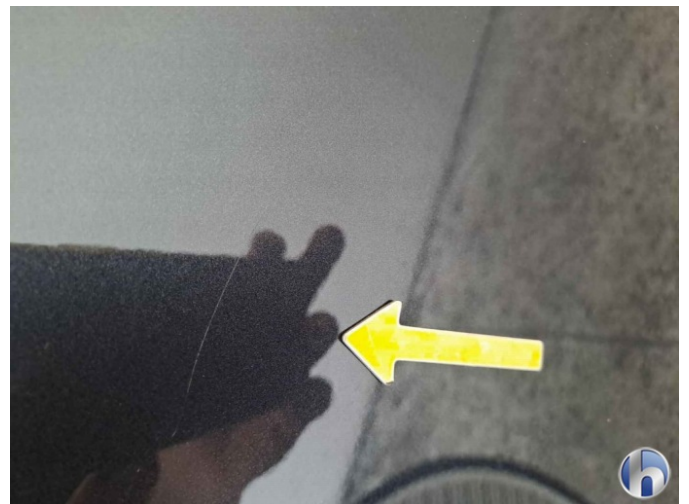
41. Sidewall - Rear - right

| 41. | Sidewall - Rear - right | Execution defect | Refurbish and paint |

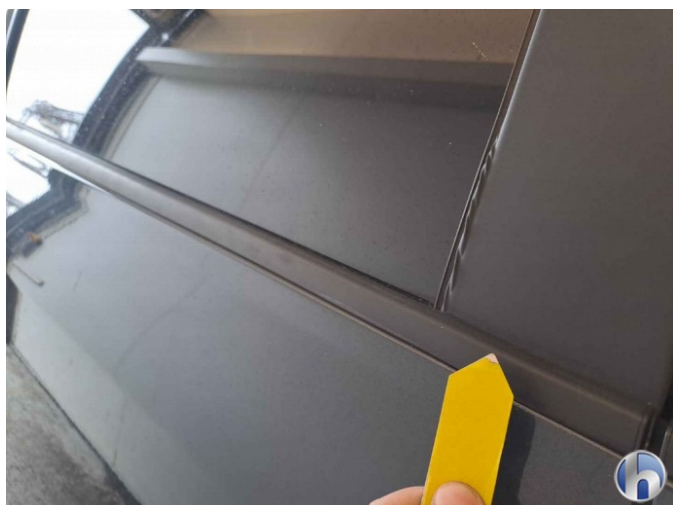
47. B-säule Mitte - Rechts Folierung

| 47. | B-säule Mitte - Rechts Folierung | Damaged | Replace |

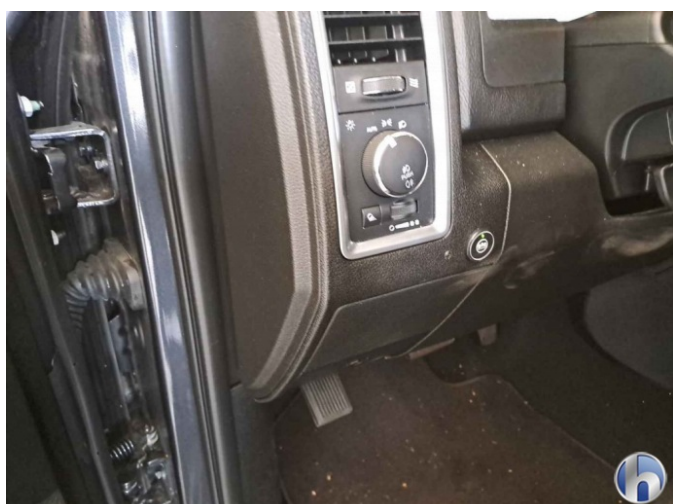
49. covering

| 49. | covering | Damaged | Replace |

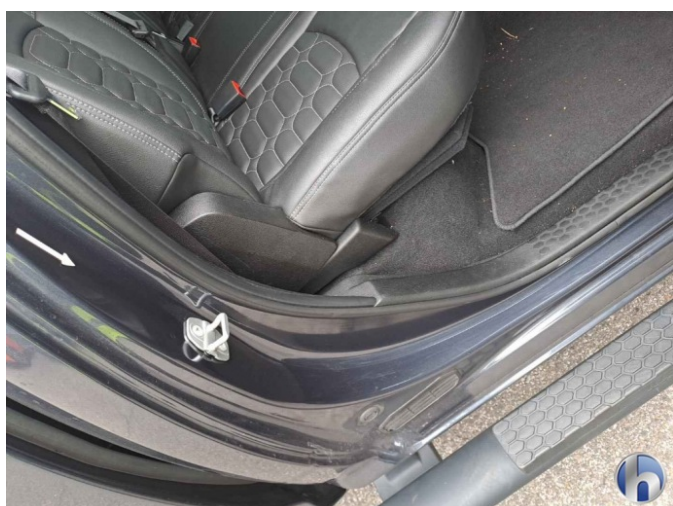
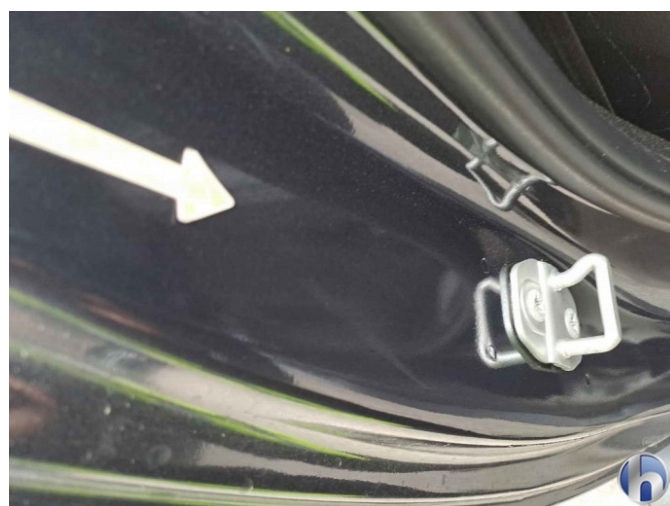
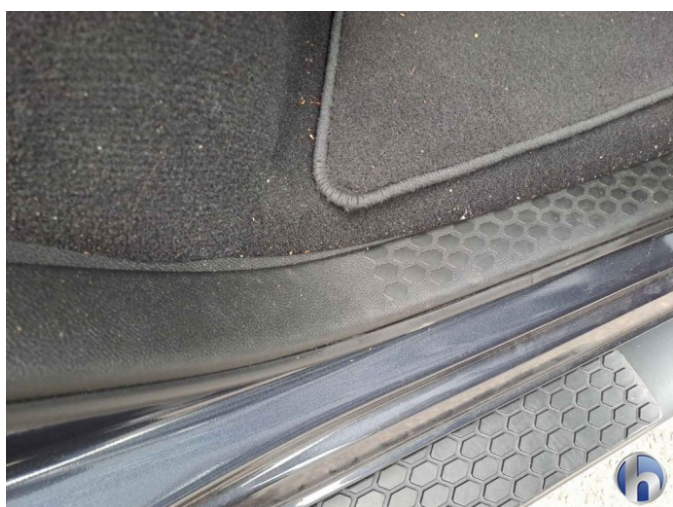
52. Türeinstieg Hinten - Rechts

| 52. | Türeinstieg Hinten - Rechts | Execution defect | Paint |

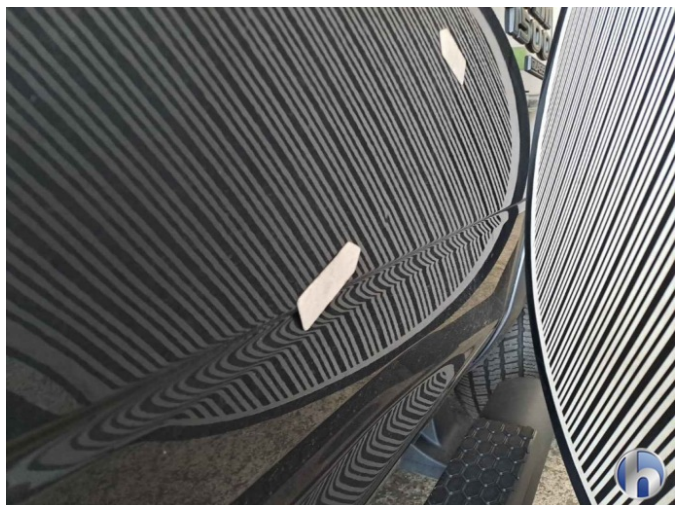
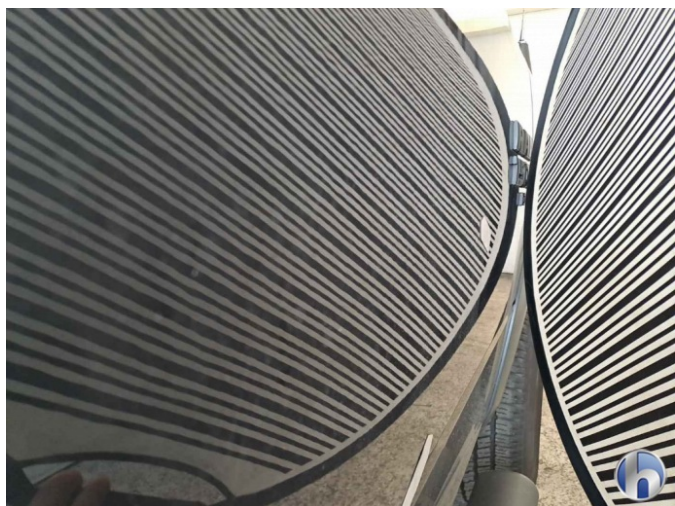
53. Front door - right

| 53. | Front door - right | Execution defect | Refurbish and paint |
