## status report

**customer:** BCA Autoauktionen GmbH  
**contract number:**  
**reference:**

#### DODGE RAM1500

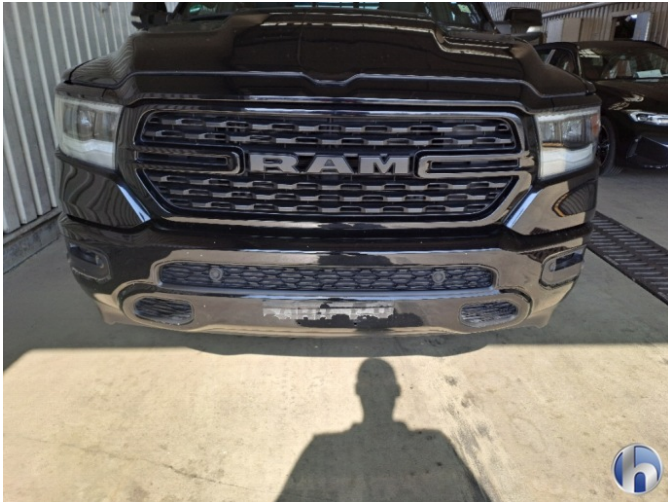
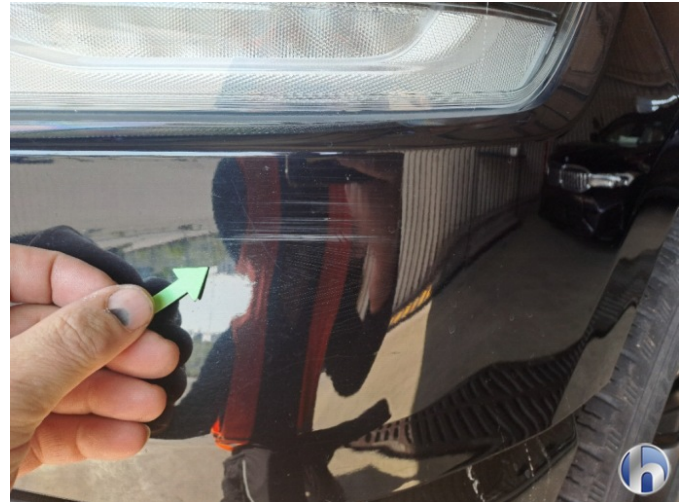
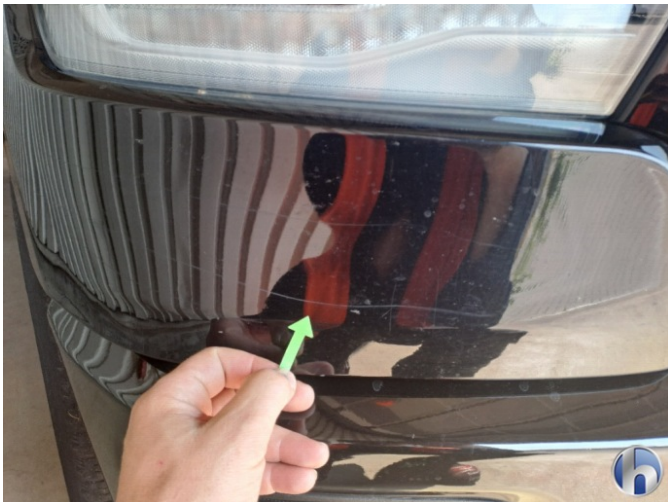
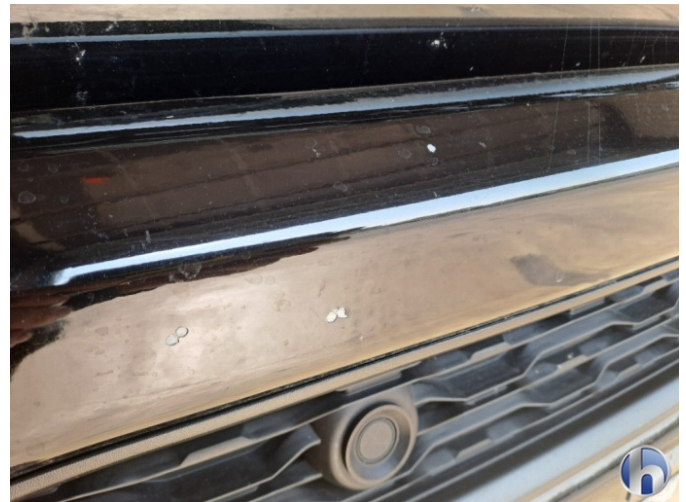
| component | Damage | Rep kind |
|---|---|---|
| 2. Front bumper | Scratch(es) | Paint |

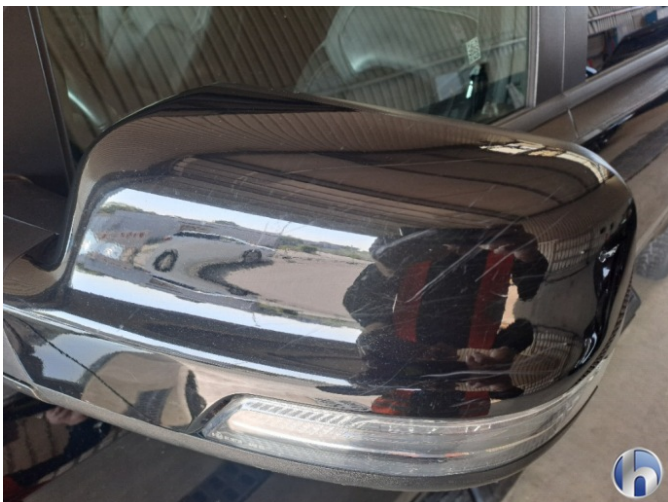
| component | Damage | Rep kind |
|---|---|---|
| 3. Spiegelkappe links | Scratch(es) | Smart repair |

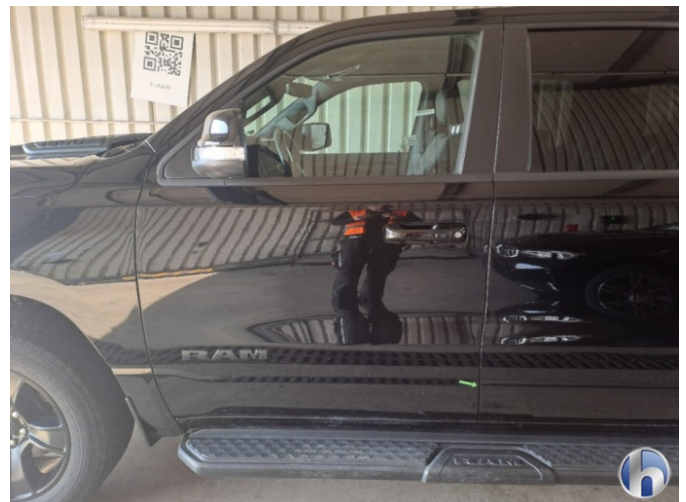
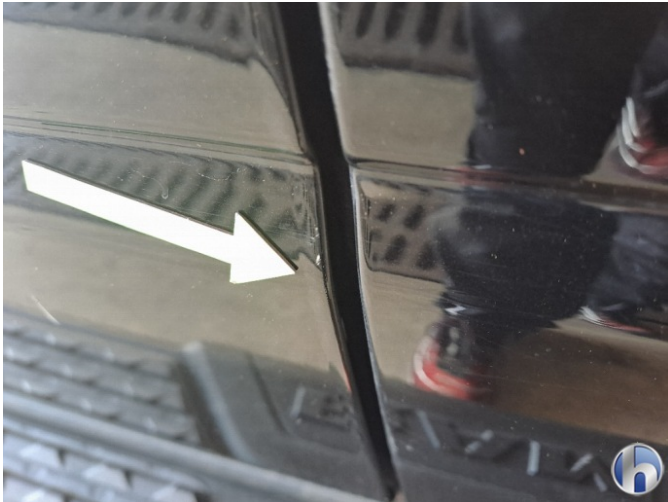
| component | Damage | Rep kind |
|---|---|---|
| 4. Front door - left | Scratch(es) | Smart repair |

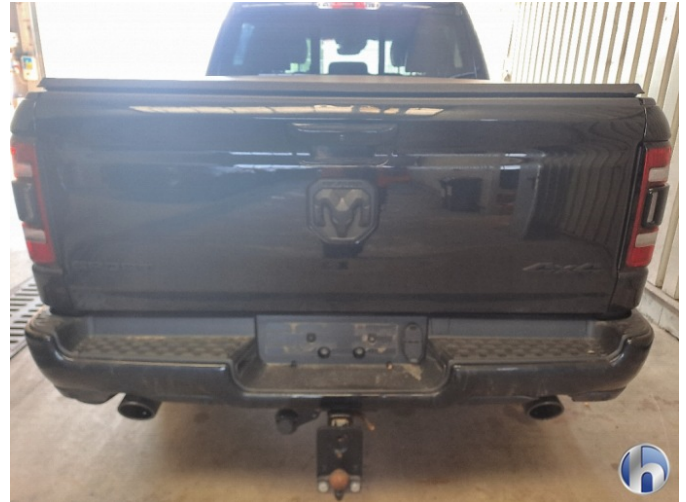
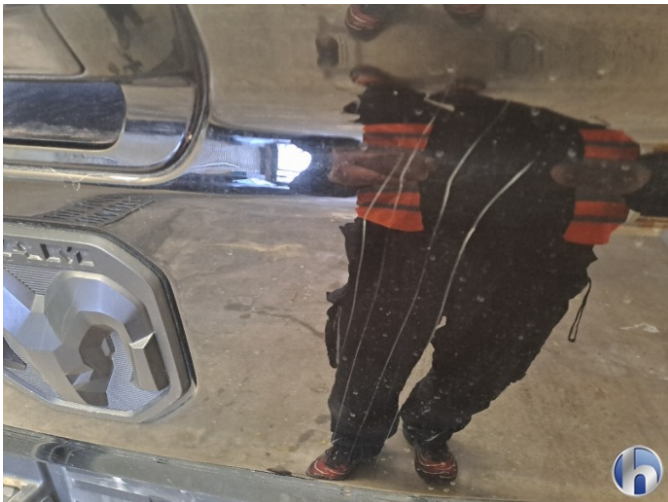
| component | Damage | Rep kind |
|---|---|---|
| 5. tailgate | Scratch(es) | Paint |

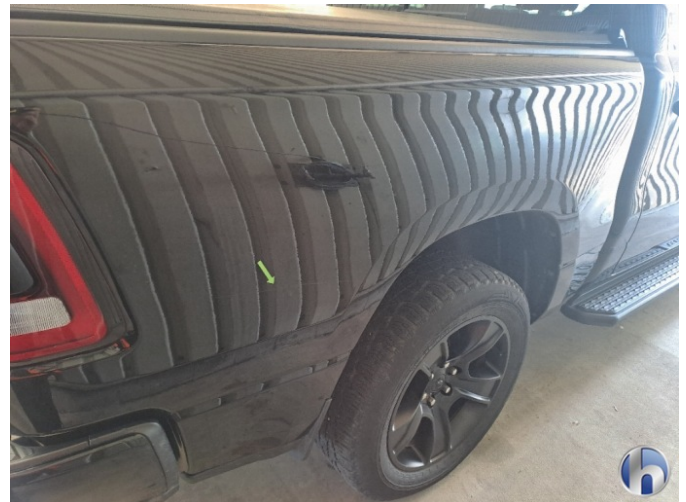
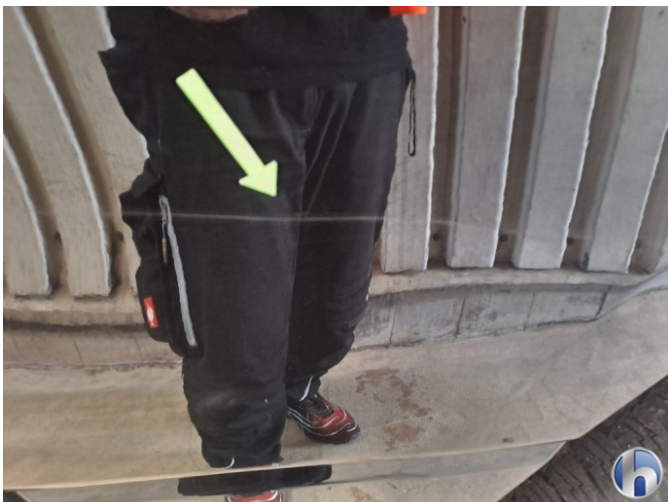
| component | Damage | Rep kind |
|---|---|---|
| 6. Sidewall - Rear - right | Scratch(es) | Paint |

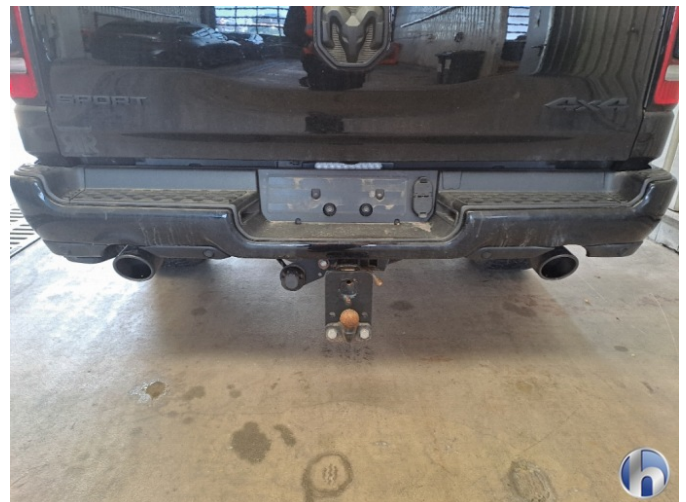
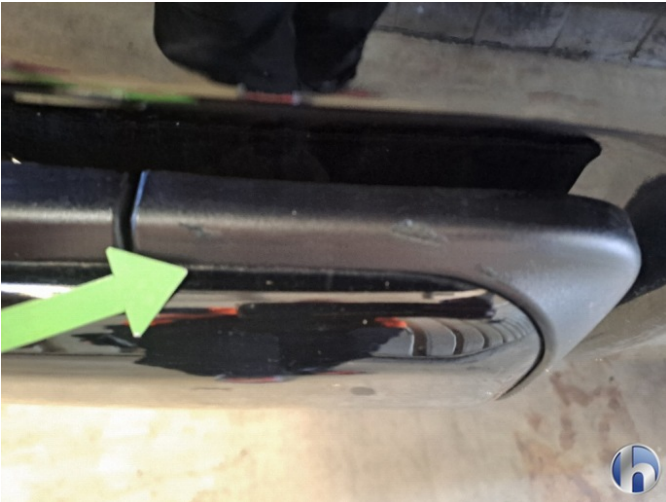
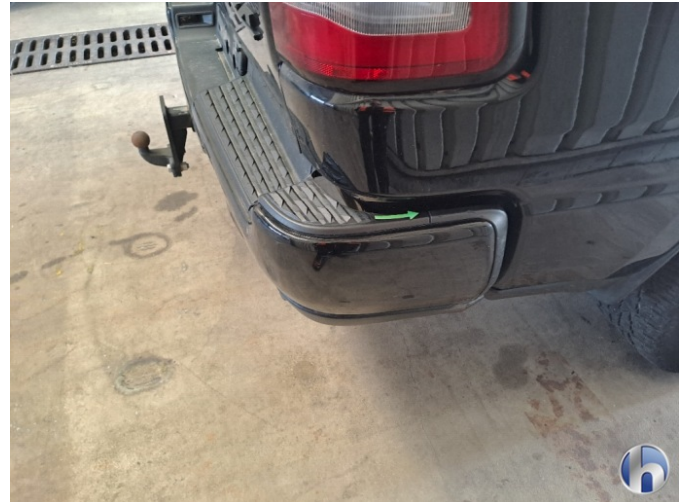
| component | Damage | Rep kind |
|---|---|---|
| 7. Rear bumper | Scratch(es) | Smart repair |

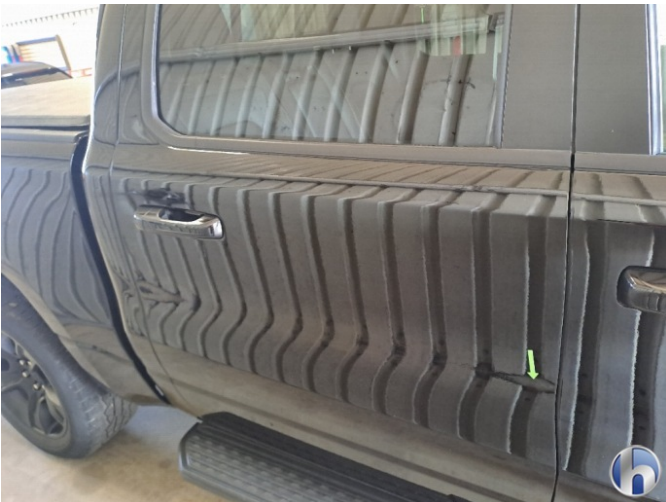
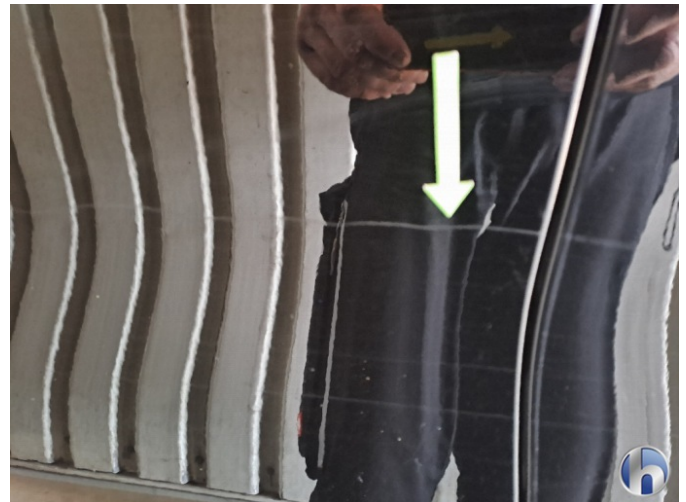
| component | Damage | Rep kind |
|---|---|---|
| 8. Door Rear - right | Scratch(es) | Paint |

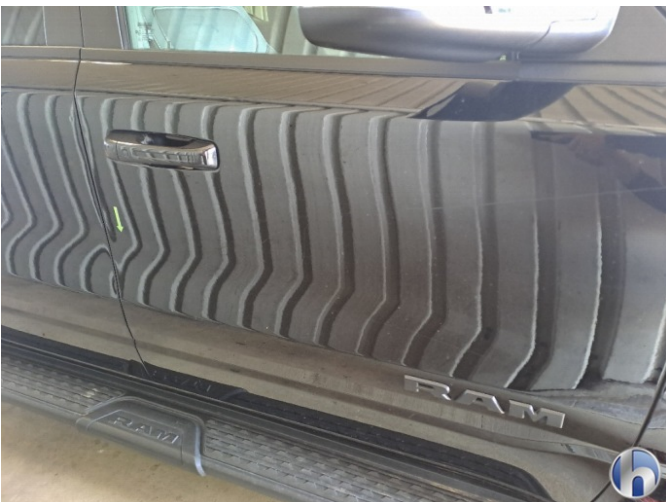
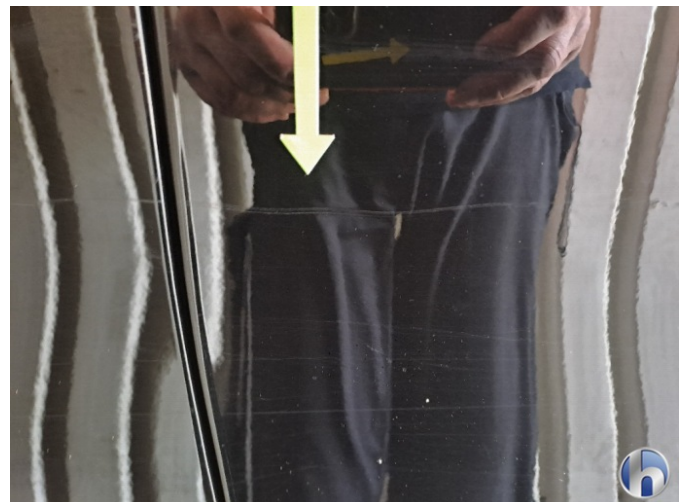
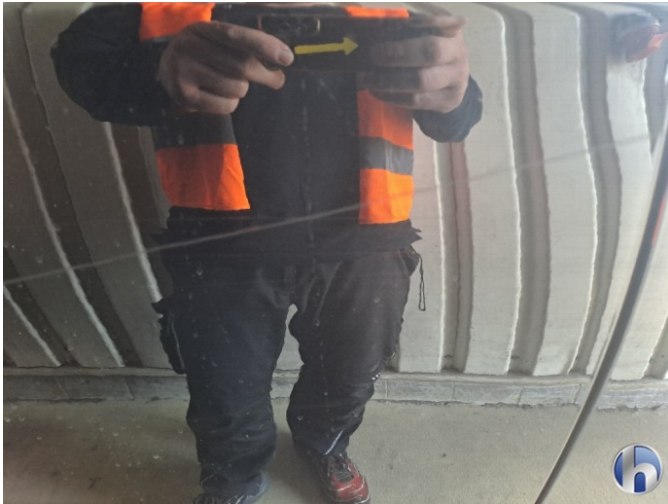
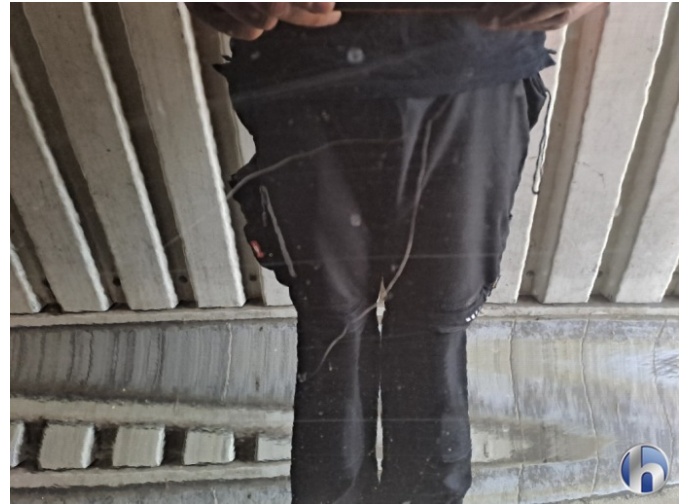
| component | Damage | Rep kind |
|---|---|---|
| 9. Front door - right | Scratch(es) | Paint |

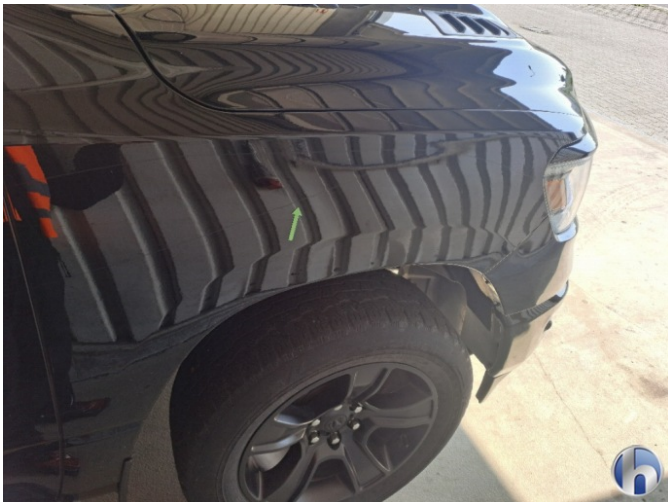
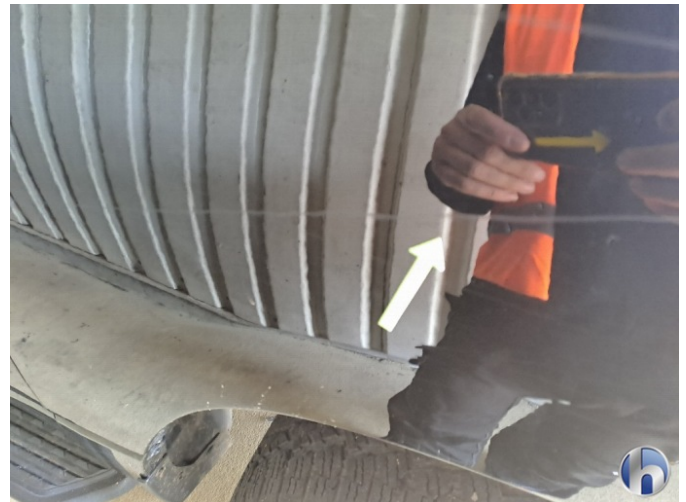
| component | Damage | Rep kind |
|---|---|---|
| 10. Front fender - right | Scratch(es) | Paint |

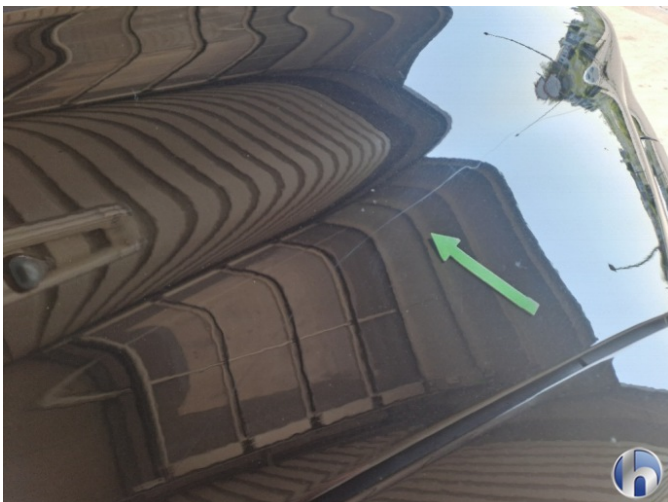
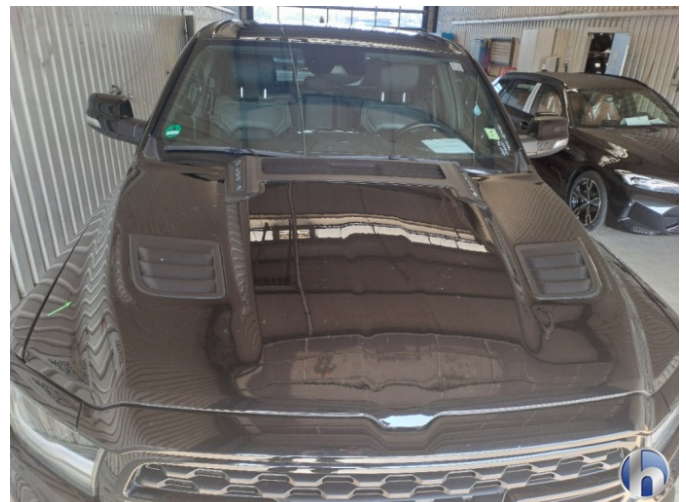
| component | Damage | Rep kind |
|---|---|---|
| 11. hood | Scratch(es) | Paint |

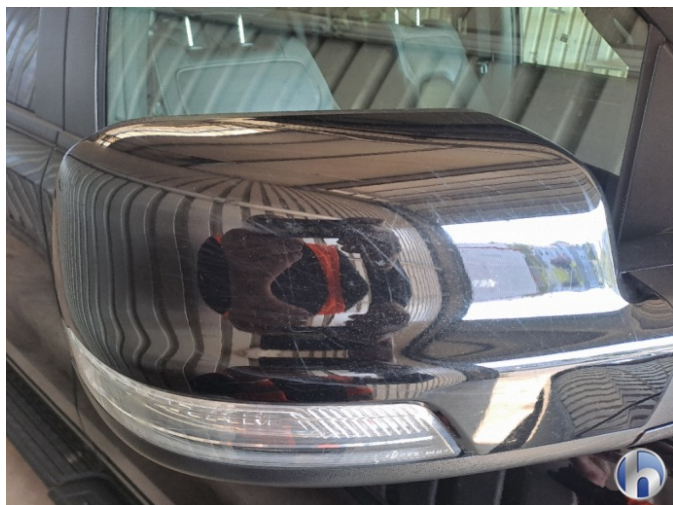
| component | Damage | Rep kind |
|---|---|---|
| 12. Spiegelkappe rechts | Scratch(es) | Smart repair |
