## status report

**customer:** BCA Autoauktionen GmbH

#### Cadillac Escalade

| Vehicle identification number | <b>1GYFK63868R257108</b> | mileage read: | <b>199113 km</b> |

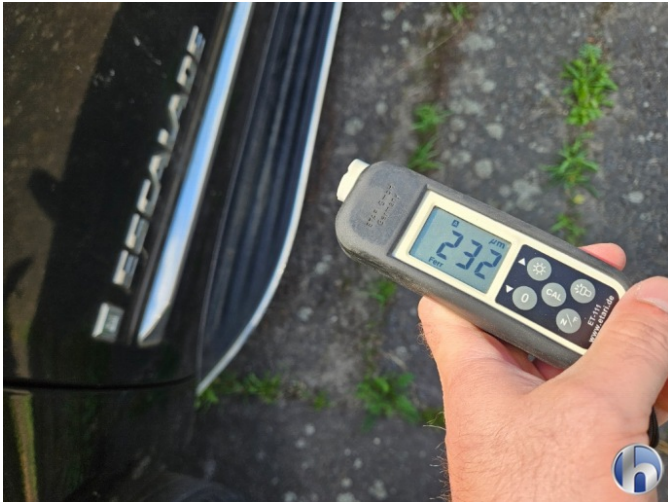
| component | Damage | Rep kind |
|---|---|---|
| 1. Front door - left | Subsequently painted | acceptable |

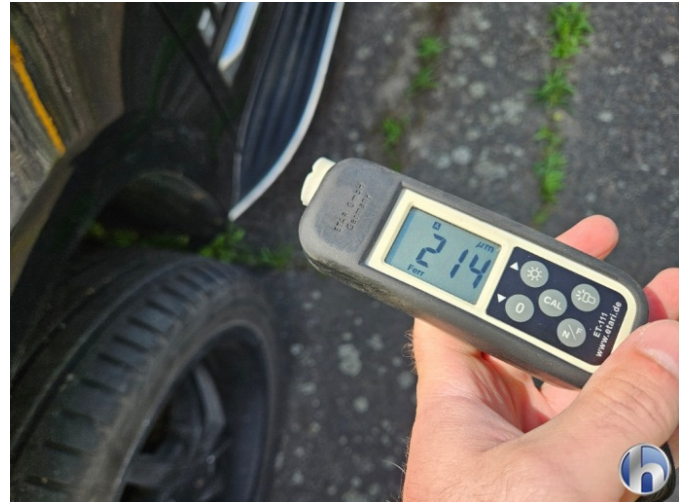
| component | Damage | Rep kind |
|---|---|---|
| 2. Front fender - left | Subsequently painted | acceptable |

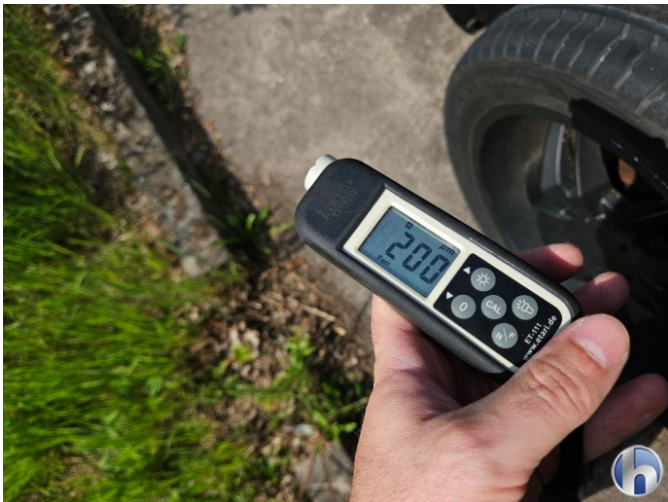
| component | Damage | Rep kind |
|---|---|---|
| 3. Door Rear - right | Subsequently painted | acceptable |

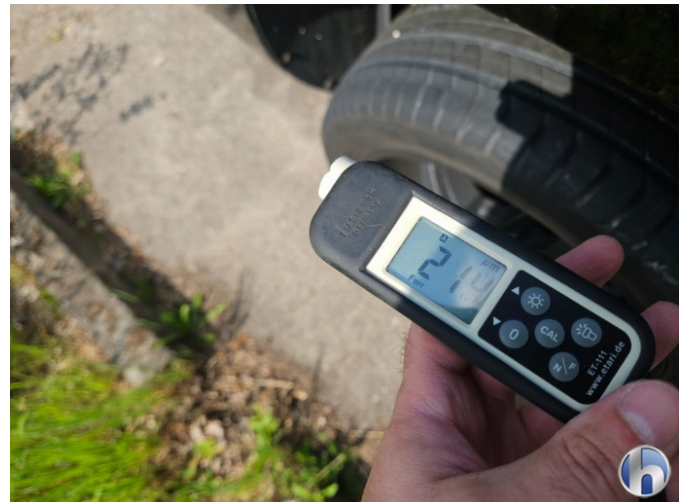
| component | Damage | Rep kind |
|---|---|---|
| 4. Sidewall - Rear - right | Subsequently painted | acceptable |

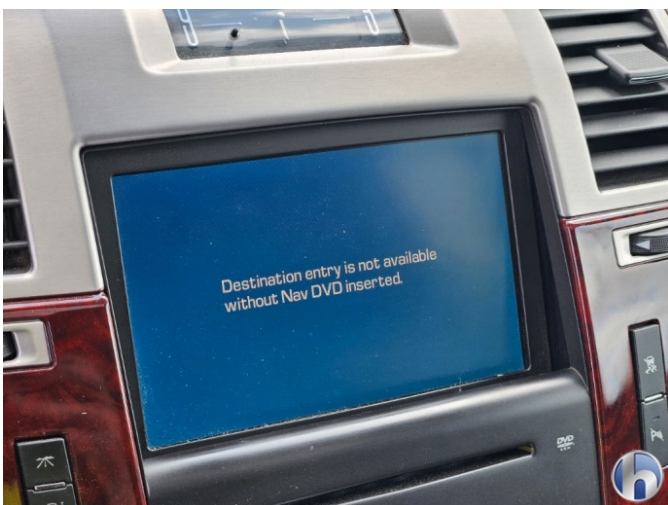
| component | Damage | Rep kind |
|---|---|---|
| 7. | Missing | Replace |

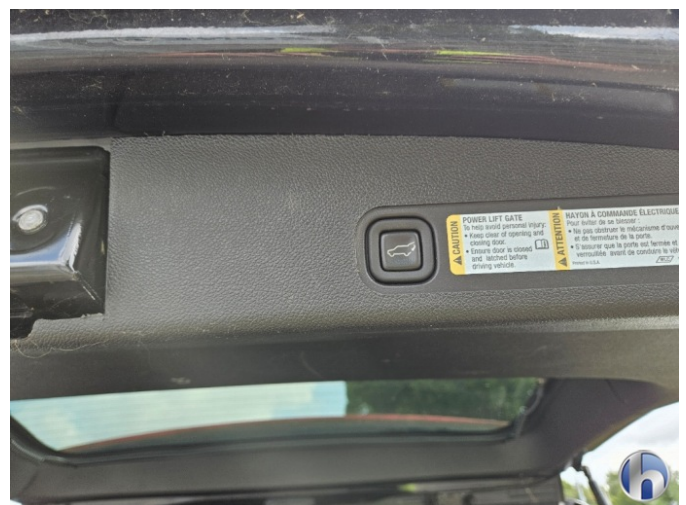
| component | Damage | Rep kind |
|---|---|---|
| 9. elektr. Heckklappe | No functionality | Carry out a fault diagnosis |

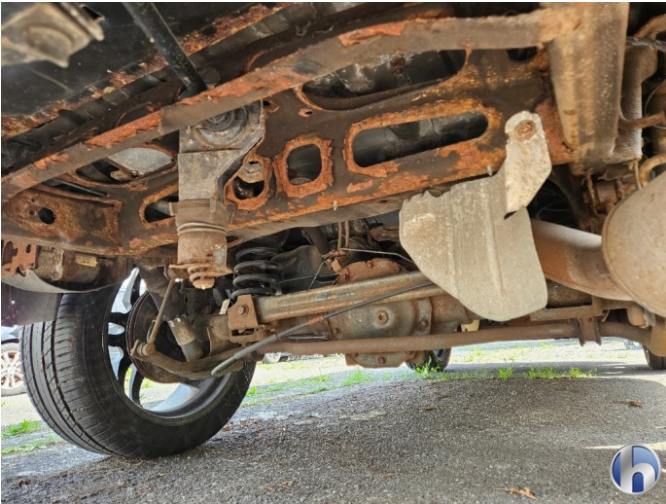
| component | Damage | Rep kind |
|---|---|---|
| 10. Unterboden | Rust | acceptable |

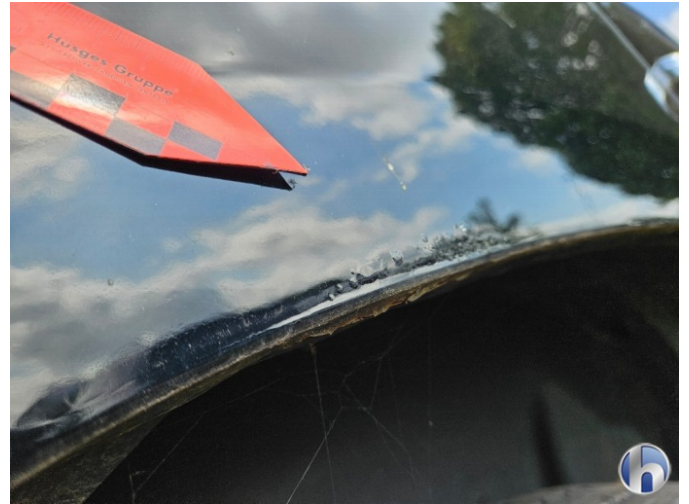
| component | Damage | Rep kind |
|---|---|---|
| 11. Sidewall - Rear - right | Execution defect | Paint |

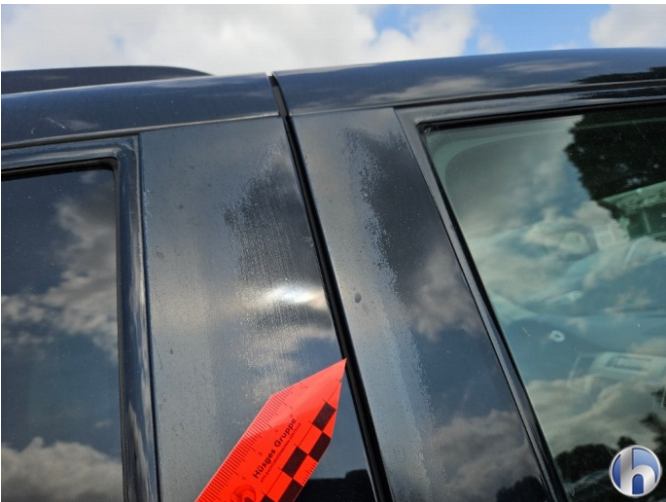
| component | Damage | Rep kind |
|---|---|---|
| 12. Front door - right | Wear and tear | acceptable |

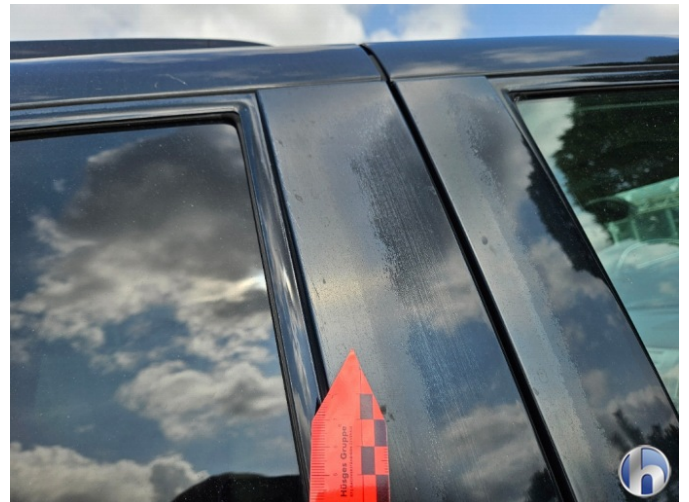
| component | Damage | Rep kind |
|---|---|---|
| 13. Door Rear - right | Wear and tear | acceptable |

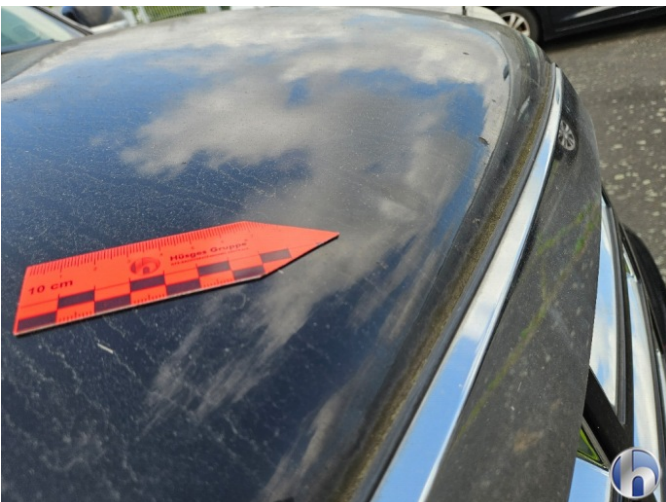
| component | Damage | Rep kind |
|---|---|---|
| 14. hood | Wear and tear | acceptable |

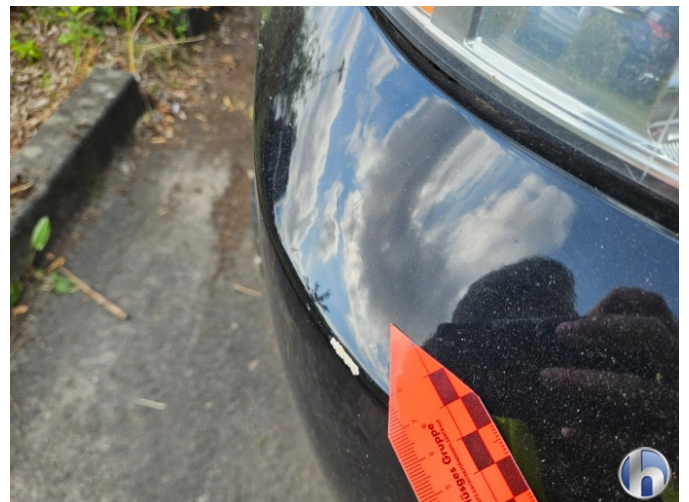
| component | Damage | Rep kind |
|---|---|---|
| 15. Front bumper | Execution defect | Paint |

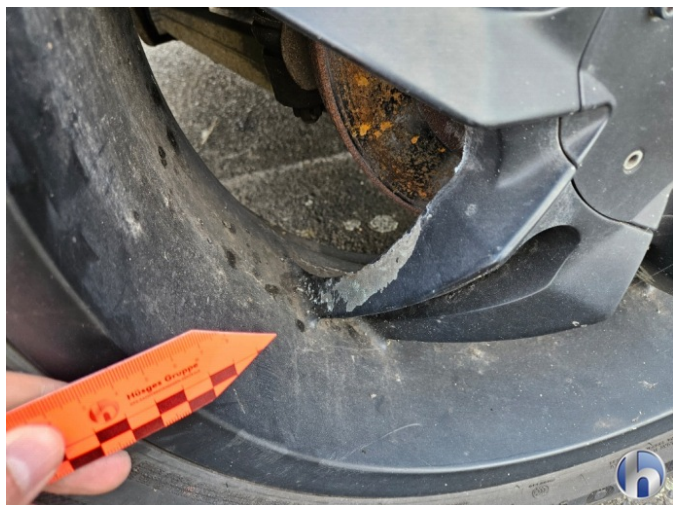
| component | Damage | Rep kind |
|---|---|---|
| 16. Felgen | Wear and tear | acceptable |

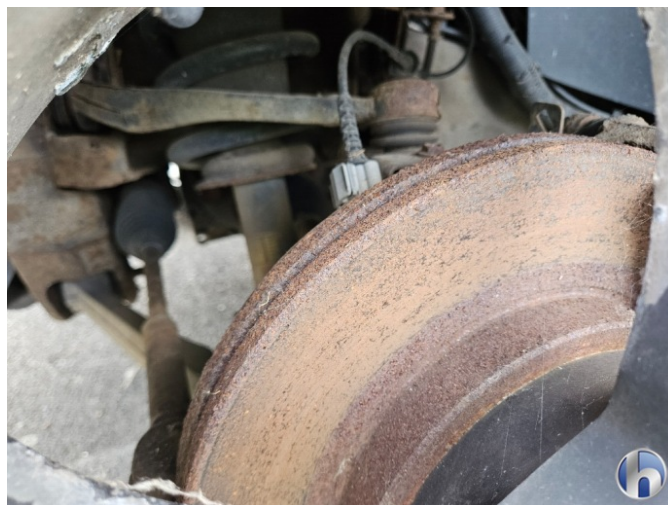
| <b>Note Road Safe:</b> | Bremsanlage stark verrostet |

| component | Damage | Rep kind |
|---|---|---|
| 17. brake system | Not okay | Replace |

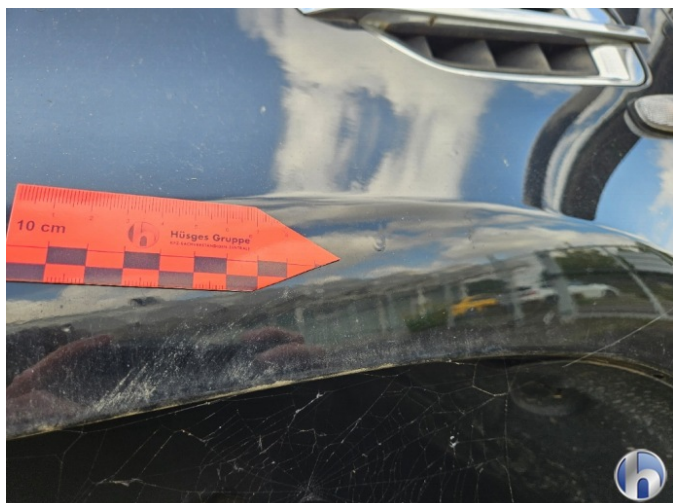
| component | Damage | Rep kind |
|---|---|---|
| 18. Front fender - left | Execution defect | Paint |

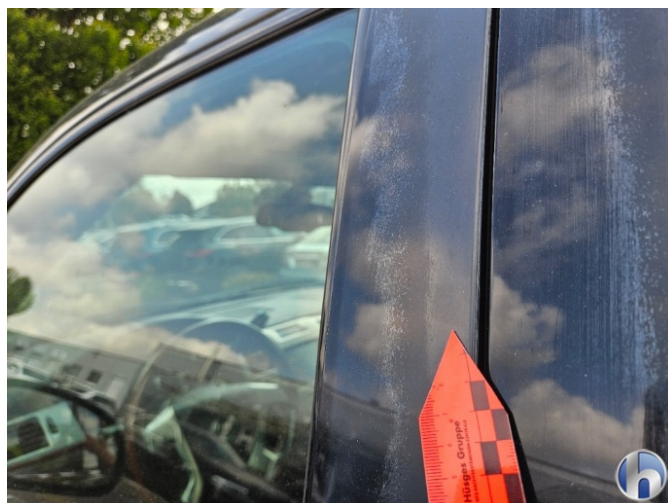
| component | Damage | Rep kind |
|---|---|---|
| 19. Front door - left | Wear and tear | acceptable |

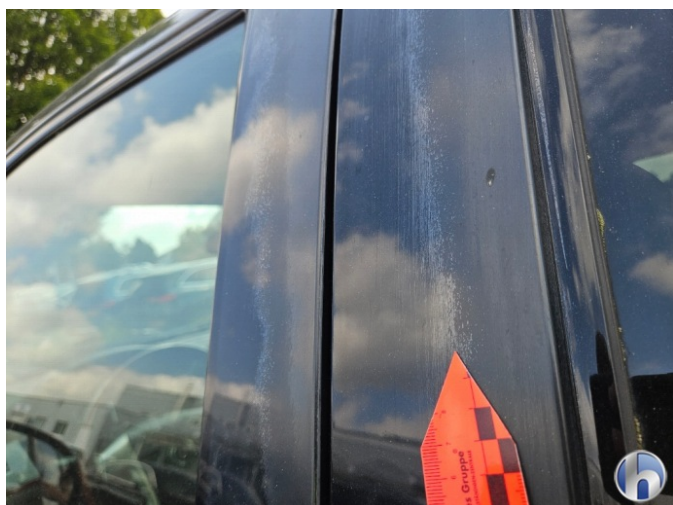
| component | Damage | Rep kind |
|---|---|---|
| 20. Rear door - left | Wear and tear | acceptable |

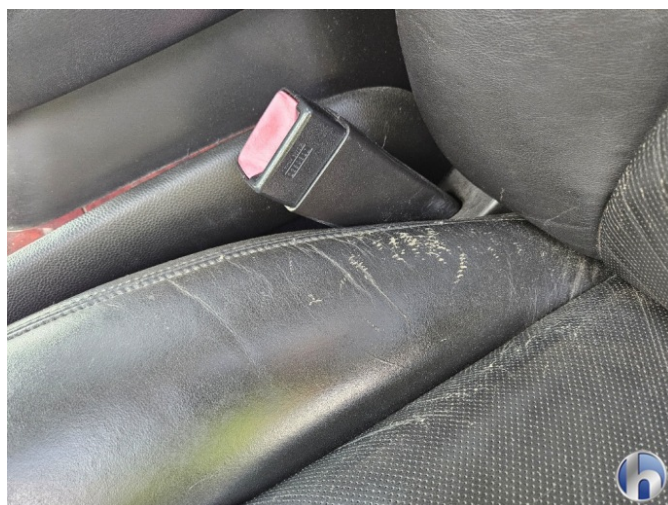
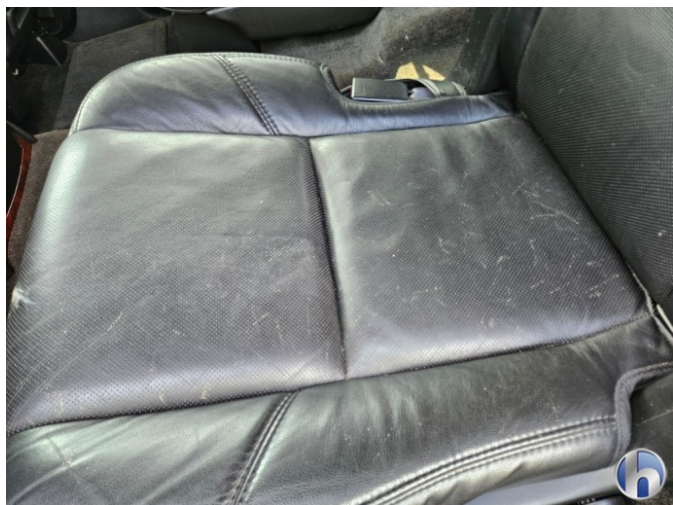
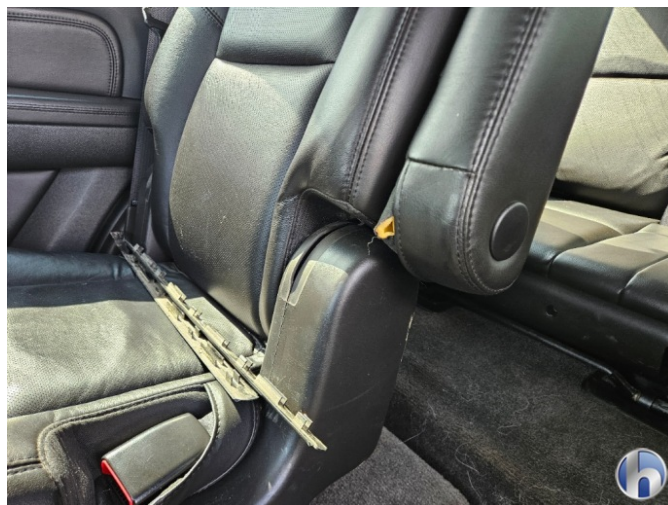
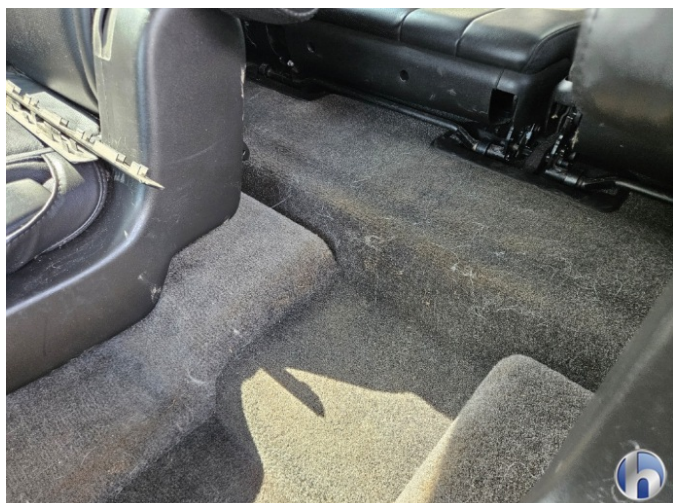
| component | Damage | Rep kind |
|---|---|---|
| 21. | Wear and tear | acceptable |
