Tesla 3: G929TJ

Vinnumber:	5YJ3E7EAXLF588830	Versionname:	Model 3 50kWh Standard Range Plus automaat
First Registrationdate:	7/01/2020	Fiscalpower:	
Expertise Mileage:	92561	Power Kw:	211
Bodytype:		Body colour:	Solid Black
Gearbox:	Automatic	Paint type:	Opaque
Transmission:	Back	Type of rims (mounted):	Aluminium
Fueltype:	Electric	Parking lot:	383
Number of seats:	5		
Type of rims (mounted):	Aluminium		
Maintenance needed:	No

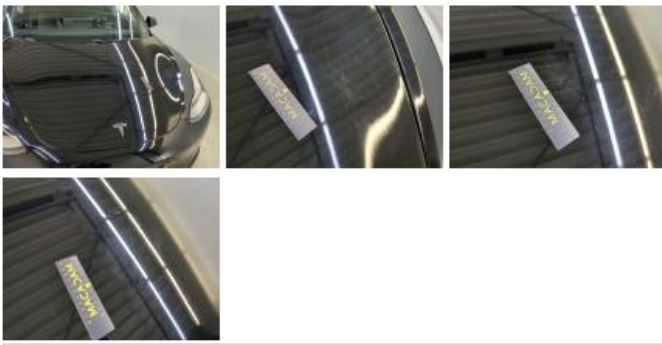
Bonnet, Scratch(es), Polish

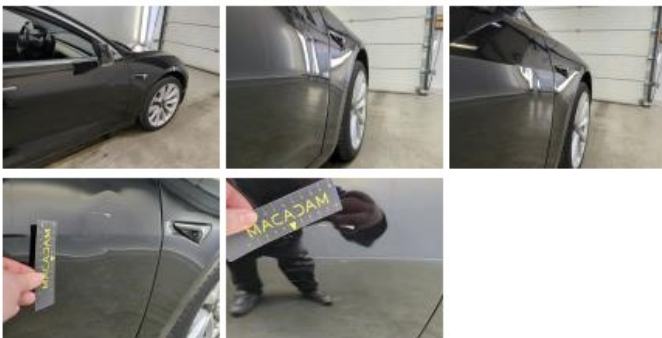
Door FR, Dent(s) and scratch(es), Repair and paint (complete)
