Expertise

Protocol number: 41653276
Order No. / Reference: 25247843
Inspection date: 24 Sept 2025

Manufacturer: Ford

Model: Ranger 2,0 I EcoBlue XL

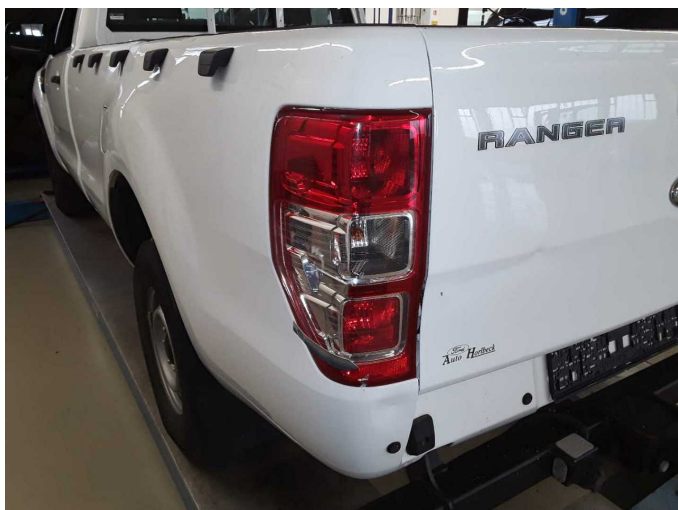
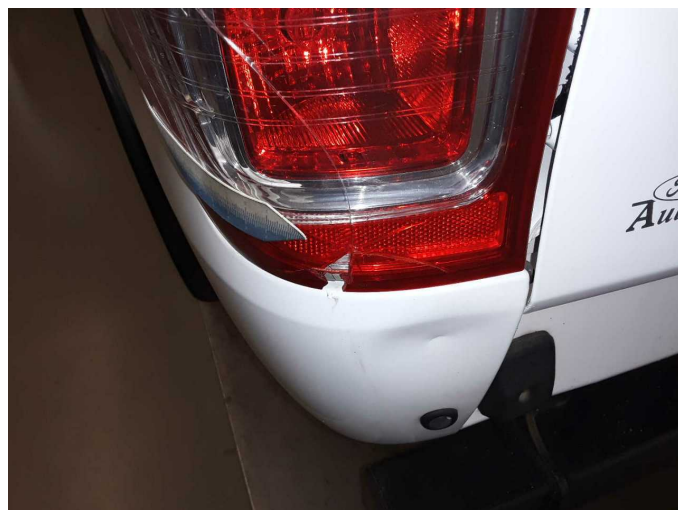
| No. | Component group | Description |
|---|---|---|
| 1 | Tail light | Tail lamp - left side - Broken / torn - Replace |

Damage 1: Tail light: Tail lamp - left side - Broken / torn - Replace

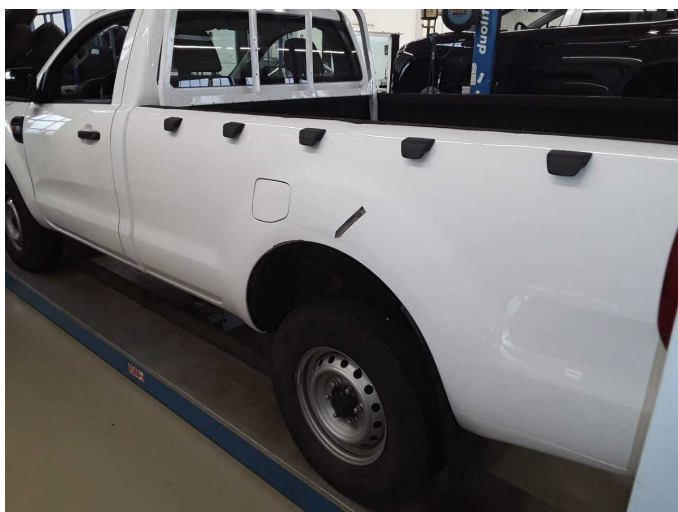
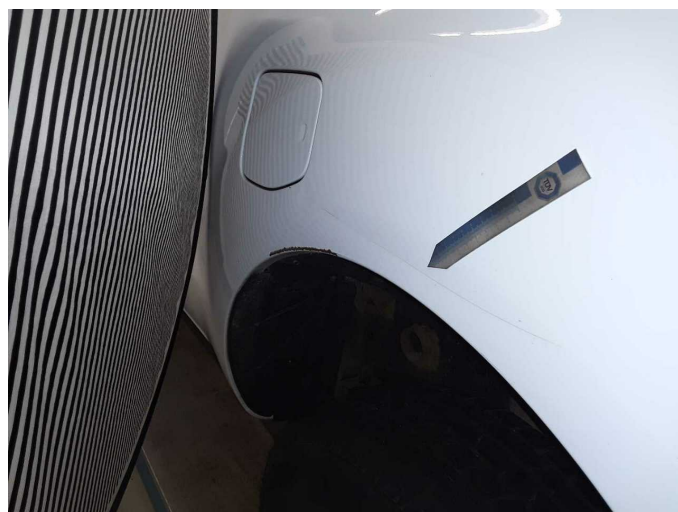
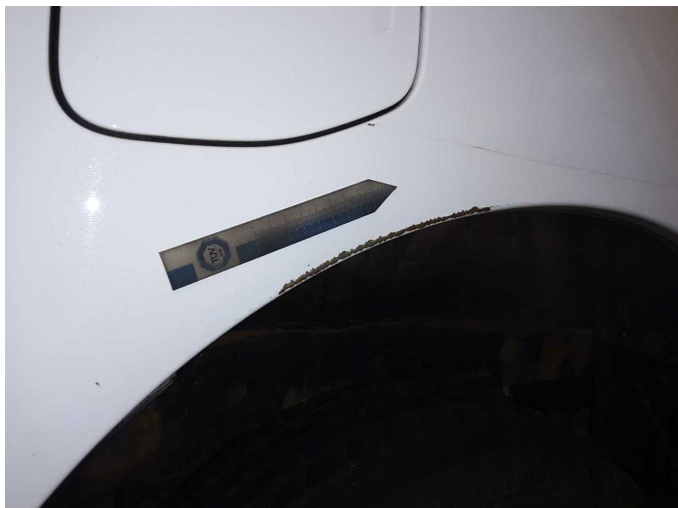
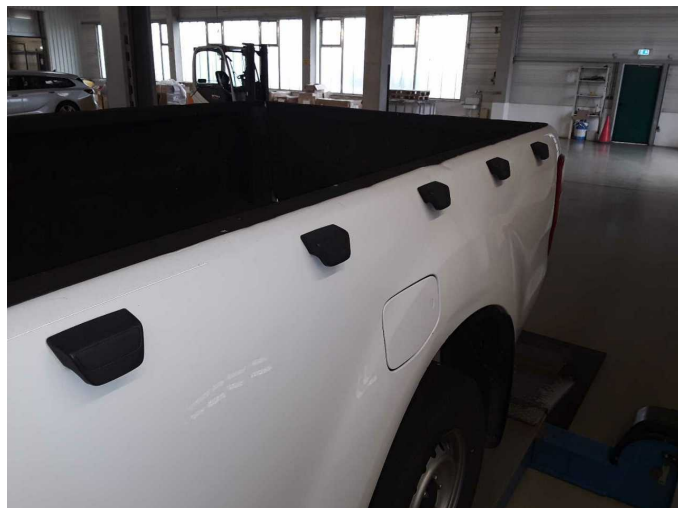
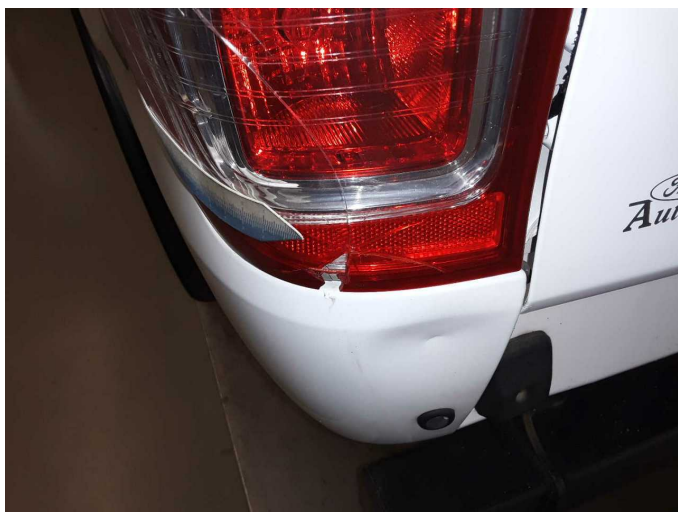
| No. | Component group | Description |
|---|---|---|
| 2 | Side panel - rear left side | Side panel - Dent / paintcoat damage - Repair and paint |

Damage 2: Side panel - rear left side: Side panel - Dent / paintcoat damage - Repair and paint

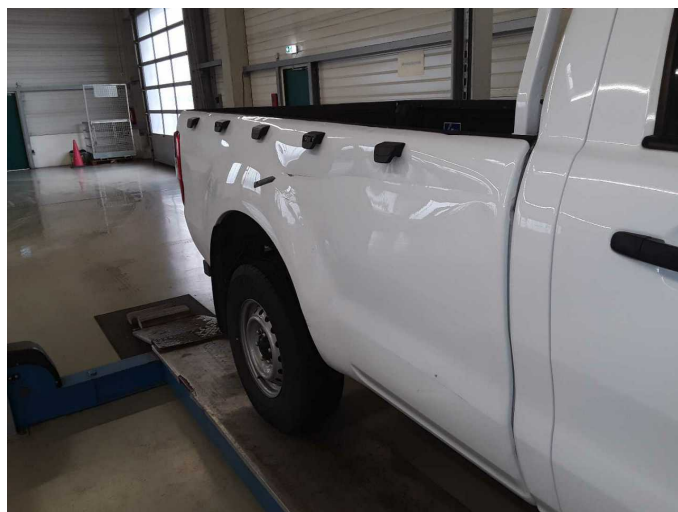
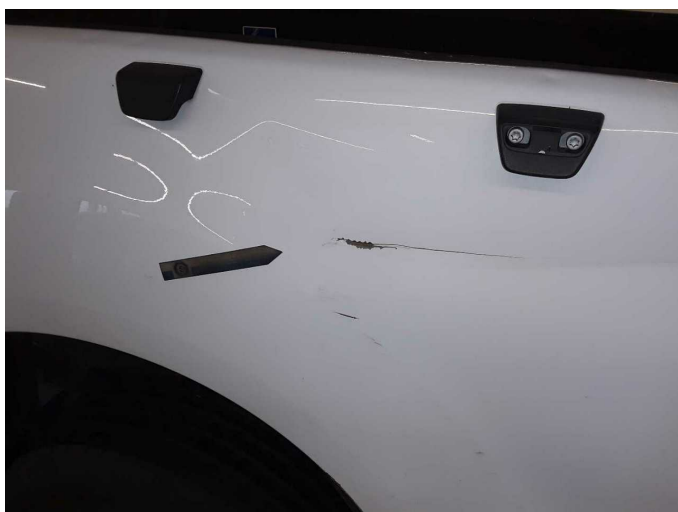
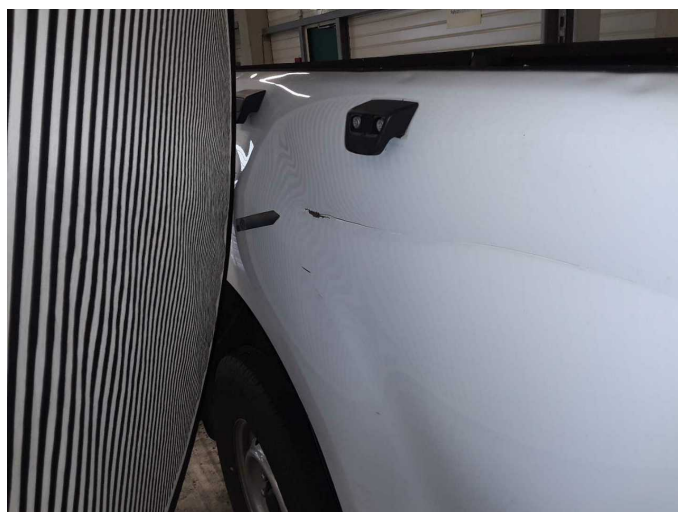
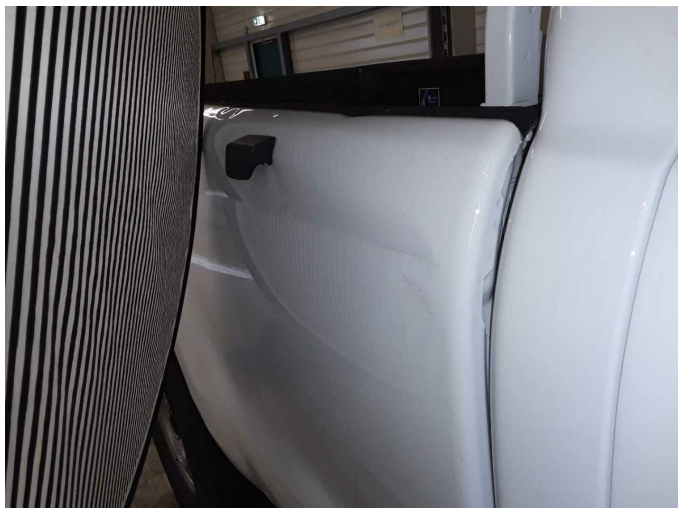
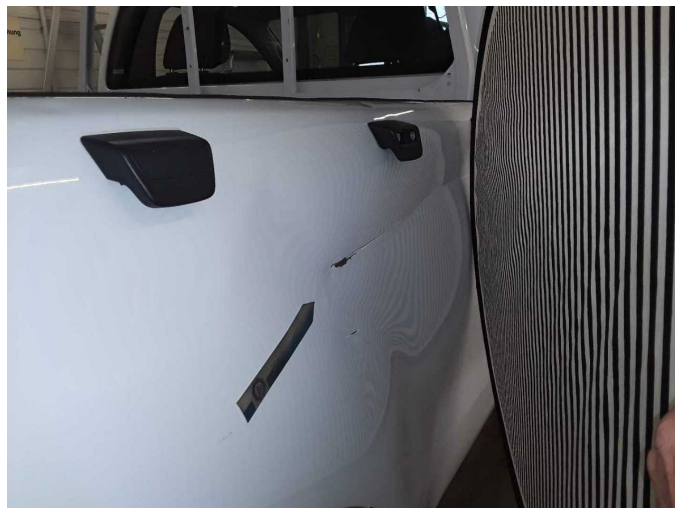
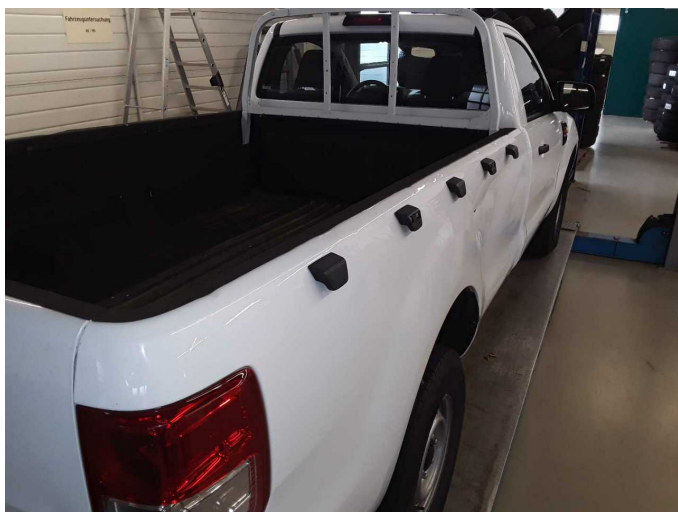
| No. | Component group | Description |
|---|---|---|
| 3 | Side panel - rear right side | Side panel - Dent / paintcoat damage - Repair and paint |

Damage 3: Side panel - rear right side: Side panel - Dent / paintcoat damage - Repair and paint

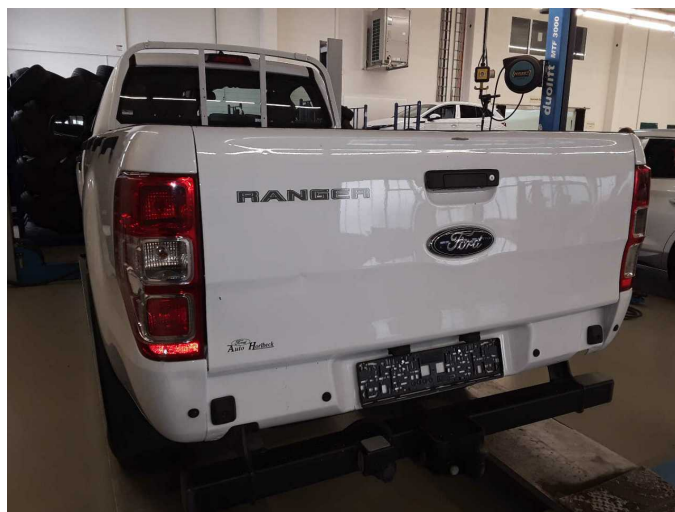
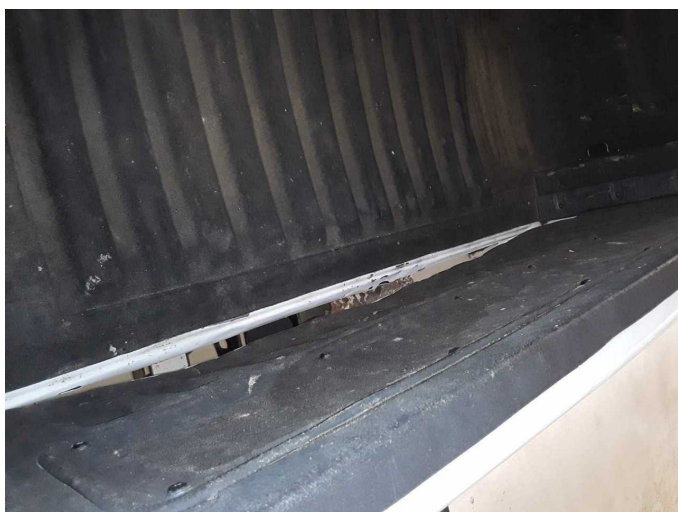
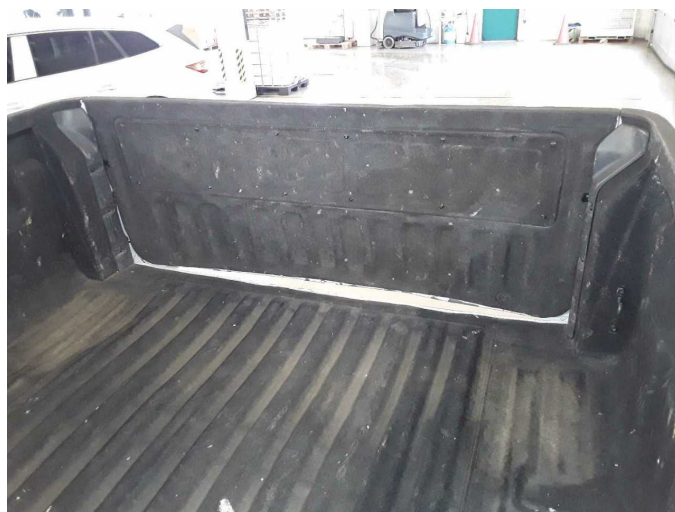
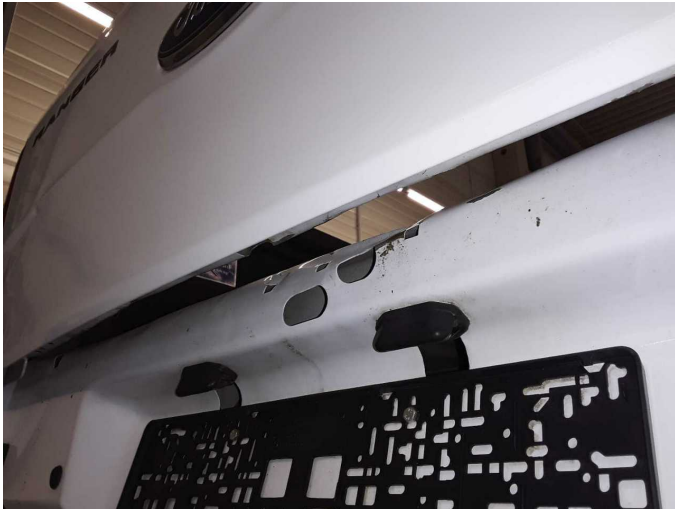
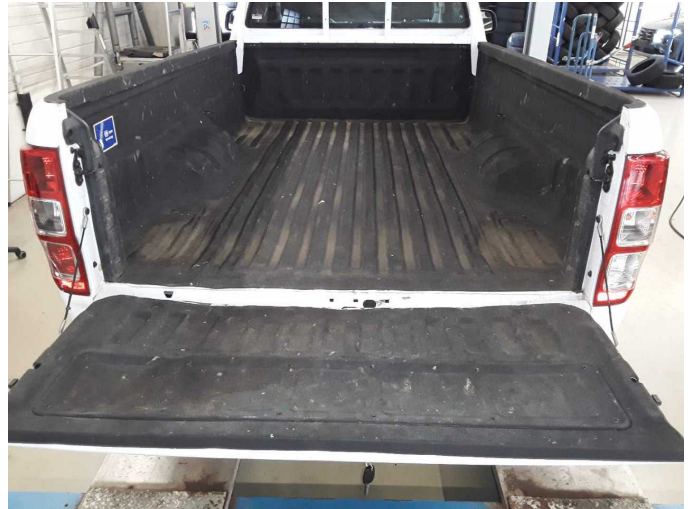
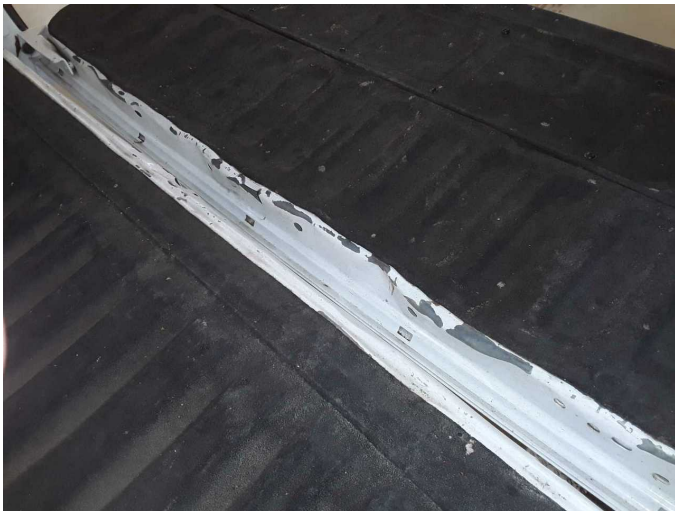
| No. | Component group | Description |
|---|---|---|
| 4 | Boot lid / rear door | Boot lid - Deformed - Replace |

Damage 4: Boot lid / rear door: Boot lid - Deformed - Replace

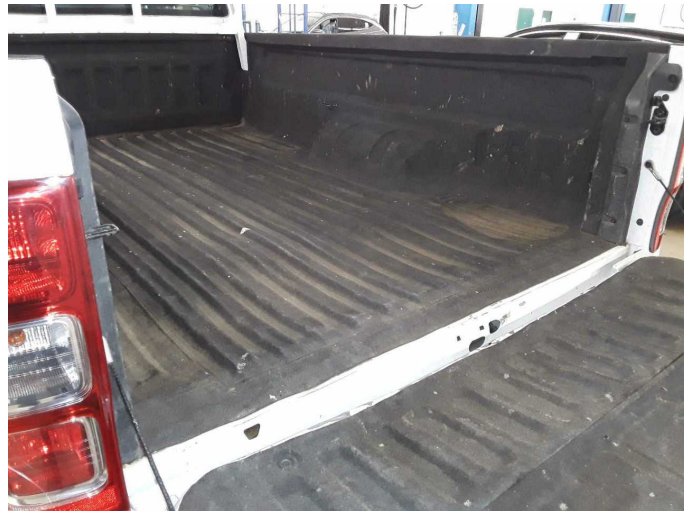
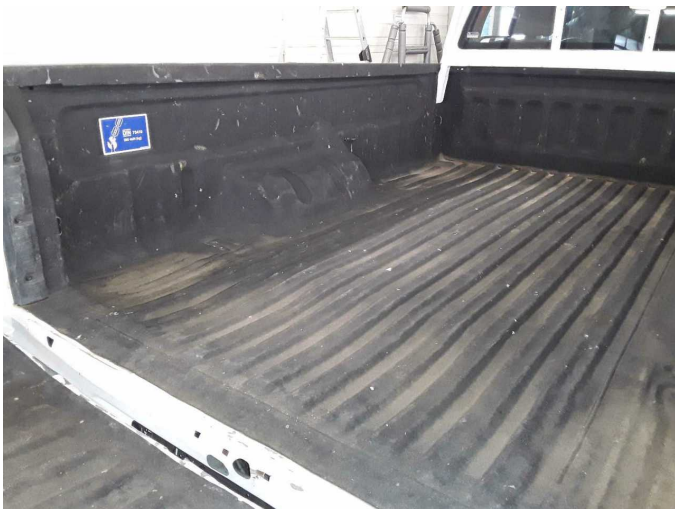
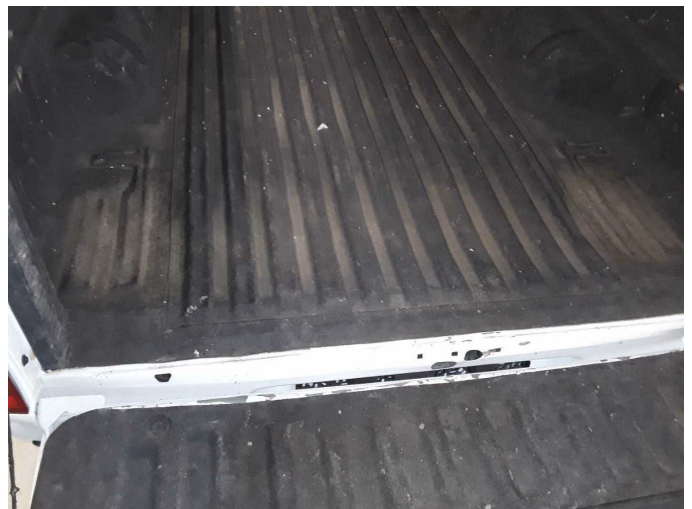
| No. | Component group | Description |
|---|---|---|
| 3 | Interior | Cargo area floor - dent(s) - No deduction |

Wear and tear 3: Interior: Cargo area floor - dent(s) - No deduction
