## status report

| vehicle data | | | |
|---|---|---|---|
| <b>Ford Ranger Wildtrak Doppelkabine 4x4</b> | | | |
| Vehicle identification number | <b>6FPXJM2PLD18117</b> | mileage read: | <b>96499 km</b> |
| First Registration / construction year: | <b>15.10.2020 / 2020</b> | Visit Date / place of birth: | <b>23.09.2025 Dorfmark</b> |

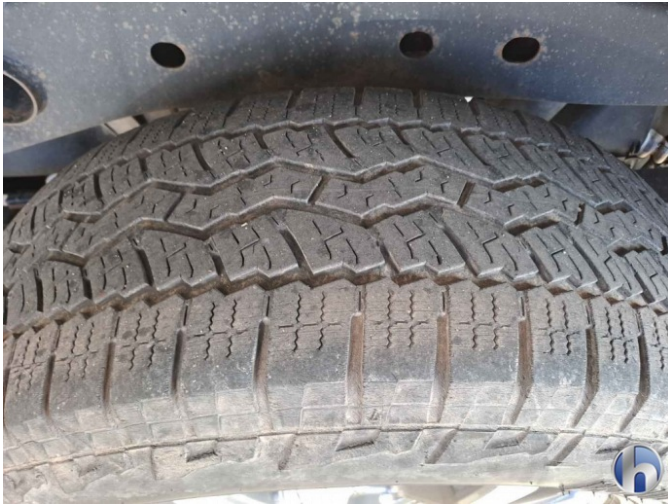
| component | Damage | Rep kind |
|---|---|---|
| 2. | Worn | Replace |

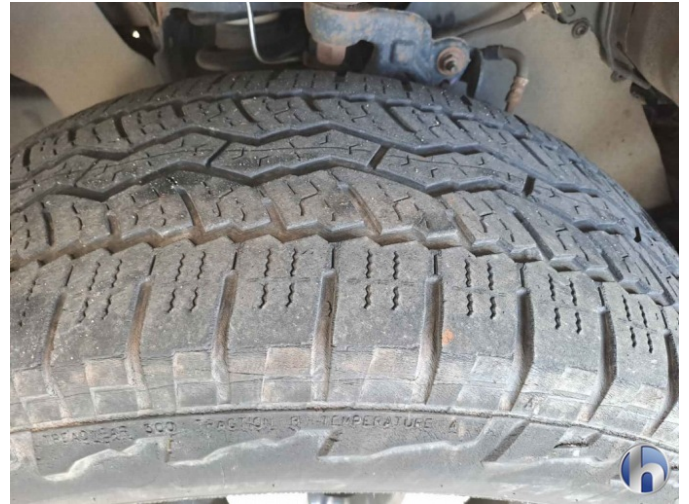
| component | Damage | Rep kind |
|---|---|---|
| 3. | Worn | Replace |

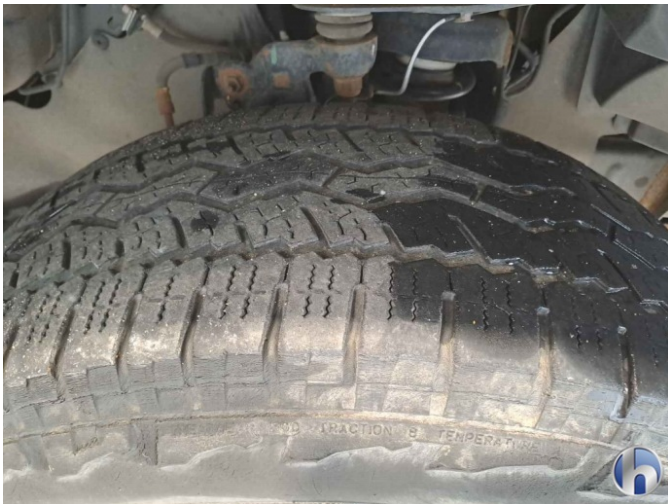
| component | Damage | Rep kind |
|---|---|---|
| 4. | Worn | Replace |

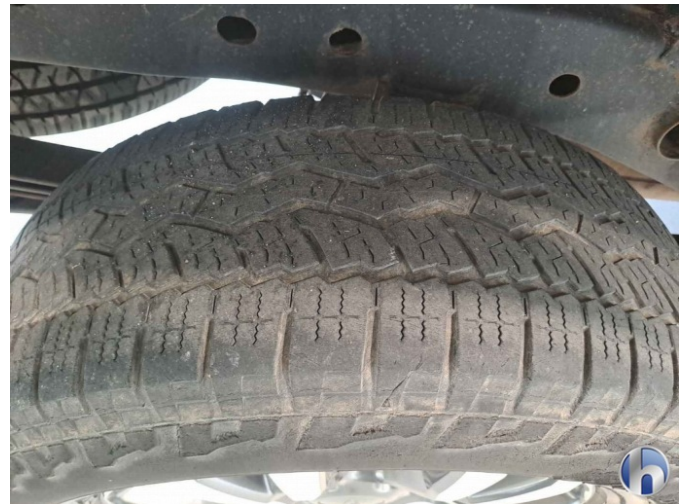
| component | Damage | Rep kind |
|---|---|---|
| 5. | Worn | Replace |

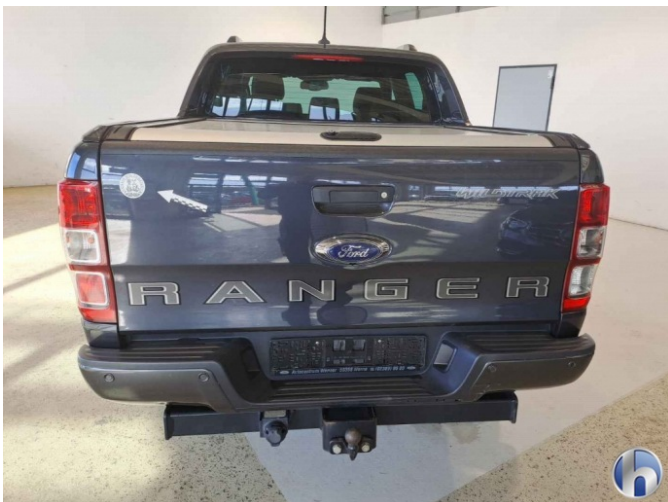
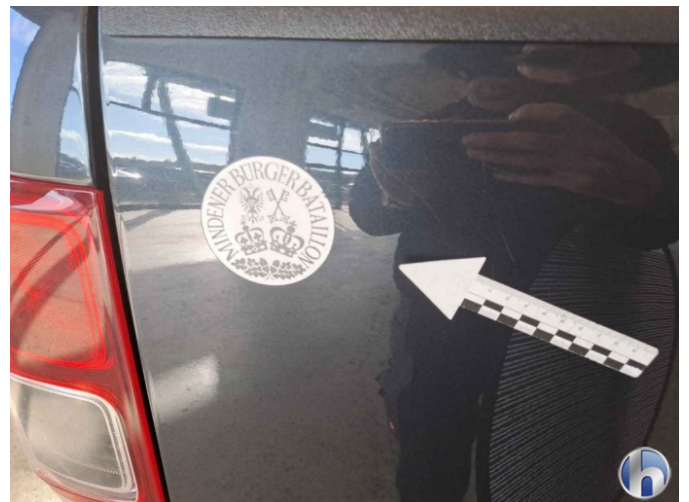
| component | Damage | Rep kind |
|---|---|---|
| 6. tailgate | Sticker | |

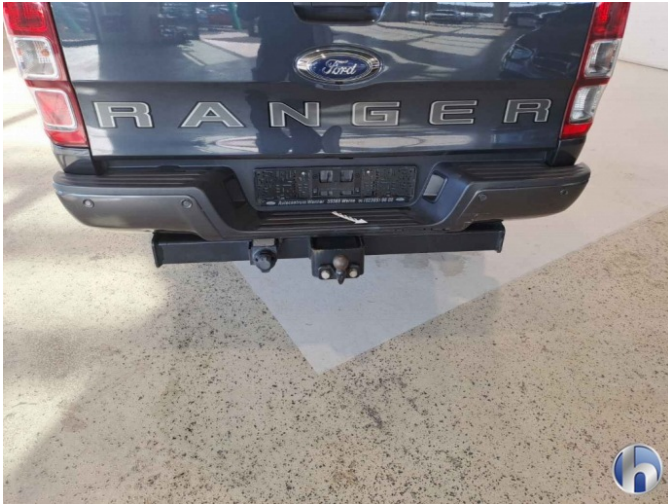
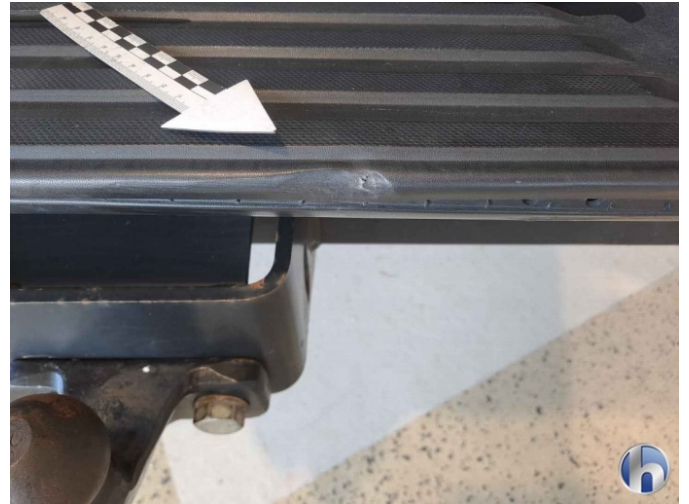
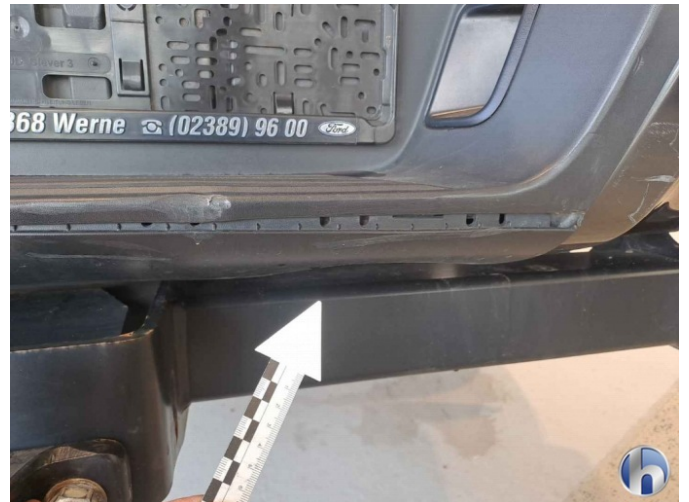
| Accident injury assessment | |
|---|---|
| <b>reference:</b> | Stoßfänger Hinten. Fahrzeug mit bestehenden Unfallschaden, zur Schadensermittlung wurden keine Demontagearbeiten durchgeführt, verborgen gebliebene Schäden können nicht ausgeschlossen werden. Unfallschaden Kosten wurden überschlägig Kalkuliert, Kostenerweiterung möglich. |

| component | Damage | Rep kind |
|---|---|---|
| 7. Rear bumper | Accident damage | Replace |

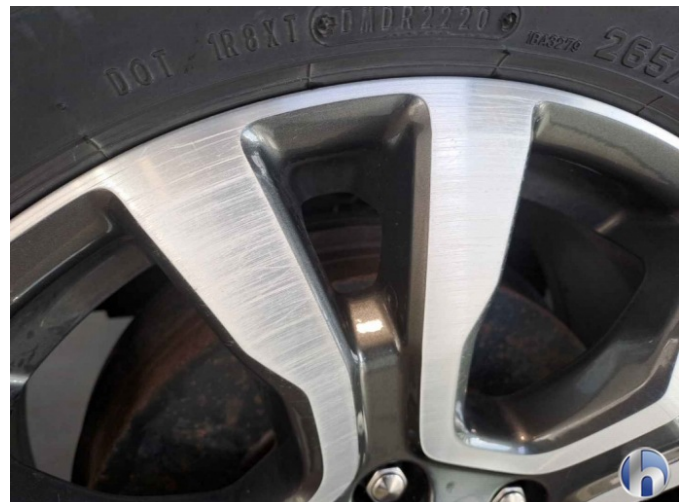
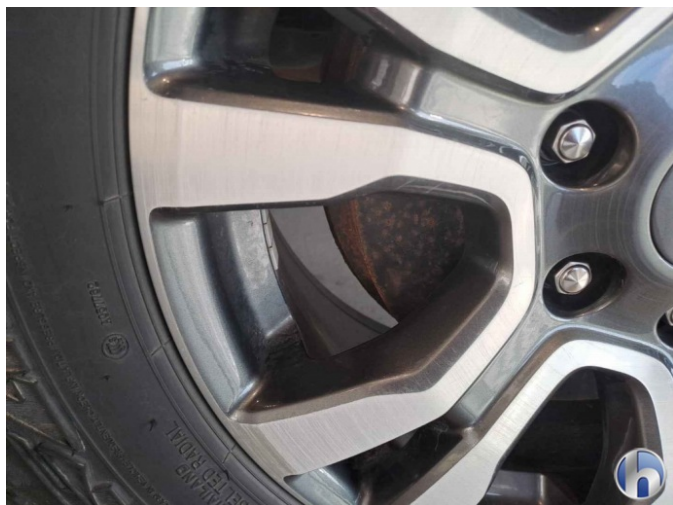
| component | Damage | Rep kind |
|---|---|---|
| 8. Rim rear - left | Damaged | Replace |

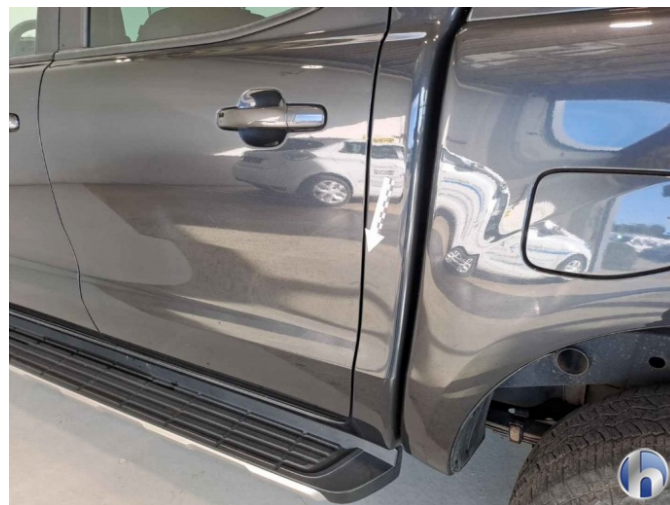
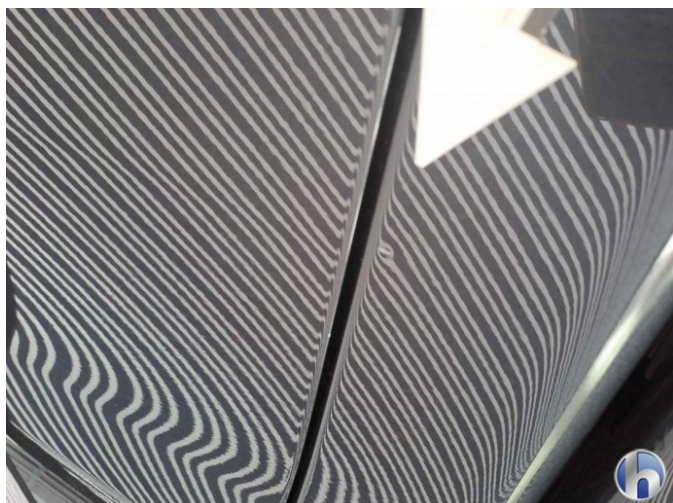
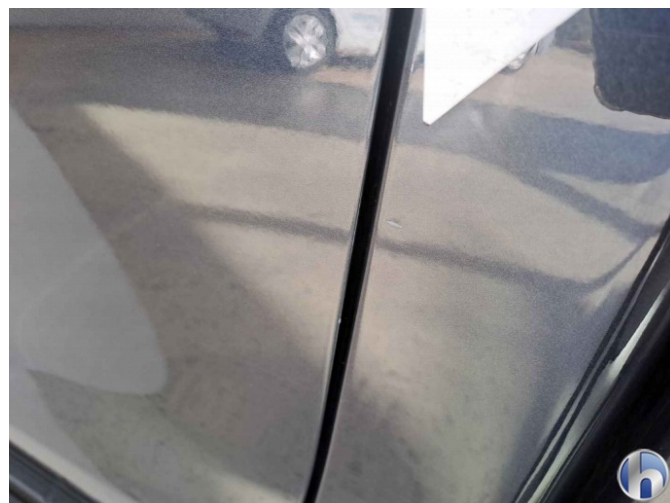
| component | Damage | Rep kind |
|---|---|---|
| 9. C-pillar back - left | | Smart repair |

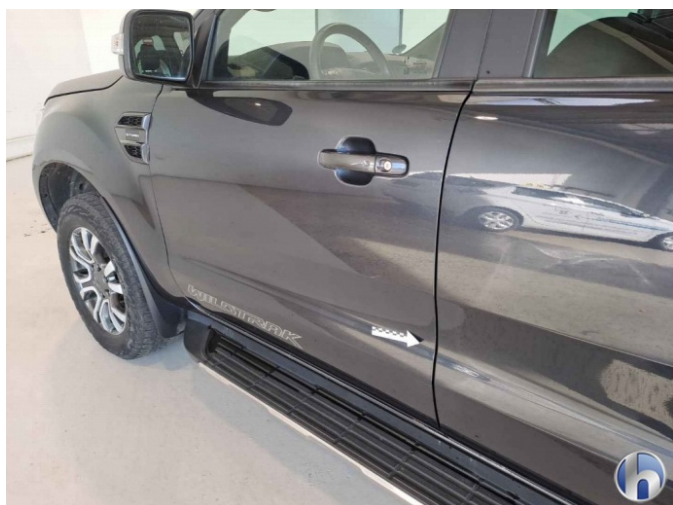
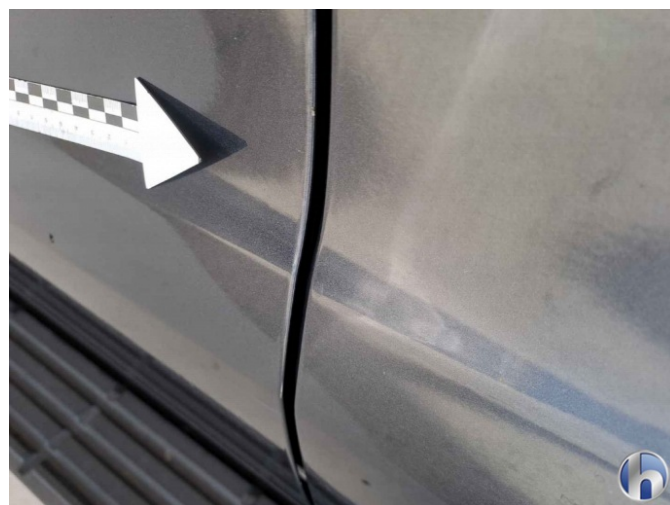
| component | Damage | Rep kind |
|---|---|---|
| 10. Front door - left | Scrape | Smart repair |

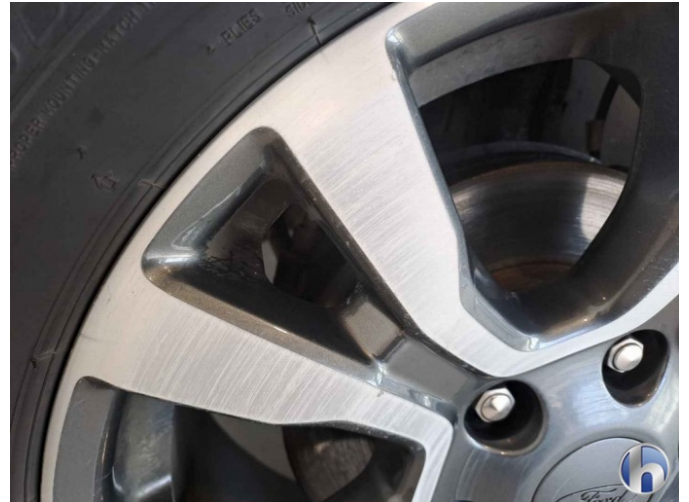
| component | Damage | Rep kind |
|---|---|---|
| 11. Rim front - left | Damaged | Replace |

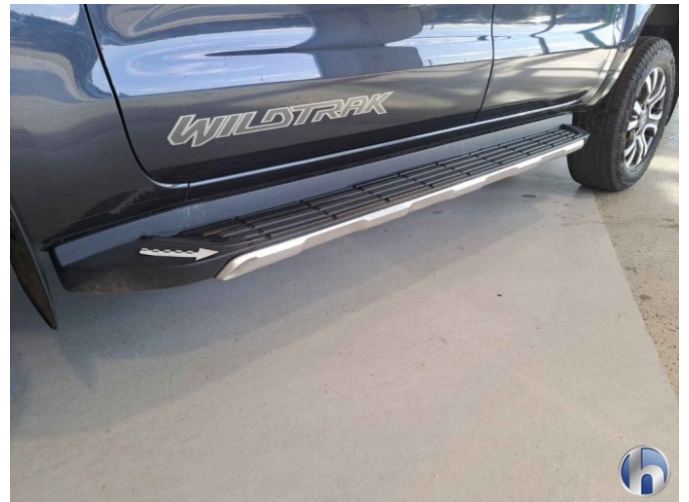
| component | Damage | Rep kind |
|---|---|---|
| 12. Trittstufe links | Damaged | Replace |

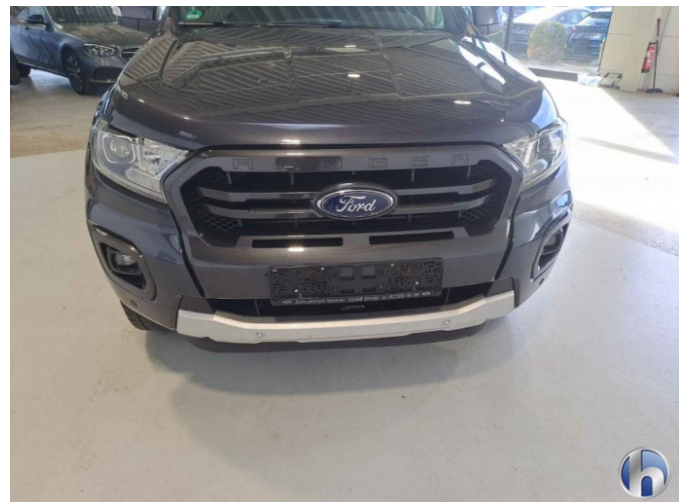
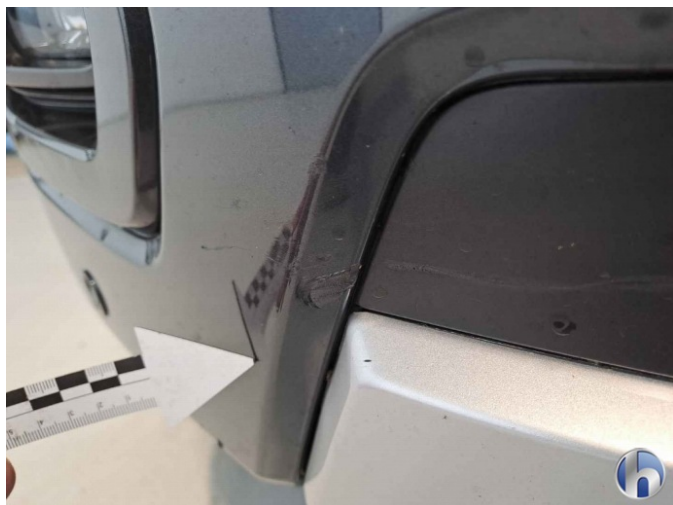
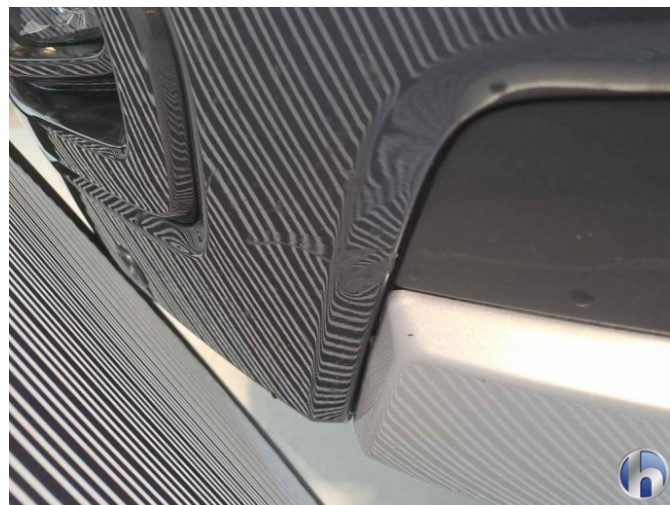
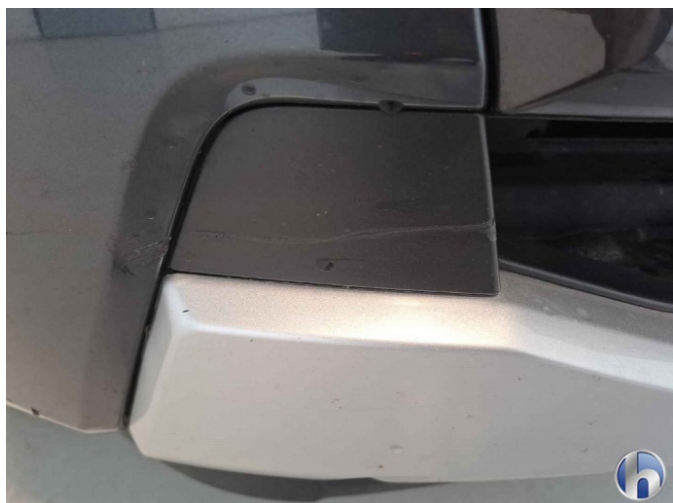
| component | Damage | Rep kind |
|---|---|---|
| 13. Front bumper | Damaged | Replace |

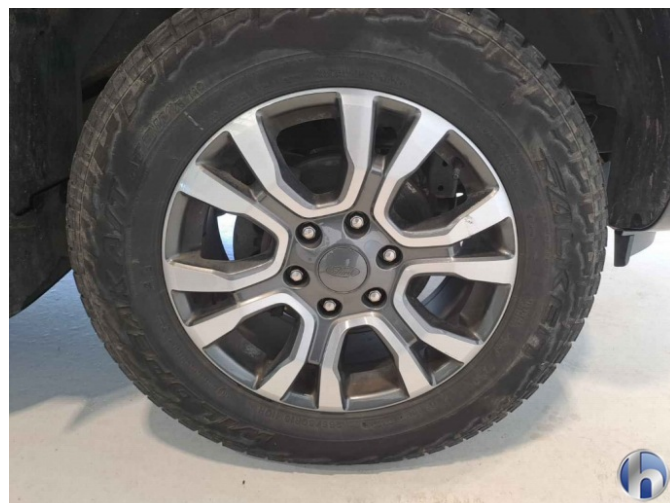
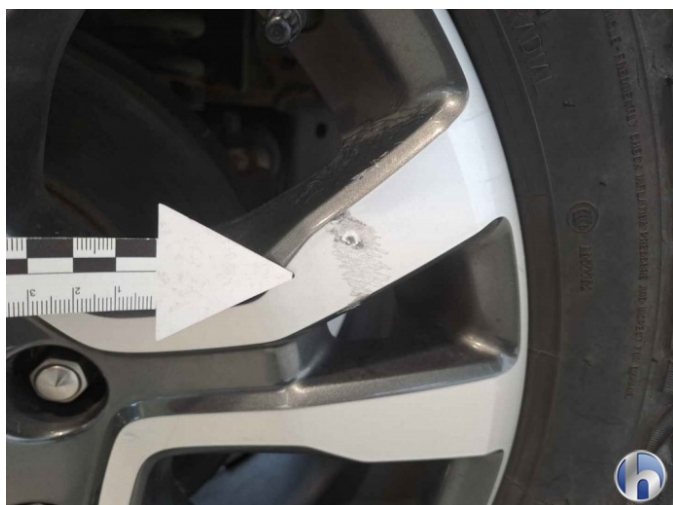
| component | Damage | Rep kind |
|---|---|---|
| 14. Rim front - right | Damaged | Replace |

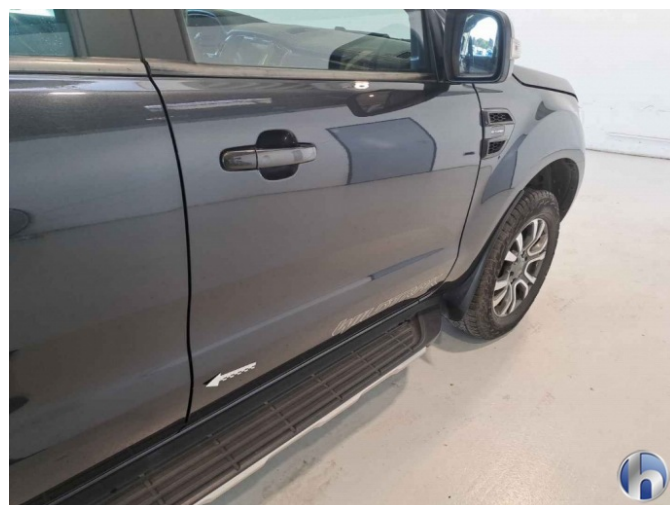
| component | Damage | Rep kind |
|---|---|---|
| 15. Front door - right | Scrape | Smart repair |

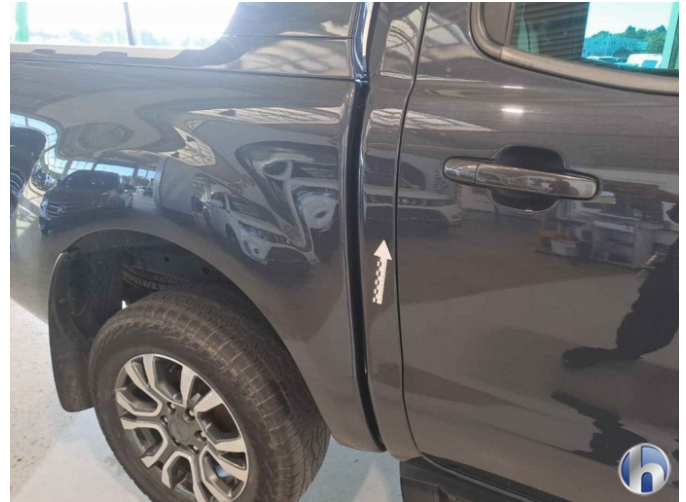
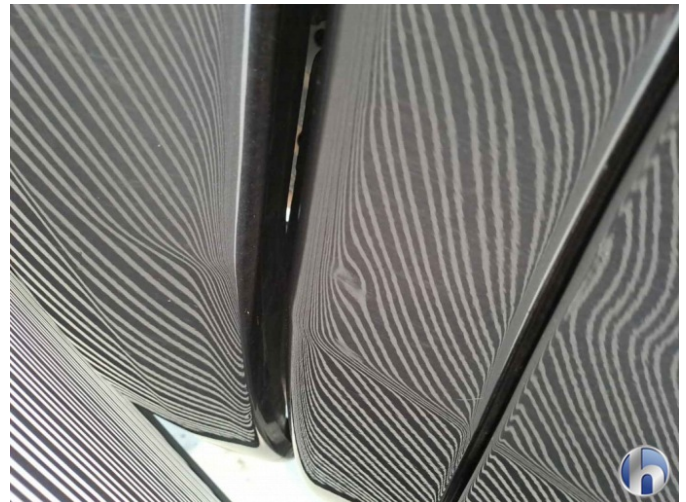
| component | Damage | Rep kind |
|---|---|---|
| 16. C-pillar rear - right | | Smart repair |

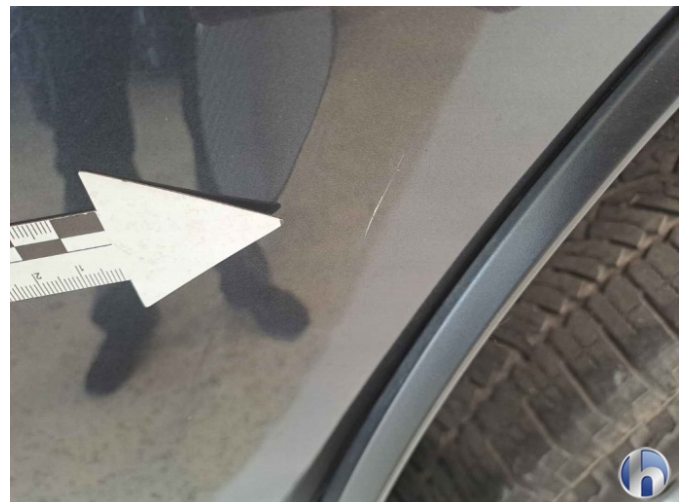
| component | Damage | Rep kind |
|---|---|---|
| 17. Sidewall - Rear - right | Scratch(es) | Smart repair |

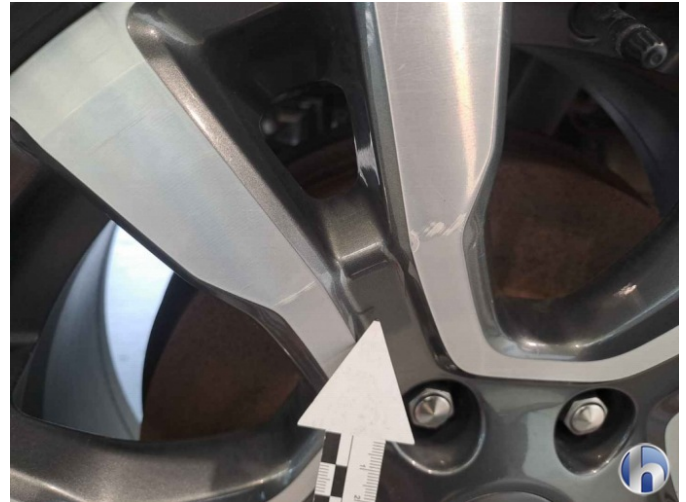
| component | Damage | Rep kind |
|---|---|---|
| 18. Rim rear - right | Damaged | Replace |

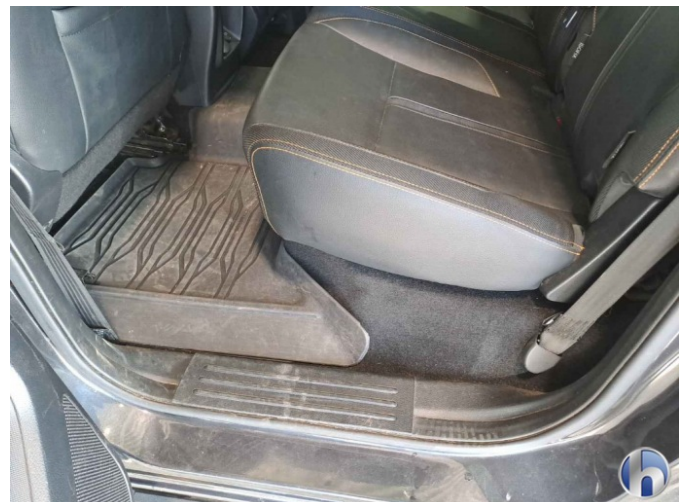
| component | Damage | Rep kind |
|---|---|---|
| 20. | Wear and tear | acceptable |

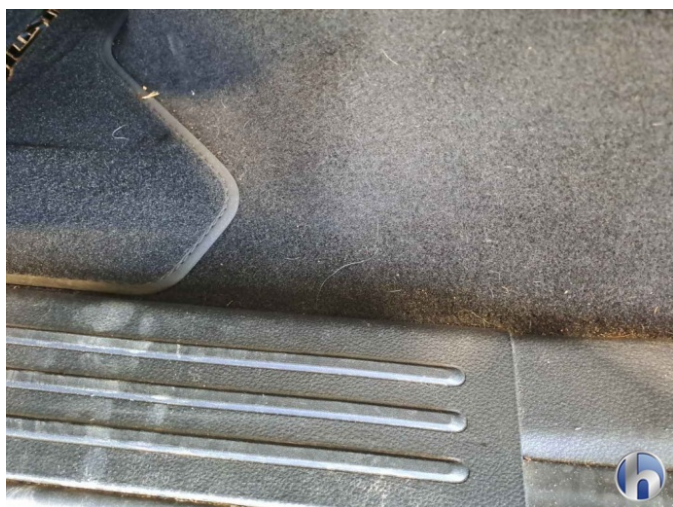
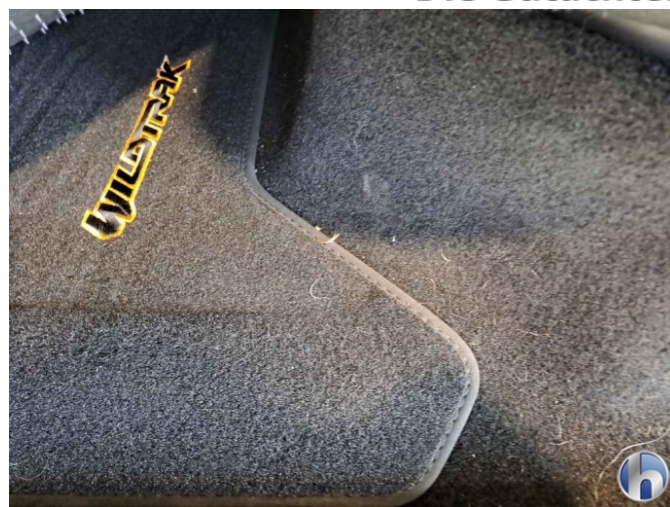
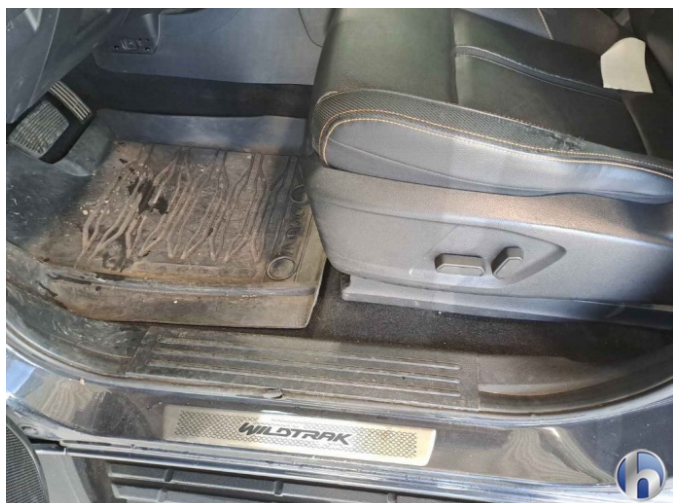
| component | Damage | Rep kind |
|---|---|---|
| 21. | Dirty (animal hair) | |

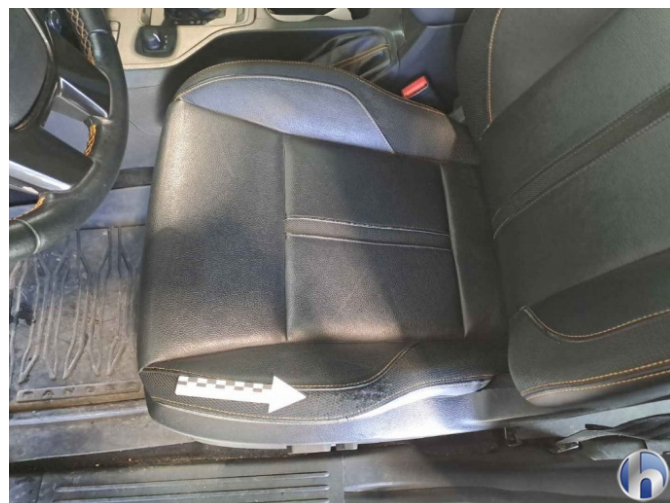
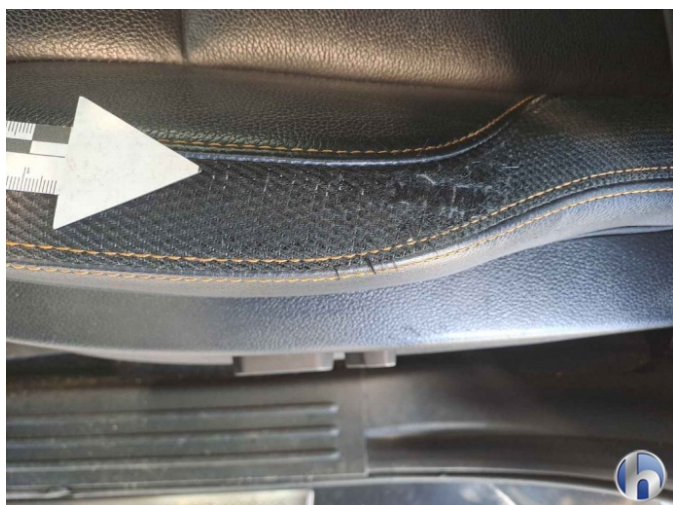
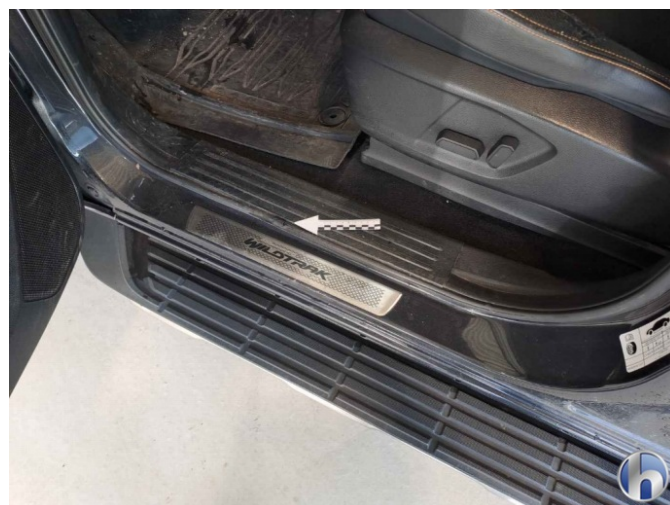
| component | Damage | Rep kind |
|---|---|---|
| 23. | Damaged | Replace |

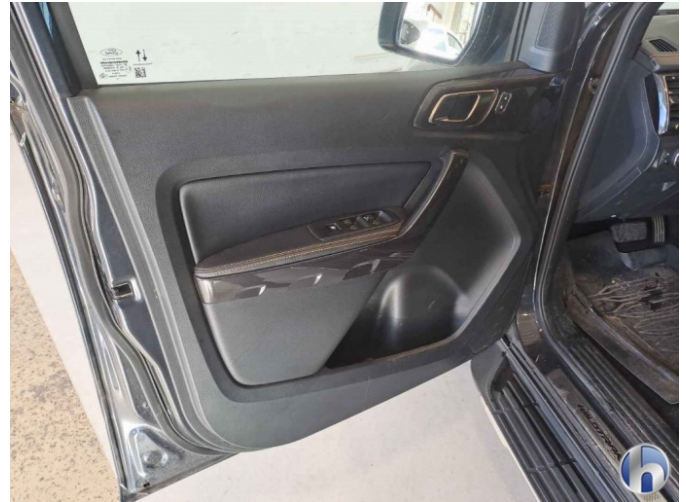
| component | Damage | Rep kind |
|---|---|---|
| 24. Front door seal - left | Damaged | Replace |

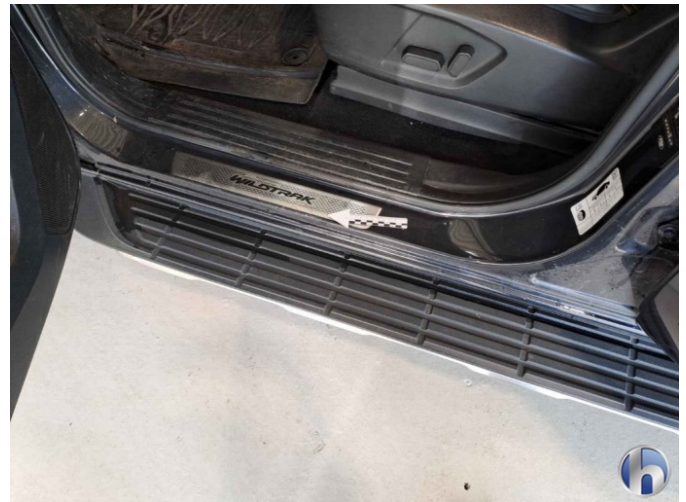
| component | Damage | Rep kind |
|---|---|---|
| 25. Front door trim - left | Scratch(es) | Replace |

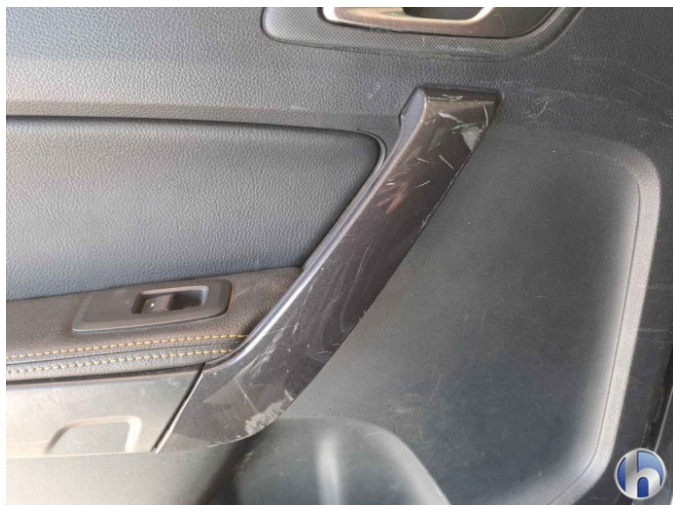
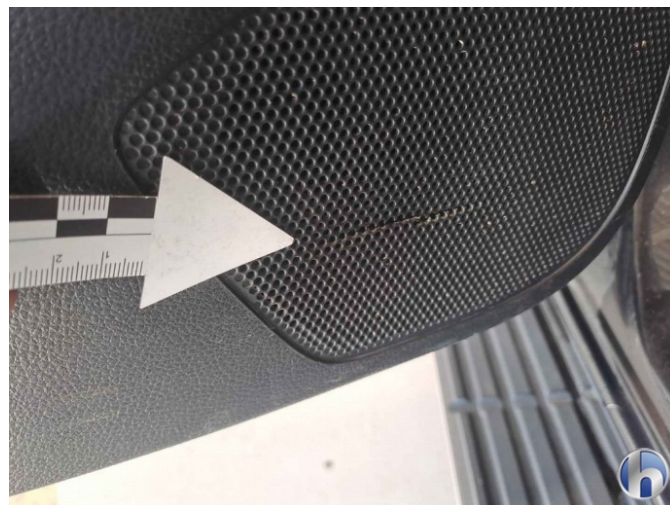
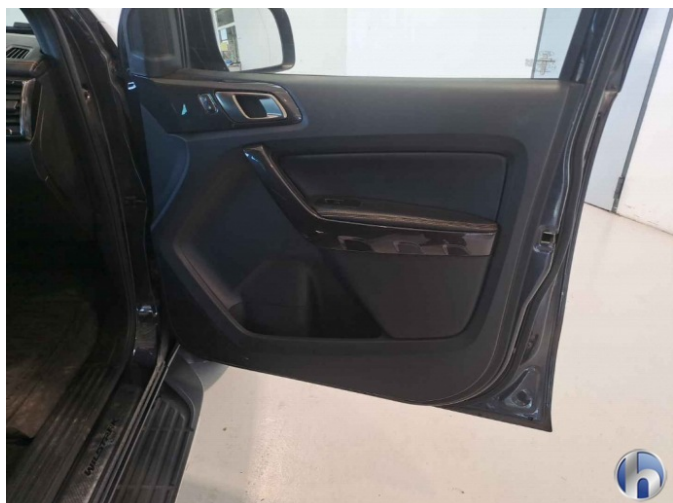
| component | Damage | Rep kind |
|---|---|---|
| 27. Rear door trim - left | Damaged | Replace |

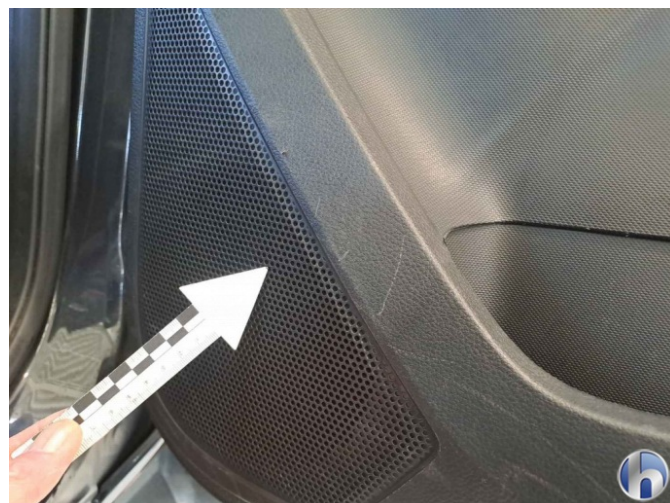
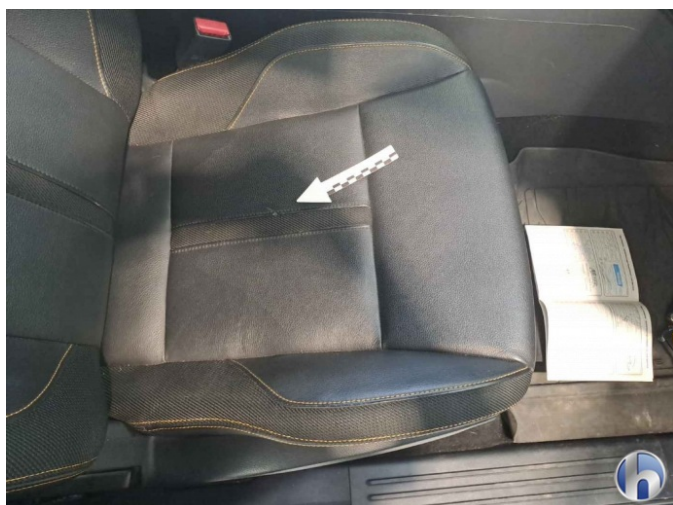
| component | Damage | Rep kind |
|---|---|---|
| 28. Door trim Front - right | Damaged | Replace |

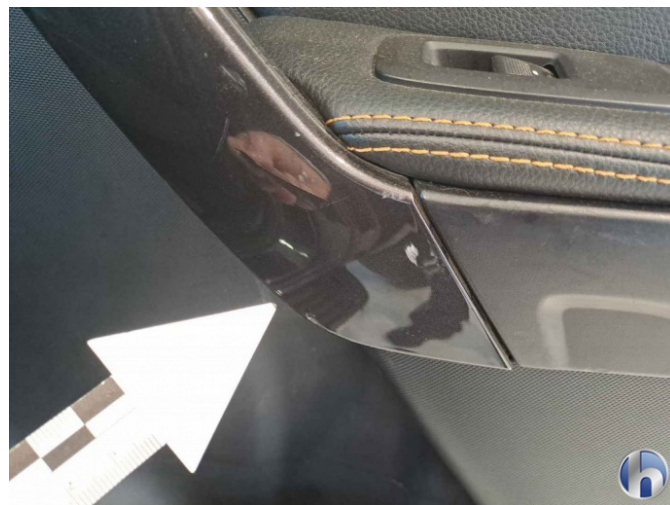
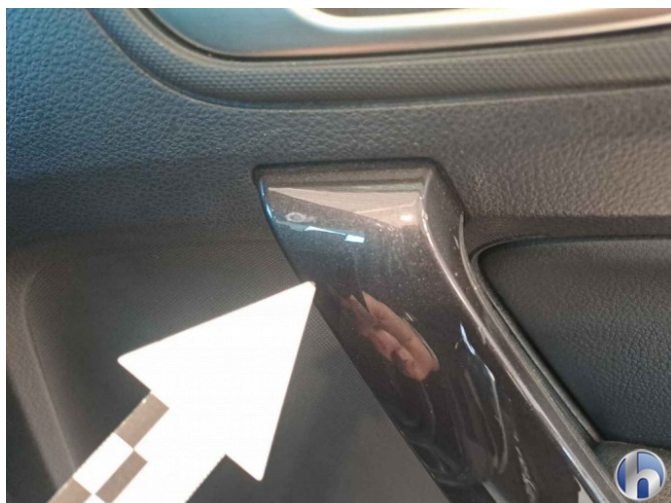
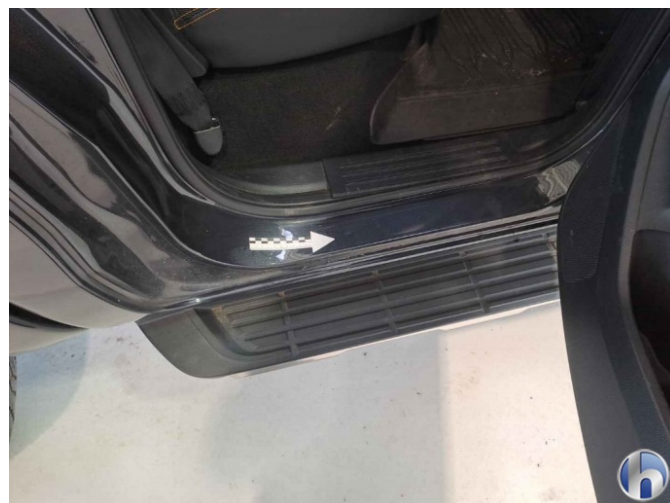
| component | Damage | Rep kind |
|---|---|---|
| 30. Door trim Rear - right | Scrape | Replace |

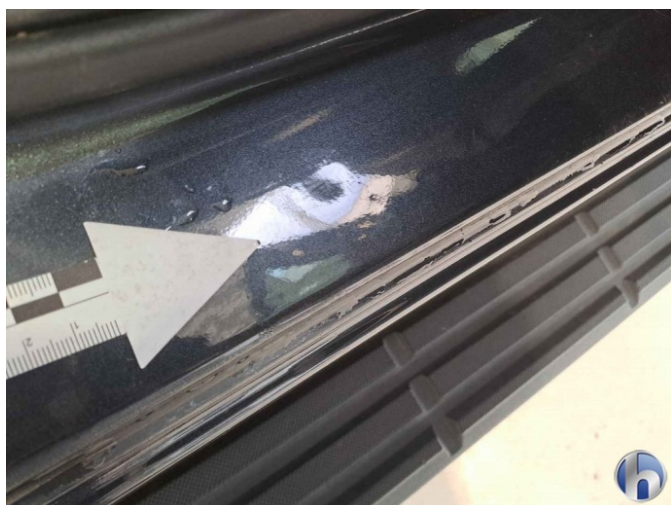
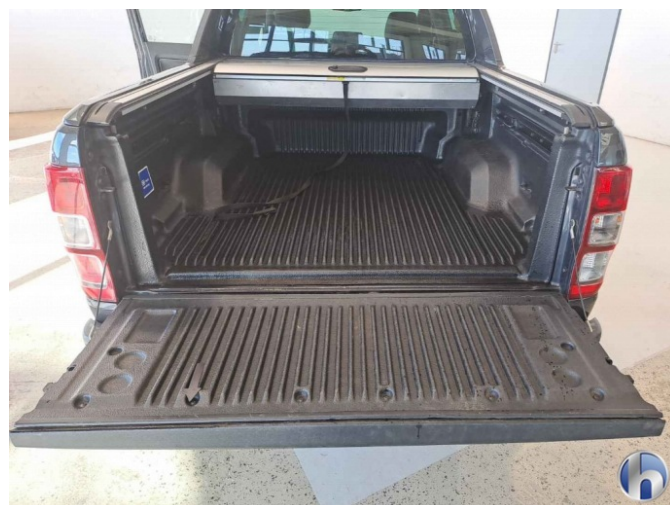
| component | Damage | Rep kind |
|---|---|---|
| 31. Türeinstieg Hinten - Rechts | | Smart repair |

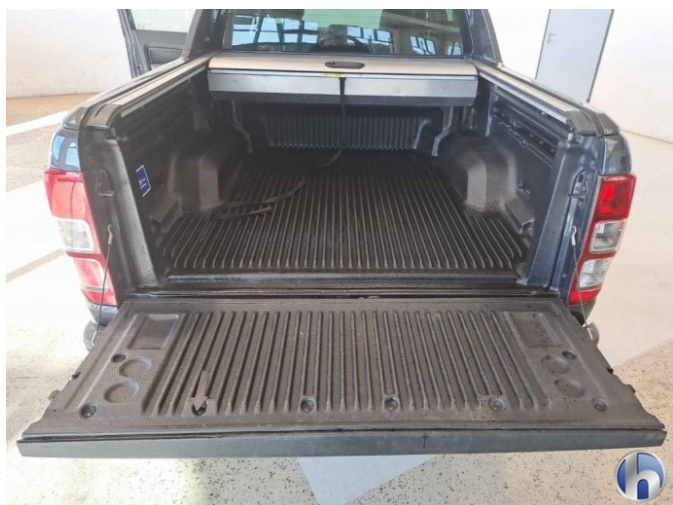
| component | Damage | Rep kind |
|---|---|---|
| 32. Ladefläche | Wear and tear | acceptable |

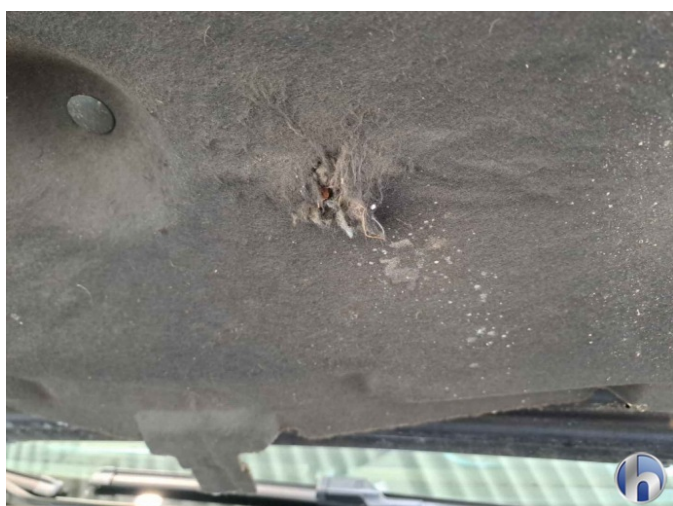
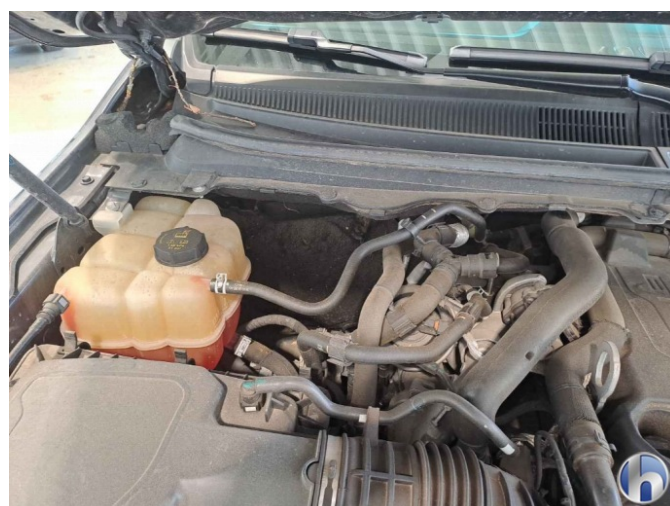
| Performed testing technology | |
|---|---|
| <b>reference:</b> | *Fahrzeug hat Alter und Laufleistungs bedingte Gebrauchsspuren innen und außen Marderbiss<br>Motorraum Schaden und Kosten Erweiterung möglich |

| component | Damage | Rep kind |
|---|---|---|
| 34. motor insulation | | Replace |
