Expertise

Protocol number: 41830977
Order number / reference: 25277617
Inspection date: 6 Oct 2025

Manufacturer: Ford

Model: Ranger 2,0 I EcoBlue Autm. XLT

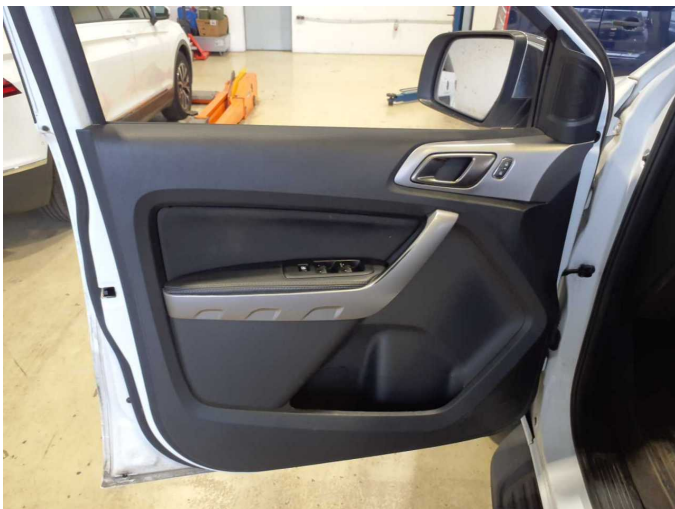
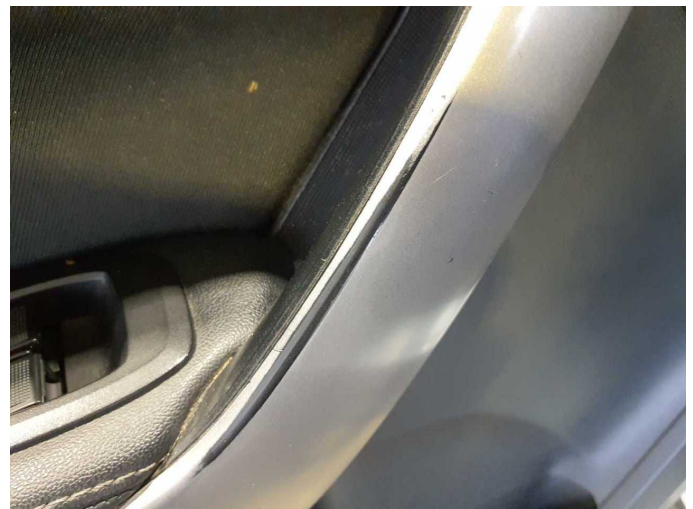
Damage 1: Trim / covers: Door trim - front left side (Griff) - Scratch(es) - Replace

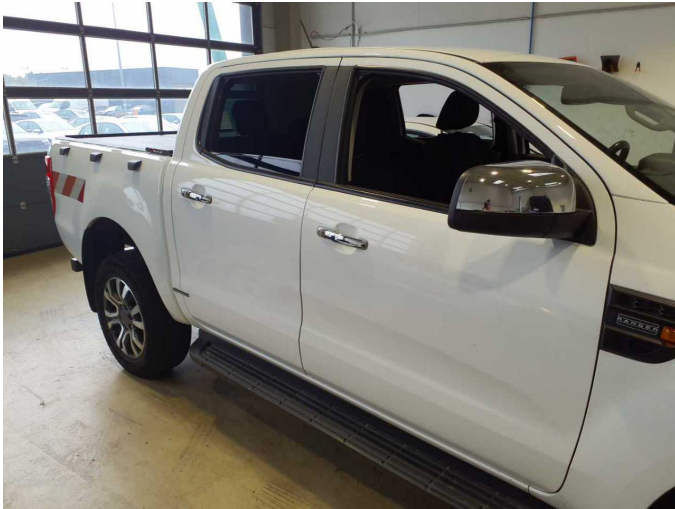
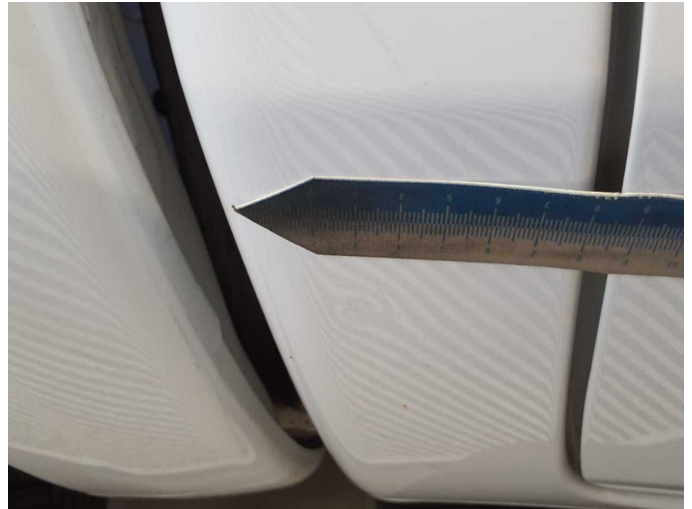
Damage 2: Body: C-pillar - right side - dent(s) - Smooth repair work

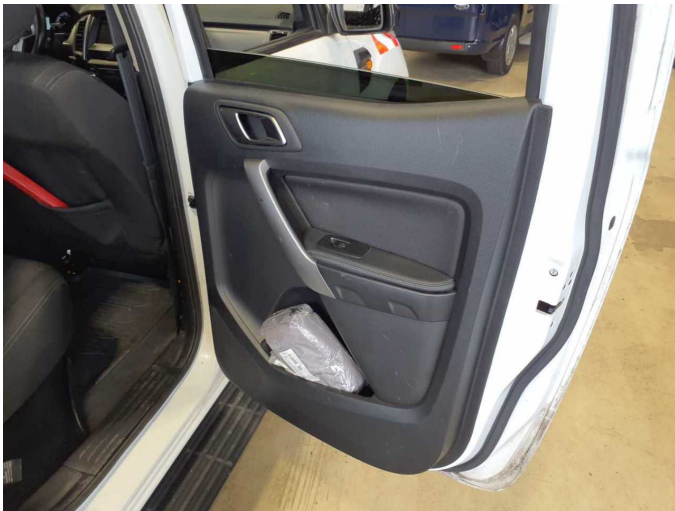
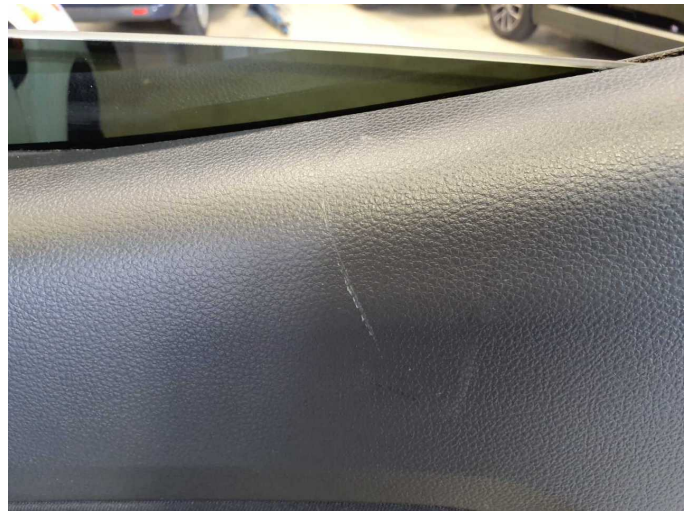
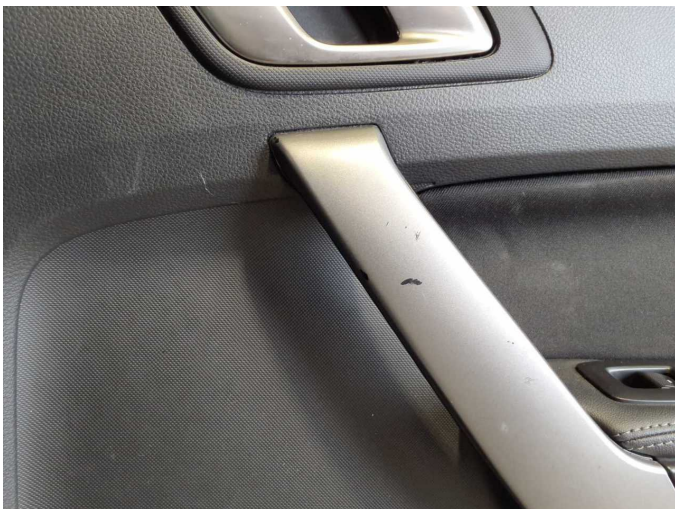
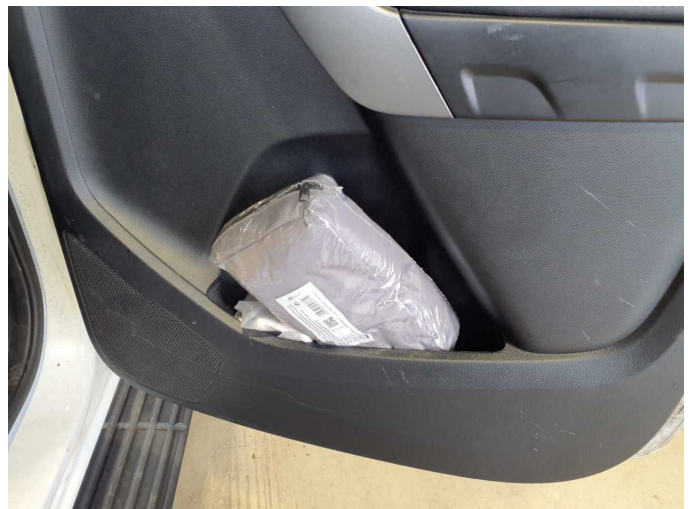
Damage 3: Trim / covers: Door trim - rear right side - Scratch(es) - Loss in value

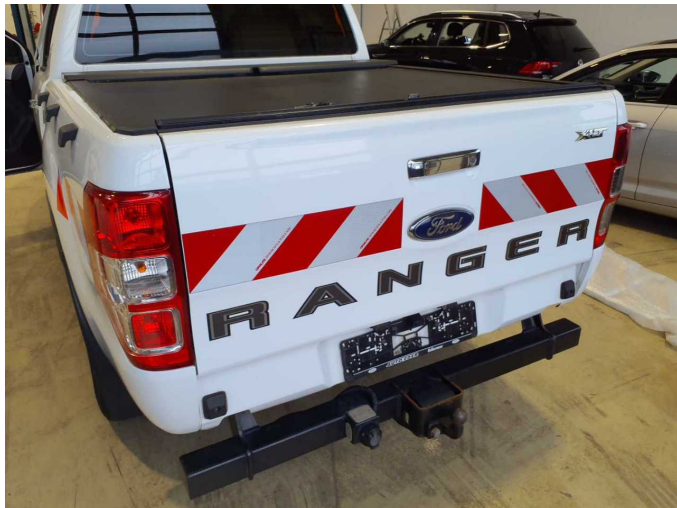
Damage 4: Boot lid / rear door: Boot lid (Öffnet nicht) - Functional / admissibility - Perform diagnosis

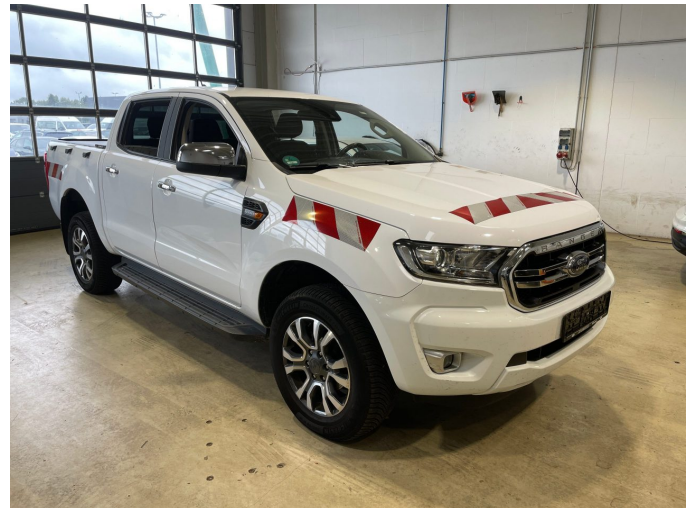
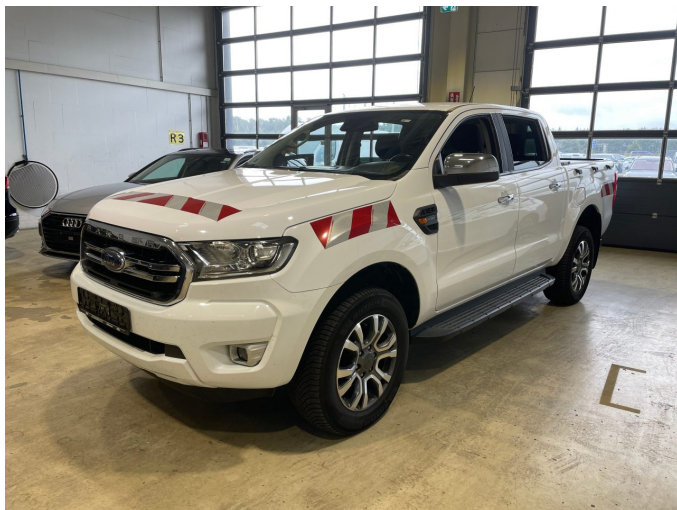
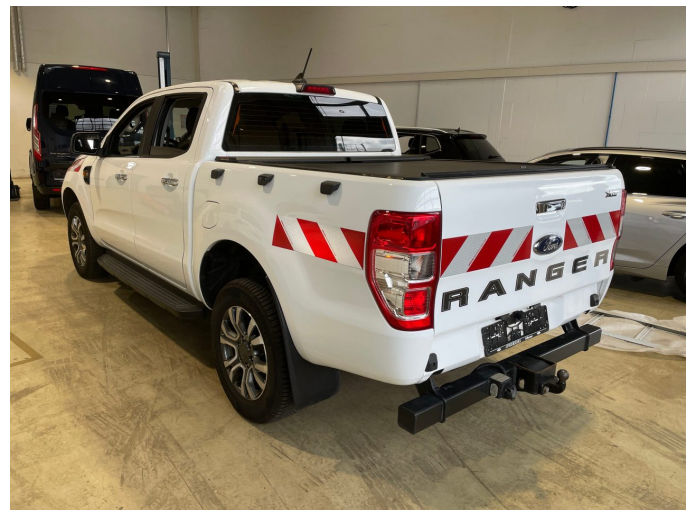
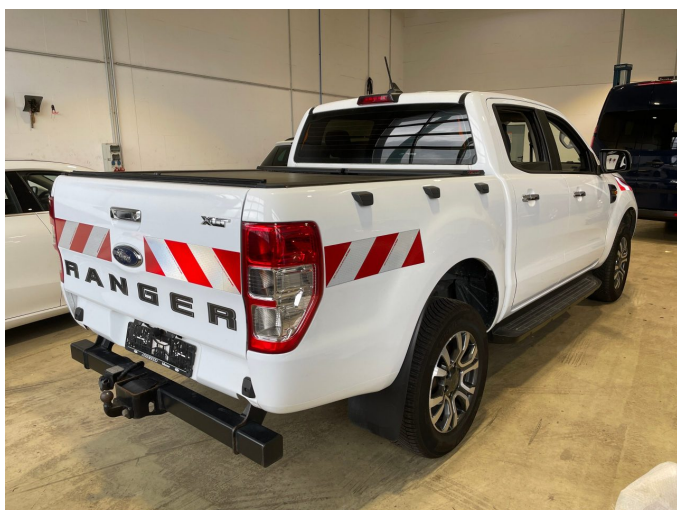
Damage 5: Interior: Interior (Rauch) - Odour - Ozone treatment

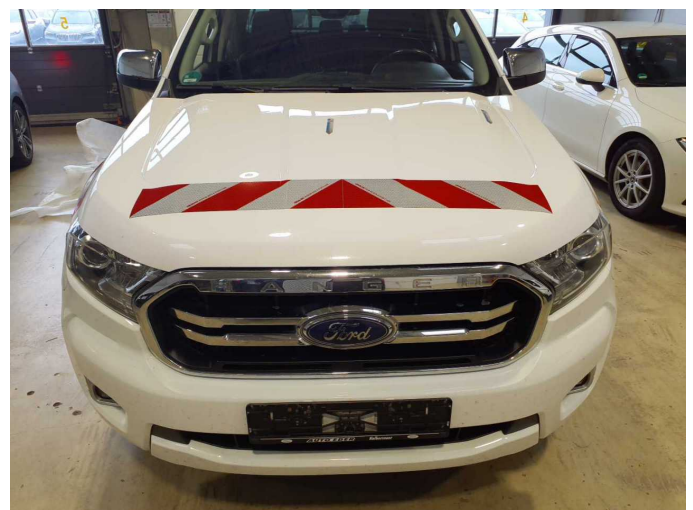
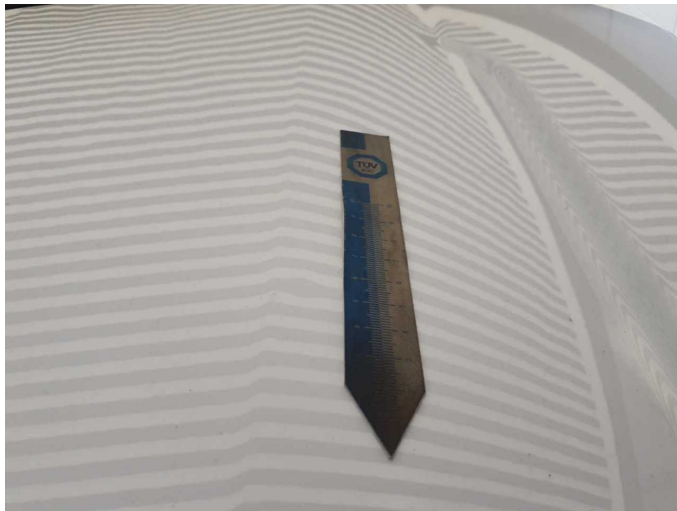
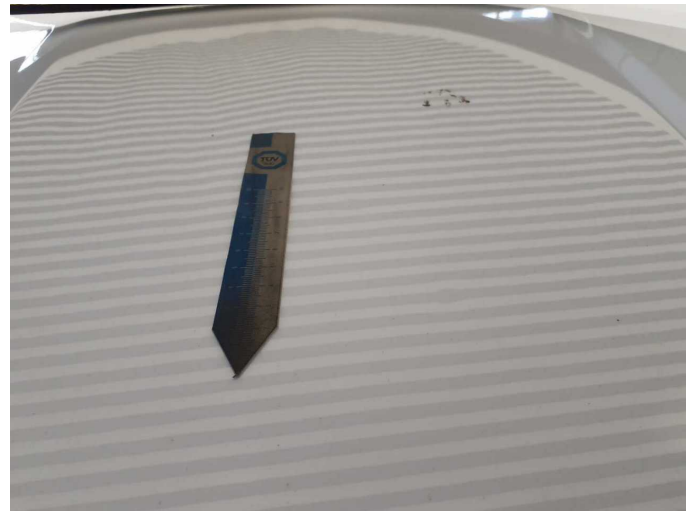
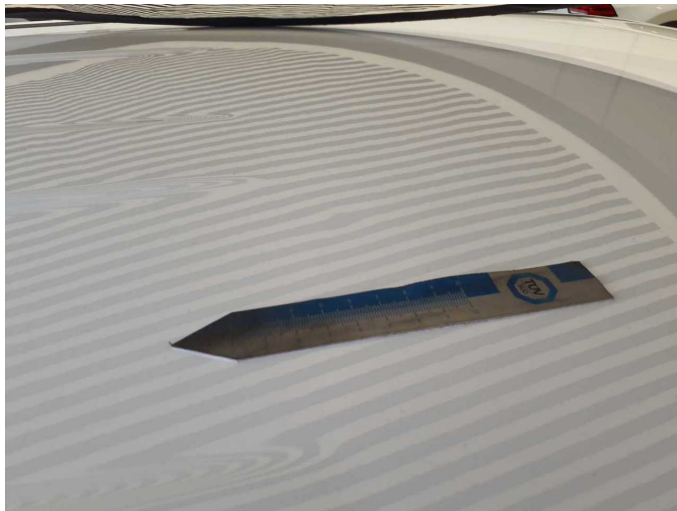
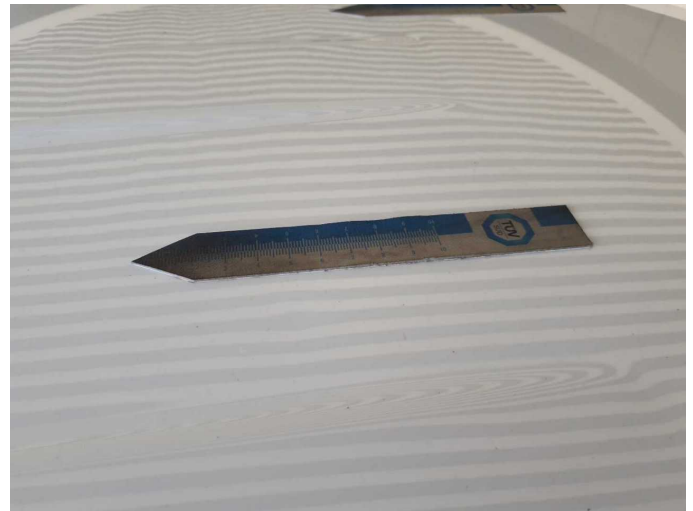
Damage 7: Body: Body - Damage by hail - Smooth repair work

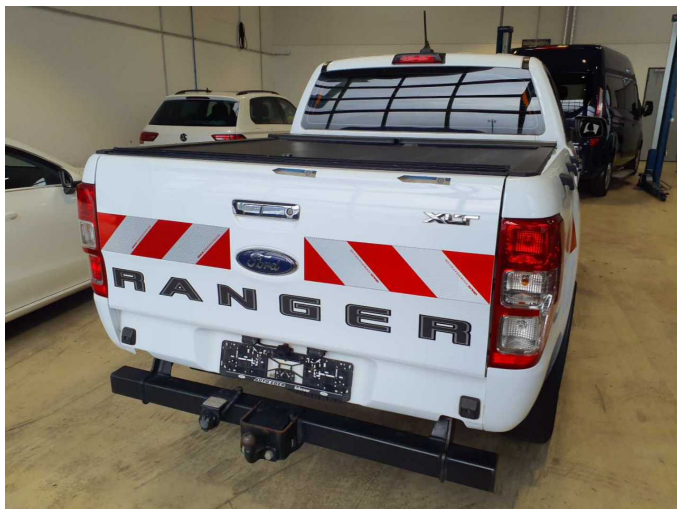
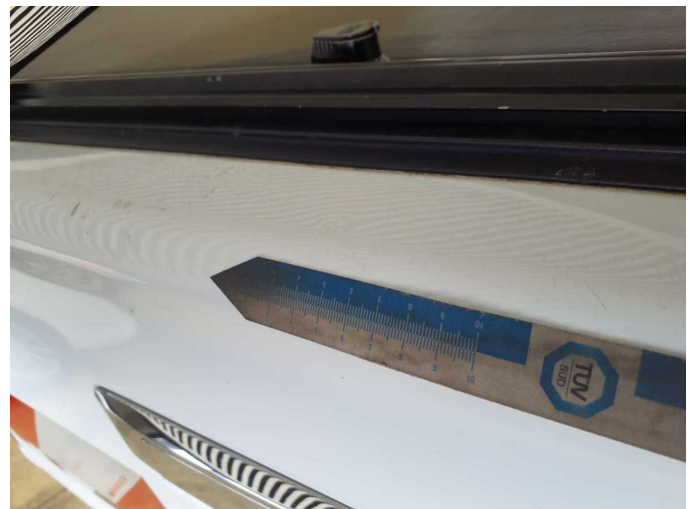
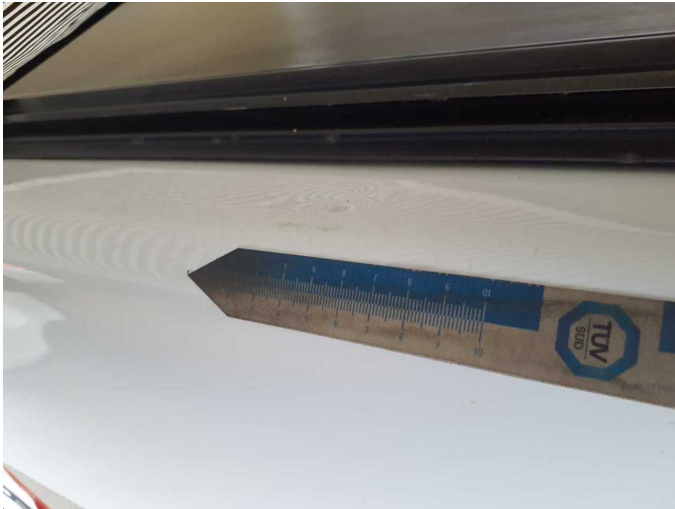
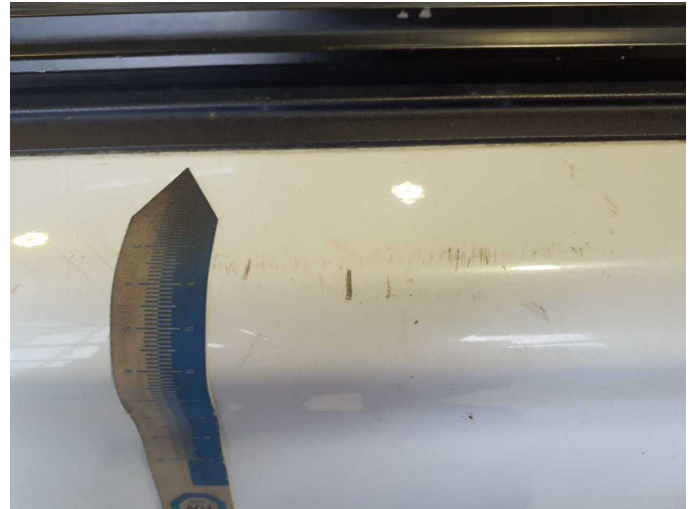
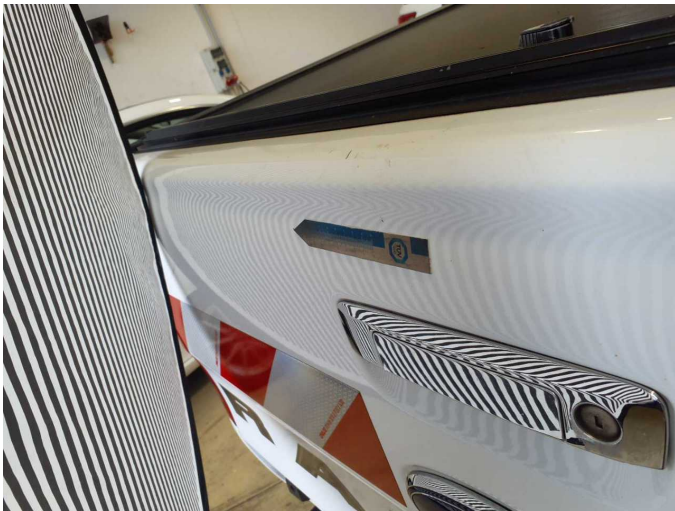
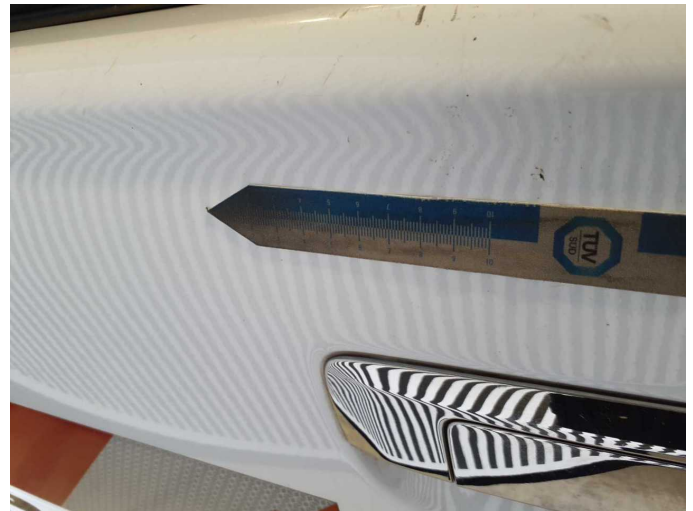
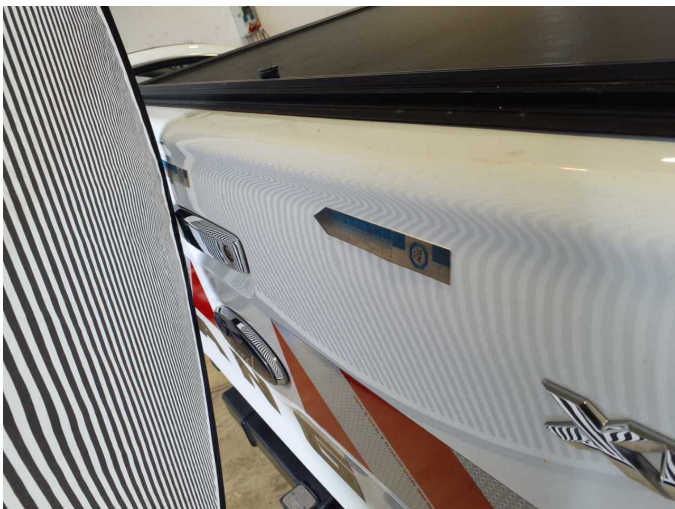
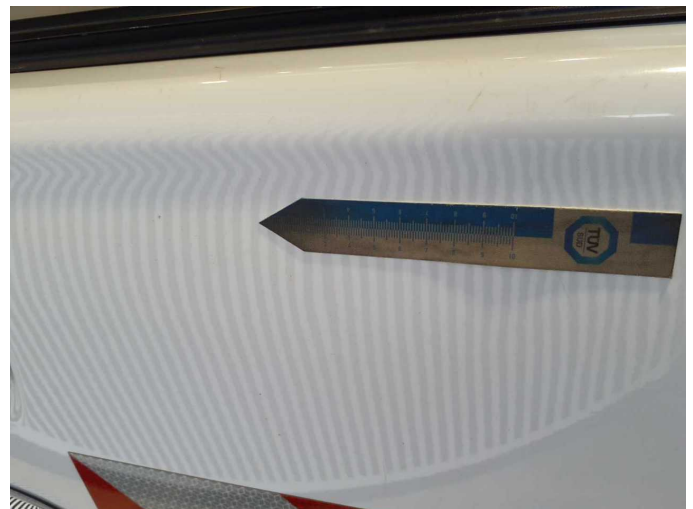
Damage 8: Boot lid / rear door: Boot lid - Dent / paintcoat damage - Repair and paint

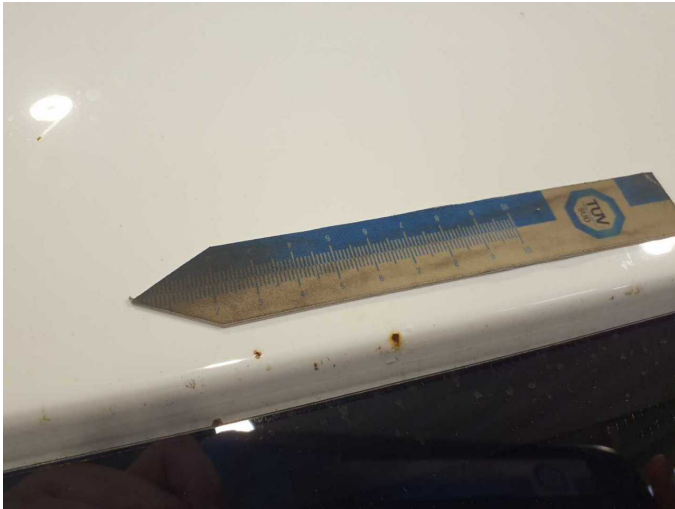
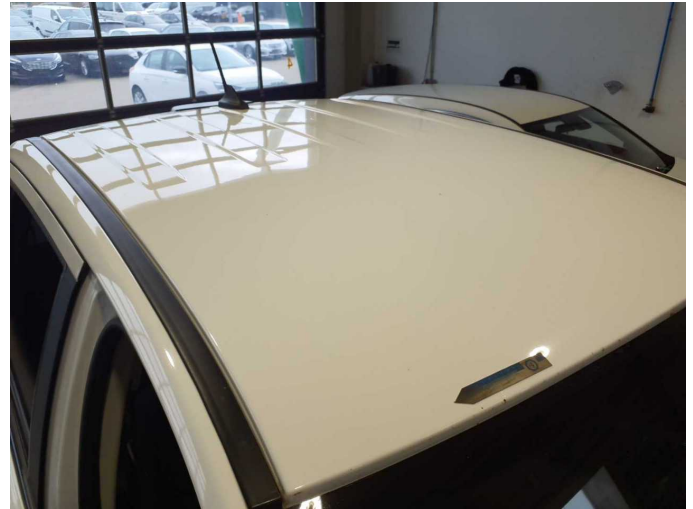
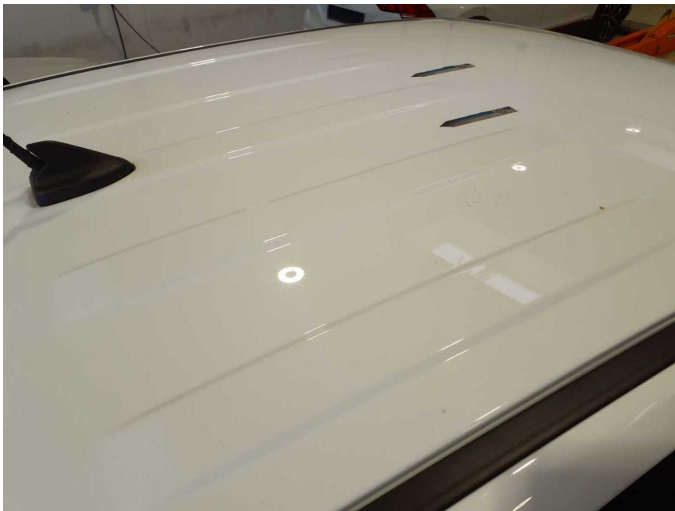
Damage 9: Roof: Roof (+ Dellen) - Corrosion - Repair and paint

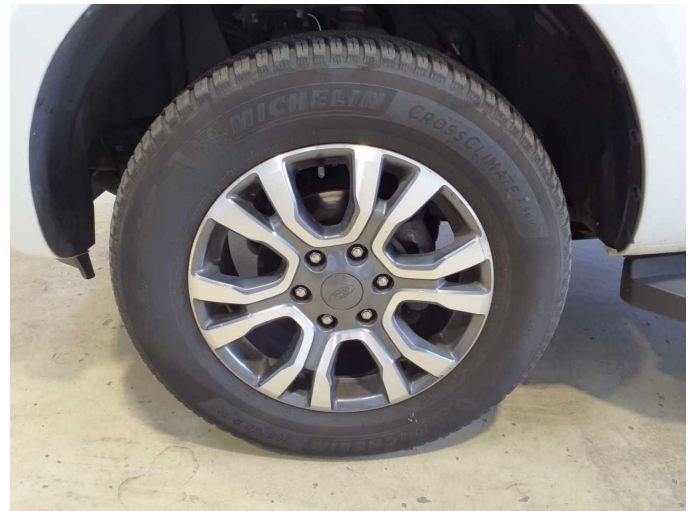
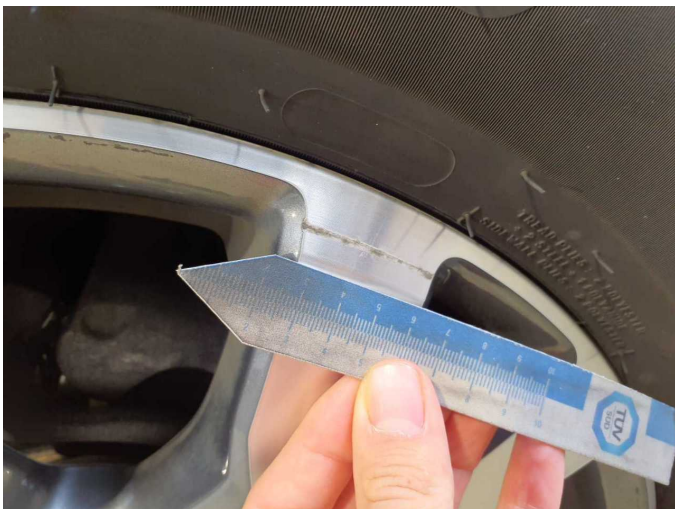
Wear and tear 7: Wheel / tyres: Alloy rim - front left side - Scratch(es) - No deduction

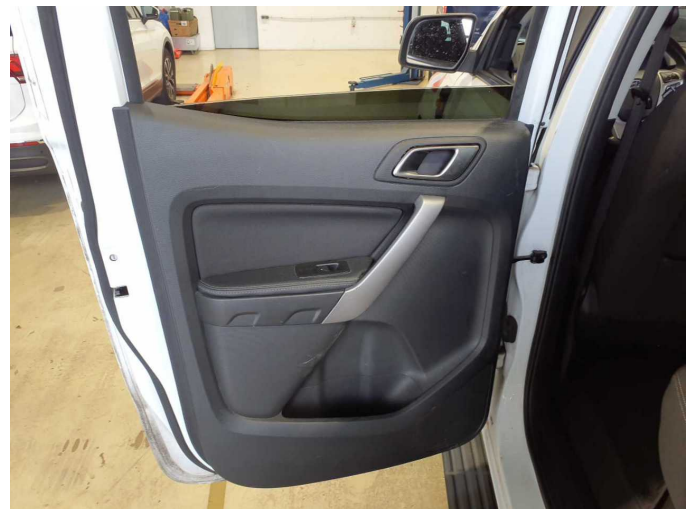
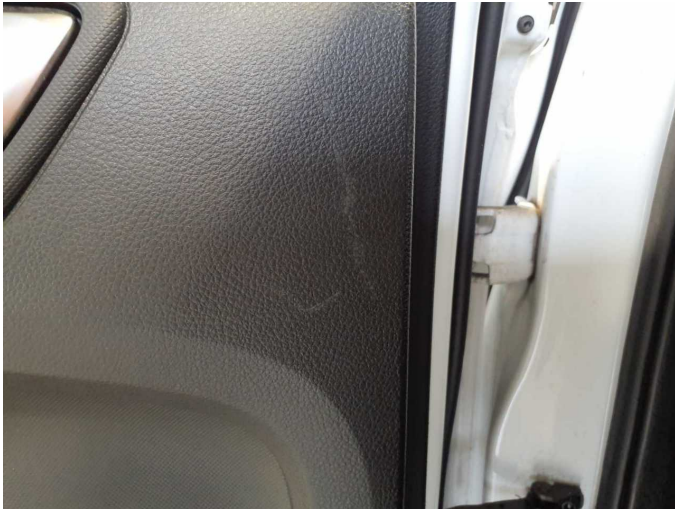
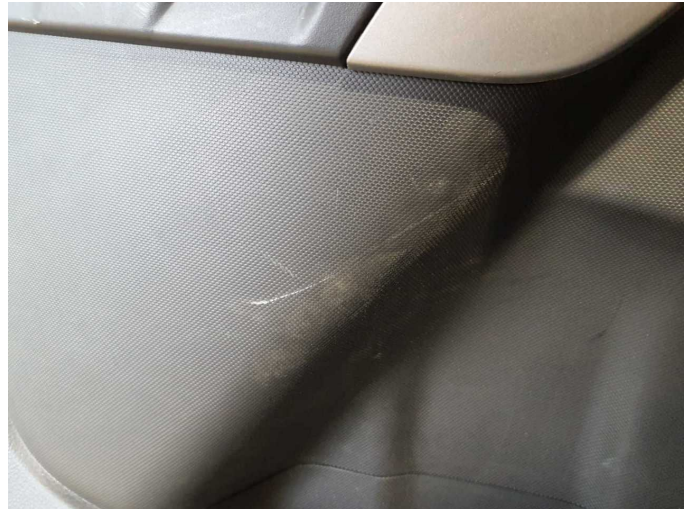
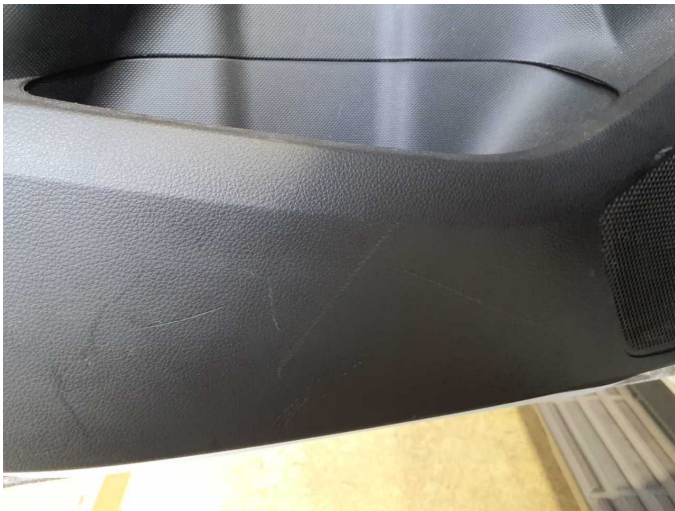
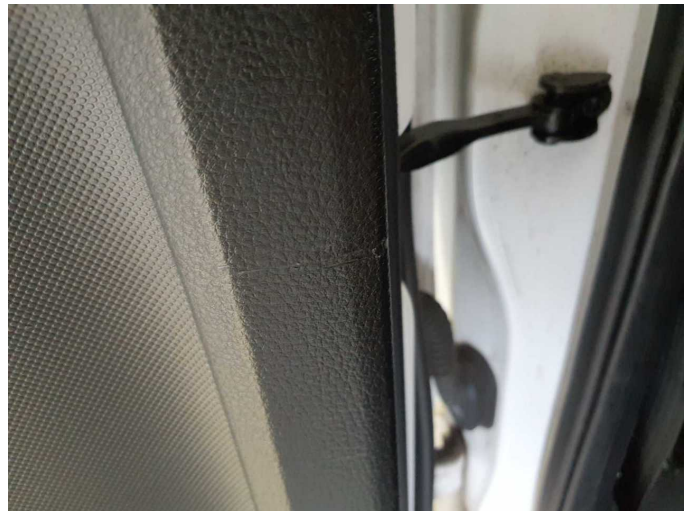
Wear and tear 8: Trim / covers: Door trim - rear left side - Scratch(es) - No deduction

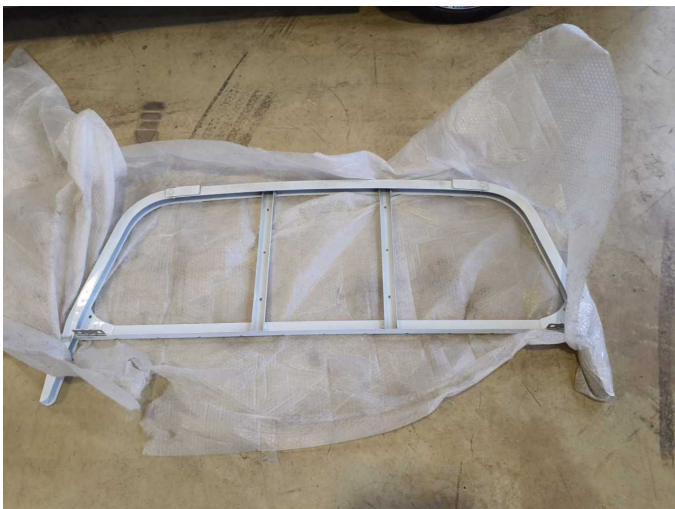
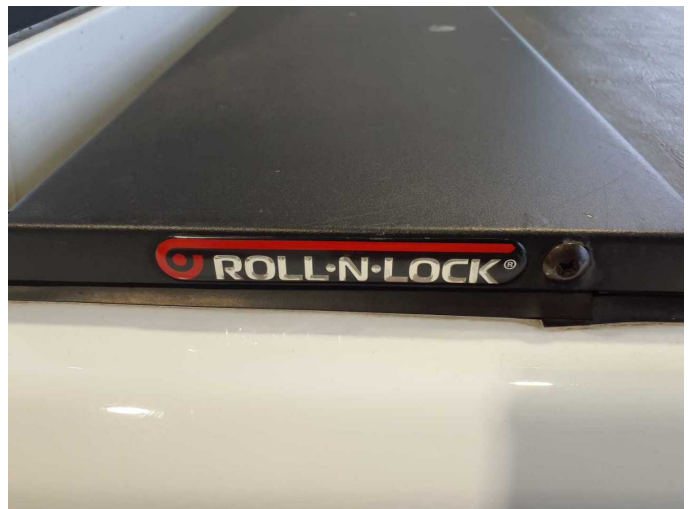
Wear and tear 9: Interior: Boot cover / roller cover (Nachgerüstet) - No deduction

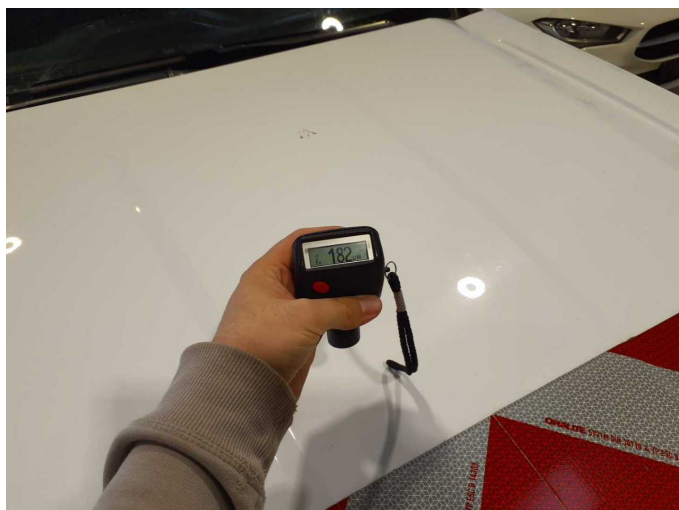
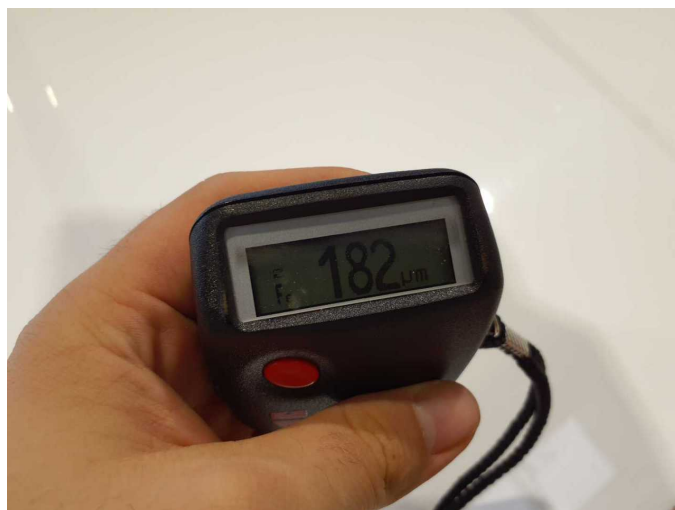
1 Bonnet, Professionally carried out, Invoice of repair done Non-existent

Bonnet 182 µm

Repainting 1: Bonnet
