MITSUBISHI Outlander

Outlander 2.0 4WD Plug-In Hybrid

Inspection Report Summary

Customer	BCA Online	Report Number	P20250915132442
Inspection Date / Place	2025-09-15 / BCA Berlin	Cosmetic Grade	3

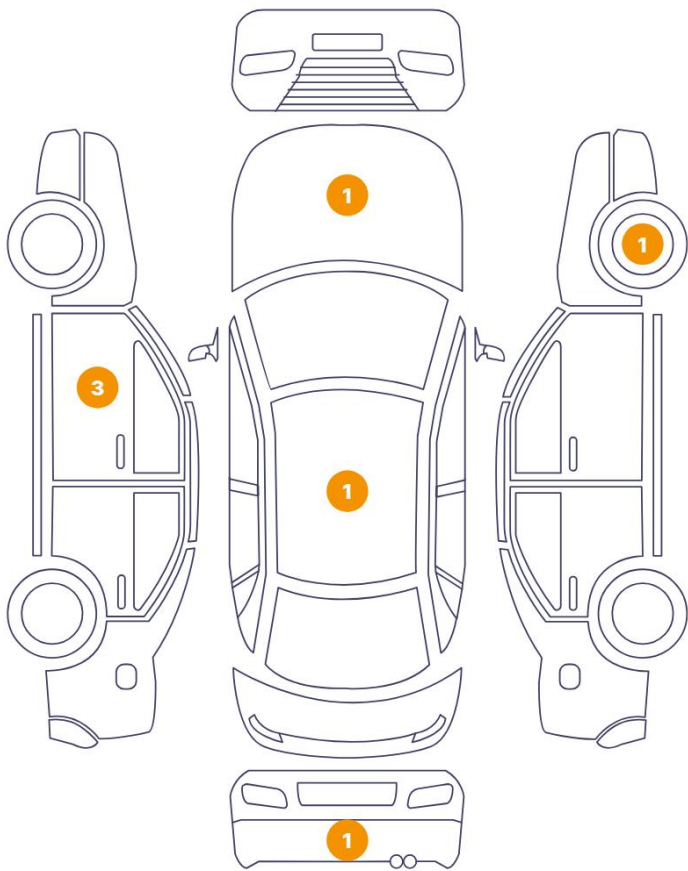
7 Schäden

Component		Damage	Comments
1	Rim / Front Right	Out of Bodywork / Scratch	
2	Mirror / Front Left	Bodywork / Breakage / Crack	
3	Door / Front Left	Bodywork / Dent / Dent	
4	Bumper / Back	Paint / Scratch / Scuff	
5	Roof	Bodywork / Dent / Dent	
6	Hood	Bodywork / Dent / Dent	
7	Door / Front Left	Bodywork / Dent / Dent

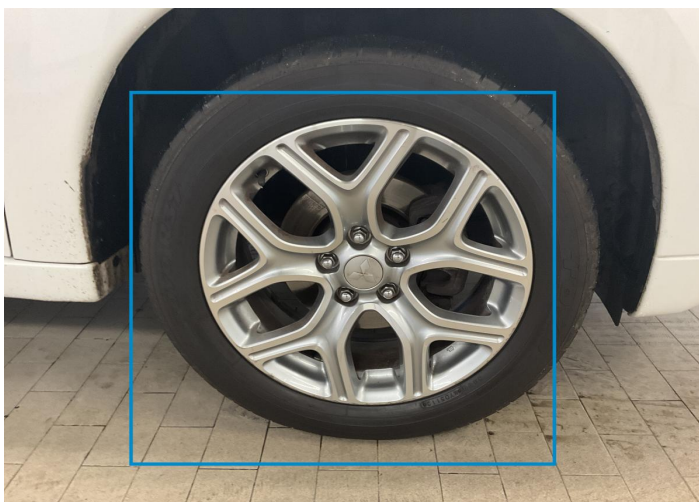
1. Rim / Front Right
Out of Bodywork / Scratch -

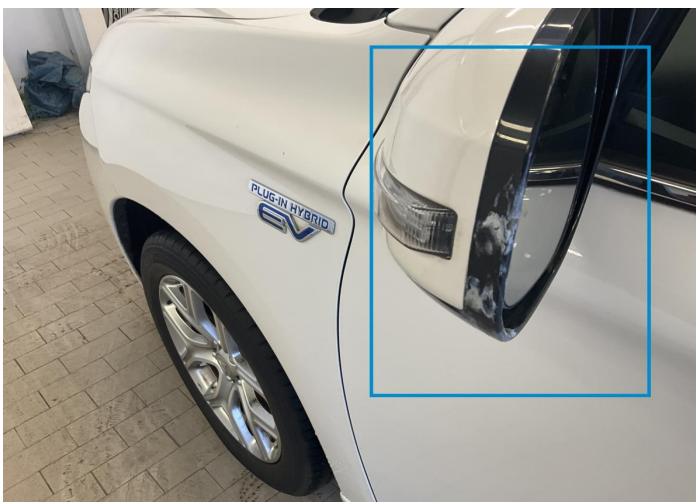
2. Mirror / Front Left
Bodywork / Breakage / Crack -

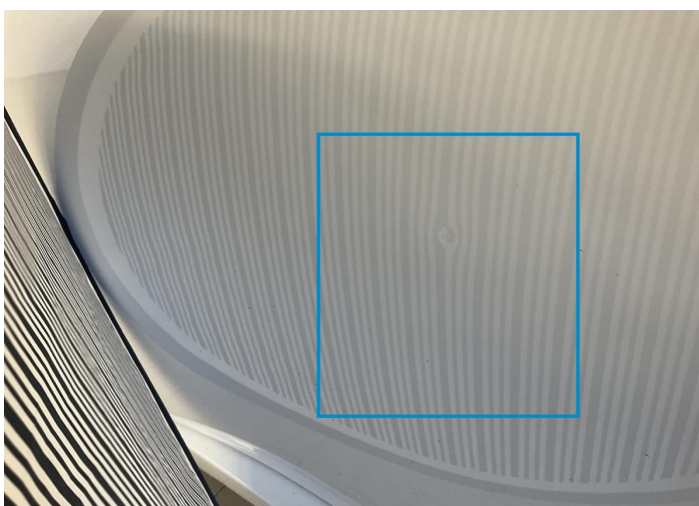
3. Door / Front Left
Bodywork / Dent / Dent -

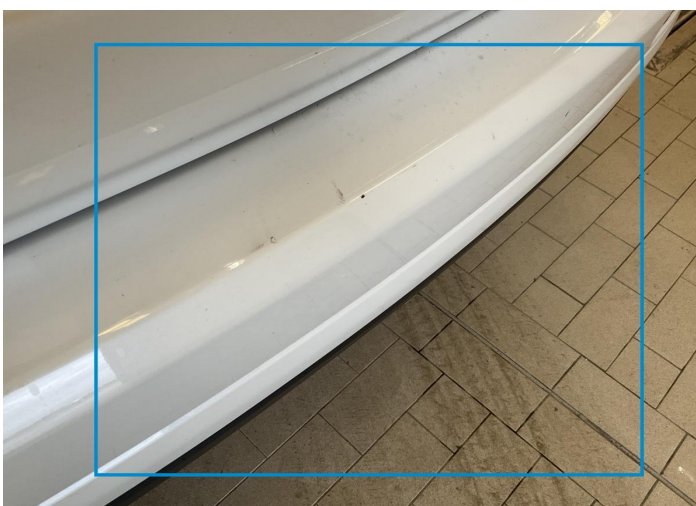
4. Bumper / Back
Paint / Scratch / Scuff -

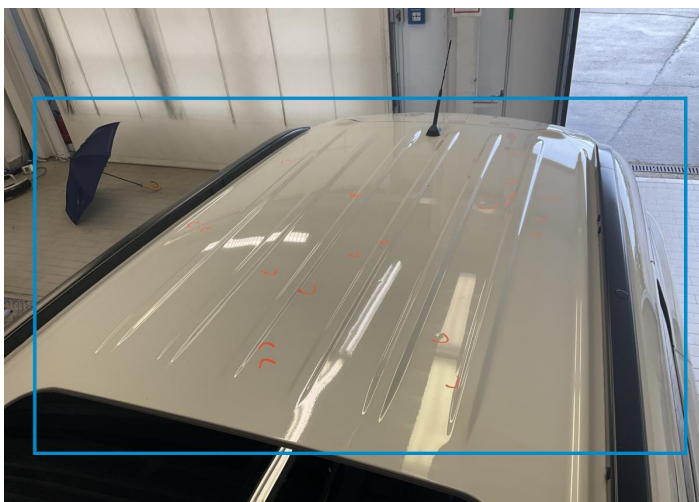
5. Roof
Bodywork / Dent / Dent -

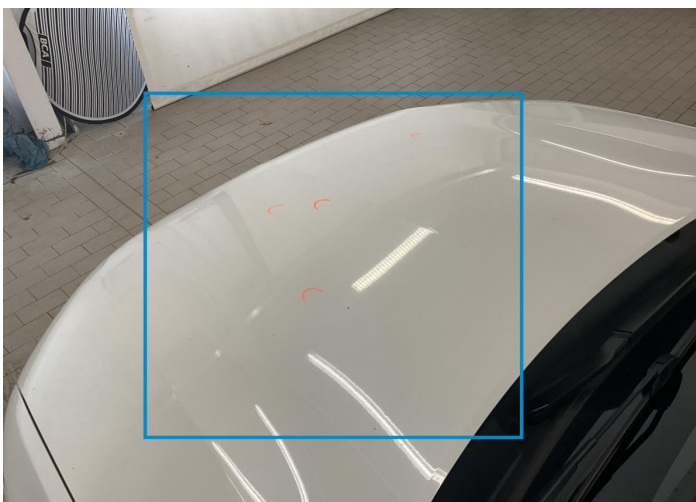
6. Hood
Bodywork / Dent / Dent -

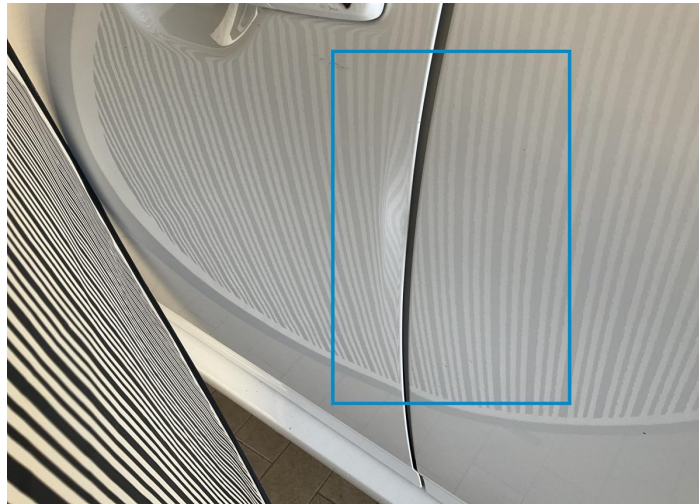
7. Door / Front Left
Bodywork / Dent / Dent -
