MITSUBISHI Outlander

Outlander 2.0 4WD Plug-In Hybrid

Inspection Report Summary

Customer	BCA Online	Report Number	P20250915132442
Inspection Date / Place	2025-09-15 / BCA Berlin	Cosmetic Grade	3

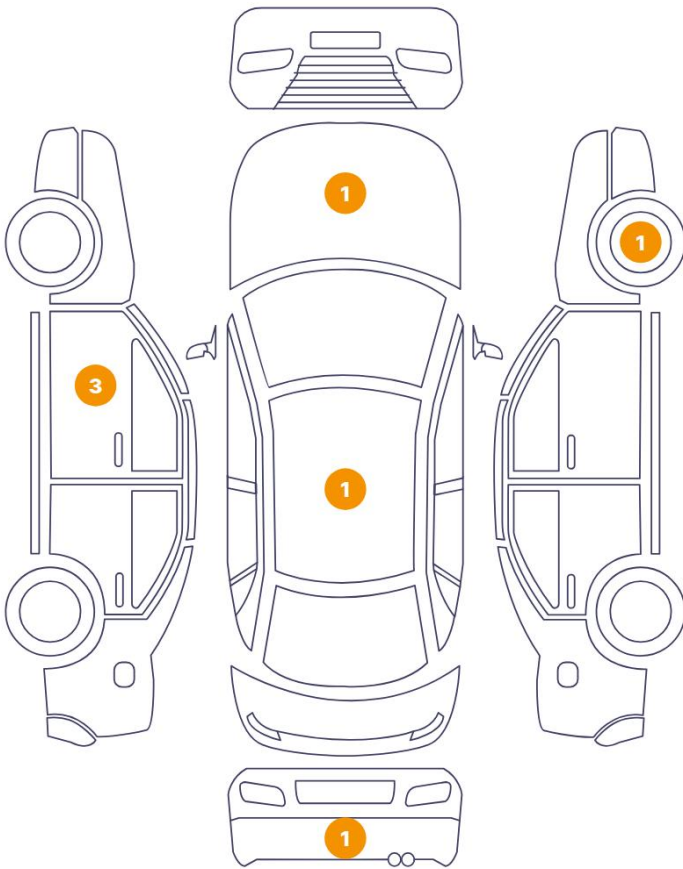
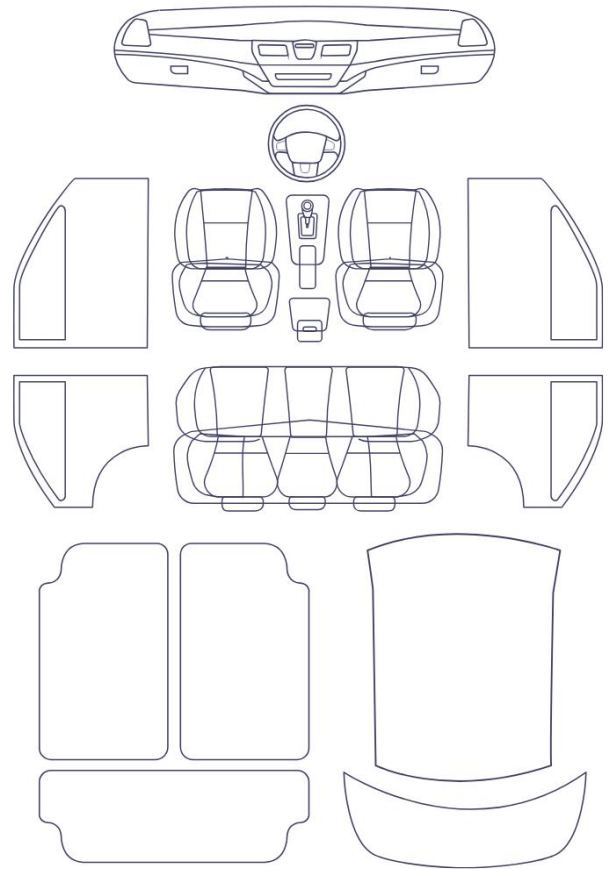
Component	Damage	Comments
1 Rim / Front Right	Out of Bodywork / Scratch	
2 Mirror / Front Left	Bodywork / Breakage / Crack	
3 Door / Front Left	Bodywork / Dent / Dent	
4 Bumper / Back	Paint / Scratch / Scuff	
5 Roof	Bodywork / Dent / Dent	
6 Hood	Bodywork / Dent / Dent	
7 Door / Front Left	Bodywork / Dent / Dent

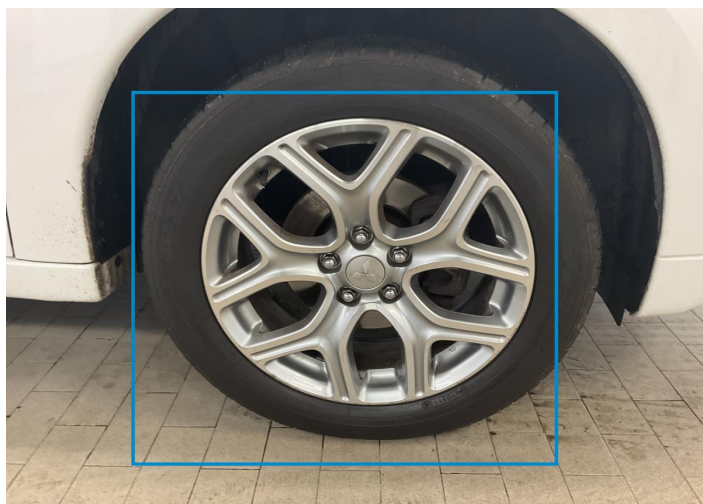
1. Rim / Front Right
Out of Bodywork / Scratch -

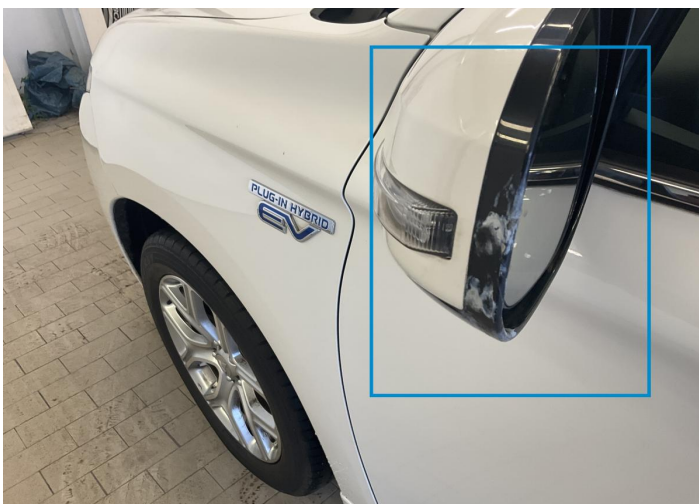
2. Mirror / Front Left
Bodywork / Breakage / Crack -

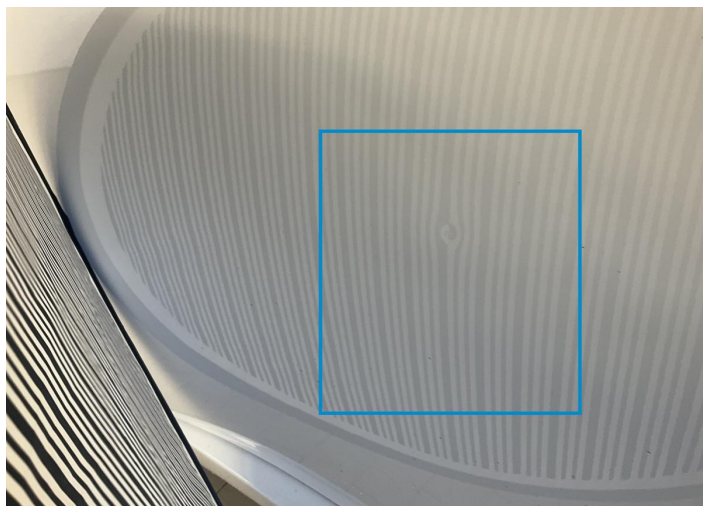
3. Door / Front Left
Bodywork / Dent / Dent -

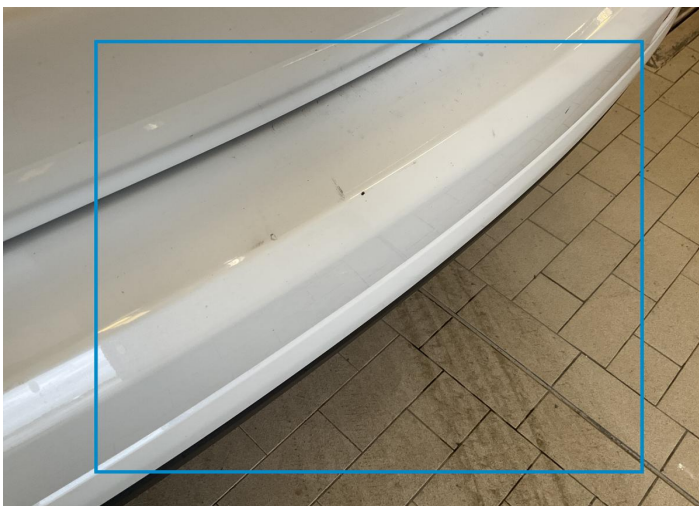
4. Bumper / Back
Paint / Scratch / Scuff -

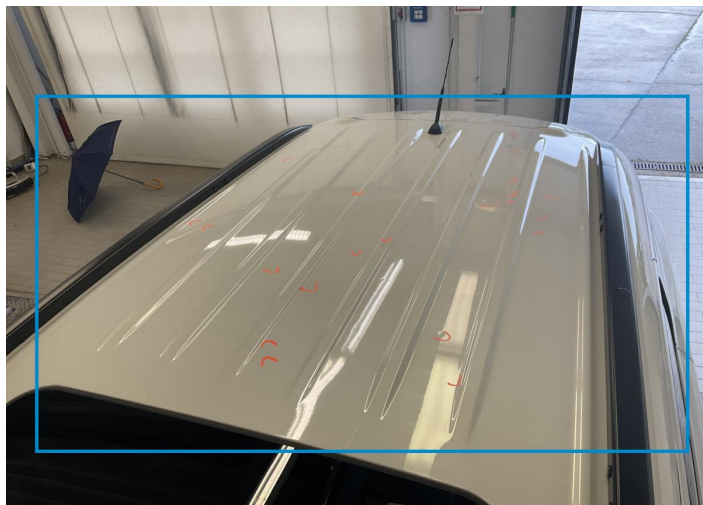
5. Roof
Bodywork / Dent / Dent -

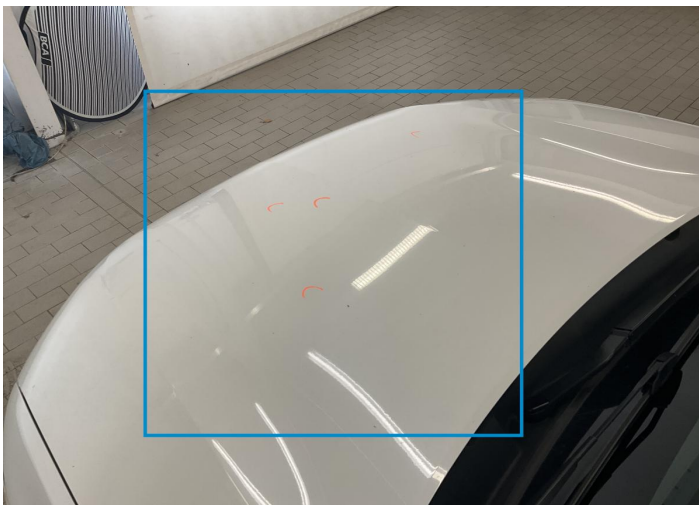
6. Hood
Bodywork / Dent / Dent -

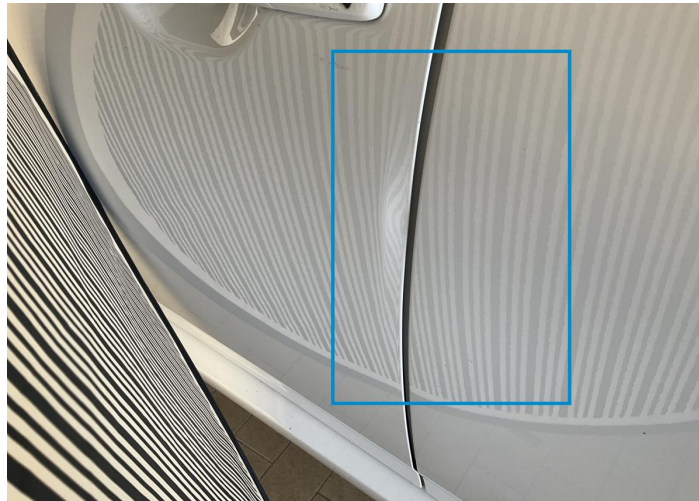
7. Door / Front Left
Bodywork / Dent / Dent -
