# MITSUBISHI Outlander

## Outlander 2.0 4WD Plug-In Hybrid

### Inspection Report Summary

Customer	BCA Online	Report Number	P20250915132442
Inspection Date / Place	2025-09-15 / BCA Berlin	Cosmetic Grade	3

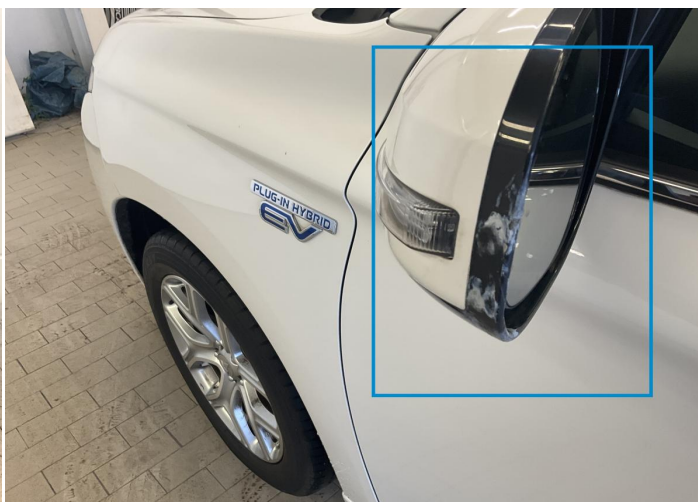
2. Mirror / Front Left  
Bodywork / Breakage / Crack -

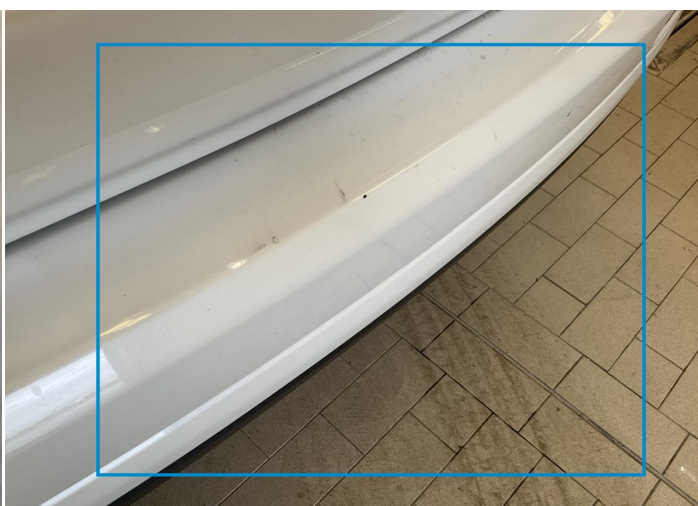
4. Bumper / Back  
Paint / Scratch / Scuff -

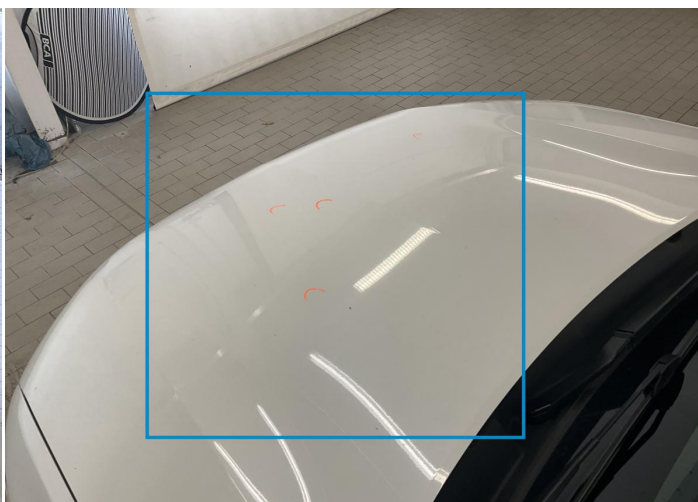
6. Hood  
Bodywork / Dent / Dent -
