MITSUBISHI Outlander Outlander 2.0 DI-D 4WD

Inspection Report Summary

Customer	BCA Online	Report Number	P20250924140823
Inspection Date / Place	2025-09-24 / BCA Oberndorf	Cosmetic Grade	5

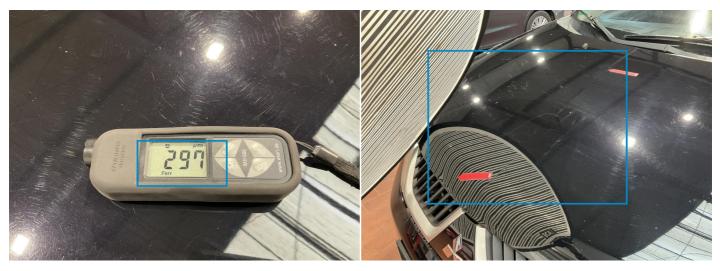
1. Anomalyon Element -

2. Hood Bodywork / Dent / Dent -

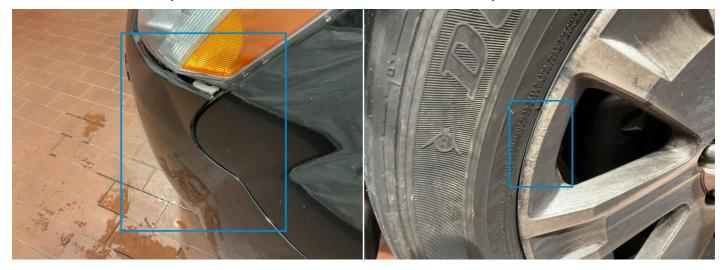
3. Bumper / Front Bodywork / Breakage / Crack -

4. Rim / Front Left
Out of Bodywork / Scratch -

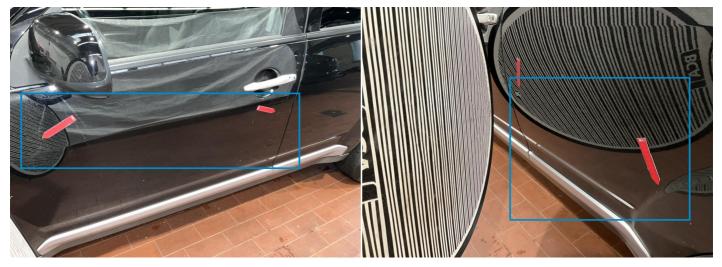
5. Door / Front Left Bodywork / Dent / Dent -

6. Door / Back Left Bodywork / Dent / Dent -

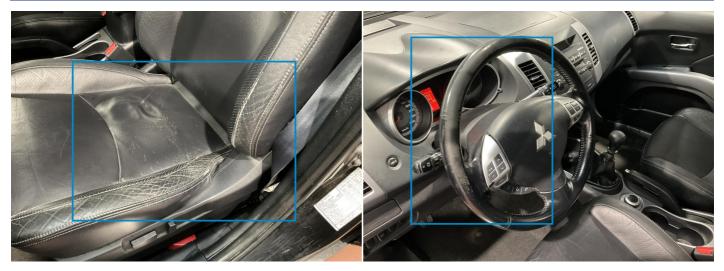
7. Seat / Front Left Interior / Scratched -

8. Steering Wheel / Front Interior / Scratched -

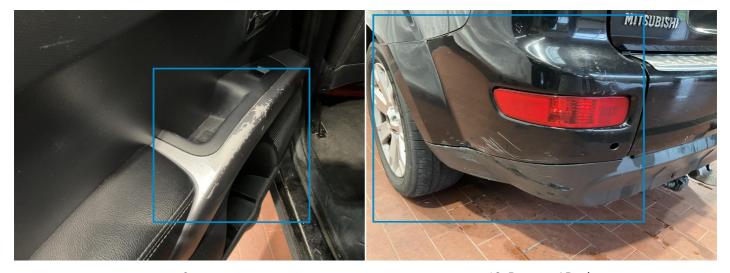
9. Interior / Scratched -

10. Bumper / Back Bodywork / Breakage / Crack -

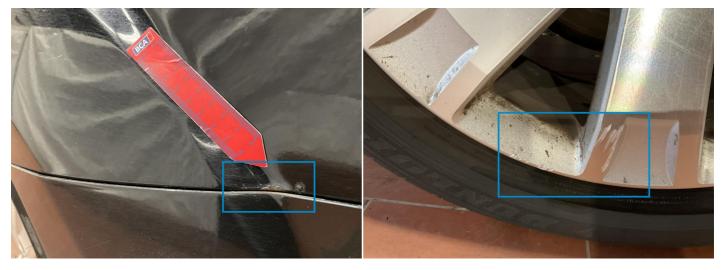
11. Fender / Back Left Paint / Scratch / Line -

12. Rim / Back Right Out of Bodywork / Scratch -

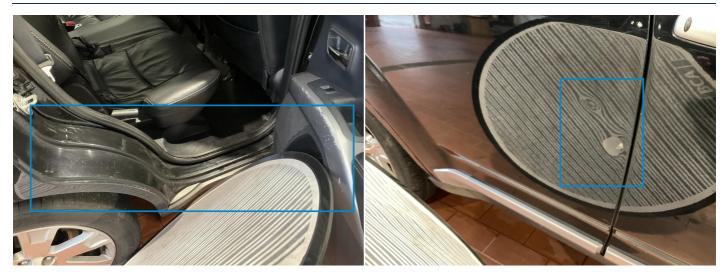
13. Fender / Back Right Bodywork / Dent / Dent -

14. Door / Back Right Bodywork / Dent / Dent -

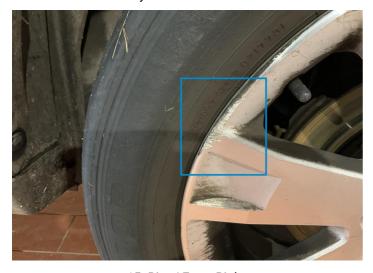
15. Rim / Front Right Out of Bodywork / Scratch -
