MAZDA CX-3 CX-3 SKYACTIV-G 120 FWD

Inspection Report Summary

Customer	BCA Online	Report Number	P20250917133205
Inspection Date / Place	2025-09-17 / ARS Altmann AG Riedstadt	Cosmetic Grade	3

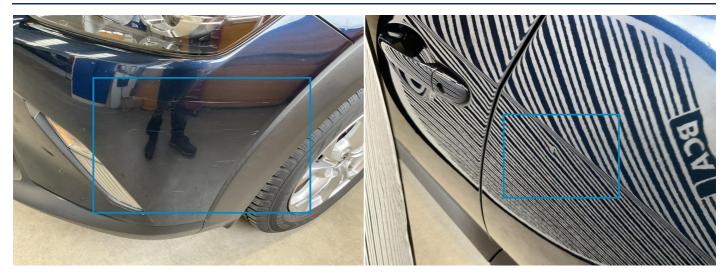
1. Bumper / Front Paint / Scratch / Scuff -

2. Door / Back Left Bodywork / Dent / Dent -

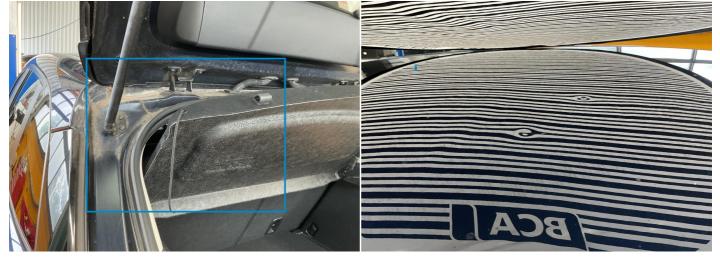
3. Luggage Space Cover / Back Interior / Dysfunctional -

4. Roof Bodywork / Dent / Hail Area -
