## status report

#### Mazda CX-5 Nakama Intense AWD

| Vehicle identification number | <b>JMZKEN92800527450</b> | mileage read: | <b>105748 km</b> |

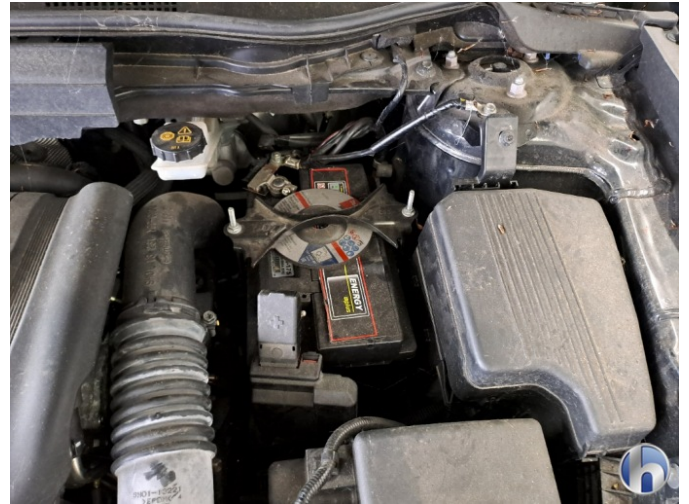
| Performed testing technology | |
|---|---|
| <b>Battery / accumulator:</b> | The battery (accumulator) was discharged for visiting time .<br>**Battery deep discharge. Vehicle was bridged with a jumper. |

| component | Damage | Rep kind |
|---|---|---|
| 2. battery | Defective | Replace |

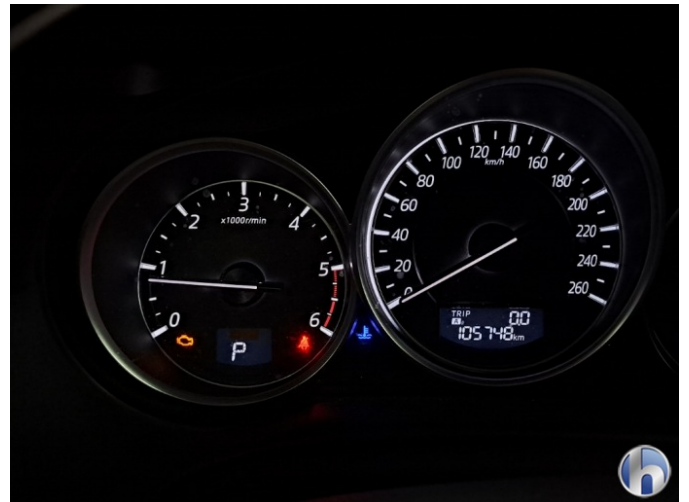
| Performed testing technology | |
|---|---|
| <b>engine running:</b> | A field test of the engine had to acoustic or visual defects for visiting time .<br>**Engine warning light. Engine run out of round. |

| component | Damage | Rep kind |
|---|---|---|
| 4. Malfunction Indicator Lamp | Error message | Carry out a fault diagnosis |

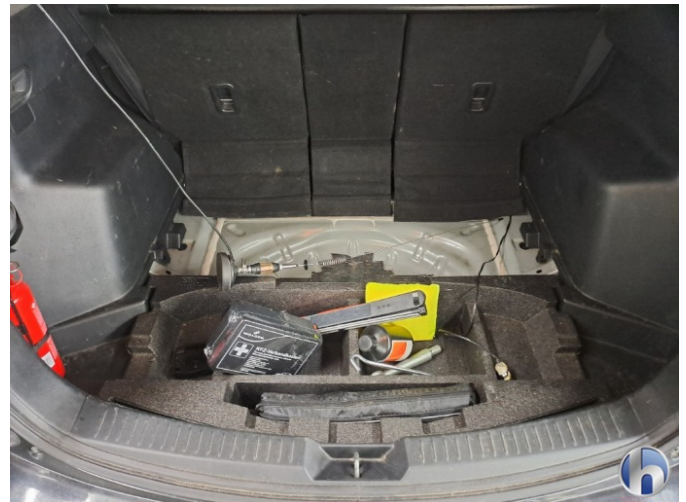
| component | Damage | Rep kind |
|---|---|---|
| 7. Trunk Flooring | Missing | Replace |

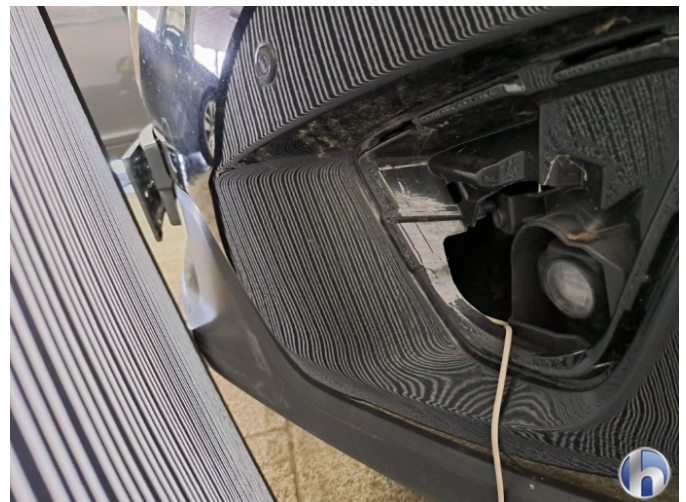
| component | Damage | Rep kind |
|---|---|---|
| 8. Front bumper | Damaged | Replace |

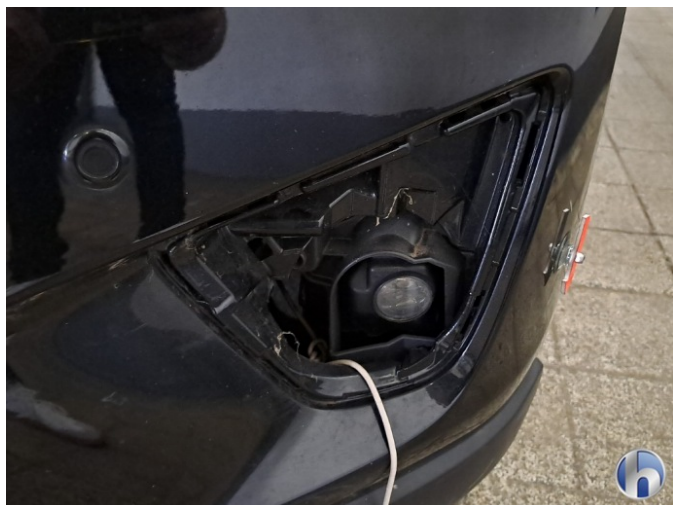
| component | Damage | Rep kind |
|---|---|---|
| 9. Blende Nebelscheinwerfer VL | Missing | Replace |

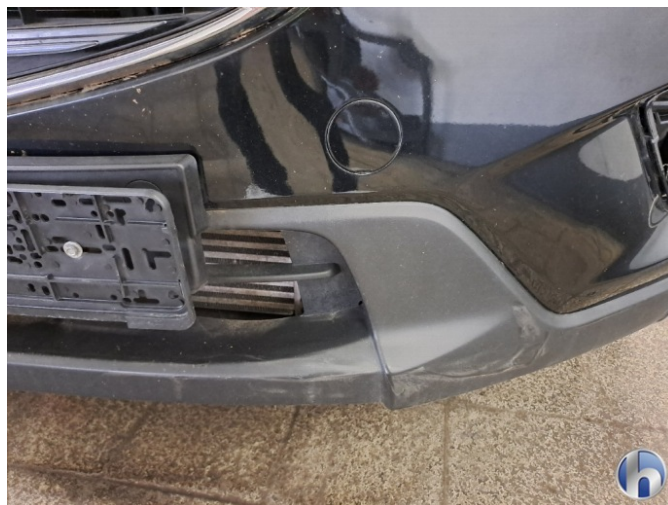
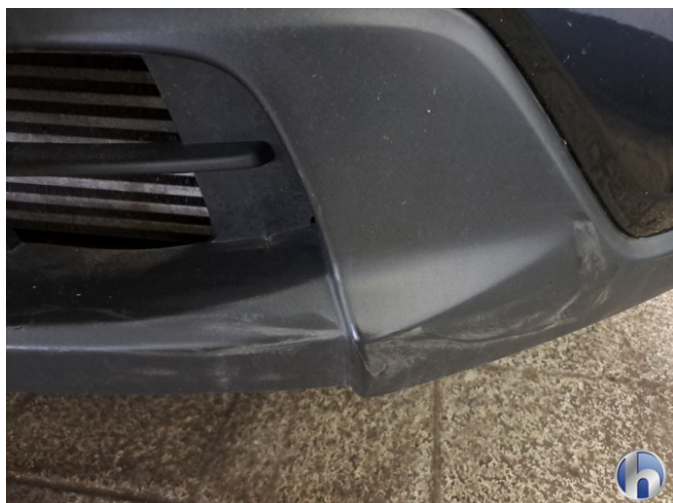
| component | Damage | Rep kind |
|---|---|---|
| 10. spoiler | Damaged | Replace |

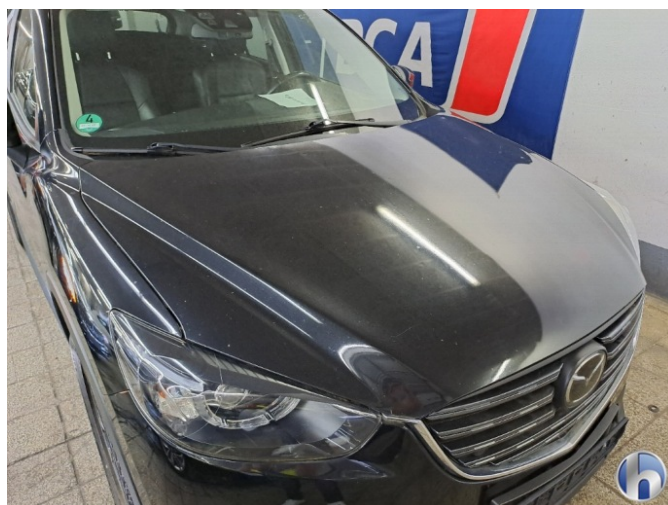
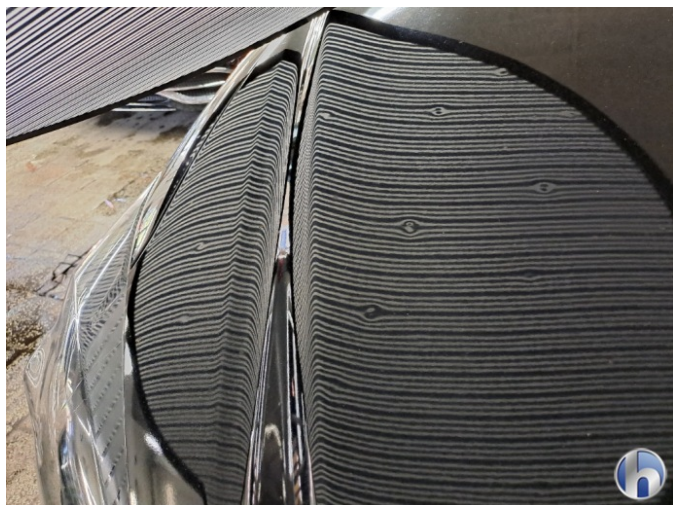
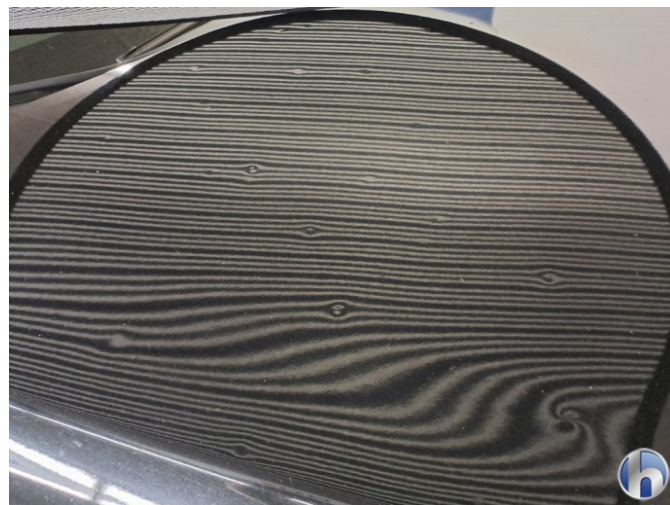
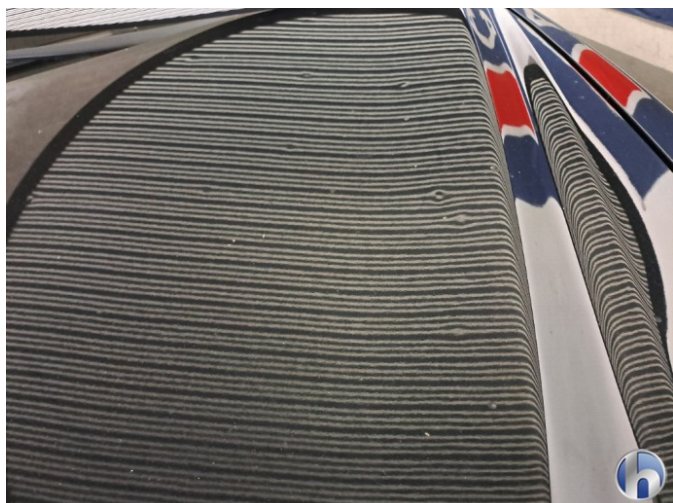
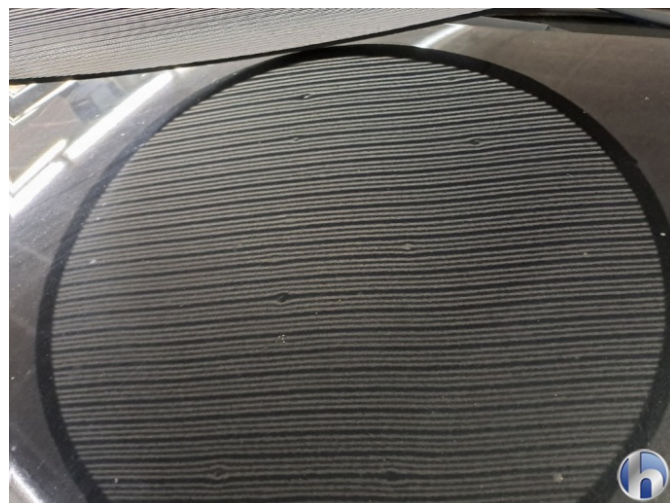
| component | Damage | Rep kind |
|---|---|---|
| 12. Motorhaube (ca. 180x20mm) | Hail damage | Refurbish and paint |

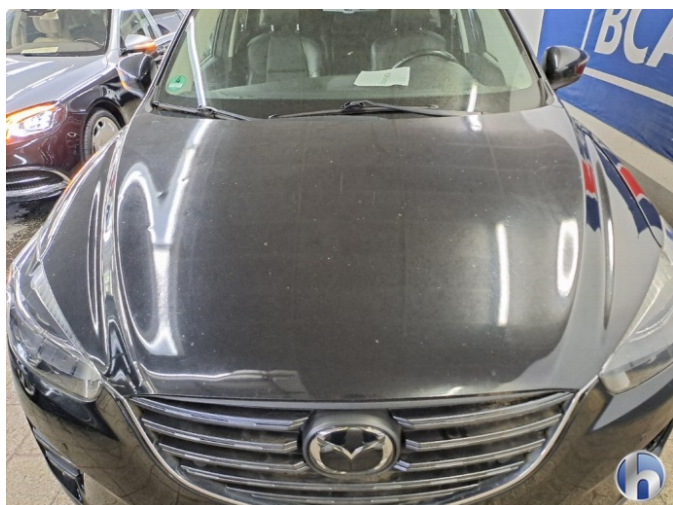
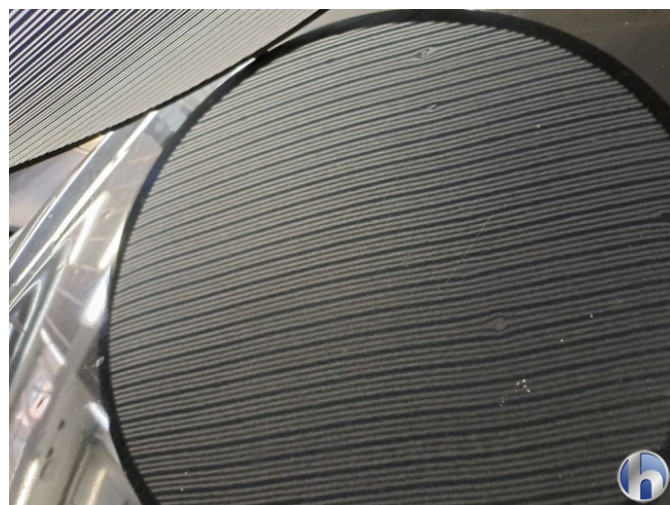
| component | Damage | Rep kind |
|---|---|---|
| 13. hood | Execution defect | Paint |

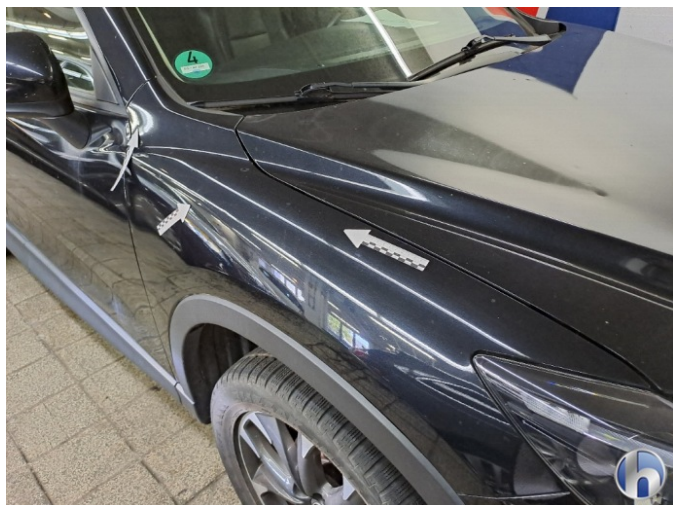
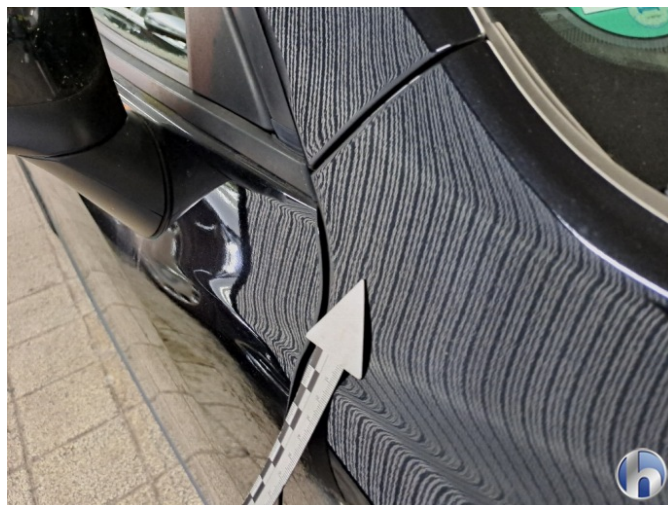
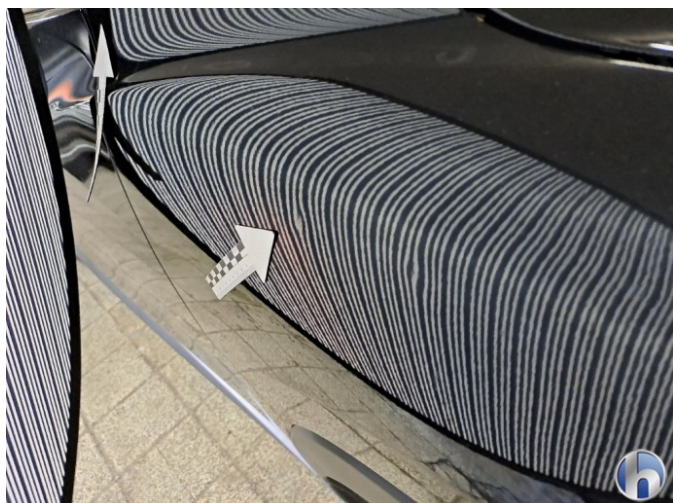
14. Kotflügel Vorne - Rechts (6×10mm)

| component | Damage | Rep kind |
|---|---|---|
| 14. Kotflügel Vorne - Rechts (6x10mm) | Hail damage | Gentle refurbishing |

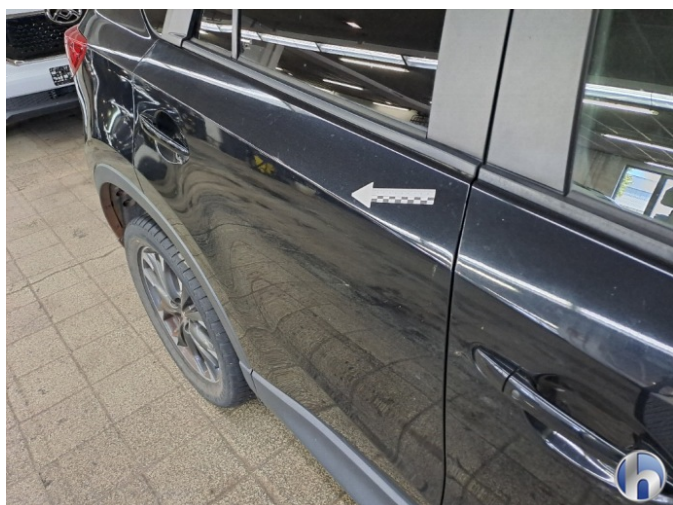
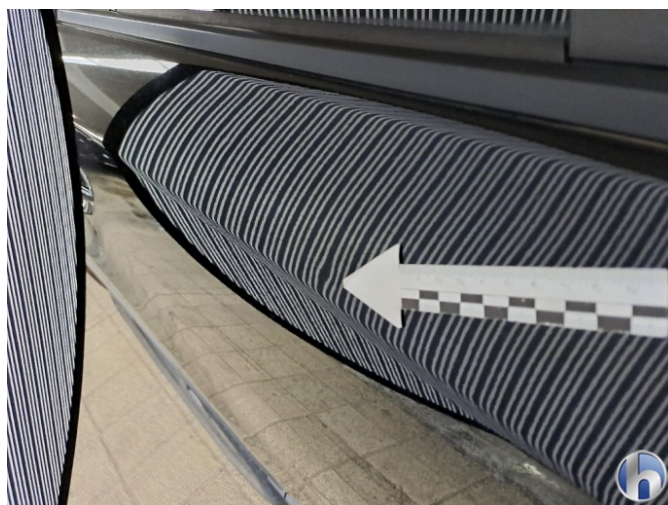
15. Tür Hinten - Rechts (1×10mm)

| component | Damage | Rep kind |
|---|---|---|
| 15. Tür Hinten - Rechts (1x10mm) | Hail damage | Gentle refurbishing |

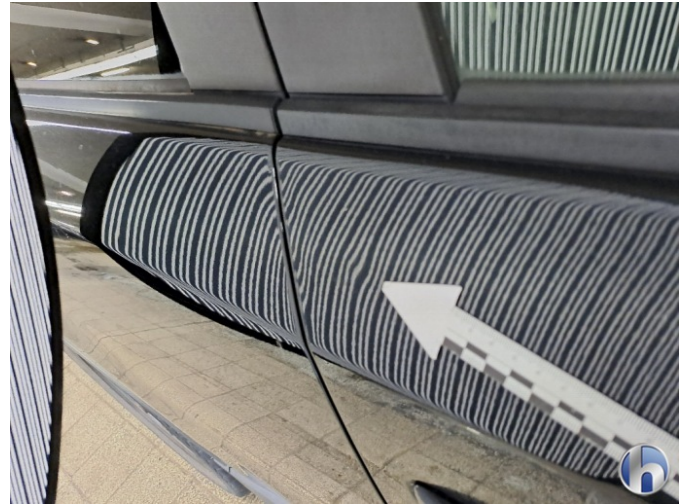
16. Tür Vorne - Rechts (1×20mm)

| component | Damage | Rep kind |
|---|---|---|
| 16. Tür Vorne - Rechts (1x20mm) | Hail damage | Gentle refurbishing |

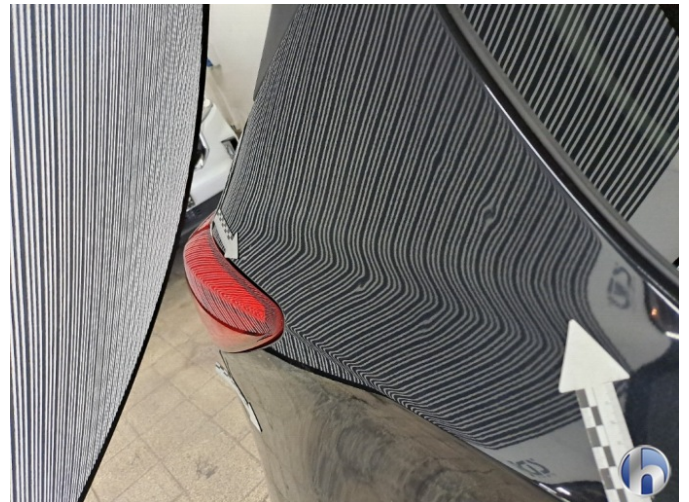
17. Seitenwand - Hinten - Rechts (13×10mm)

| component | Damage | Rep kind |
|---|---|---|
| 17. Seitenwand - Hinten - Rechts (13x10mm) | Hail damage | Gentle refurbishing |

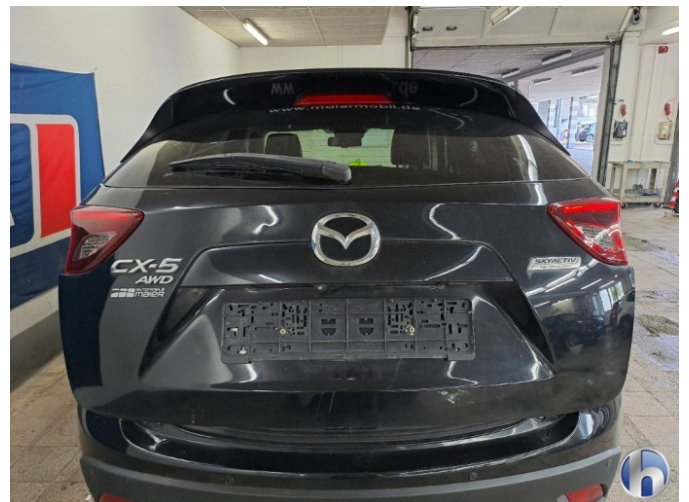
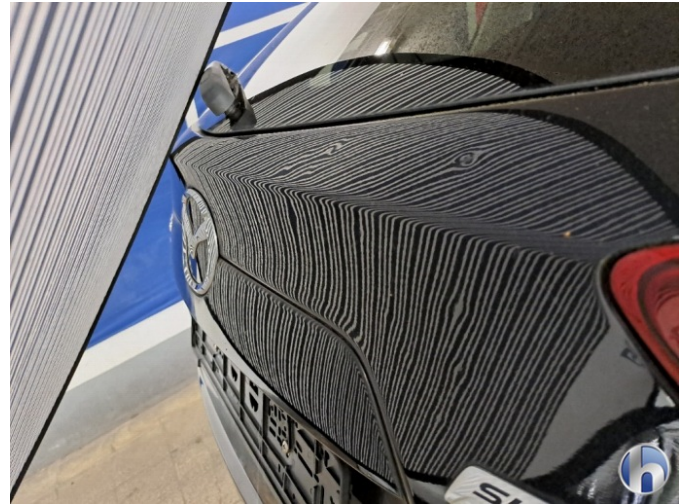
| component | Damage | Rep kind |
|---|---|---|
| 18. Heckklappe (ca.50x20mm) | Hail damage | Gentle refurbishing |

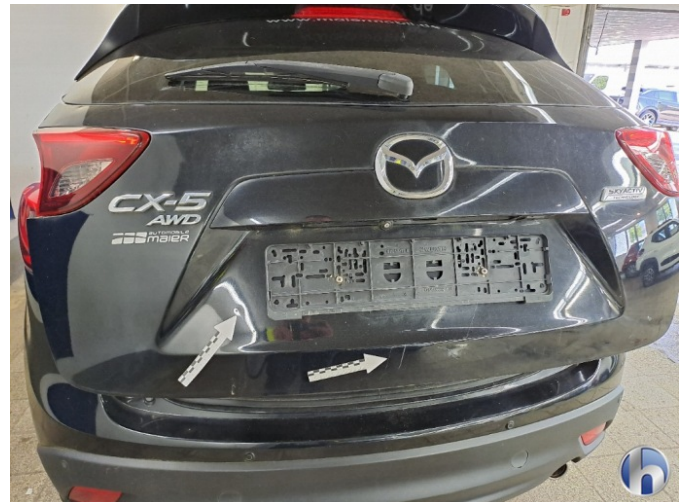
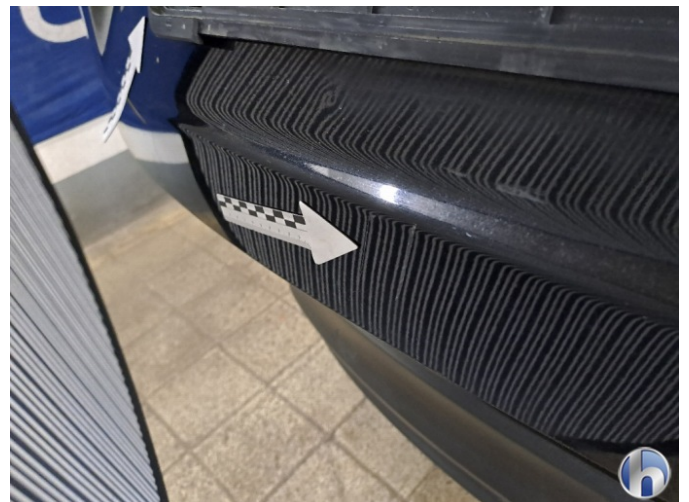
| component | Damage | Rep kind |
|---|---|---|
| 19. tailgate | Damaged | Refurbish and paint |

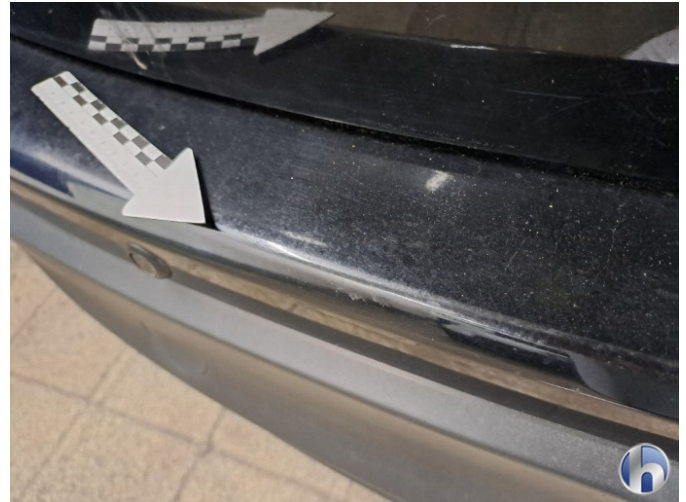
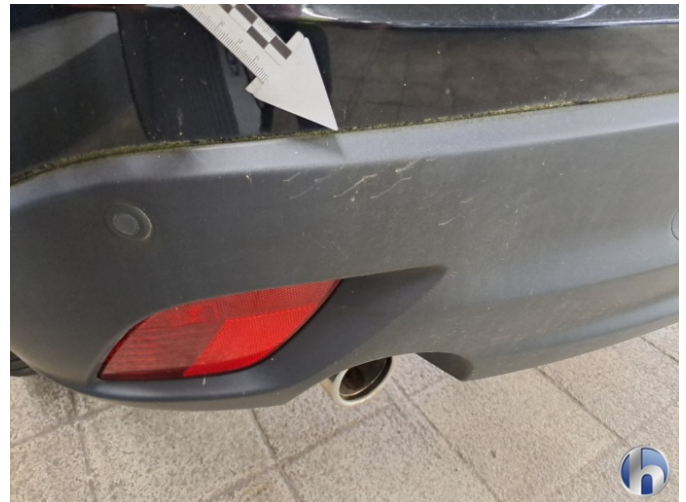
| component | Damage | Rep kind |
|---|---|---|
| 20. Rear bumper | Scratch(es) | Paint |

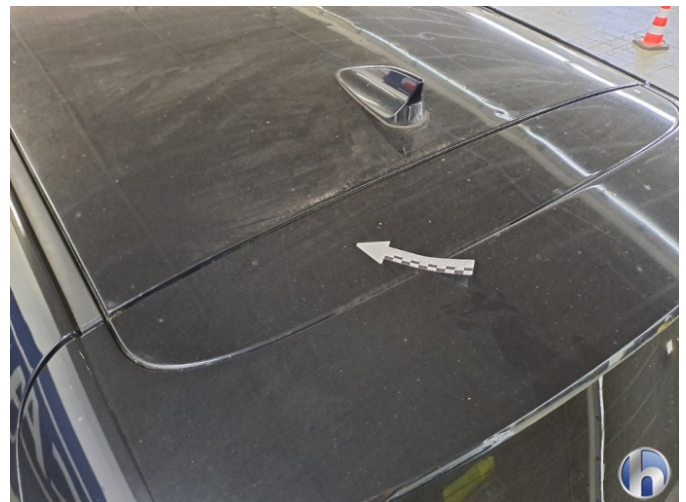
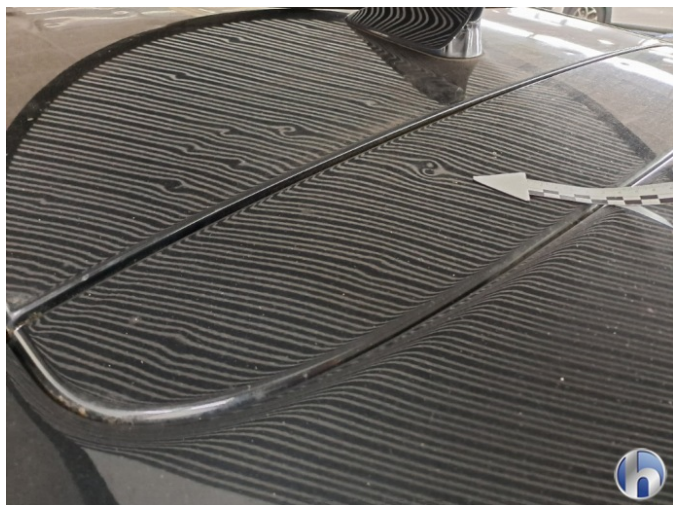
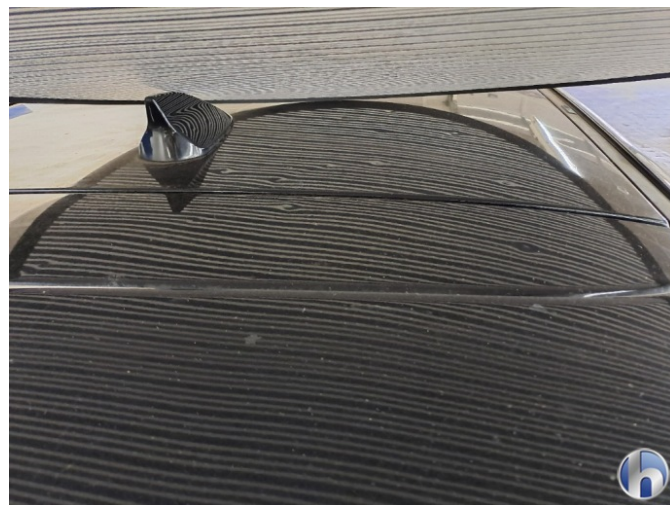
22. Spoiler Heckklappe (20×40mm)

| component | Damage | Rep kind |
|---|---|---|
| 22. Spoiler Heckklappe (20x40mm) | Hail damage | Gentle refurbishing |

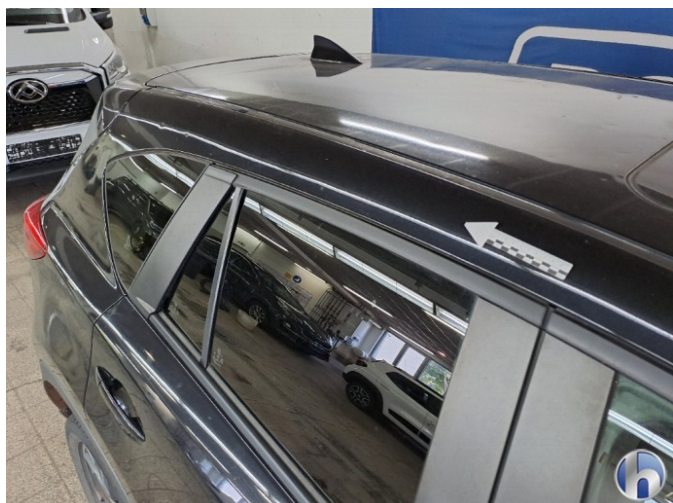
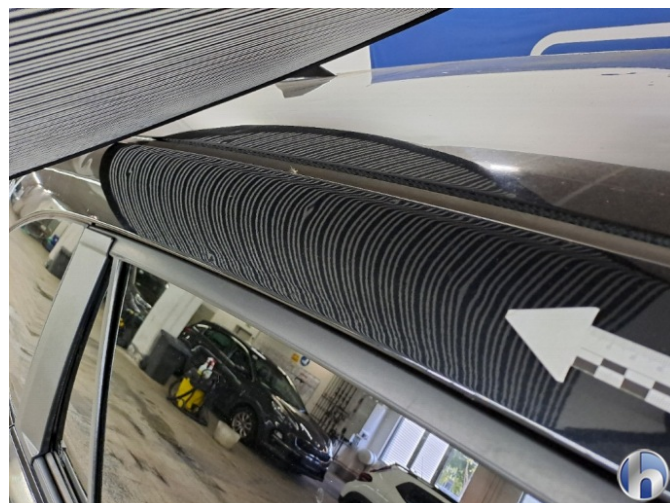
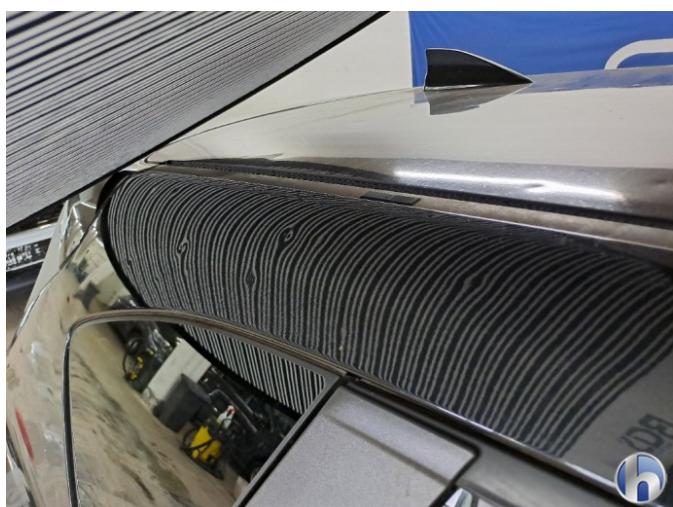
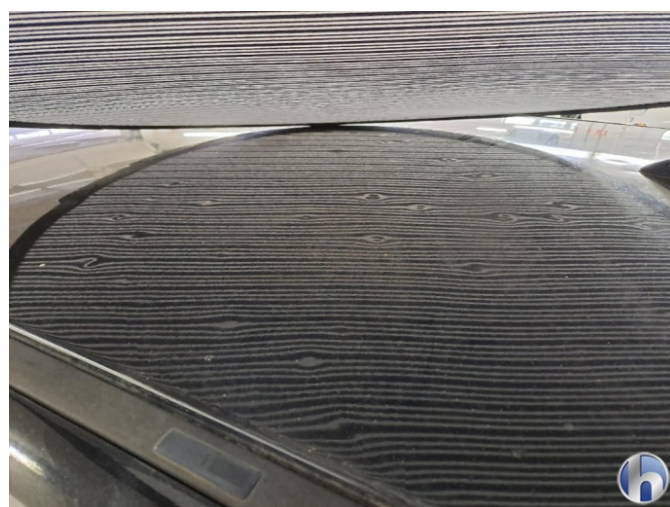
23. Dachrahmen - Rechts (25×10mm)

| component | Damage | Rep kind |
|---|---|---|
| 23. Dachrahmen - Rechts (25x10mm) | Hail damage | Gentle refurbishing |

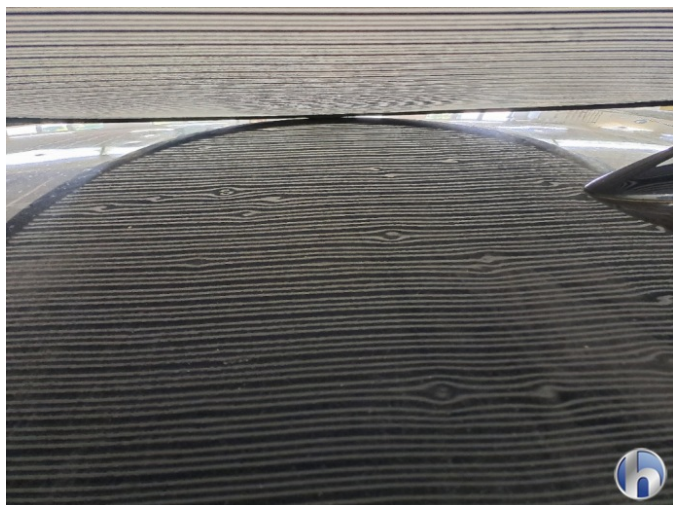
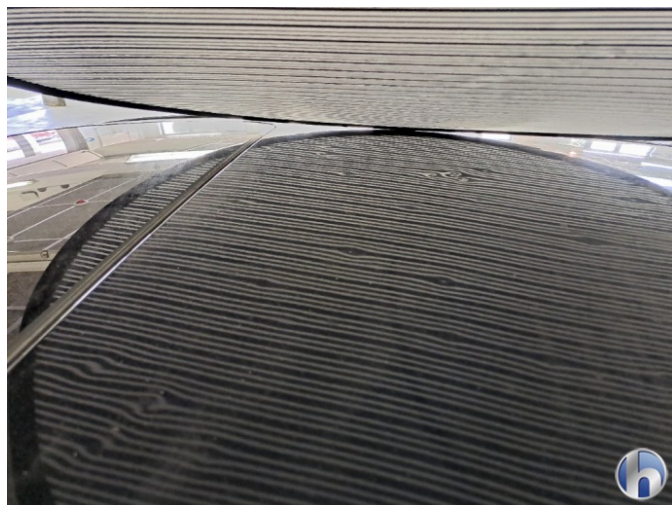
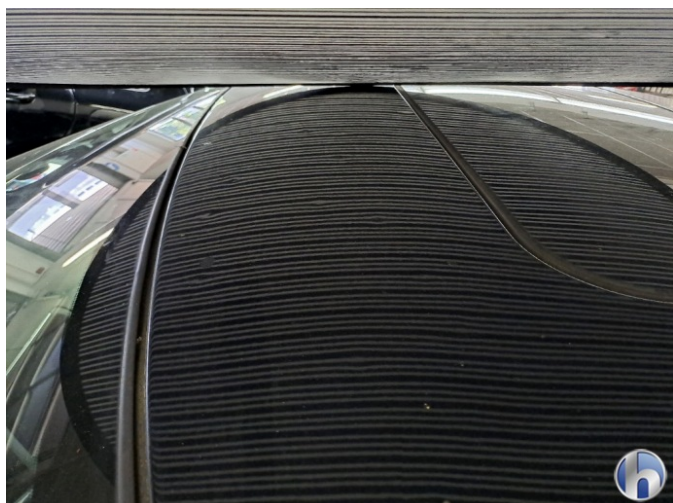
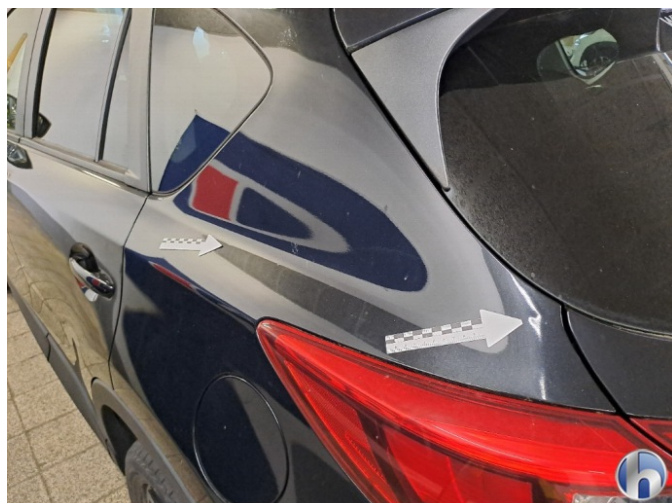
24. Dach (250×30mm)

| component | Damage | Rep kind |
|---|---|---|
| 24. Dach (250x30mm) | Hail damage | Refurbish and paint |

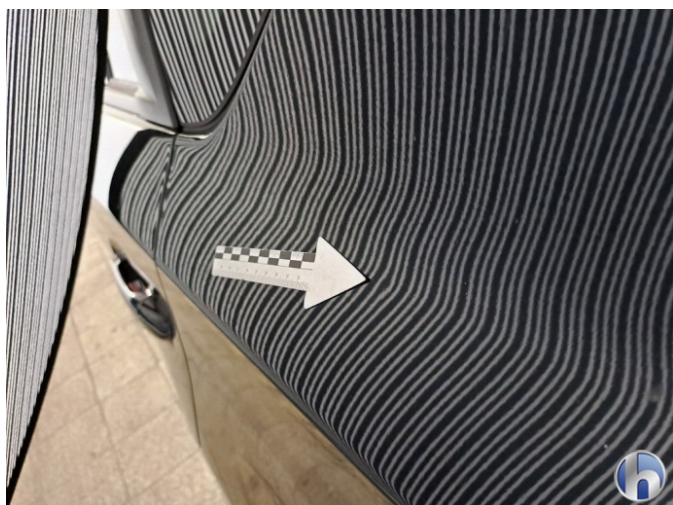
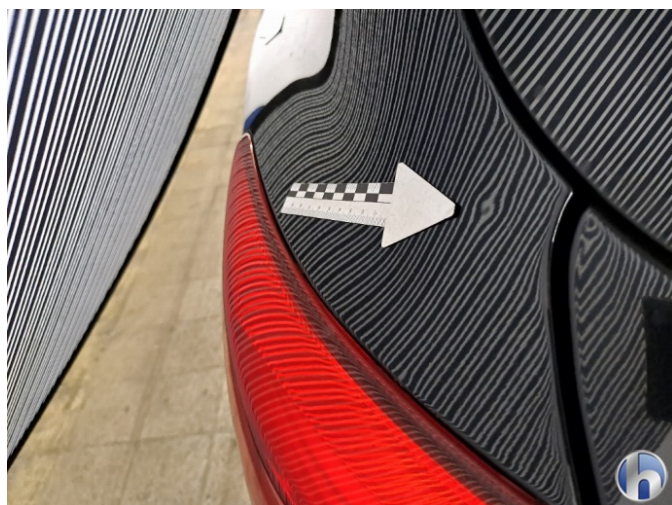
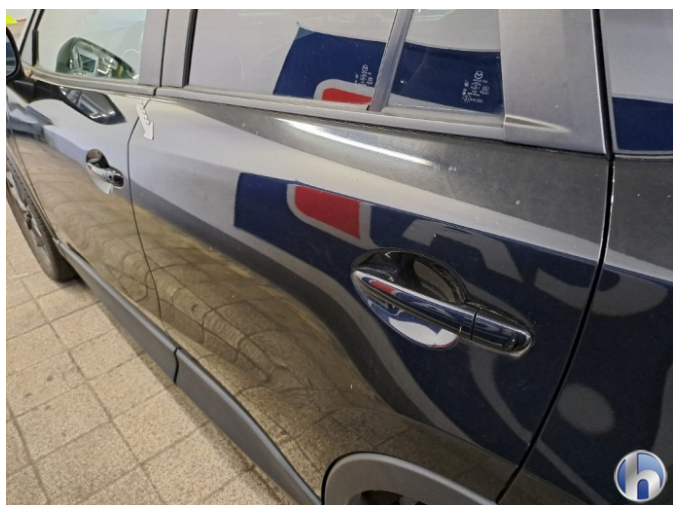
25. Seitenwand - Hinten - Links (2×10mm)

| component | Damage | Rep kind |
|---|---|---|
| 25. Seitenwand - Hinten - Links (2x10mm) | Hail damage | Gentle refurbishing |

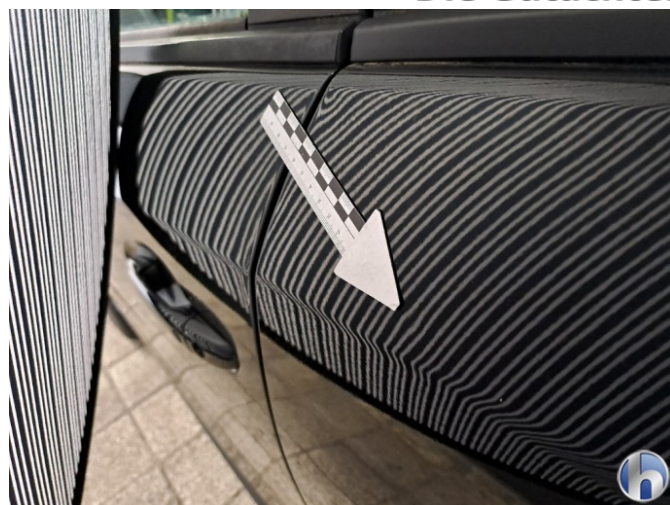
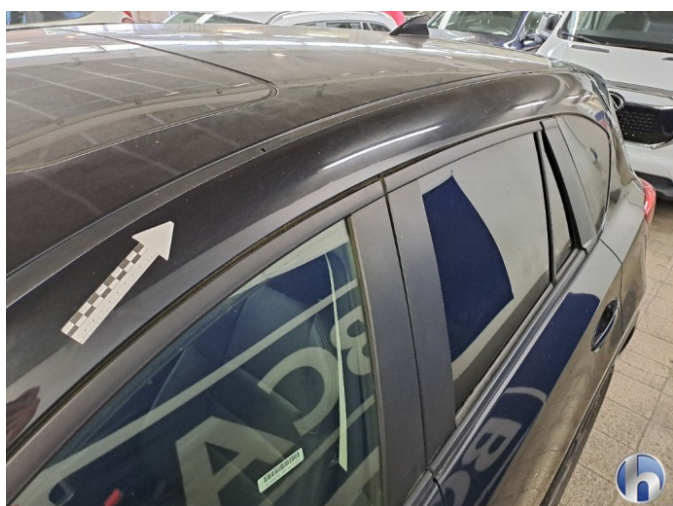
26. Tür Hinten - Links (1×10mm)

| component | Damage | Rep kind |
|---|---|---|
| 26. Tür Hinten - Links (1x10mm) | Hail damage | Gentle refurbishing |

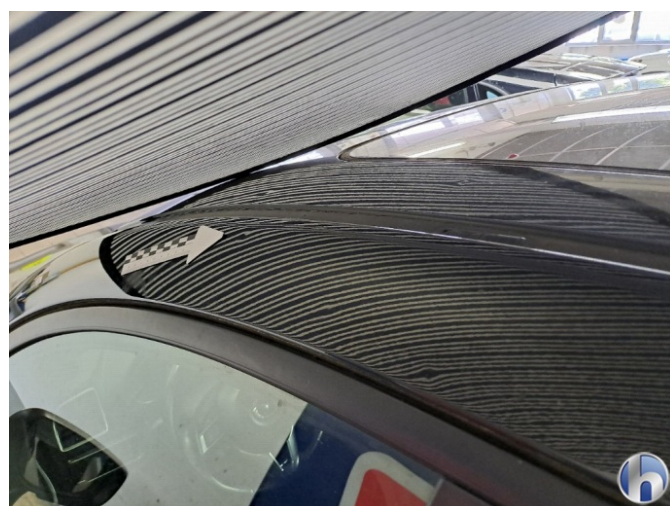
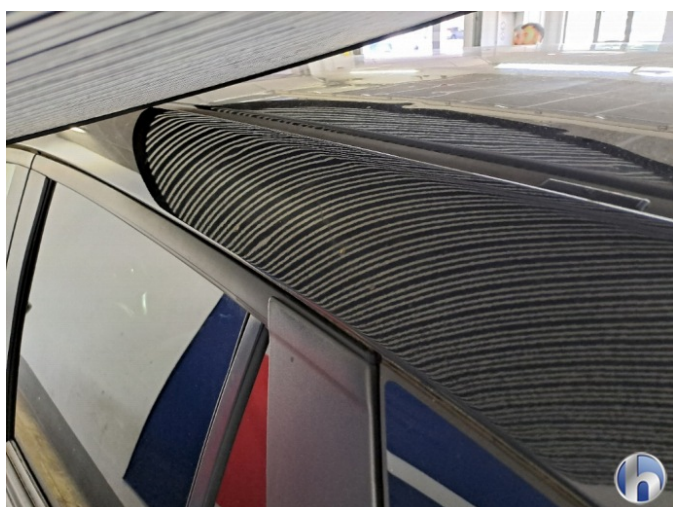
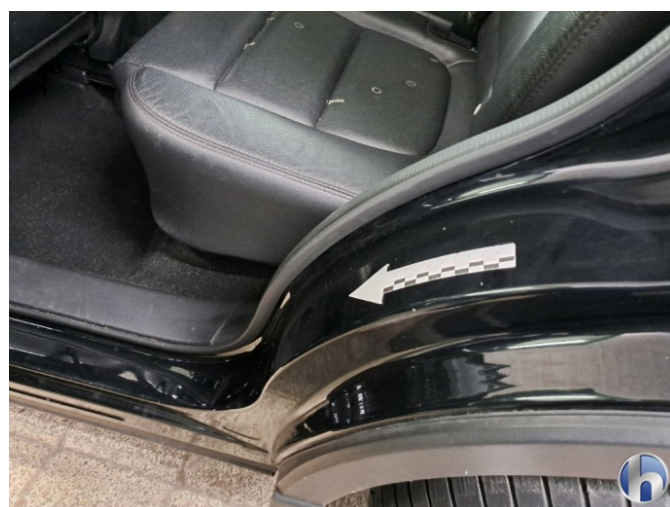
27. Dachrahmen - Links (10×10mm)

| component | Damage | Rep kind |
|---|---|---|
| 27. Dachrahmen - Links (10x10mm) | Hail damage | Gentle refurbishing |

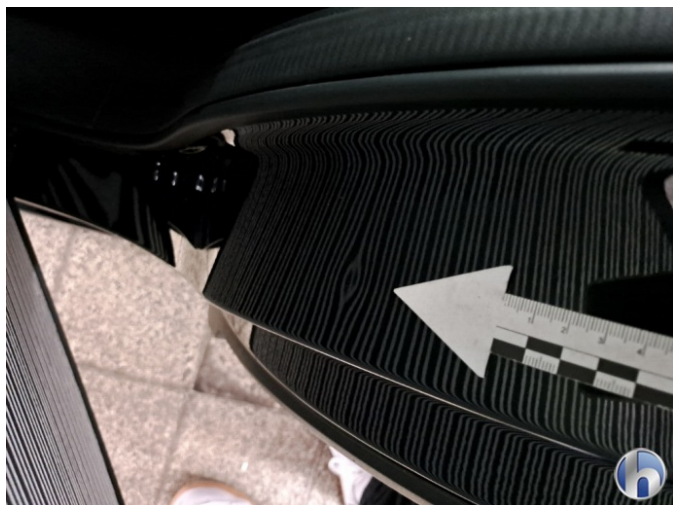
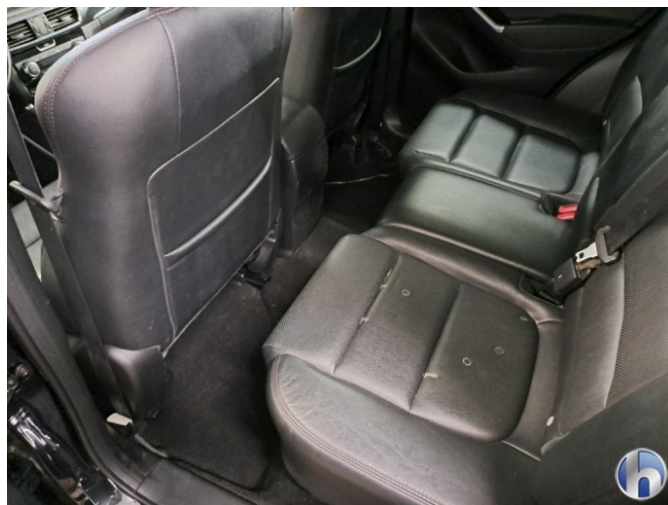
| component | Damage | Rep kind |
|---|---|---|
| 28. Türeinstieg Hinten - Links | Delle | Refurbish and paint |

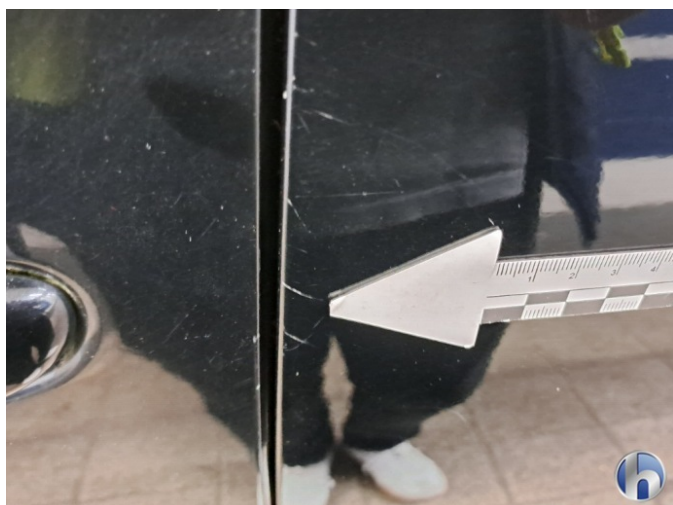
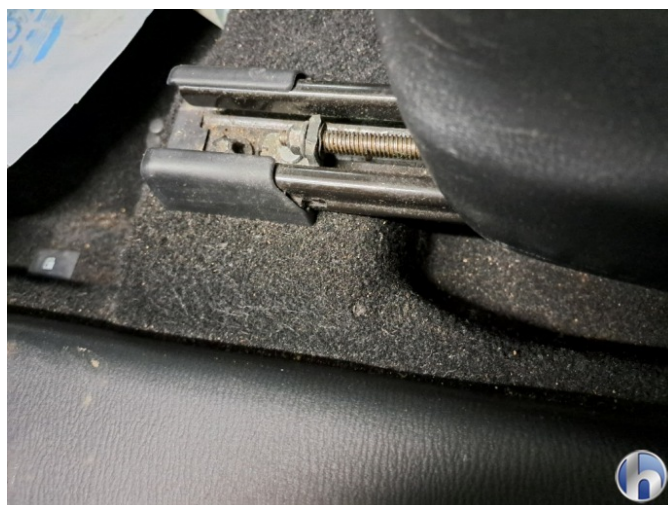
| component | Damage | Rep kind |
|---|---|---|
| 30. Rear door - left | Scratch(es) | Smart repair |

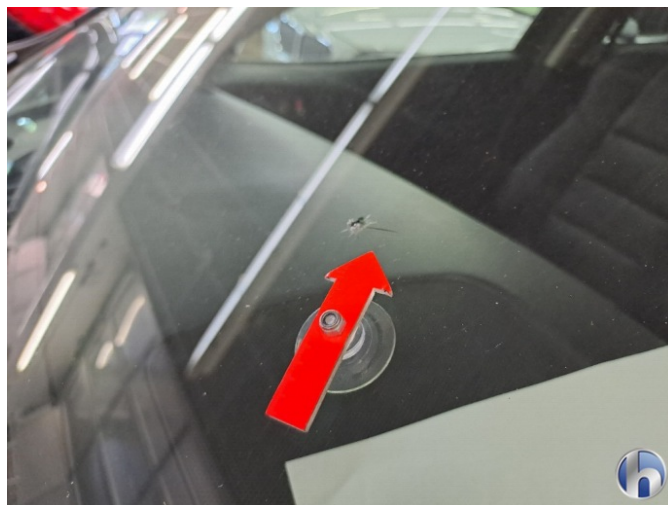
| component | Damage | Rep kind |
|---|---|---|
| 32. Windshield | Damaged | Replace |
