MAZDA CX-5

CX-5 SKYACTIV-G 192 Drive AWD

Inspection Report Summary

Customer	BCA Online	Report Number	P20251010085318
Inspection Date / Place	2025-10-10 / BCA Berlin	Cosmetic Grade	3

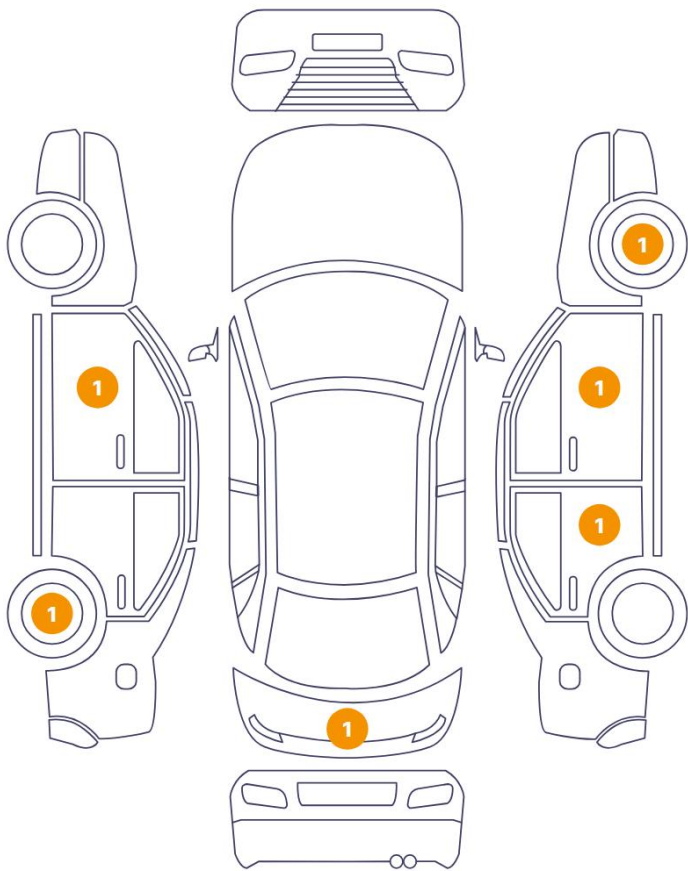
6 Schäden

Component		Damage	Comments
1	Rim / Back Left	Out of Bodywork / Scratch	
2	Rim / Front Right	Out of Bodywork / Scratch	
3	Door / Front Right	Paint / Scratch / Scuff	
4	Tailgate light	Bodywork / Dent / Dent	
5	Door / Front Left	Paint / Scratch / Scuff	
6	Door / Back Right	Bodywork / Dent / Dent

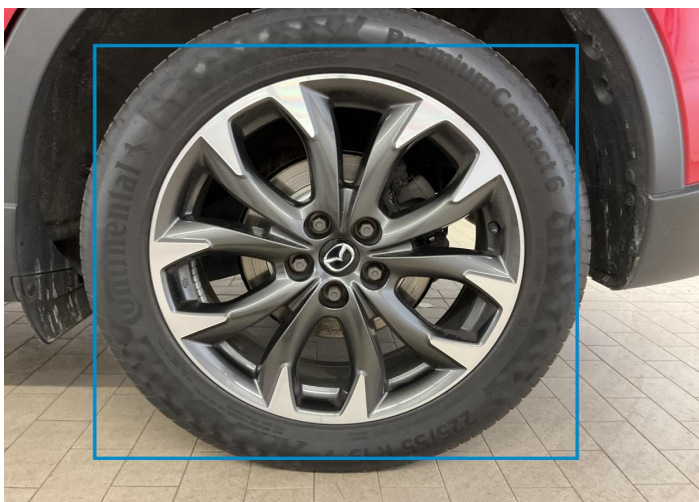
1. Rim / Back Left
Out of Bodywork / Scratch -

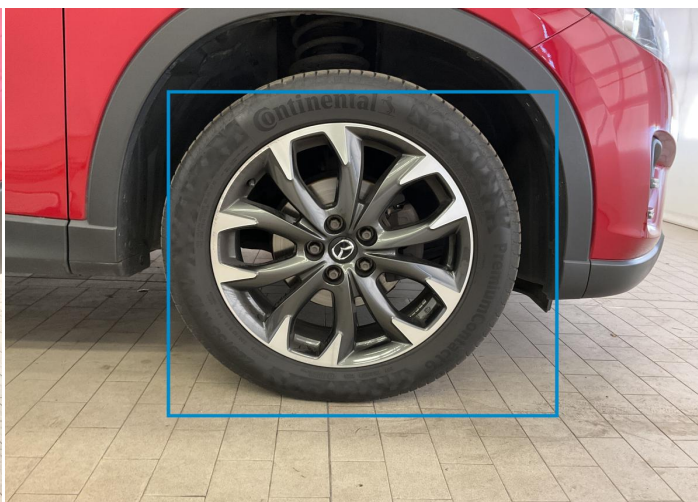
2. Rim / Front Right
Out of Bodywork / Scratch -

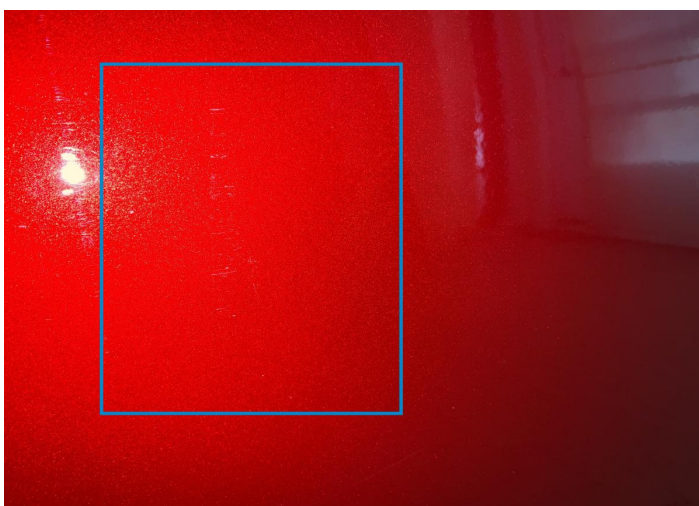
3. Door / Front Right
Paint / Scratch / Scuff -

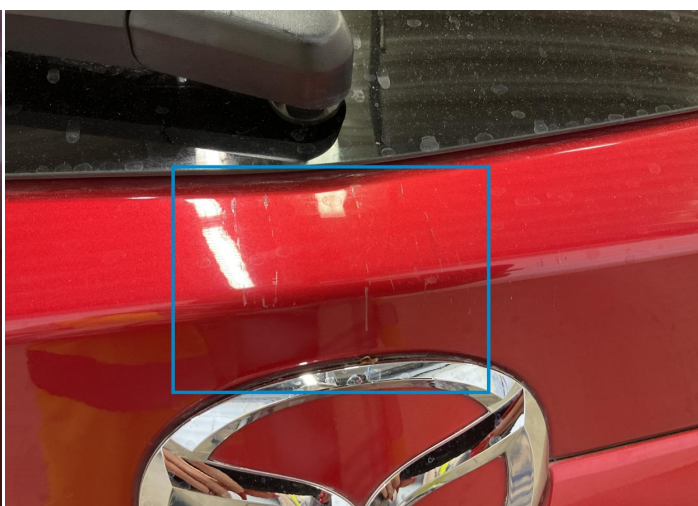
4. Tailgate light
Bodywork / Dent / Dent -

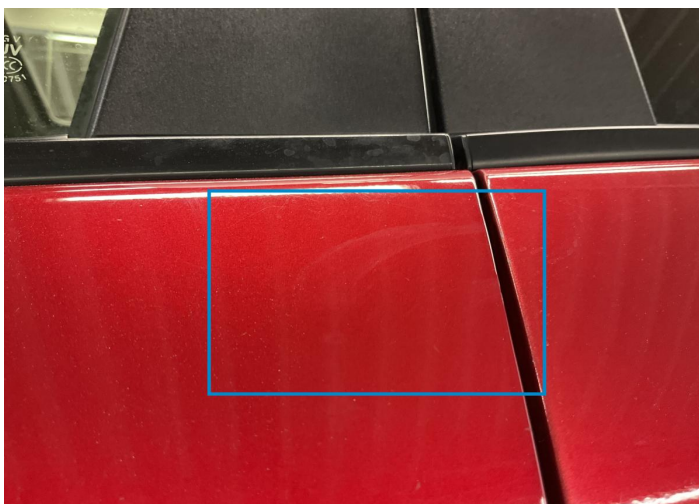
5. Door / Front Left
Paint / Scratch / Scuff -

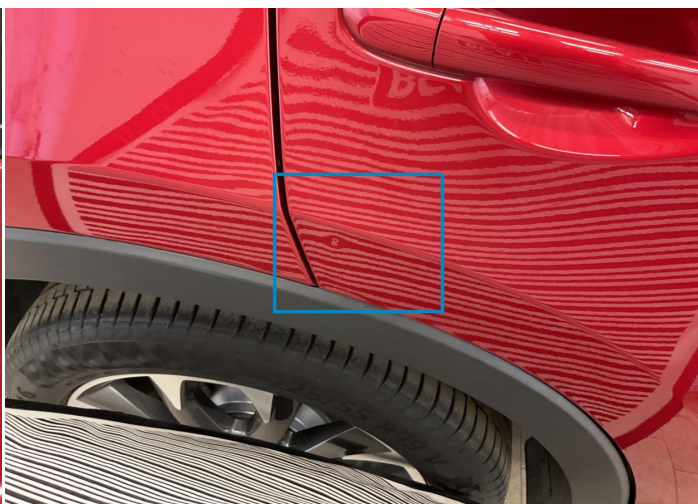
6. Door / Back Right
Bodywork / Dent / Dent -
