## status report

customer: Santander Consumer Leasing GmbH

#### Mazda CX-5 Ad'vantage AWD

Vehicle identification number	JMZKFGW7A90271610	mileage read:	25818 km
First Registration / construction year:	23.08.2022 / 2022	Visit Date / place of birth:	09.05.2025 Hoppegarten
Bodywork:	cars	Re - import:	unknown
Body type:	hatchback	KBA no. :	7118//AHQ
Fuel / emission class:	gasoline / € 6	transmission type:	automatic
Displacement / power:	1998 ccm / 121 kW (165 PS)	Engine:	four-wheel
paint:	Deep Crystal Blue	Number of previous owners:	1
Doors / seats:	5 / 5	number keys:	2
Next HU / AU:	- / -	cushion type:	substance
Service book available:	no	Interior Color:	black
smoking vehicle:	no	Last service km / on the:	- / -
Vehicle roadworthy:	yes	Vehicle roadworthy:	yes
Submitted vehicle	Eg II ( veh - letter )	state outside:	3 - Average
documents:			
visit condition:	-	condition inside:	2 - Good
state general:	3 - Average

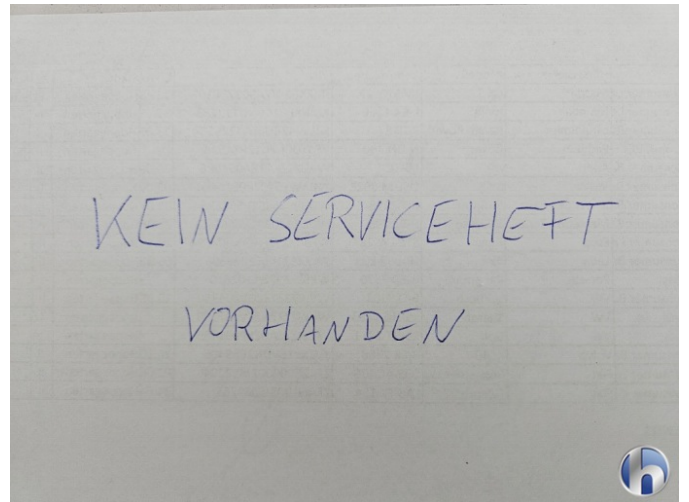
service book

component	Damage	Rep kind
1.	Wartungsnachweis	Missing	Replace
2.	Rear bumper	Wear and tear	acceptable
3.	Sidewall - Rear - right	Scratch(es)	
4.	Außenspiegelkappe re.	Scratch(es)	Paint
5.	Front bumper	Scrape	Paint
6.	Wartung	Missing	Replace
