## status report

#### Suzuki Swift

| Vehicle identification number | <b>JSAAZC13S00253502</b> | mileage read: | <b>110460 km</b> |

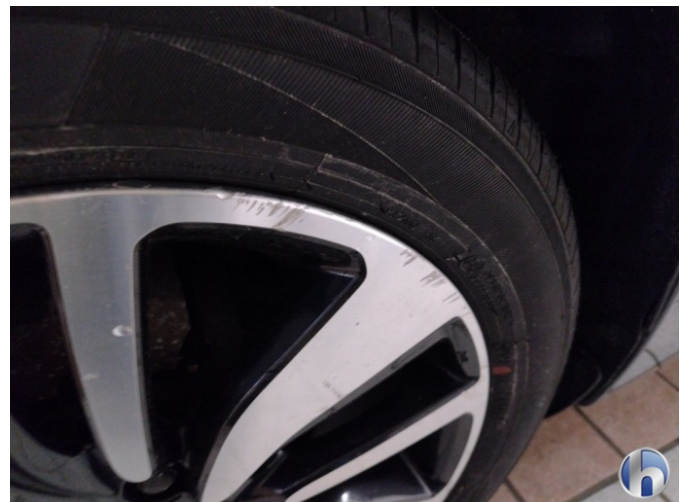
1. Rim rear - right

| | component | Damage | Rep kind |
|---|---|---|---|
| 1. | Rim rear - right | Damaged | Replace |

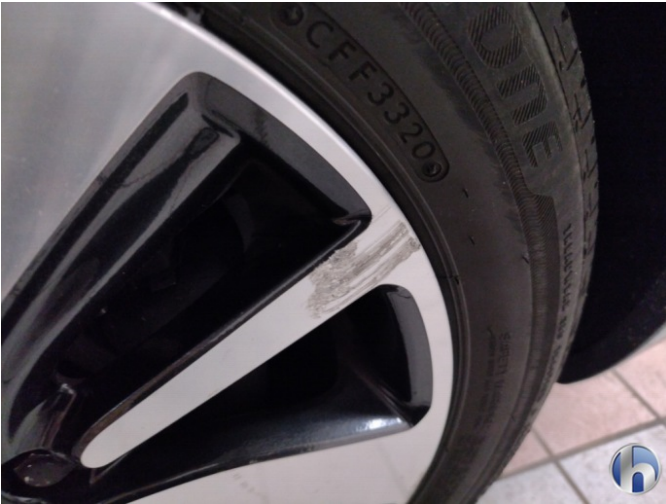
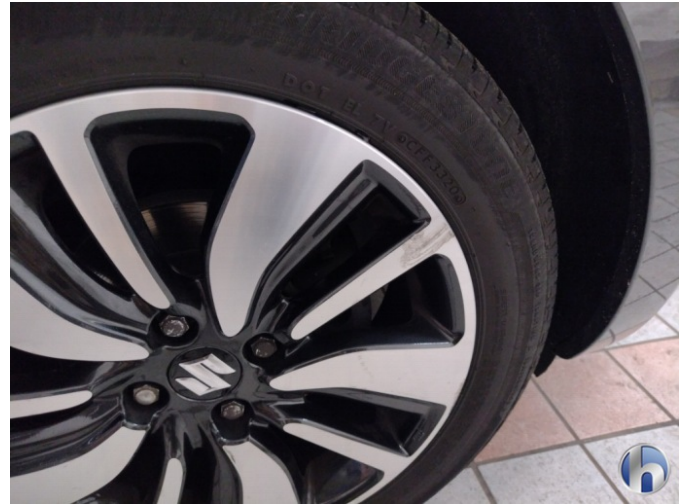
2. Rim front - right

| | component | Damage | Rep kind |
|---|---|---|---|
| 2. | Rim front - right | Damaged | Replace |

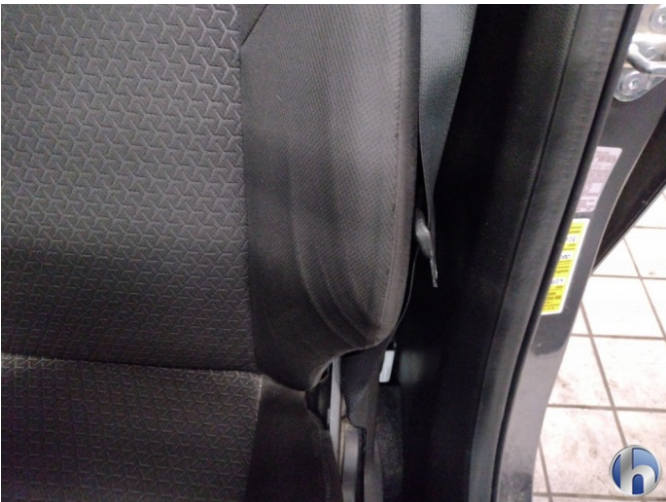
| | component | Damage | Rep kind |
|---|---|---|---|
| 4. | | Damaged | Smart repair |

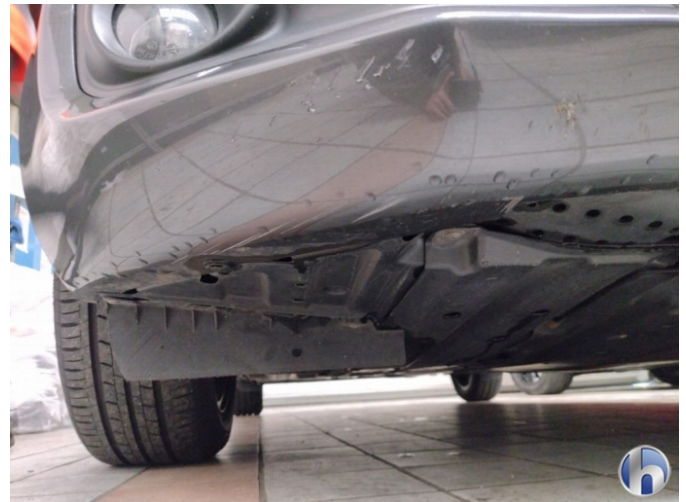
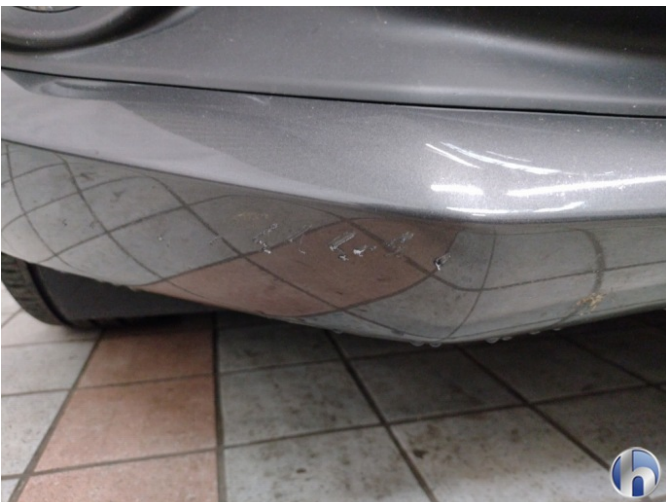
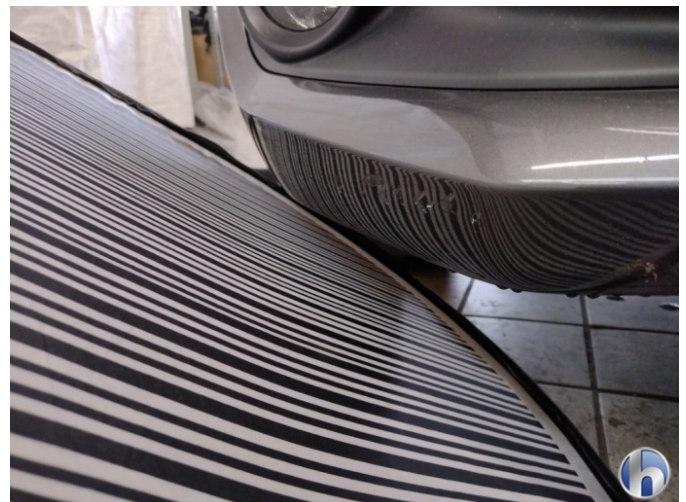
6. Front bumper

| | component | Damage | Rep kind |
|---|---|---|---|
| 6. | Front bumper | Damaged | Refurbish and paint |

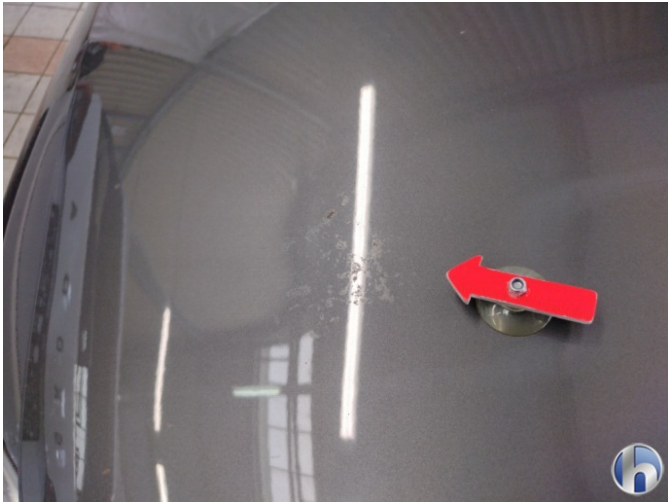
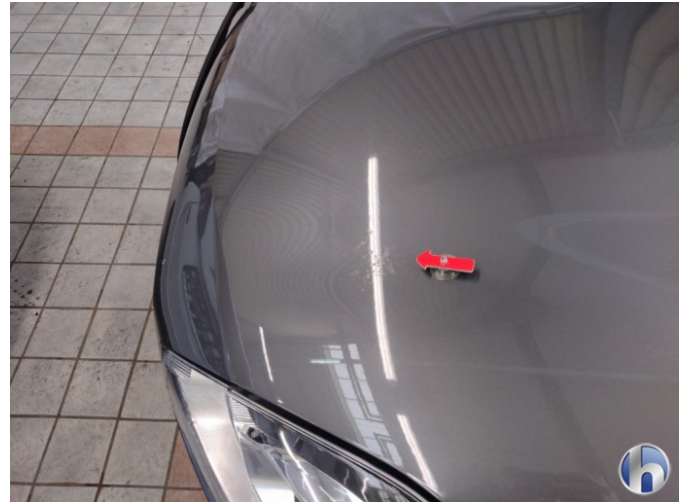
7. hood

| | component | Damage | Rep kind |
|---|---|---|---|
| 7. | hood | | Paint |

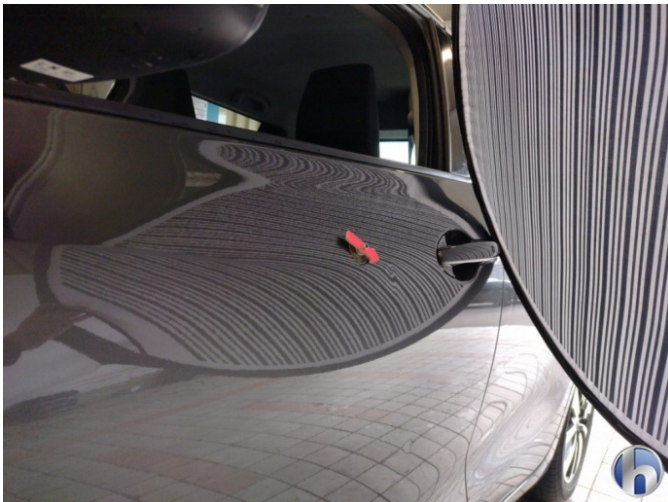
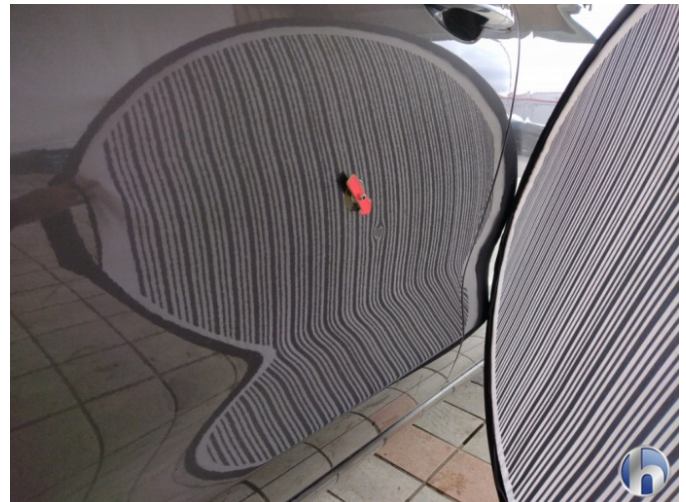
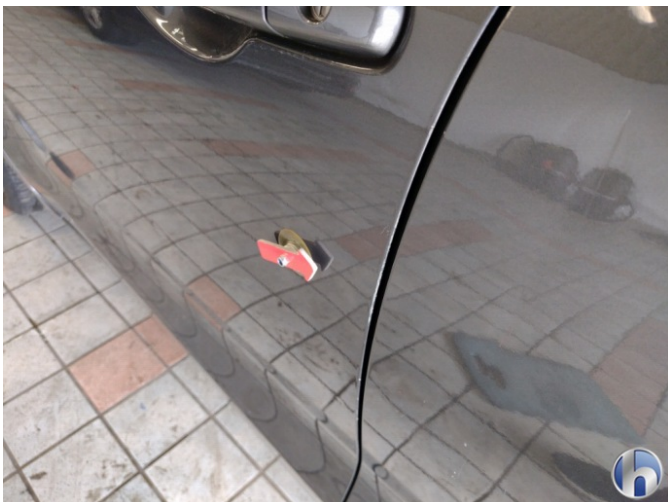
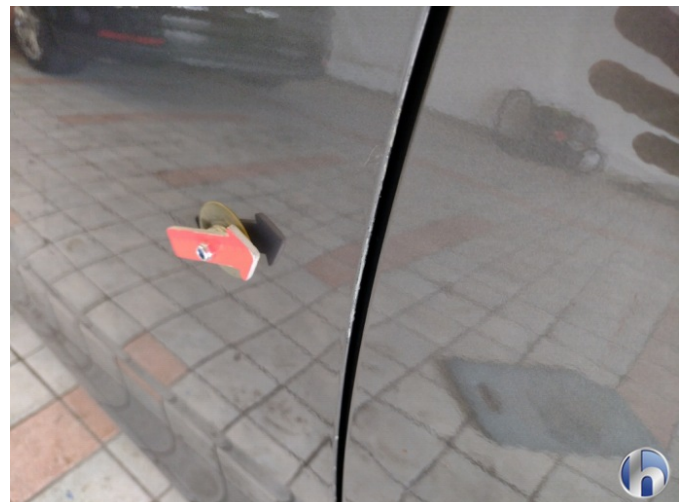
8. Front door - left

| | component | Damage | Rep kind |
|---|---|---|---|
| 8. | Front door - left | Damaged | Refurbish and paint |

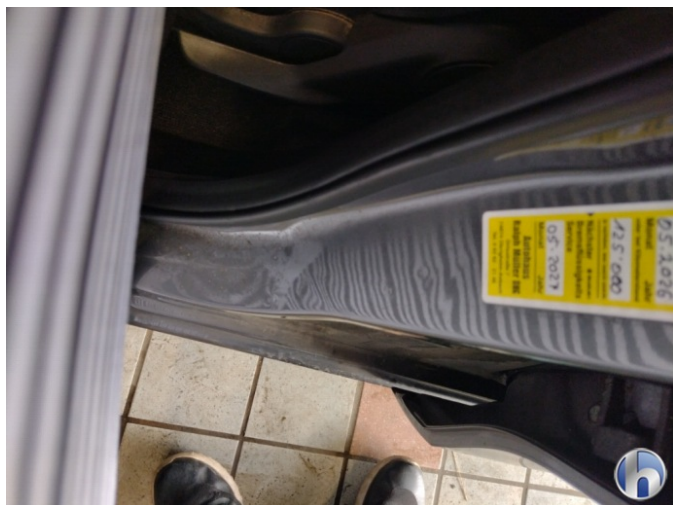
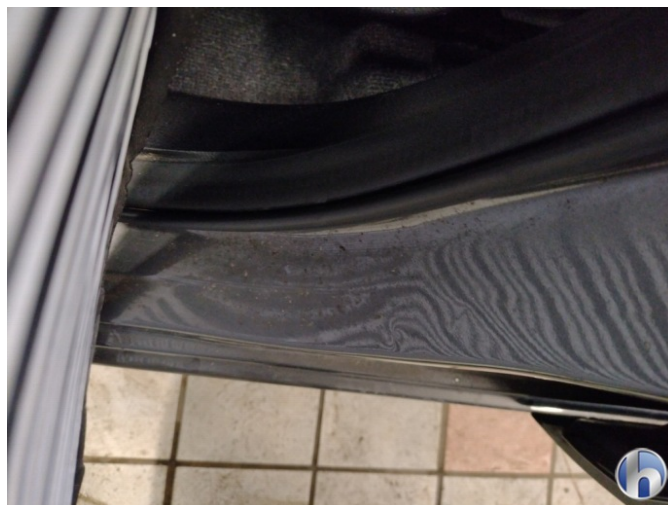
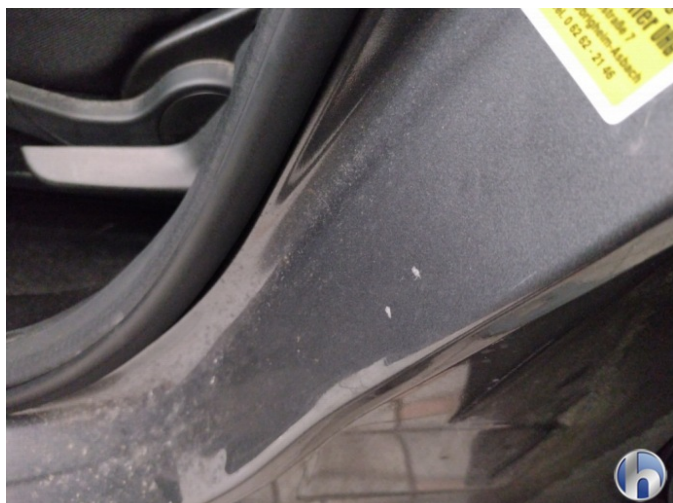
9. Türeinstieg Vorne - Links

| | component | Damage | Rep kind |
|---|---|---|---|
| 9. | Türeinstieg Vorne - Links | Damaged | Refurbish and paint |

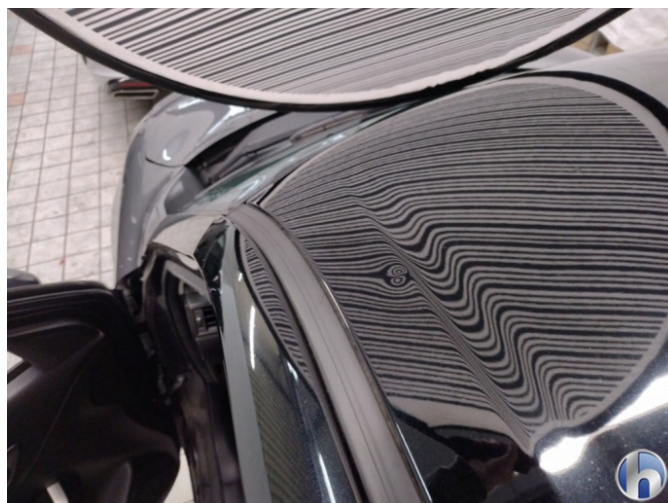
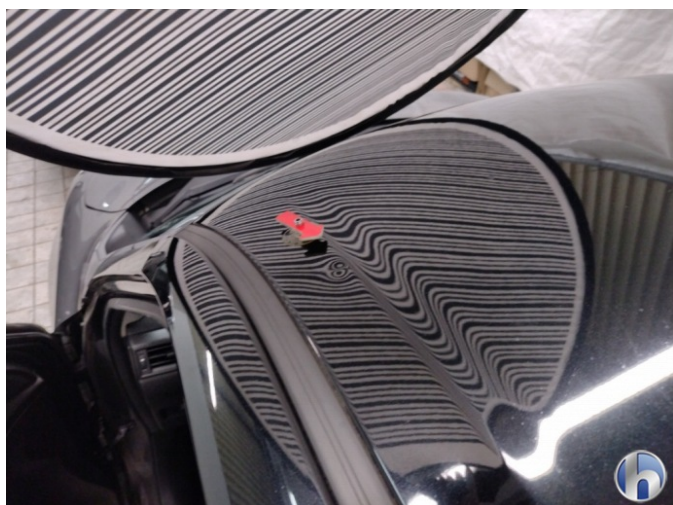
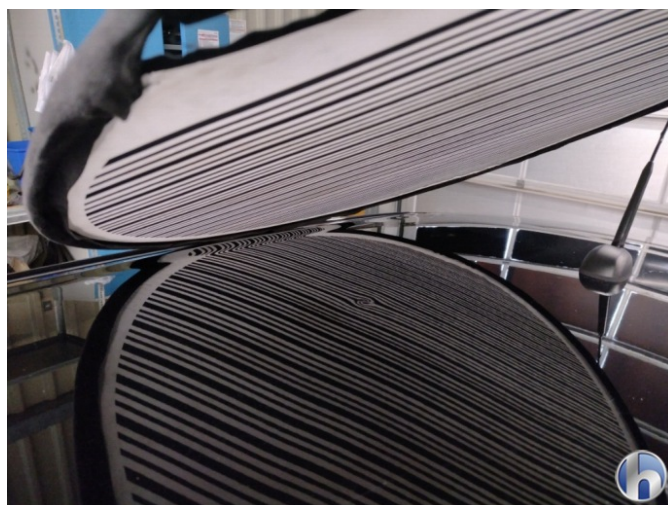
10. roof

| | component | Damage | Rep kind |
|---|---|---|---|
| 10. | roof | Deformed | Refurbish and paint |

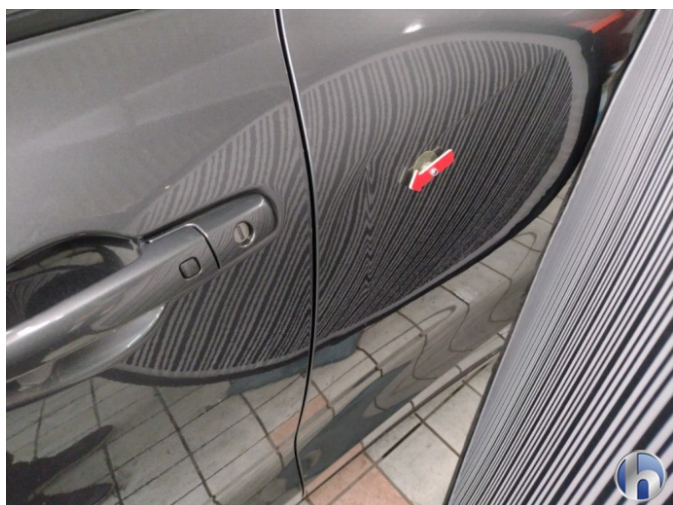
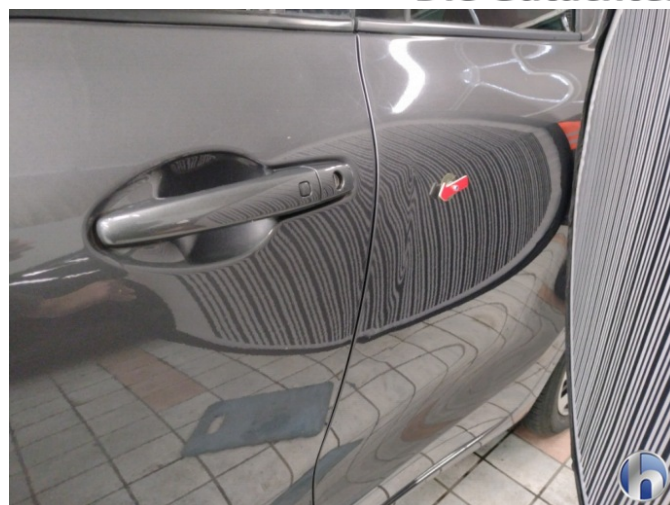
11. Rear door - left

| | component | Damage | Rep kind |
|---|---|---|---|
| 11. | Rear door - left | Deformed | Refurbish and paint |

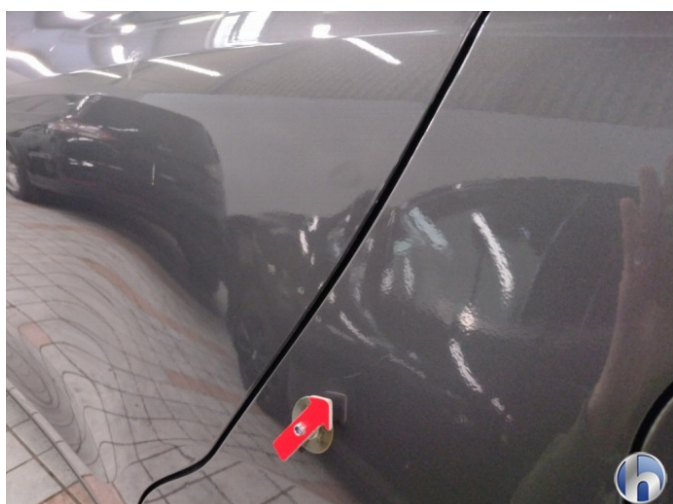
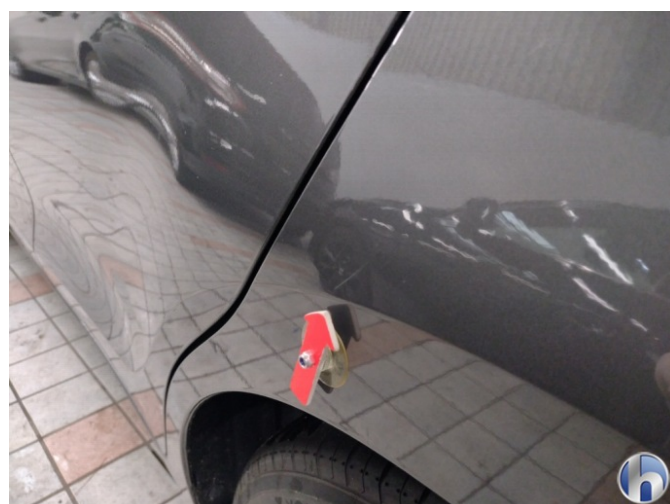
12. Sidewall - Rear - Left

| | component | Damage | Rep kind |
|---|---|---|---|
| 12. | Sidewall - Rear - Left | Scratch(es) | |

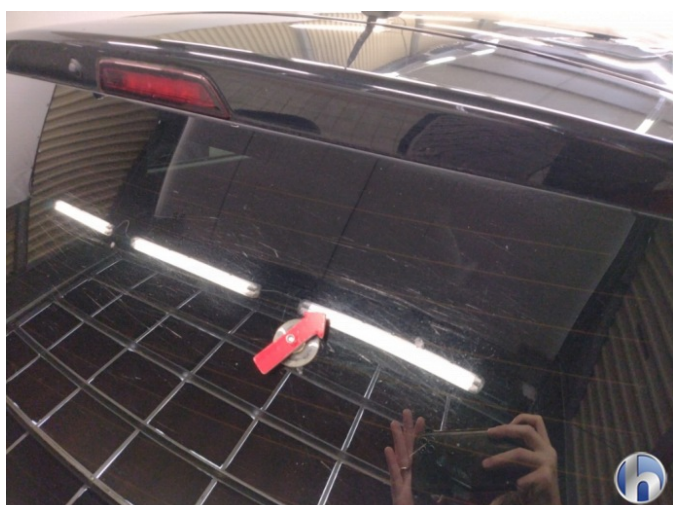
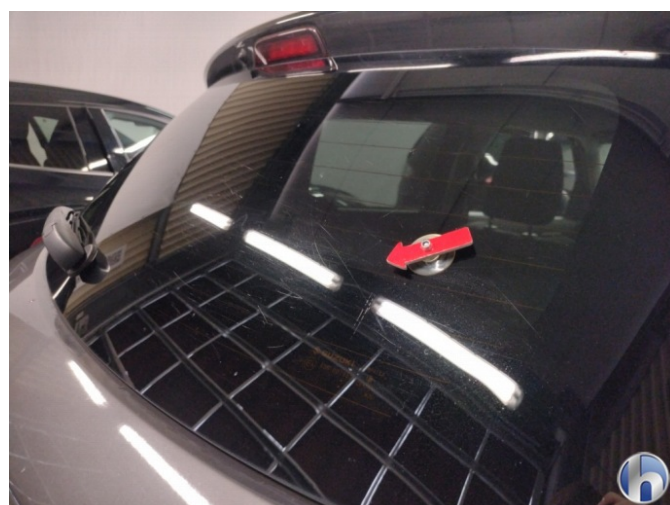
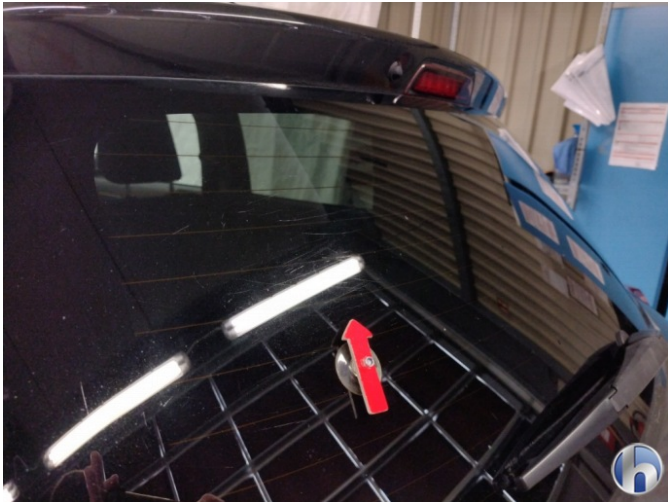
13. rear window

| | component | Damage | Rep kind |
|---|---|---|---|
| 13. | rear window | Scratch(es) | Replace |

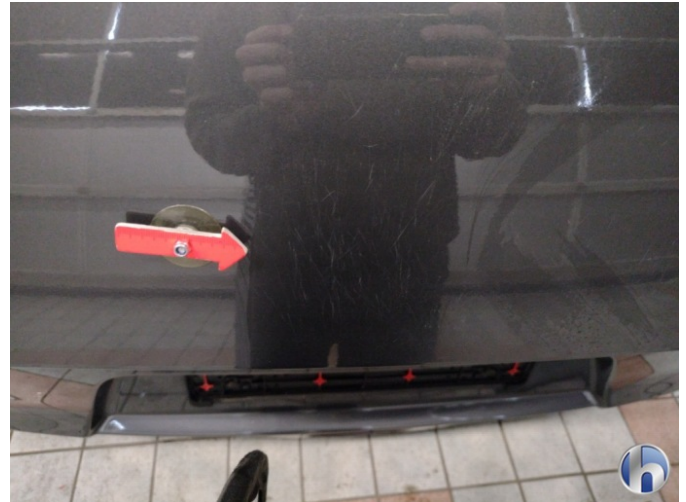
14. tailgate

| | component | Damage | Rep kind |
|---|---|---|---|
| 14. | tailgate | Scratch(es) | |

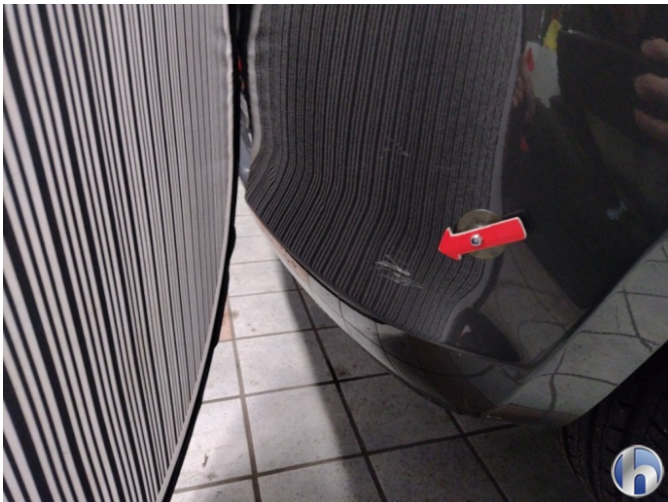
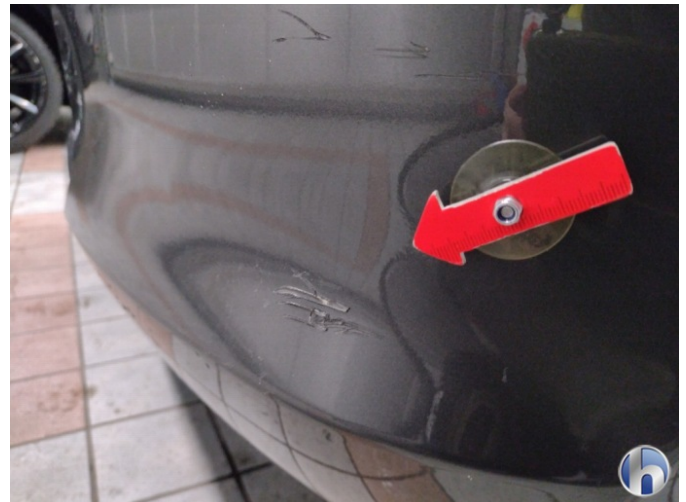
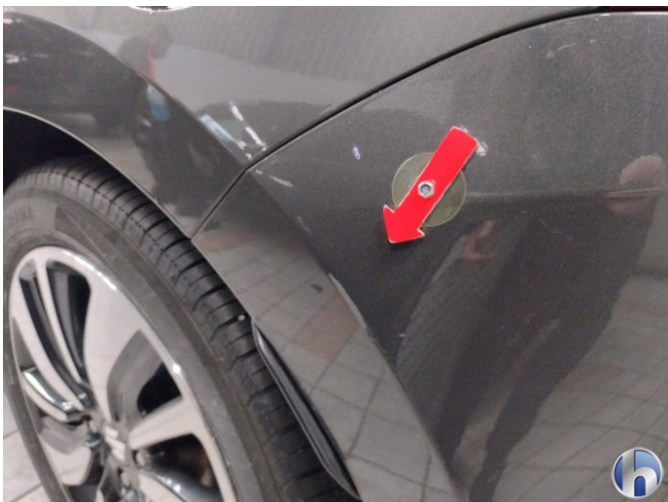
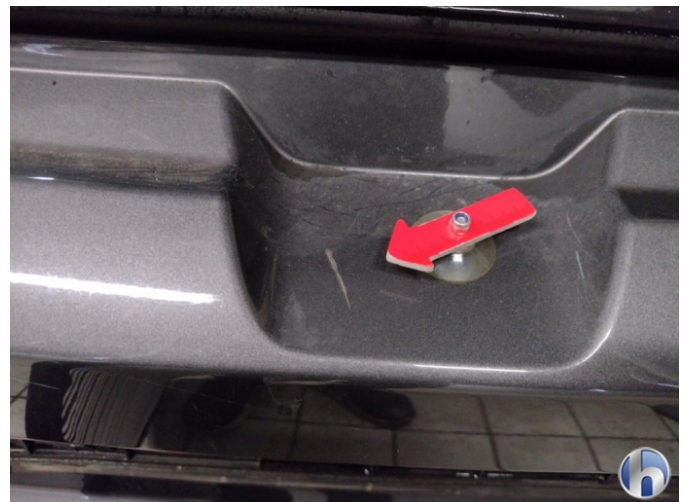
15. Rear bumper

| | component | Damage | Rep kind |
|---|---|---|---|
| 15. | Rear bumper | Damaged | Refurbish and paint |

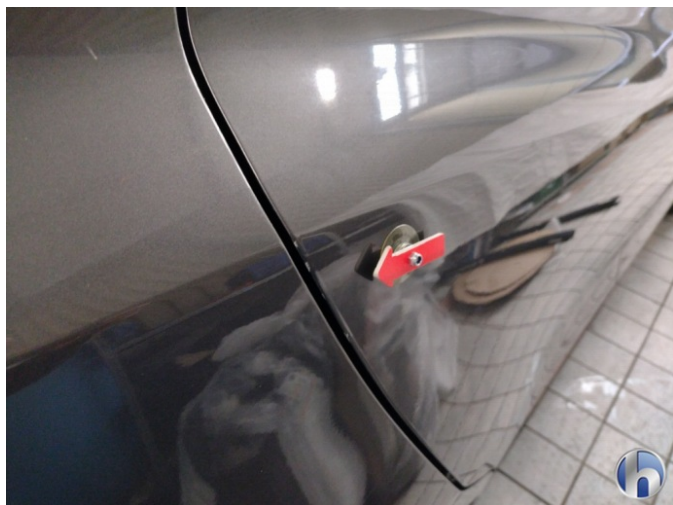
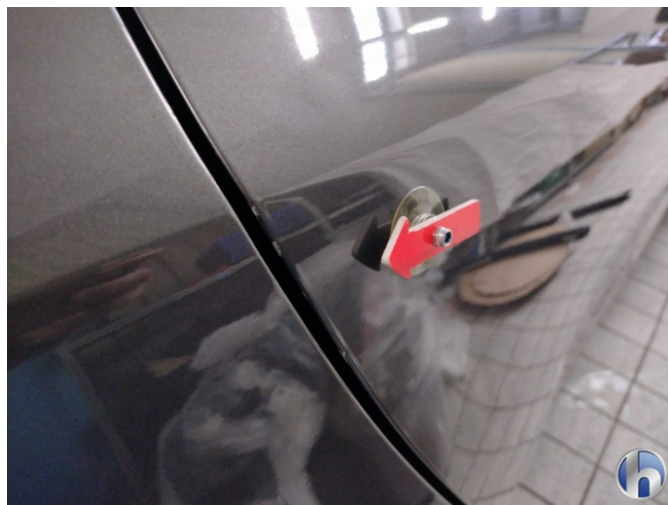
16. Door Rear - right

| | component | Damage | Rep kind |
|---|---|---|---|
| 16. | Door Rear - right | Scratch(es) | Paint |

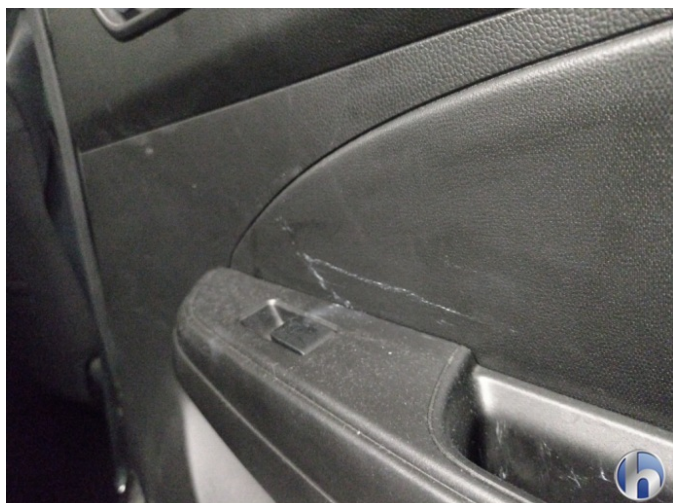
17. Door trim Rear - right

| | component | Damage | Rep kind |
|---|---|---|---|
| 17. | Door trim Rear - right | Damaged | Smart repair |

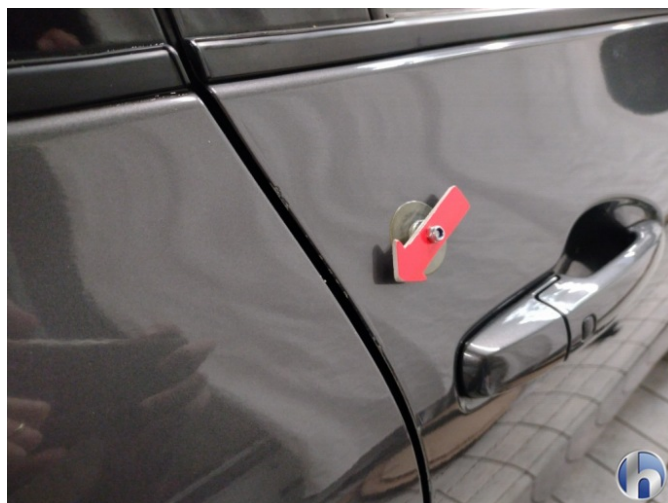
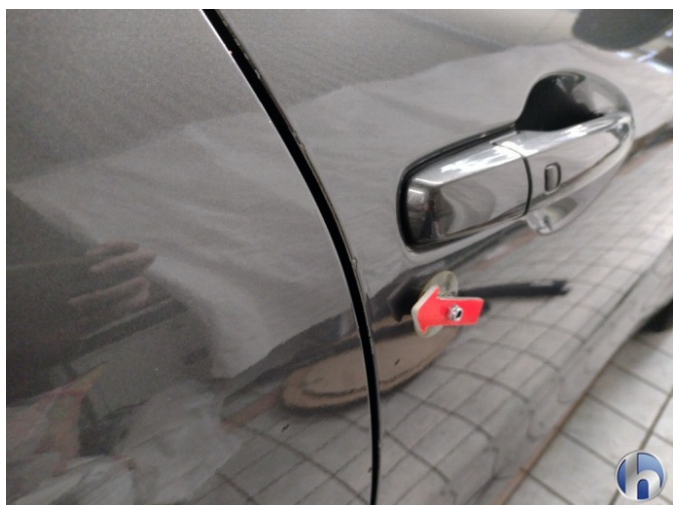
18. Front door - right

| | component | Damage | Rep kind |
|---|---|---|---|
| 18. | Front door - right | Scratch(es) | Paint |
