## status report

#### Suzuki Swift Comfort

| Vehicle identification number | <b>JSAAZC23S00300486</b> | mileage read: | <b>59189 km</b> |
| First Registration / construction year: | <b>12.12.2019 / 2019</b> | Visit Date / place of birth: | <b>16.05.2025 Heidenheim</b> |

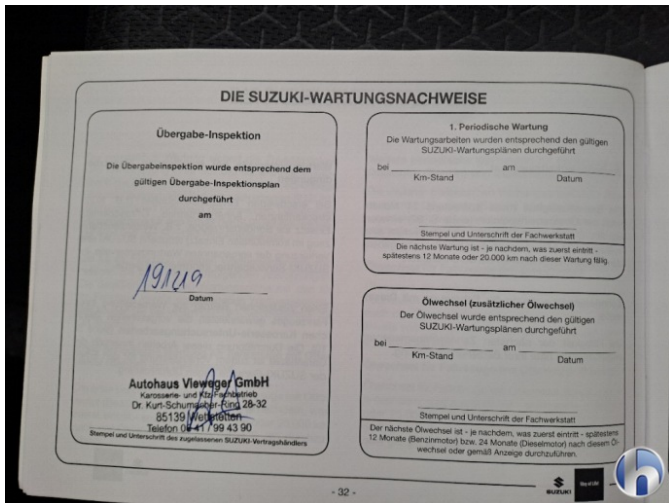
1. Wartung

| | component | Damage | Rep kind |
|---|---|---|---|
| 1. | Wartung | Due | Replace |

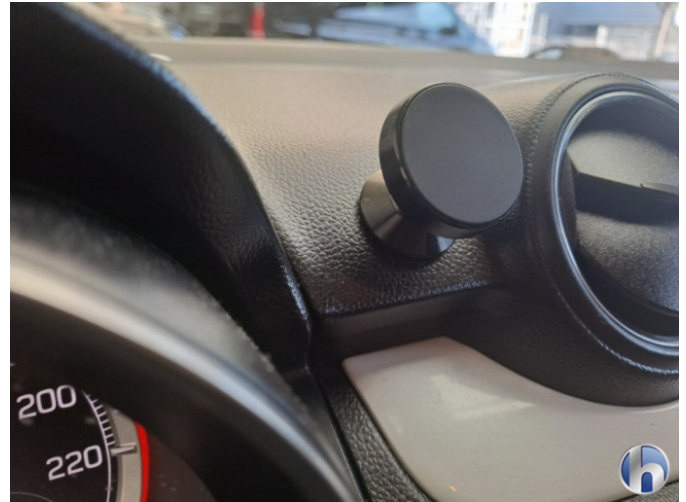
2. Amaturenbrett

| | component | Damage | Rep kind |
|---|---|---|---|
| 2. | Amaturen Brett | Sticker | |

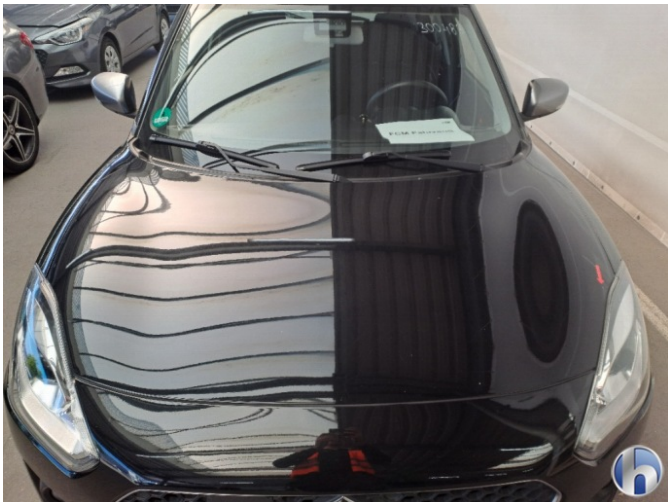
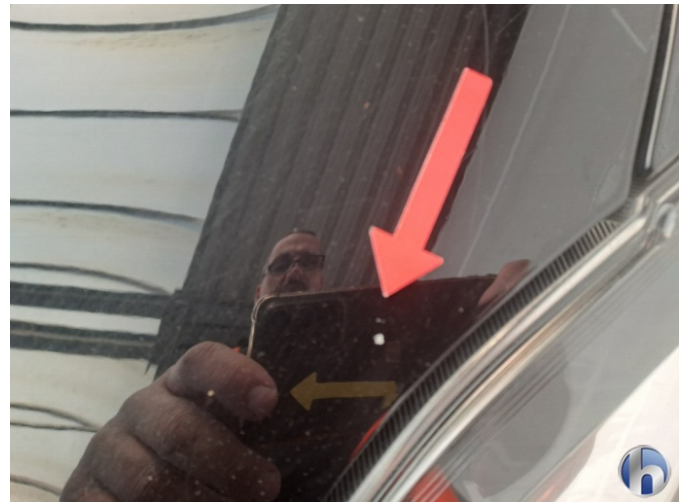
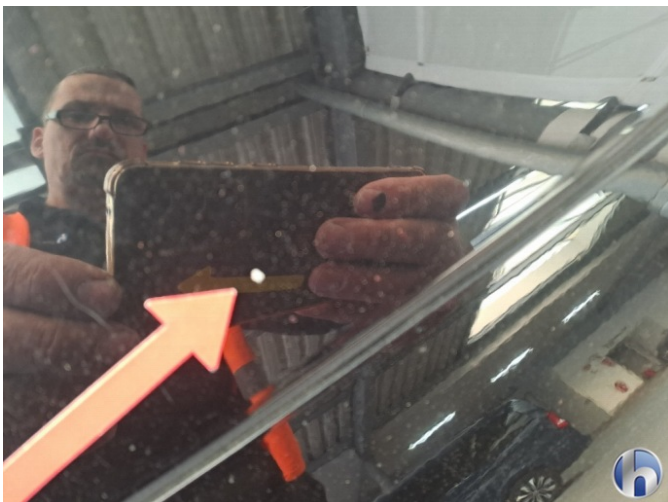
3. hood

| | component | Damage | Rep kind |
|---|---|---|---|
| 3. | hood | Scratch(es) | Smart repair |

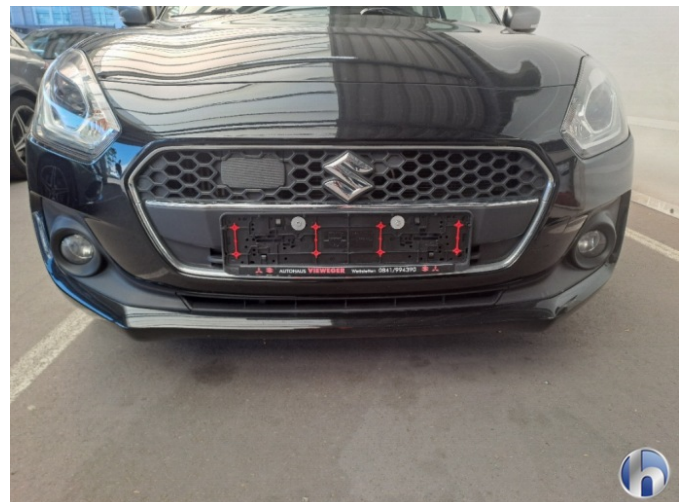
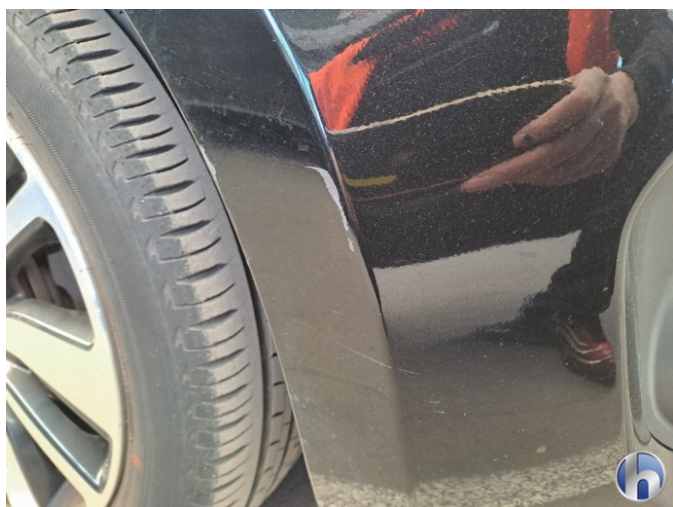
4. Front bumper

| | component | Damage | Rep kind |
|---|---|---|---|
| 4. | Front bumper | Scratch(es) | Paint |

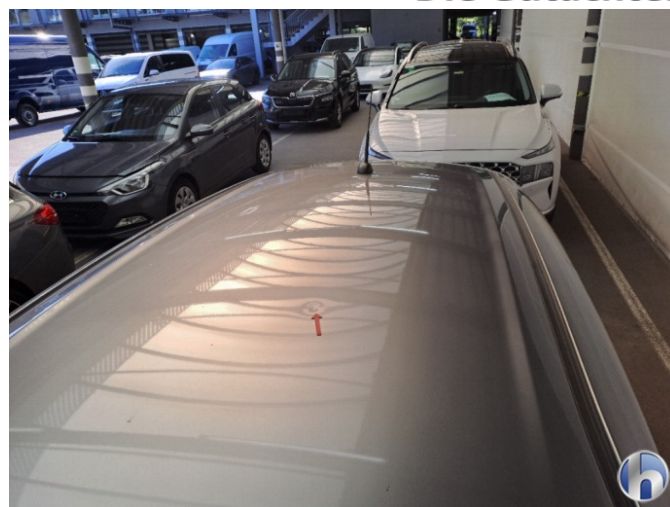
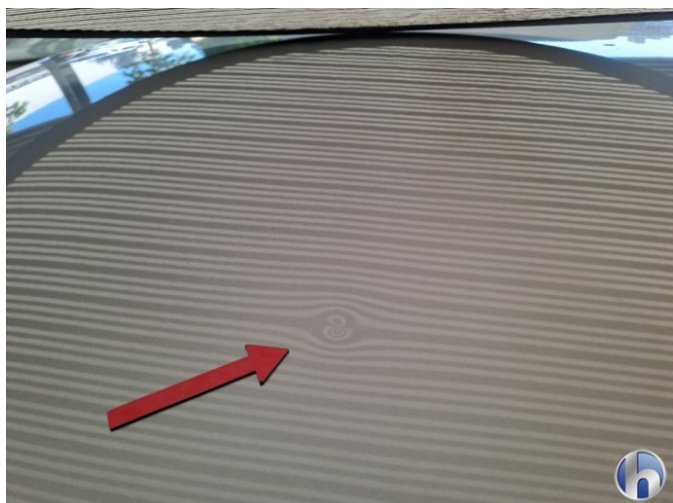
5. roof

| | component | Damage | Rep kind |
|---|---|---|---|
| 5. | roof | | Smart repair |

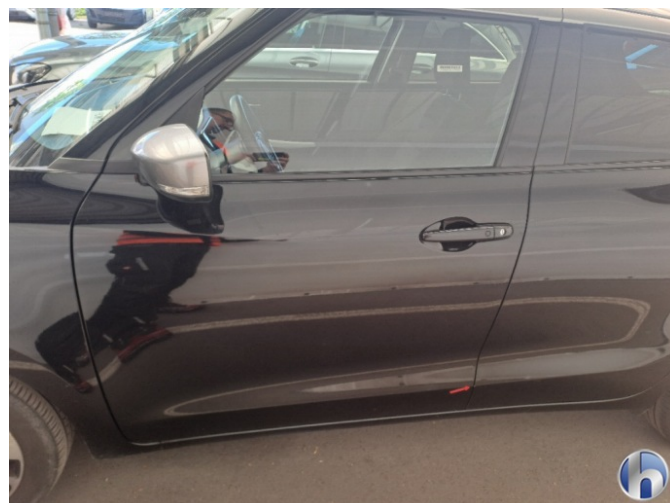
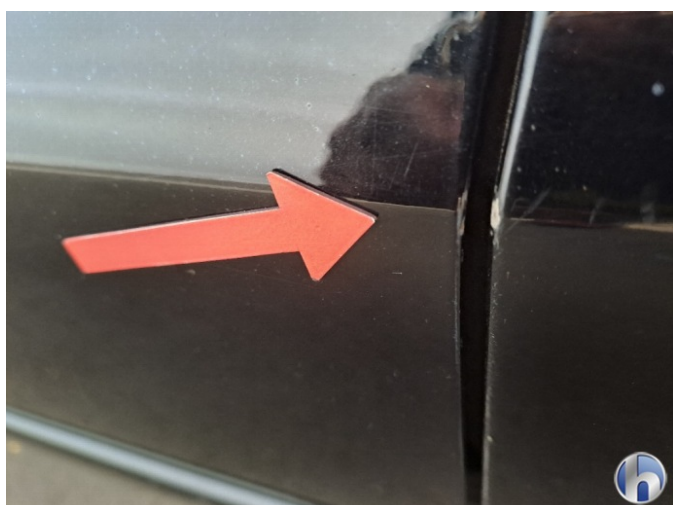
6. Front door - left

| | component | Damage | Rep kind |
|---|---|---|---|
| 6. | Front door - left | Scratch(es) | Smart repair |

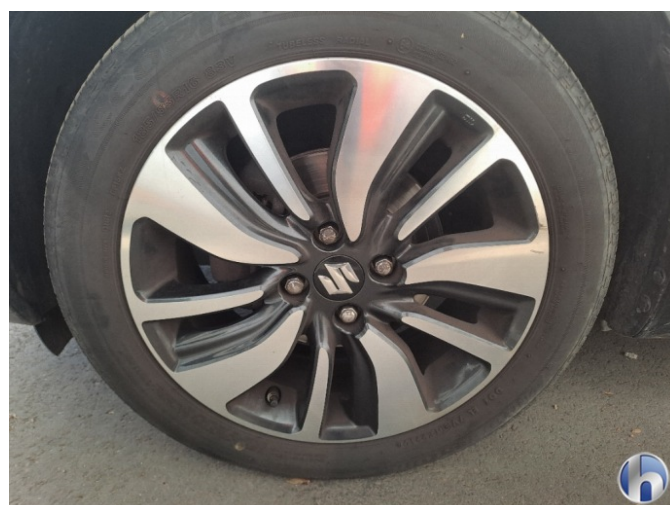
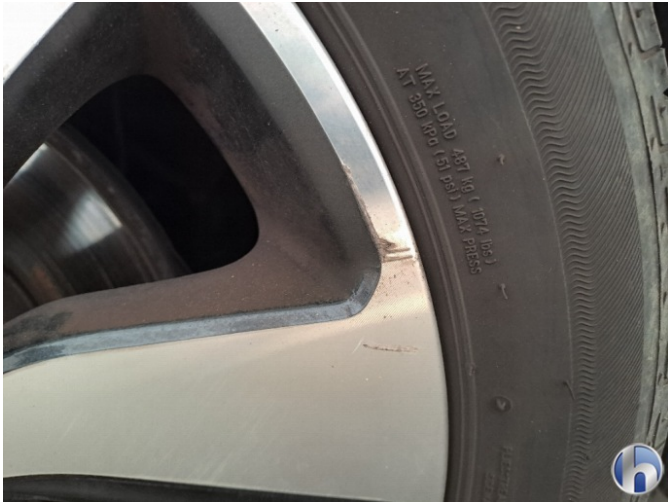
7. Felge vorn links

| | component | Damage | Rep kind |
|---|---|---|---|
| 7. | Felge vorn links | Scratch(es) | Replace |

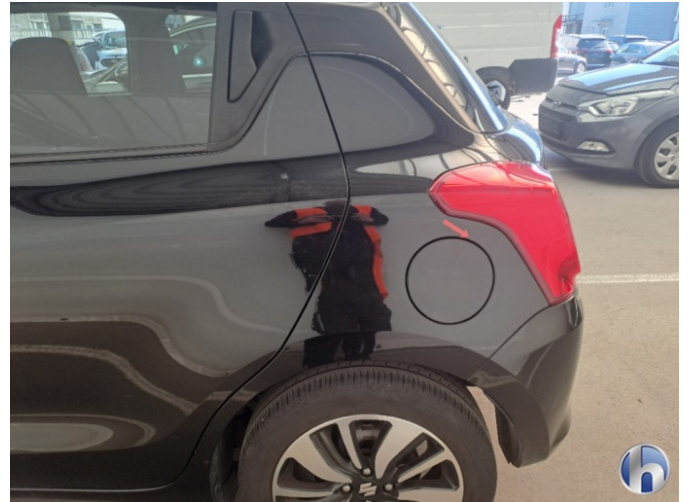
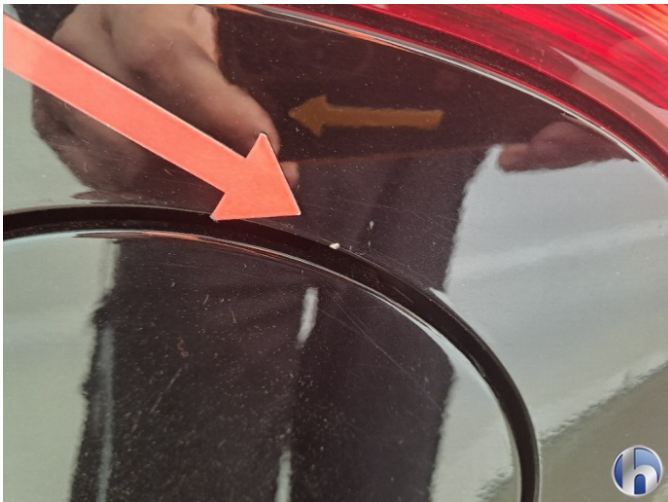
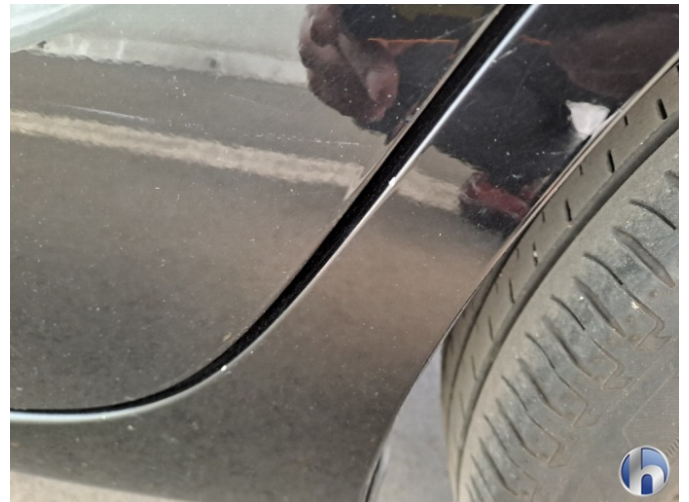
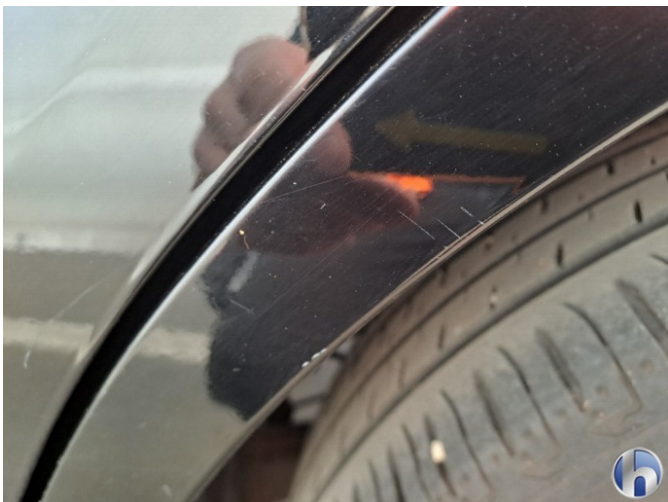
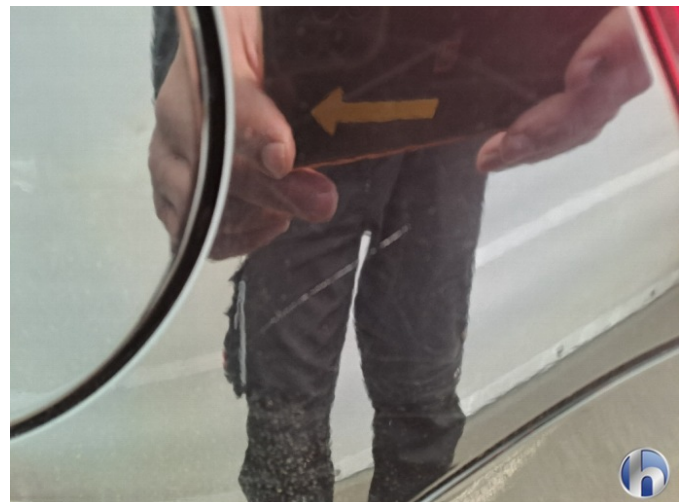
8. Sidewall - Rear - Left

| | component | Damage | Rep kind |
|---|---|---|---|
| 8. | Sidewall - Rear - Left | Scratch(es) | Paint |

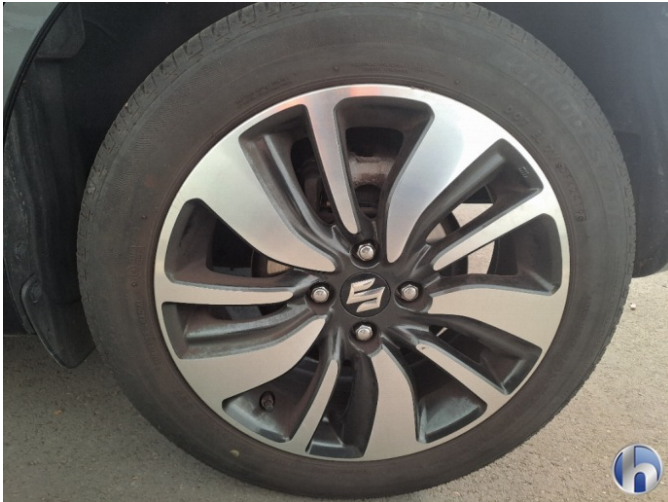
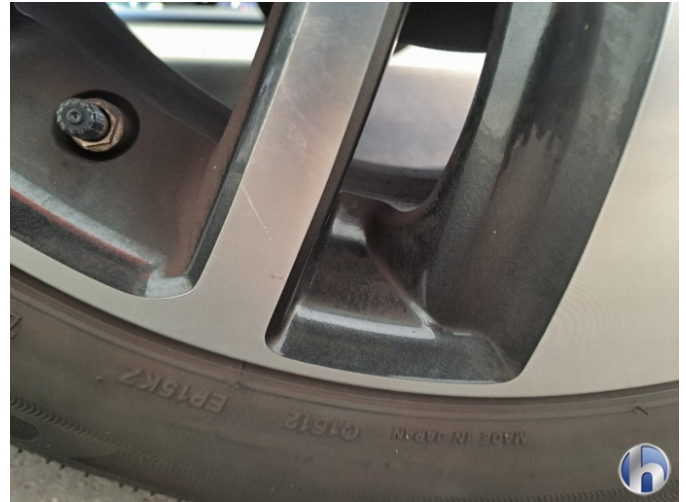
9. Felge Hinten links

| | component | Damage | Rep kind |
|---|---|---|---|
| 9. | Felge Hinten links | Scratch(es) | Replace |

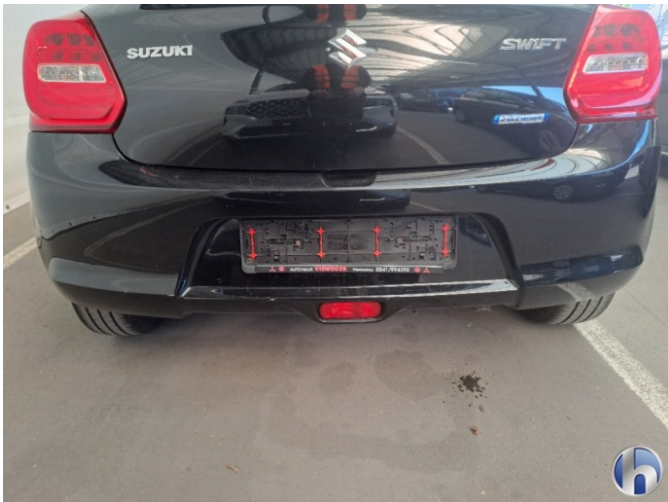
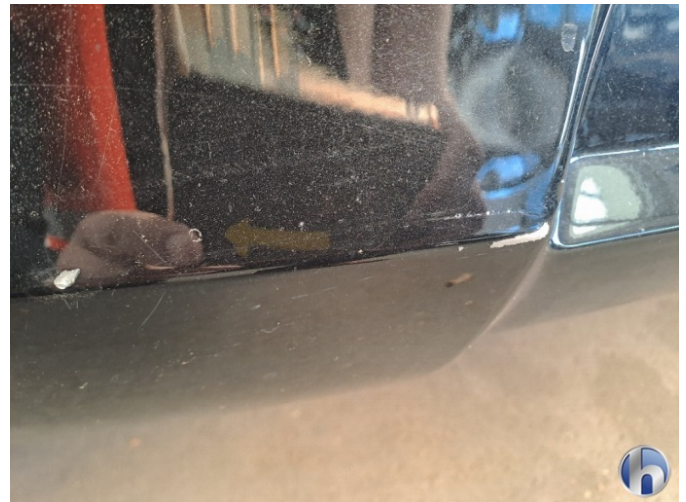
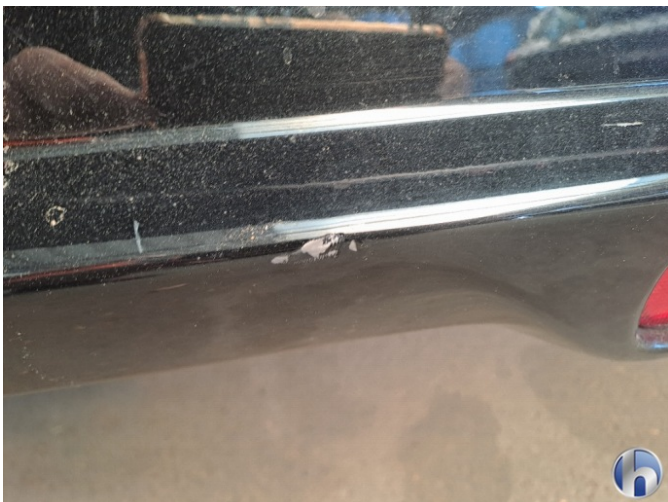
10. Rear bumper

| | component | Damage | Rep kind |
|---|---|---|---|
| 10. | Rear bumper | Scratch(es) | Paint |

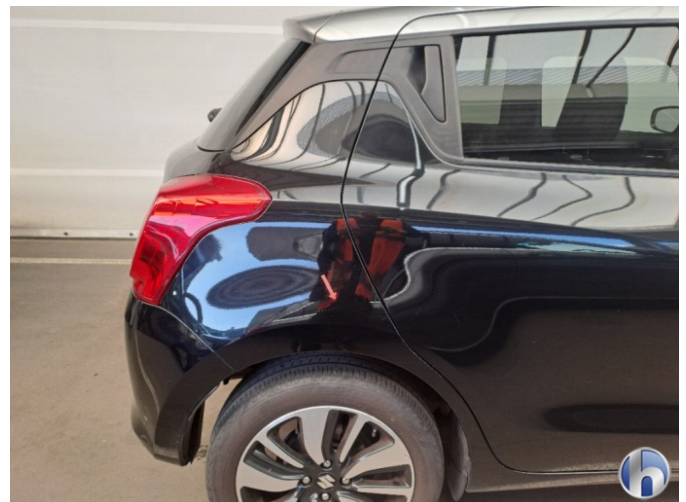
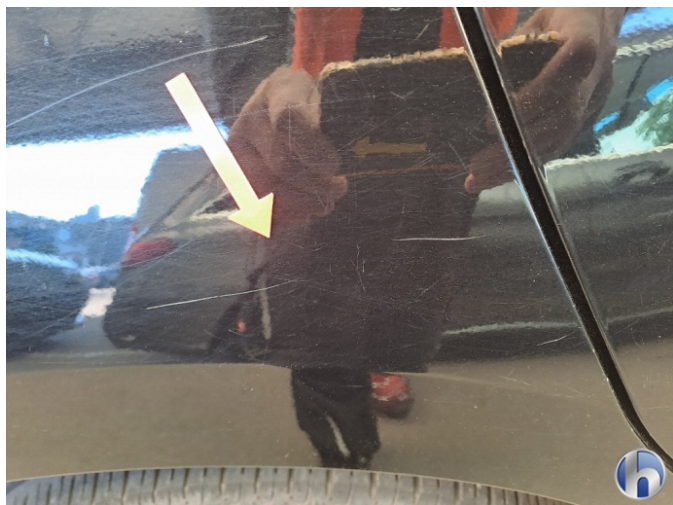
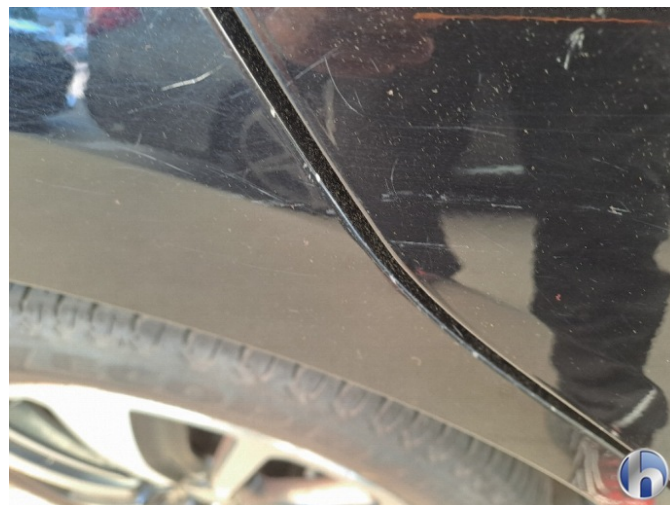
11. Sidewall - Rear - right

| | component | Damage | Rep kind |
|---|---|---|---|
| 11. | Sidewall - Rear - right | Scratch(es) | Paint |

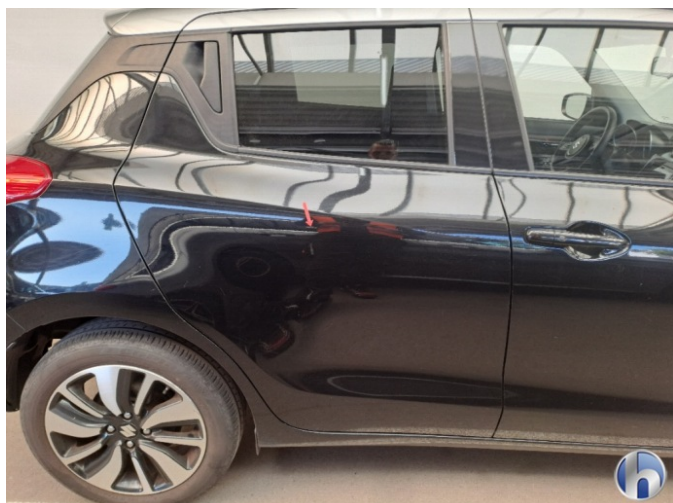
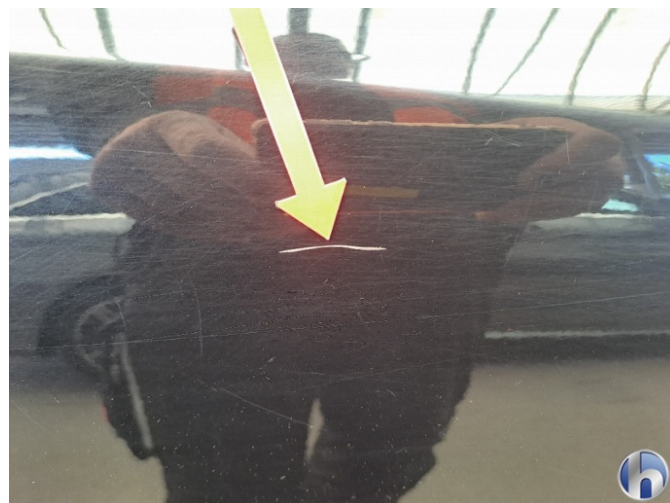
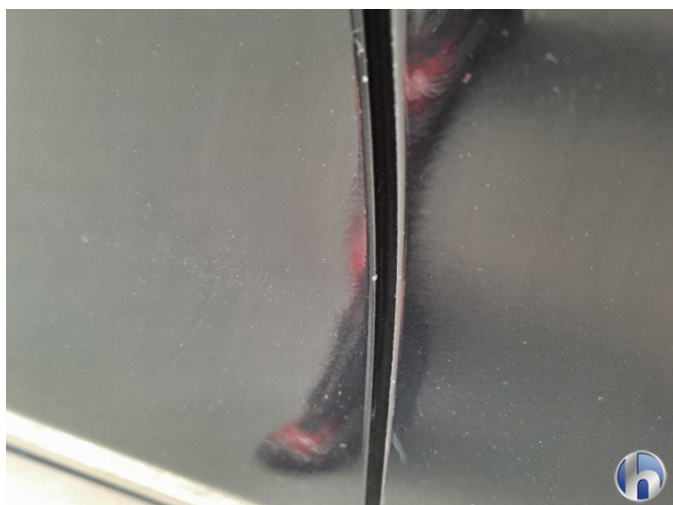
12. Door Rear - right

| | component | Damage | Rep kind |
|---|---|---|---|
| 12. | Door Rear - right | Scratch(es) | Paint |

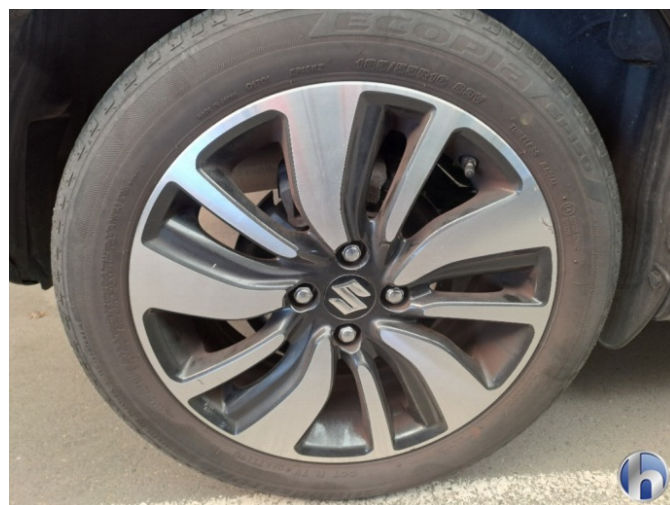
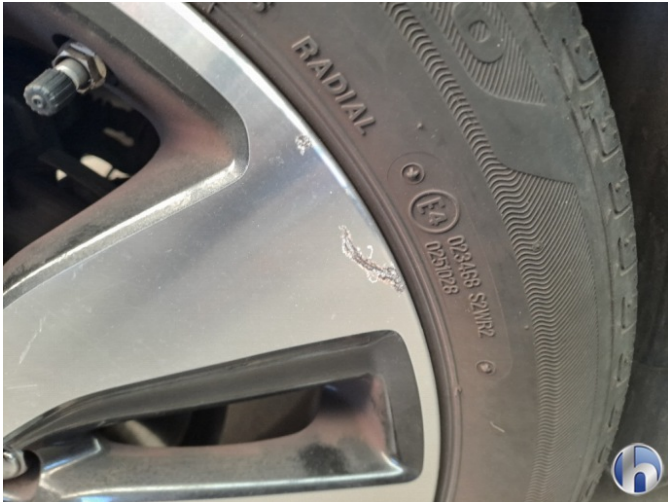
13. Felge Hinten rechts

| | component | Damage | Rep kind |
|---|---|---|---|
| 13. | Felge Hinten rechts | Scratch(es) | Replace |

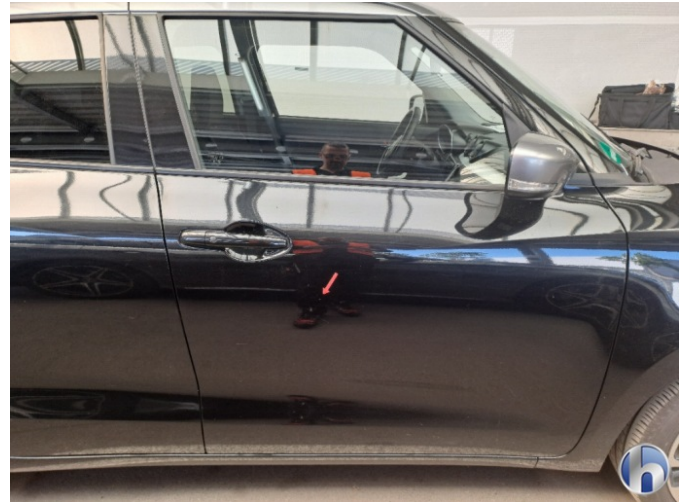
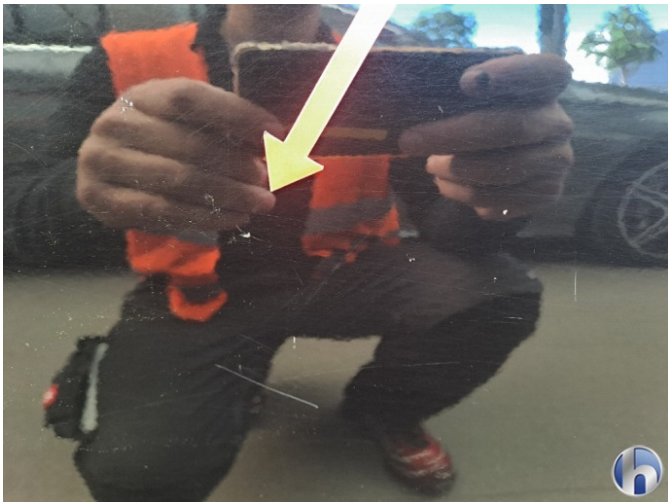
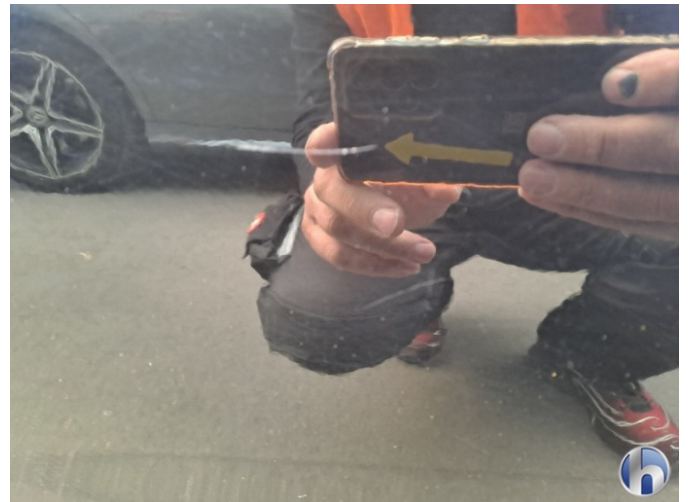
14. Front door - right

| | component | Damage | Rep kind |
|---|---|---|---|
| 14. | Front door - right | Scratch(es) | Paint |

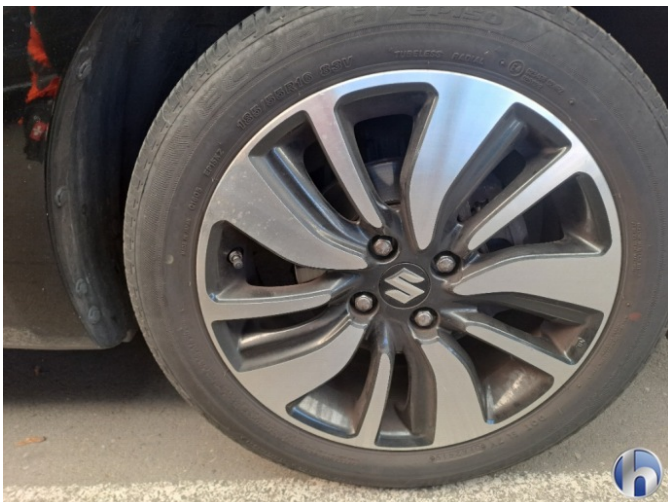
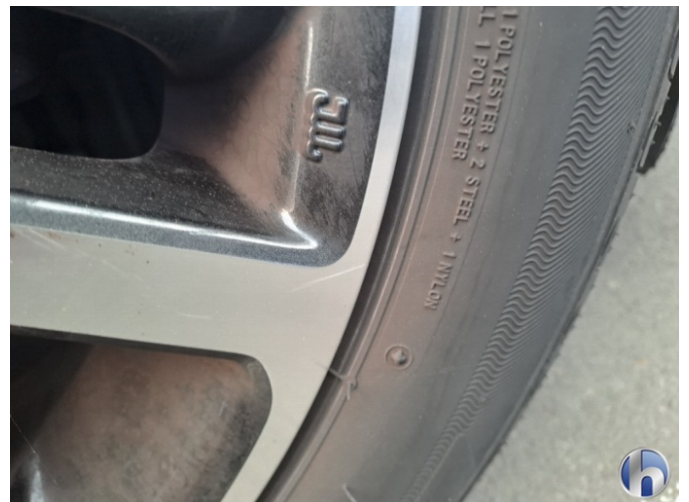
15. Felge vorn rechts

| | component | Damage | Rep kind |
|---|---|---|---|
| 15. | Felge vorn rechts | Scratch(es) | Replace |

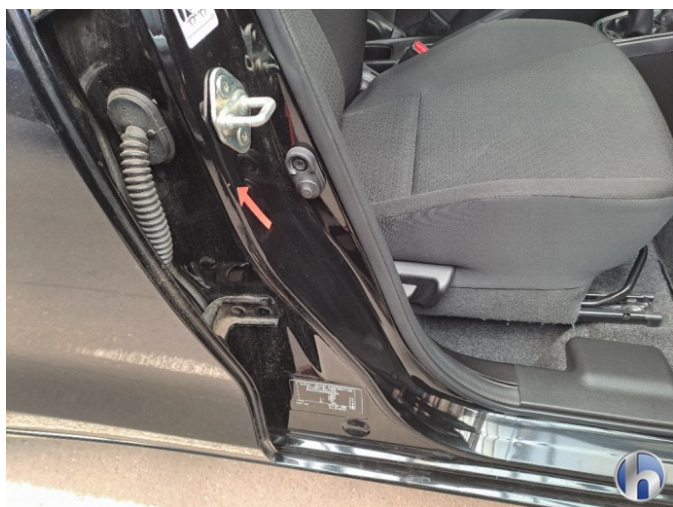
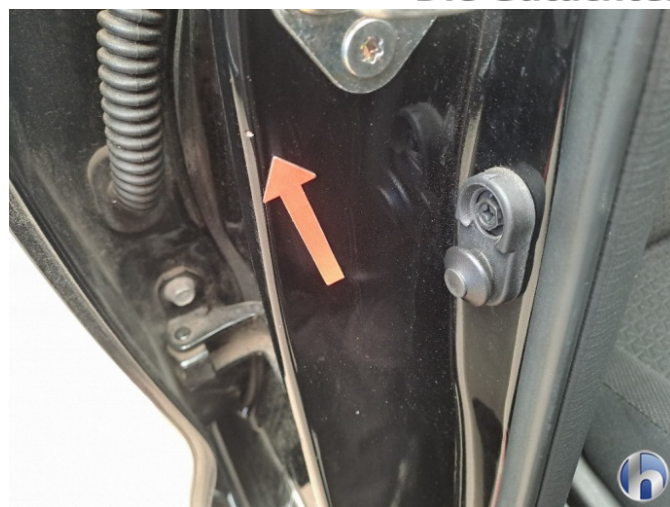
16. Türeinstieg Vorne rechts

| | component | Damage | Rep kind |
|---|---|---|---|
| 16. | Türeinstieg Vorne rechts | Scratch(es) | Smart repair |

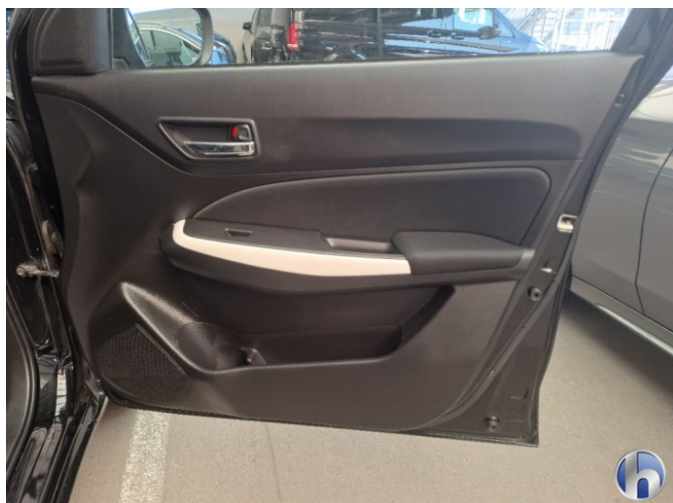
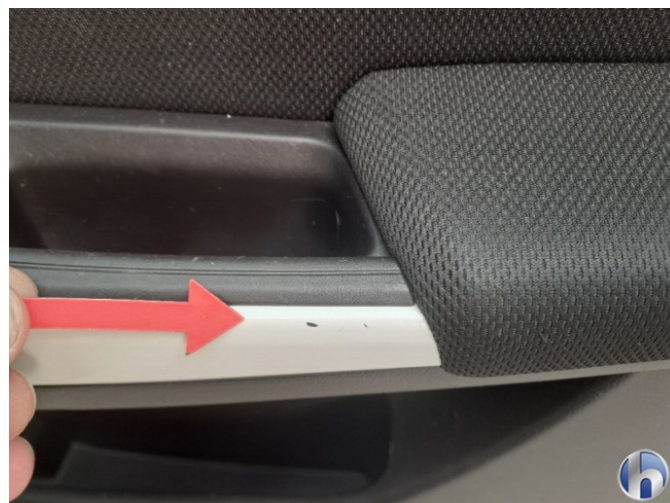
17. Türverkleidung Vorne rechts

| | component | Damage | Rep kind |
|---|---|---|---|
| 17. | Türverkleidung Vorne rechts | Scratch(es) | Smart repair |

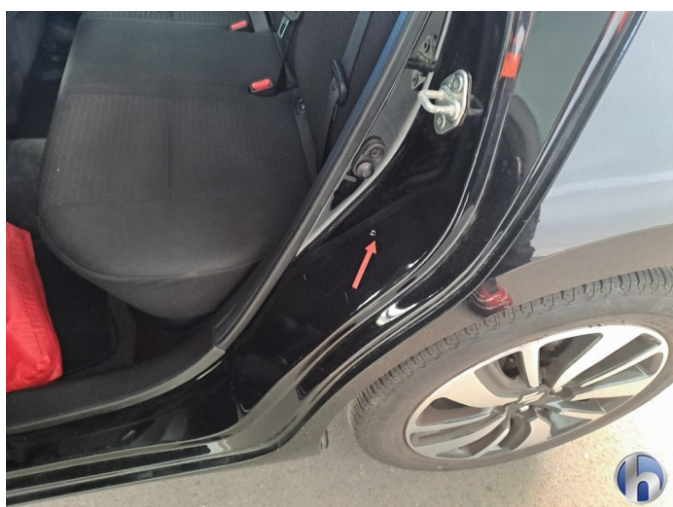
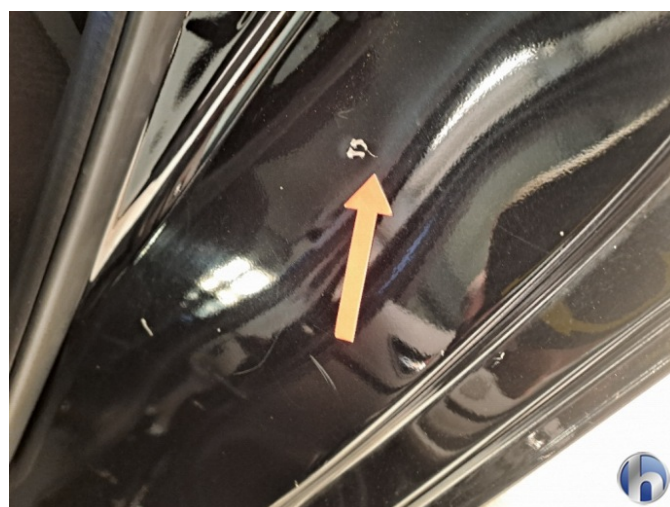
18. Türeinstieg Hinten links

| | component | Damage | Rep kind |
|---|---|---|---|
| 18. | Türeinstieg Hinten links | Scratch(es) | Smart repair |

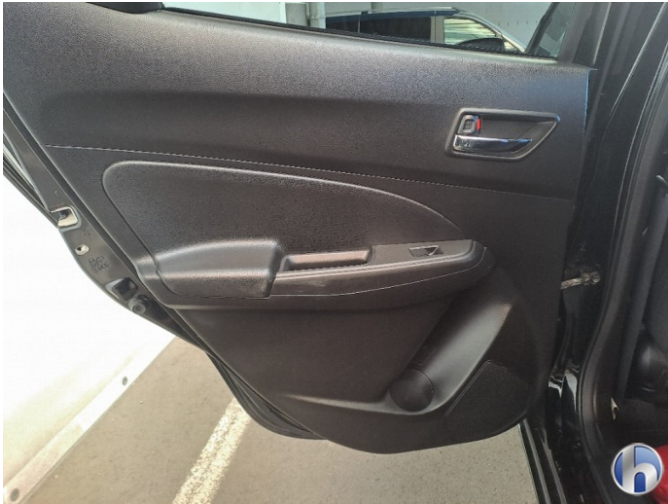
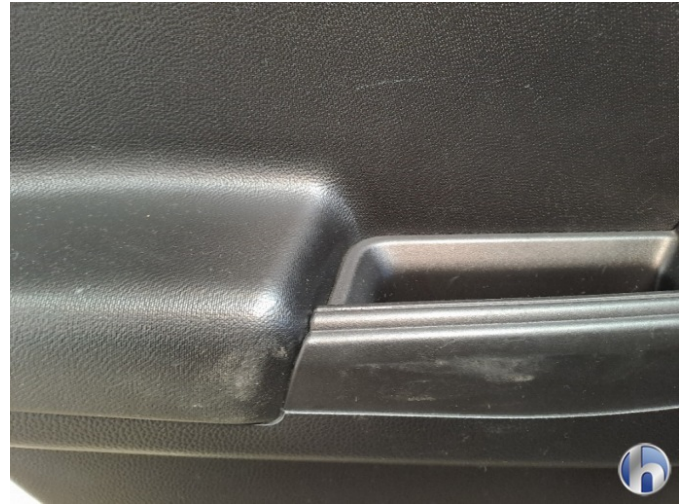
19. Türverkleidung Hinten links

| | component | Damage | Rep kind |
|---|---|---|---|
| 19. | Türverkleidung Hinten links | Scratch(es) | Smart repair |

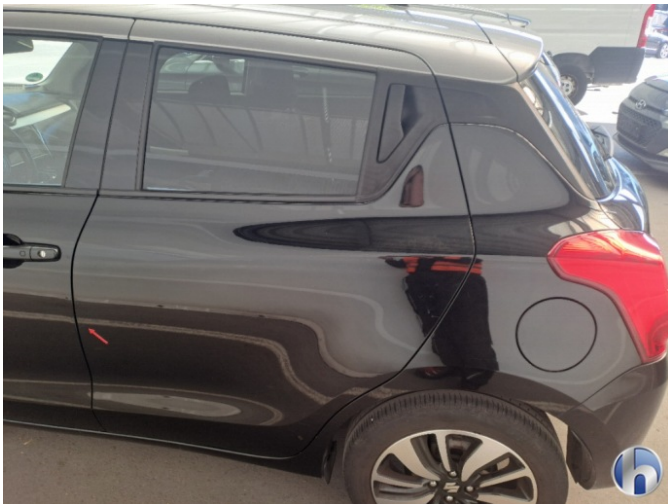
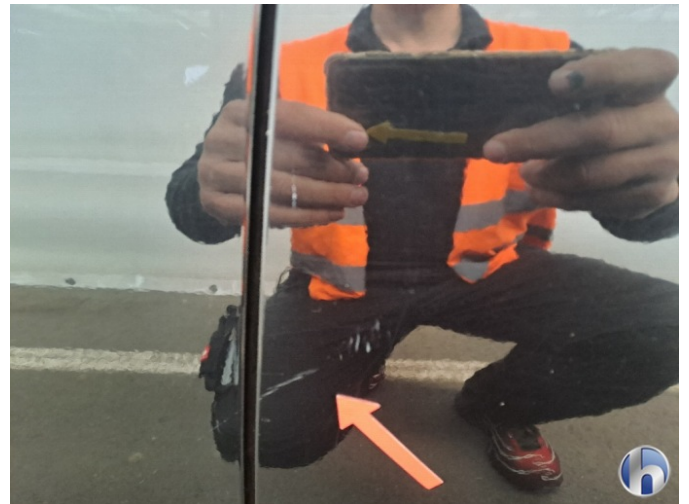
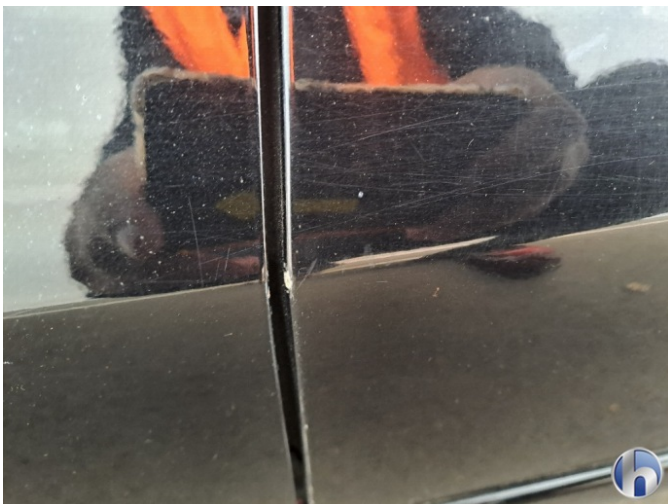
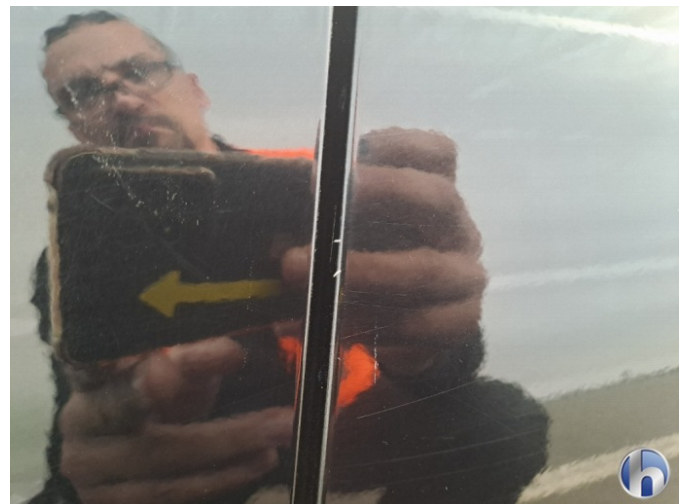
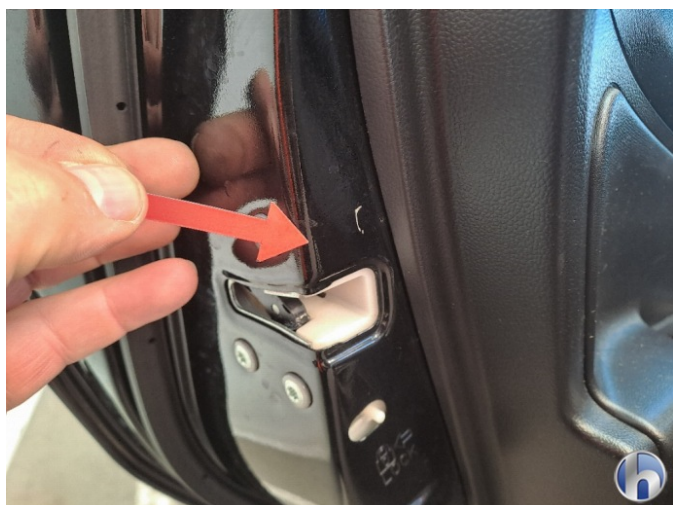
20. Rear door - left

| | component | Damage | Rep kind |
|---|---|---|---|
| 20. | Rear door - left | Scratch(es) | Paint |

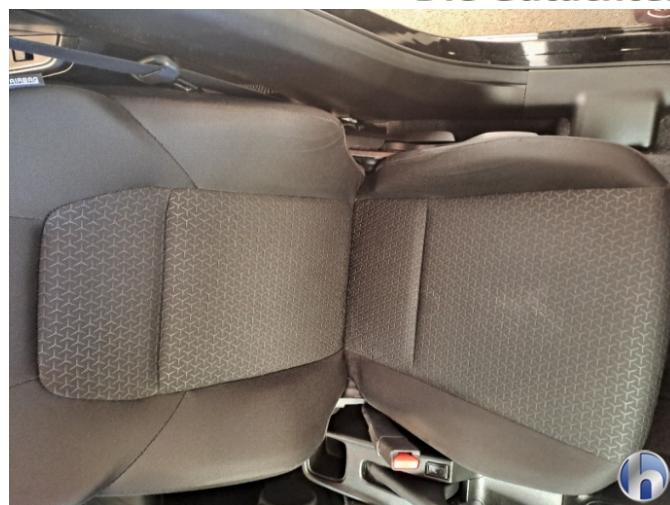
21. Fahrersitz

| | component | Damage | Rep kind |
|---|---|---|---|
| 21. | Fahrersitz | Wear and tear | acceptable |

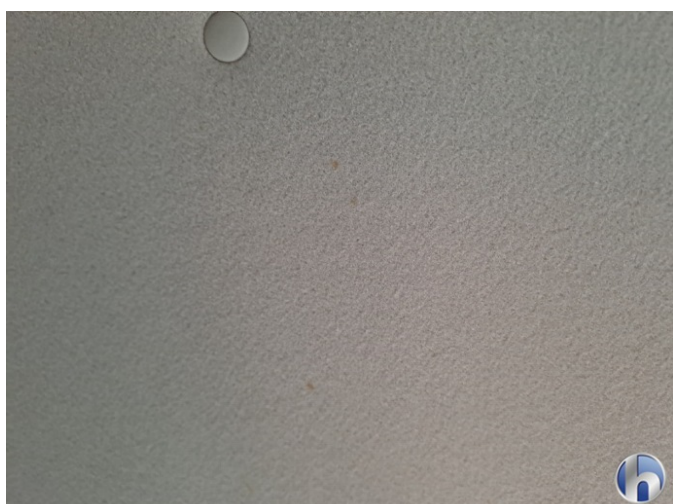
22. Dachhimmel

| | component | Damage | Rep kind |
|---|---|---|---|
| 22. | Dachhimmel | Dirty | |

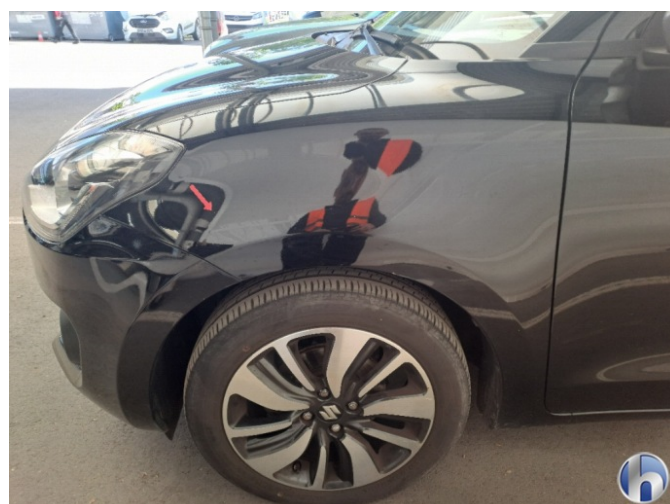
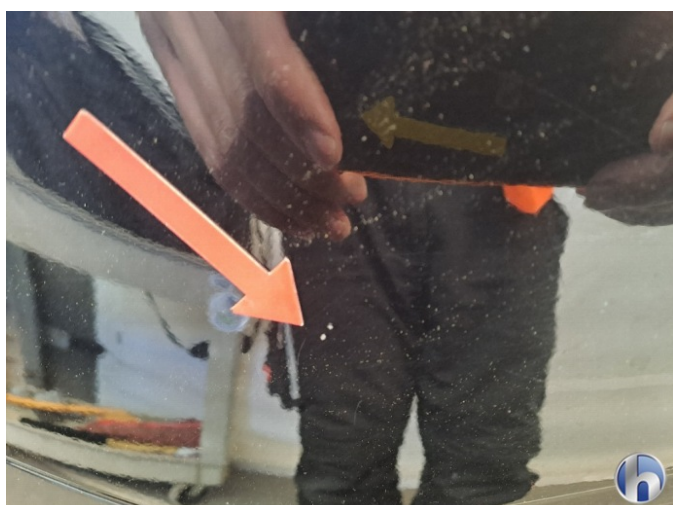
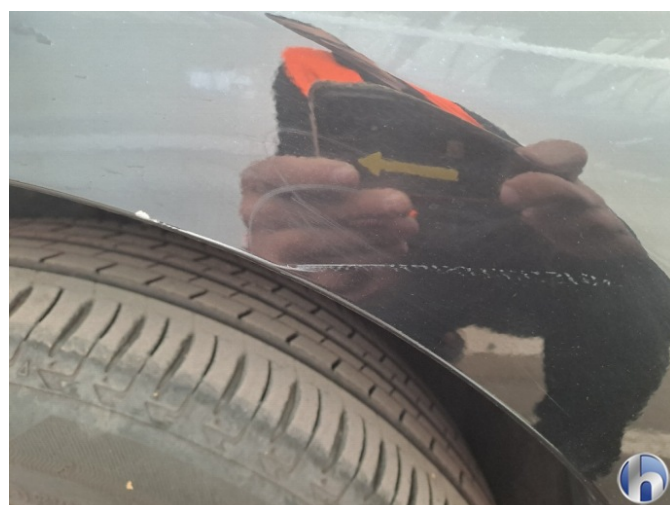
23. Front fender - left

| | component | Damage | Rep kind |
|---|---|---|---|
| 23. | Front fender - left | Scratch(es) | Refurbish and paint |
