## status report

#### Suzuki SWIFT

| Vehicle identification number | <b>JSAAZCA3S00585216</b> | mileage read: | <b>22065 km</b> |

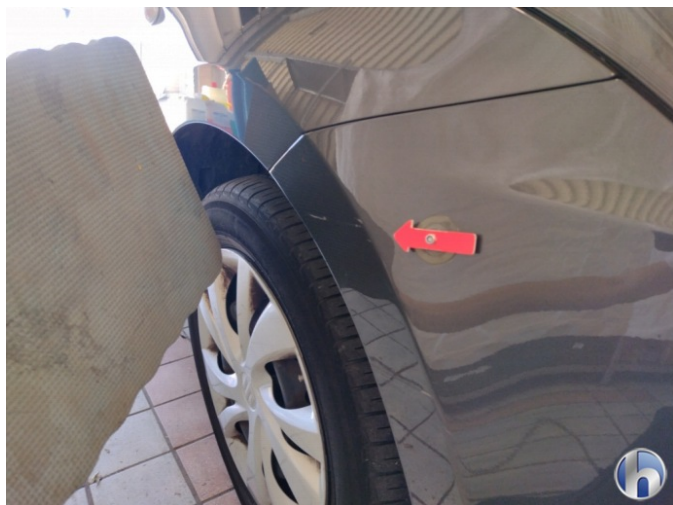
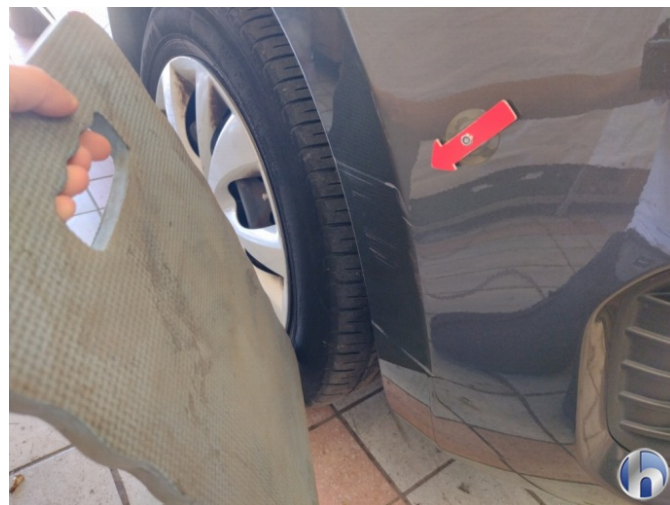
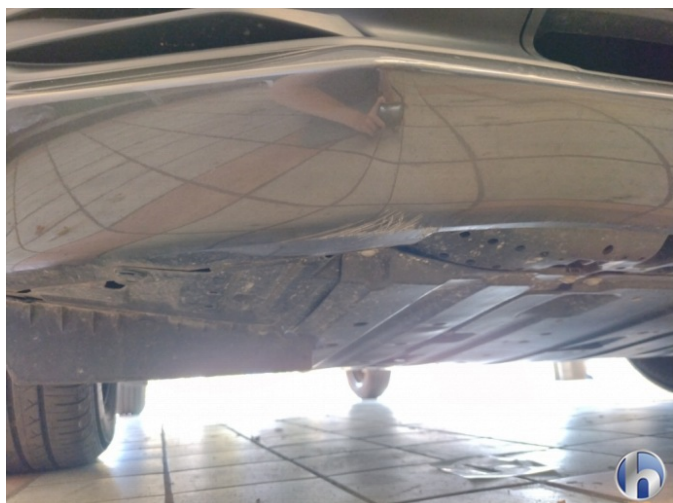
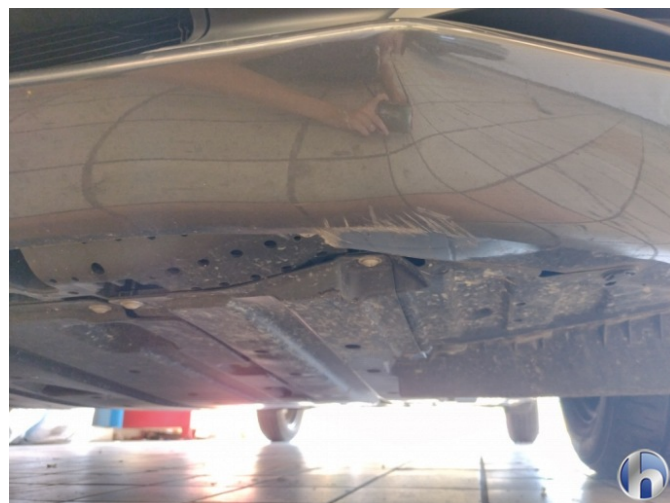
| component | Damage | Rep kind |
|---|---|---|
| 4. Front bumper | Scrape | Paint |

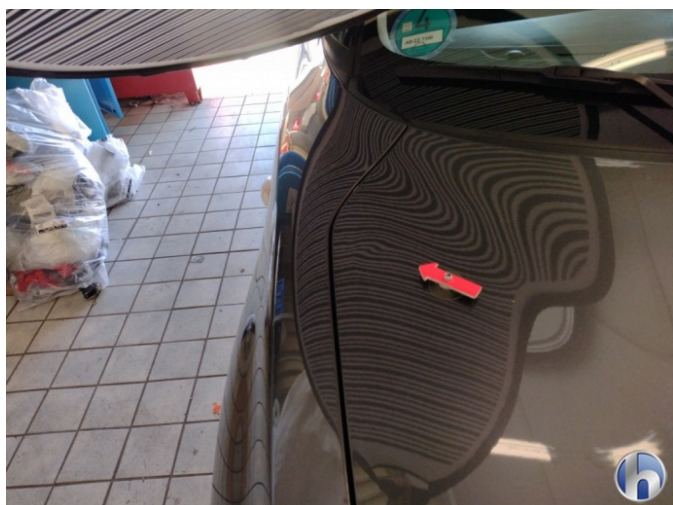
| component | Damage | Rep kind |
|---|---|---|
| 5. hood | Delle | Smart repair |

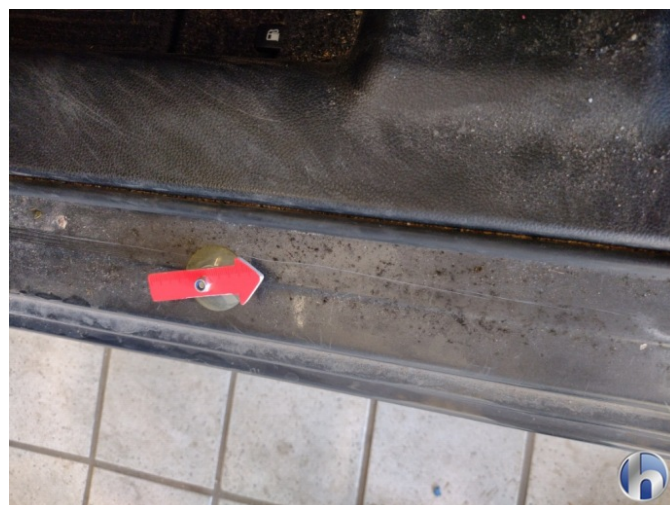
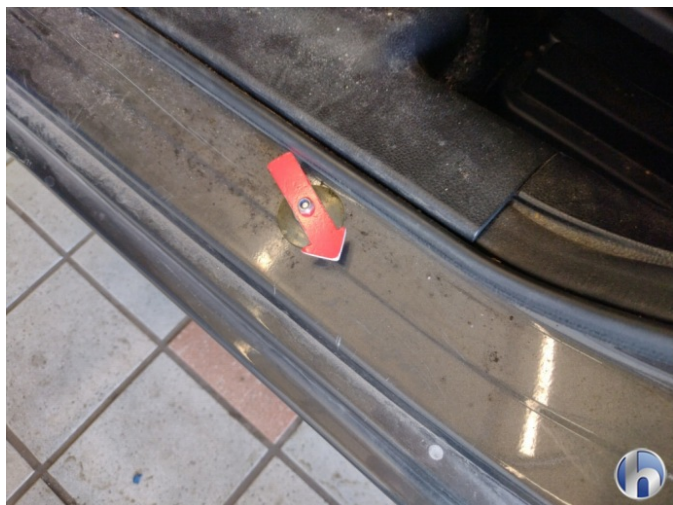
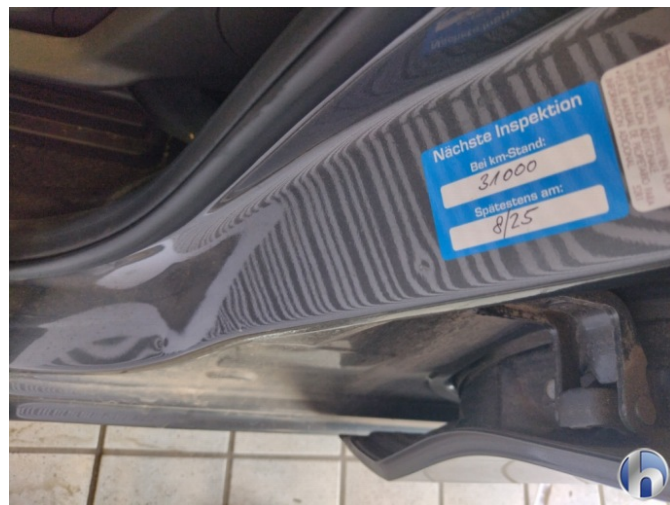
| component | Damage | Rep kind |
|---|---|---|
| 6. Türeinstieg Vorne - Links | Damaged | Refurbish and paint |

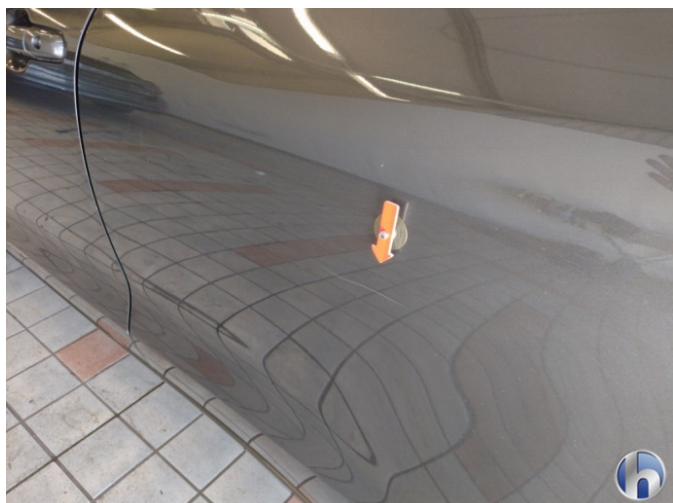
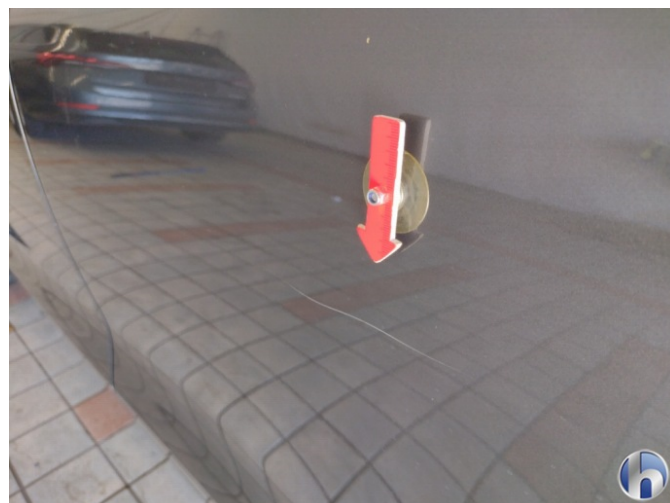
| component | Damage | Rep kind |
|---|---|---|
| 7. Rear door - left | Scratch(es) | Paint |

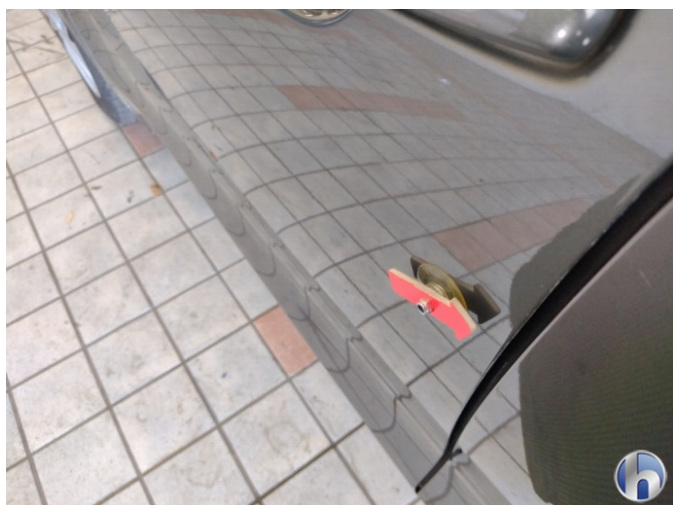
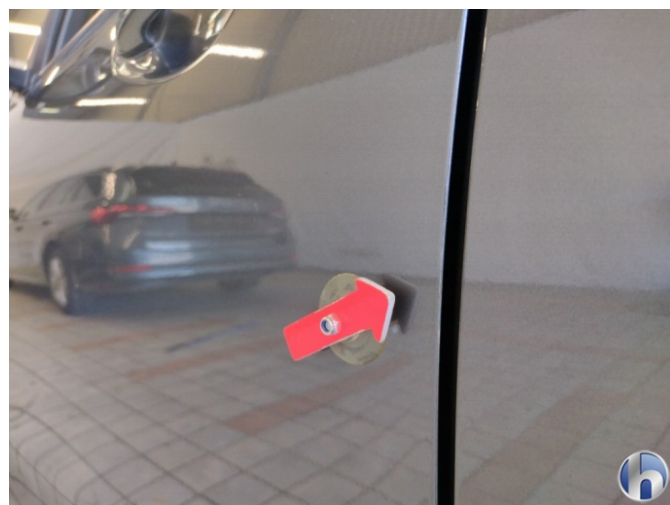
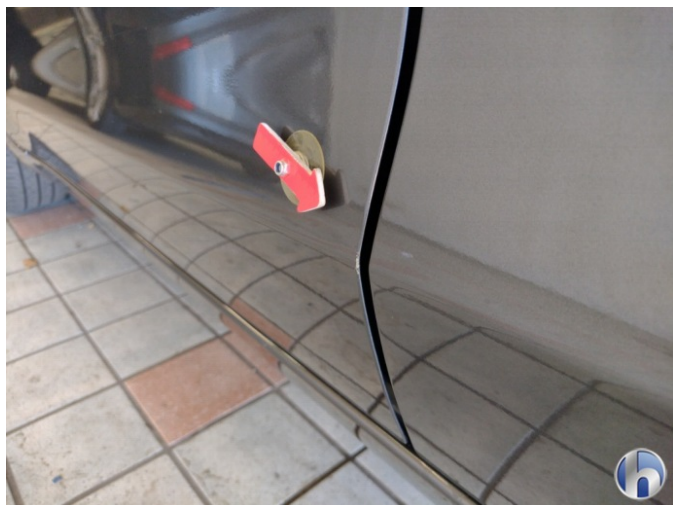
| component | Damage | Rep kind |
|---|---|---|
| 8. Front door - left | Scratch(es) | Smart repair |

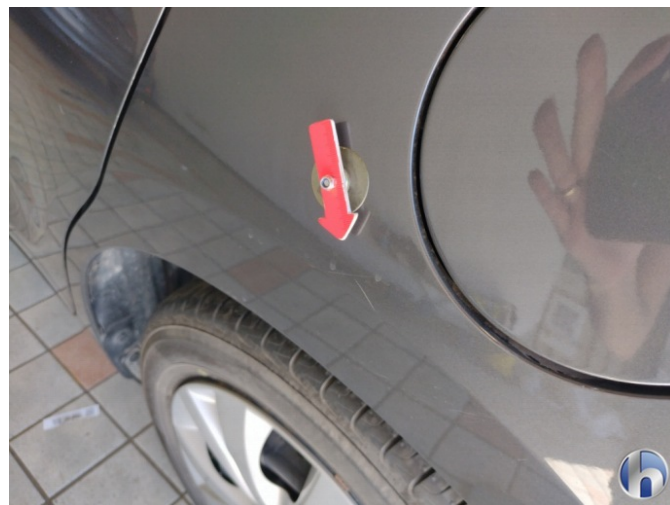
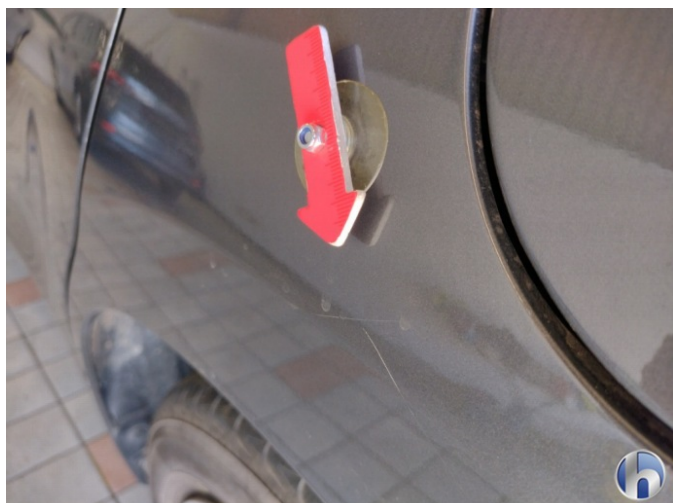
| component | Damage | Rep kind |
|---|---|---|
| 9. Sidewall - Rear - Left | Scratch(es) | |

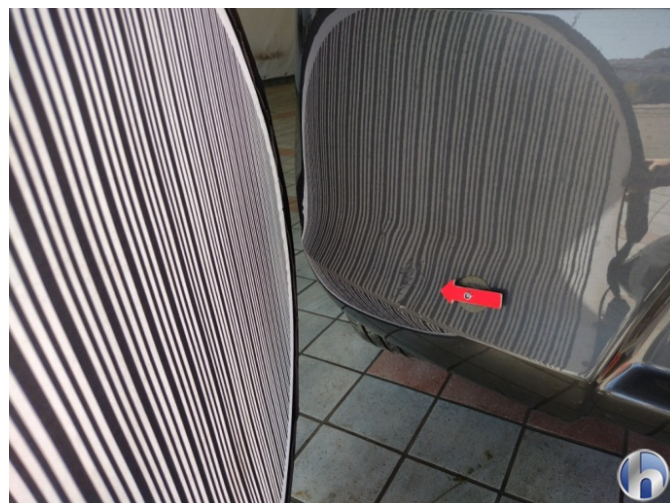
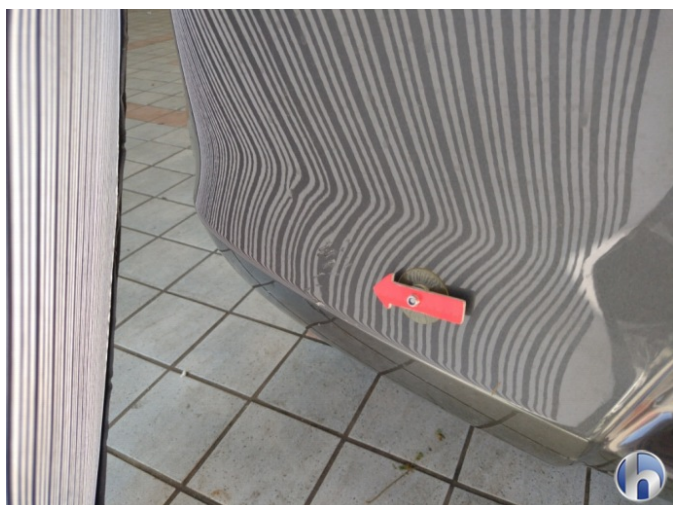
| component | Damage | Rep kind |
|---|---|---|
| 10. Rear bumper | Damaged | Refurbish and paint |

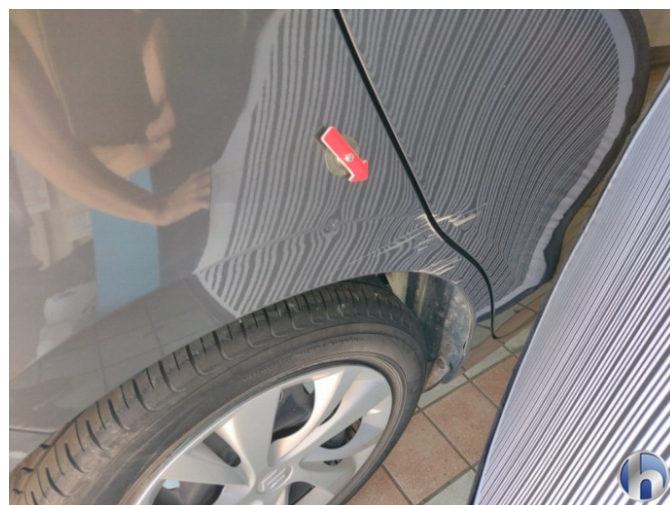
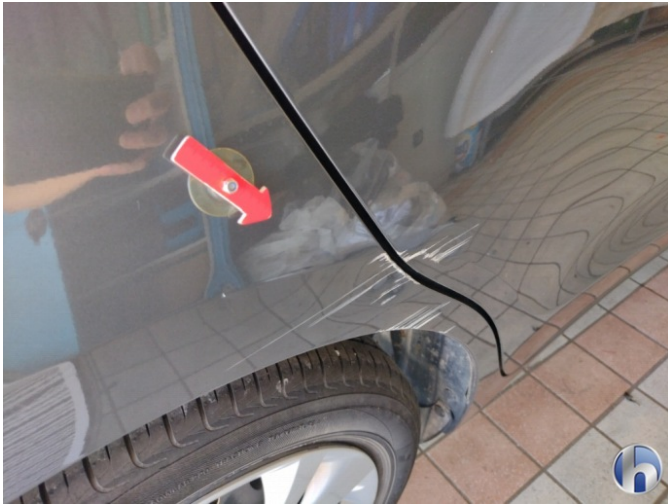
| component | Damage | Rep kind |
|---|---|---|
| 11. Sidewall - Rear - right | Deformed | Refurbish and paint |

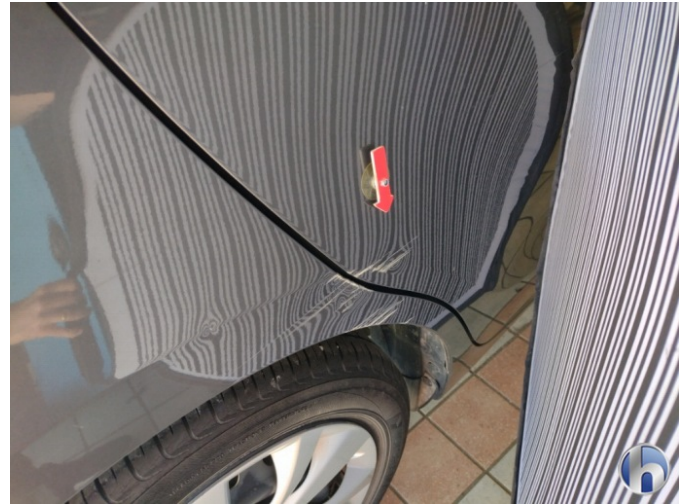
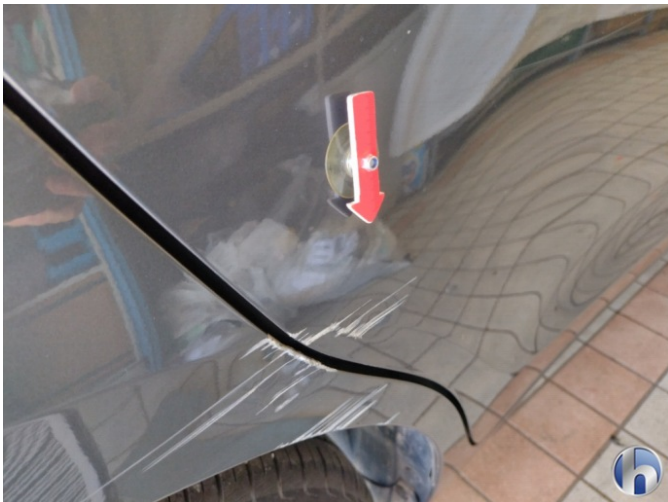
| component | Damage | Rep kind |
|---|---|---|
| 12. Door Rear - right | Deformed | Refurbish and paint |

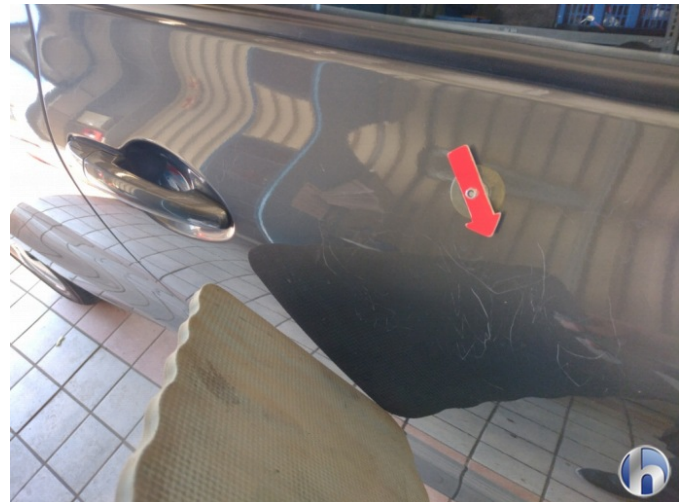
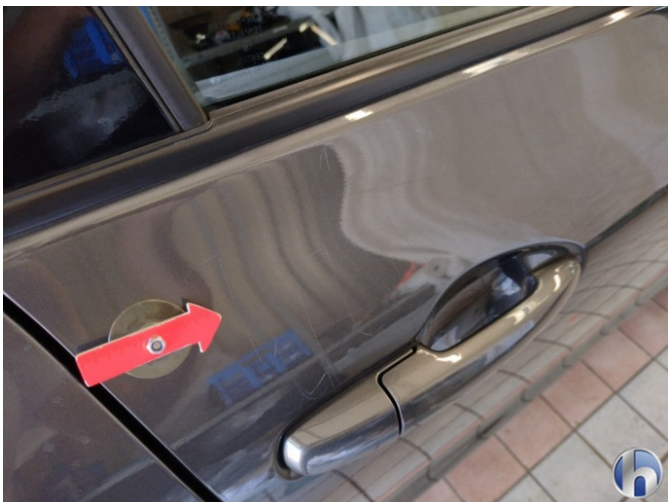
| component | Damage | Rep kind |
|---|---|---|
| 13. Front door - right | Scratch(es) | Paint |

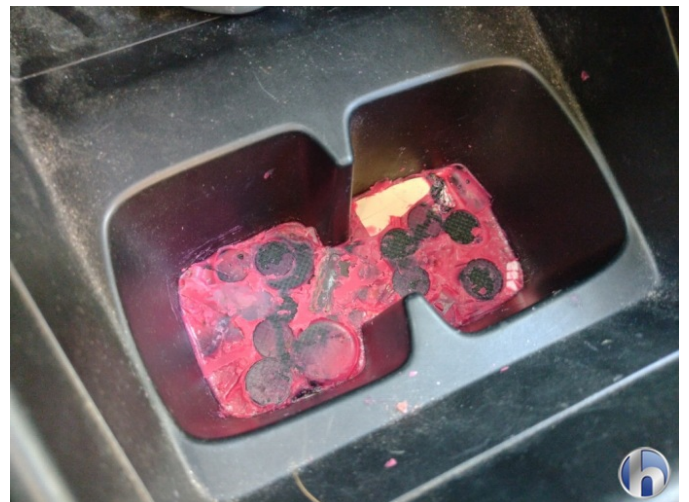
| component | Damage | Rep kind |
|---|---|---|
| 14. Mittelkonsole | Dirty | |
