TOYOTA Aygo

VIN NO JTDKG18C40N676057

Inspection Report Summary

Customer	BCA Online	Report Number	P20251006130421
Inspection Date / Place	2025-10-06 / BCA Oberndorf	Cosmetic Grade	3

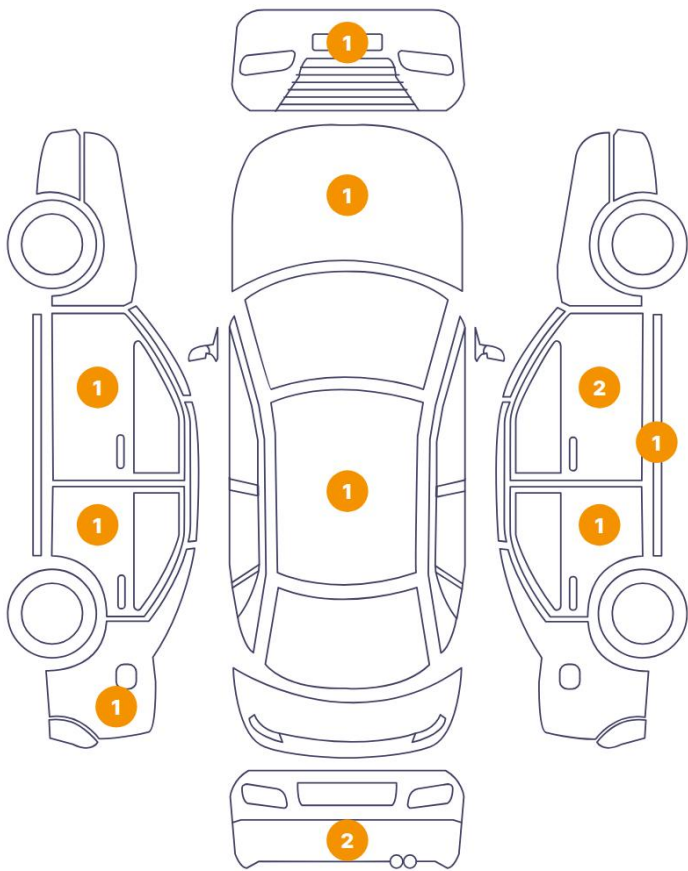
12 Schäden

Component		Damage	Comments
1	Bumper / Front	Bodywork / Dent / Dent	
2	Hood	Bodywork / Dent / Dent	
3	Roof	Bodywork / Dent / Dent	
4	Door / Front Left	Bodywork / Dent / Dent	
5	Door / Back Left	Paint / Scratch / Line	
6	Door Edge / Back Left	Bodywork / Dent / Dent	
7	Bumper / Back	Paint / Scratch / Line	
8	Bumper / Back	Paint / Scratch / Scuff	
9	Rocker Panel / Center Right	Bodywork / Dent / Dent	
10	Door / Back Right	Bodywork / Dent / Dent	
11	Door / Front Right	Bodywork / Dent / Dent	
12	Mirror / Front Right	Paint / Stone Chip

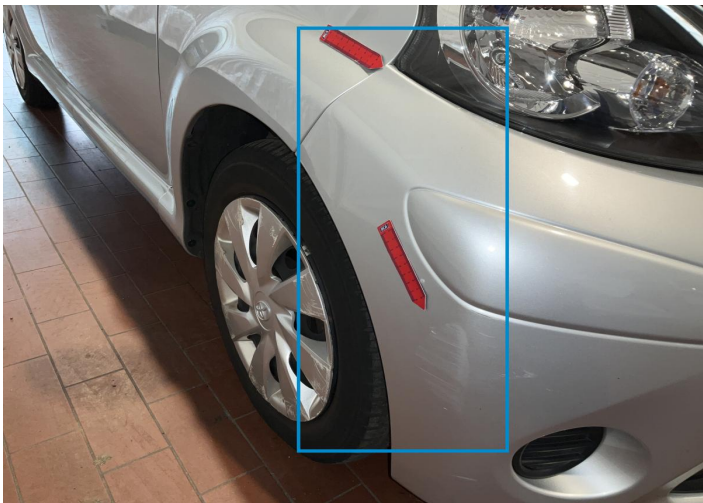
1. Bumper / Front
Bodywork / Dent / Dent -

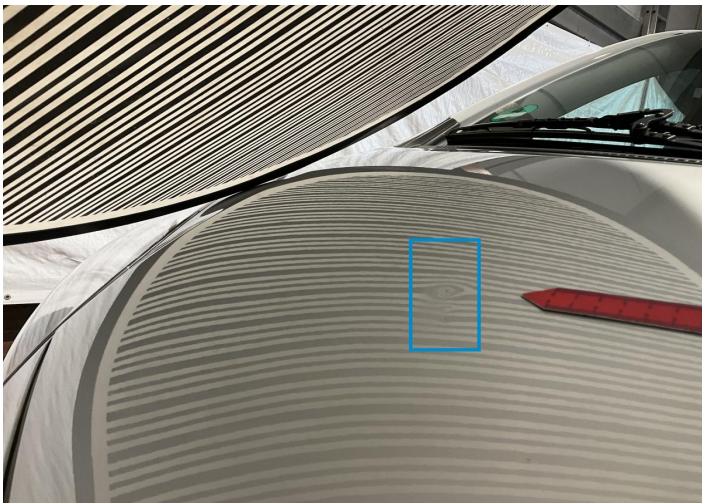
2. Hood
Bodywork / Dent / Dent -

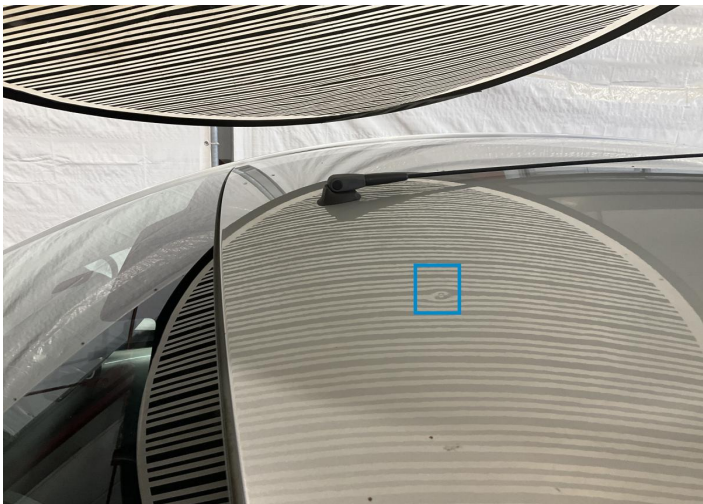
3. Roof
Bodywork / Dent / Dent -

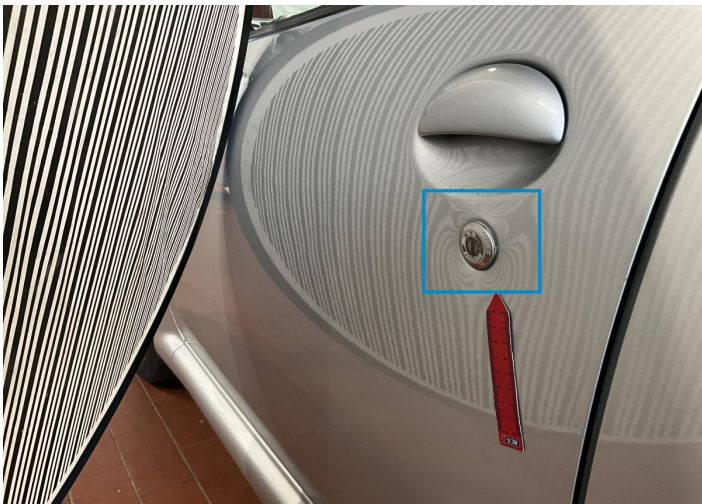
4. Door / Front Left
Bodywork / Dent / Dent -

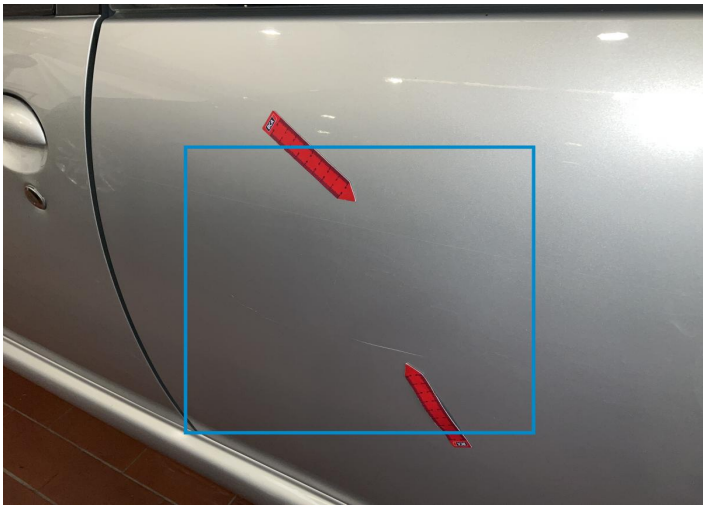
5. Door / Back Left
Paint / Scratch / Line -

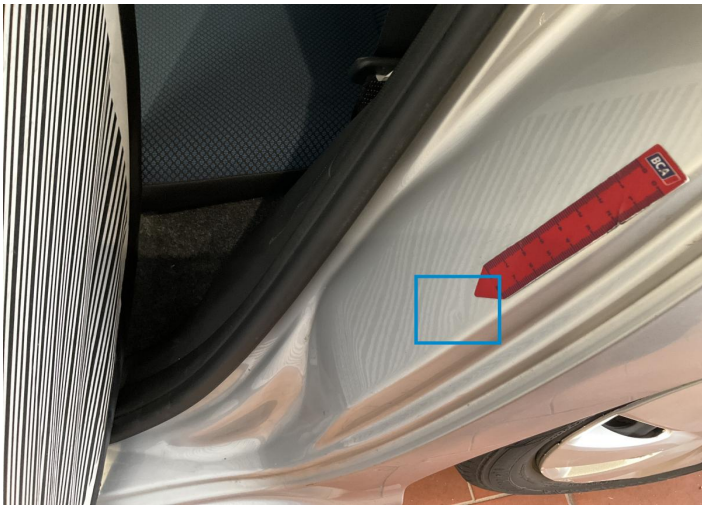
6. Door Edge / Back Left
Bodywork / Dent / Dent -

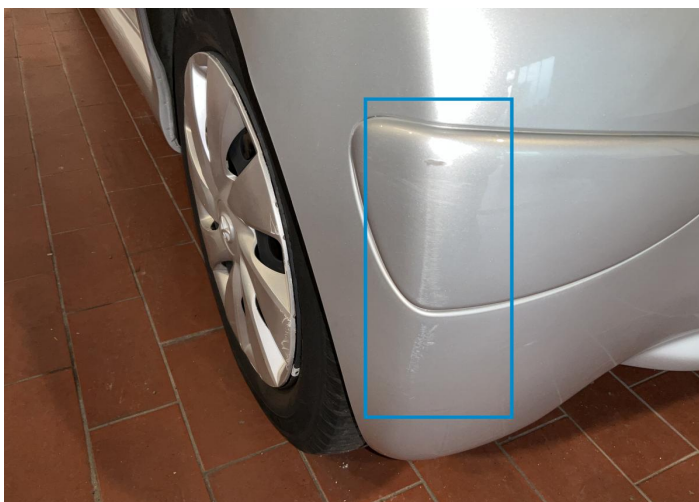
7. Bumper / Back
Paint / Scratch / Line -

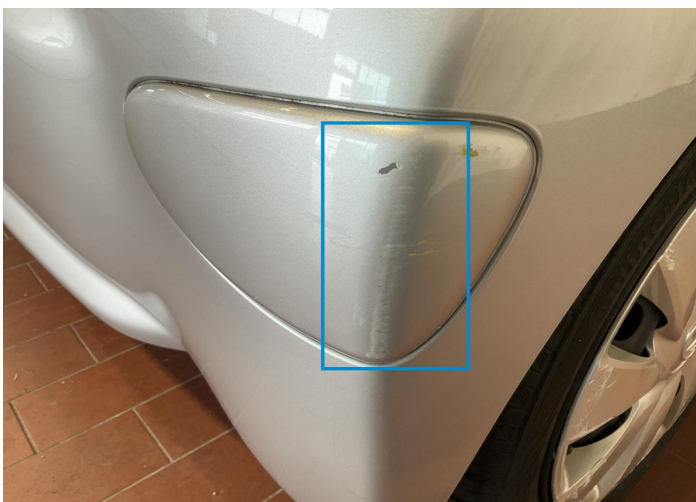
8. Bumper / Back
Paint / Scratch / Scuff -

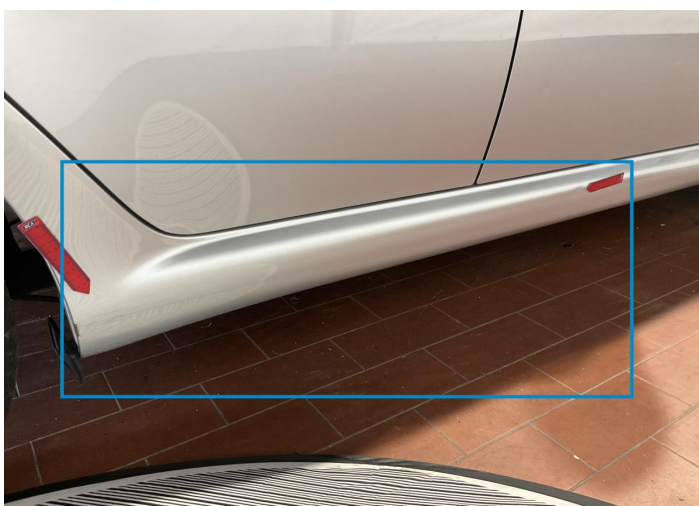
9. Rocker Panel / Center Right
Bodywork / Dent / Dent -

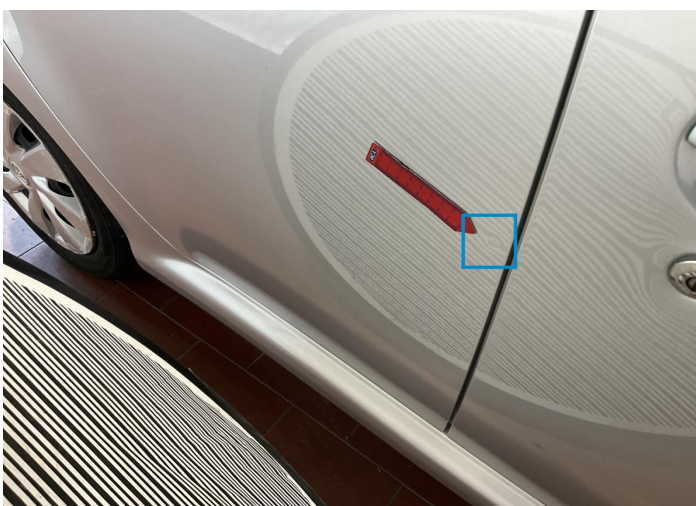
10. Door / Back Right
Bodywork / Dent / Dent -

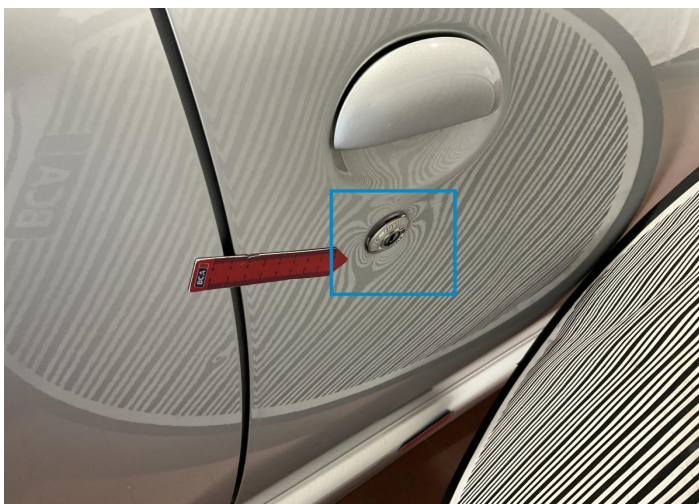
11. Door / Front Right
Bodywork / Dent / Dent -

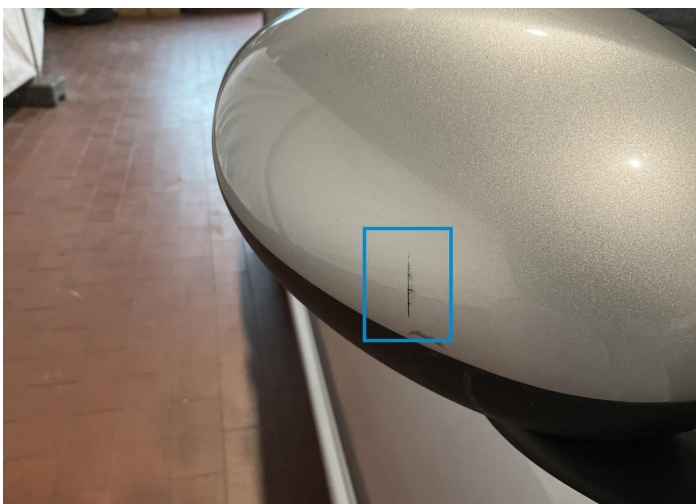
12. Mirror / Front Right
Paint / Stone Chip -
