CHEVROLET Spark Spark 1.2

VIN NO KL1MF48D9BC616900
Registration Number D9BC616900

Inspection Report Summary

Customer	BCA Online	Report Number	P20250926132200
Inspection Date / Place	2025-09-26 / Dürkop Eberswalde	Cosmetic Grade	3

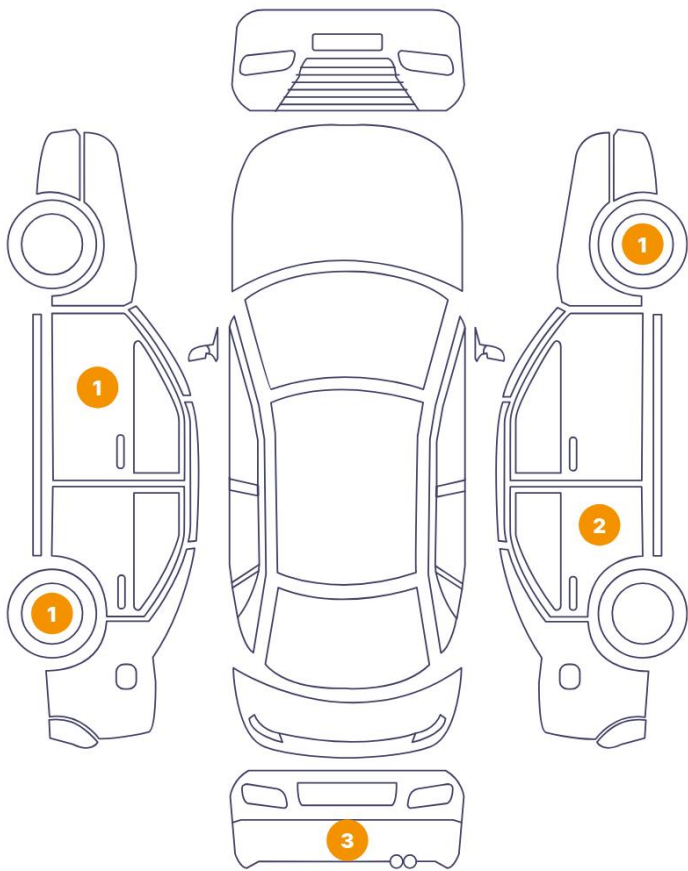
8 Schäden

Component	Damage	Comments
1 Rim / Back Left	Out of Bodywork / Scratch	
2 Corner Bumper / Back Left	Paint / Scratch / Scuff	
3 Bumper / Back	Paint / Scratch / Scuff	
4 Corner Bumper / Back Right	Paint / Scratch / Scuff	
5 Door / Back Right	Bodywork / Dent / Dent	
6 Door / Back Right	Bodywork / Dent / Dent	
7 Rim / Front Right	Out of Bodywork / Scratch	
8 Door / Front Left	Bodywork / Dent / Dent

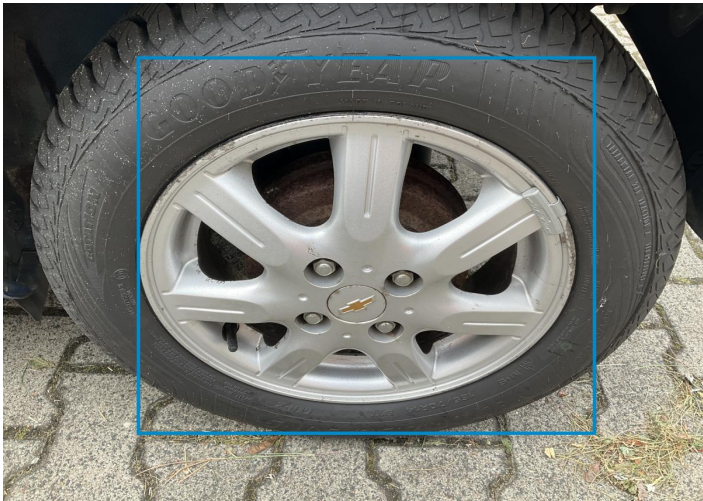
1. Rim / Back Left
Out of Bodywork / Scratch -

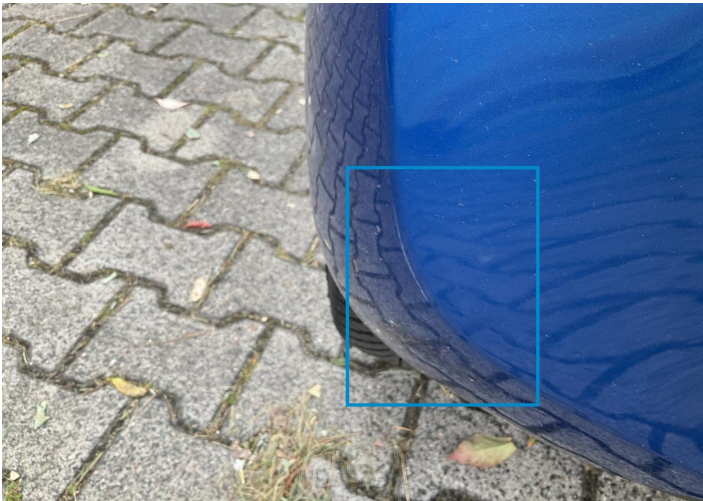
2. Corner Bumper / Back Left
Paint / Scratch / Scuff -

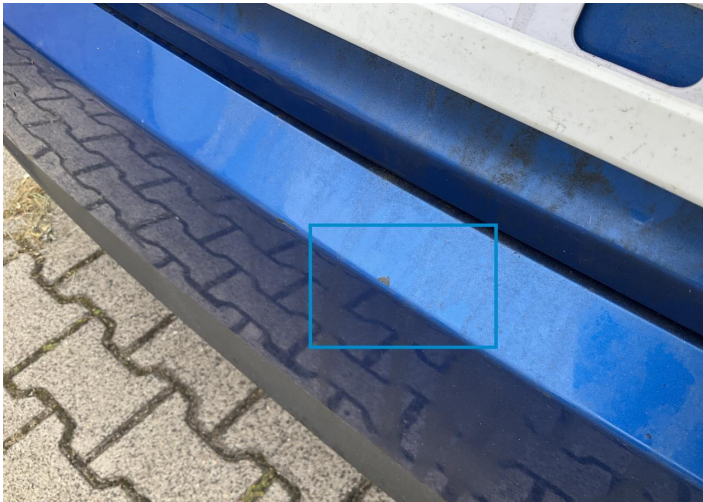
3. Bumper / Back
Paint / Scratch / Scuff -

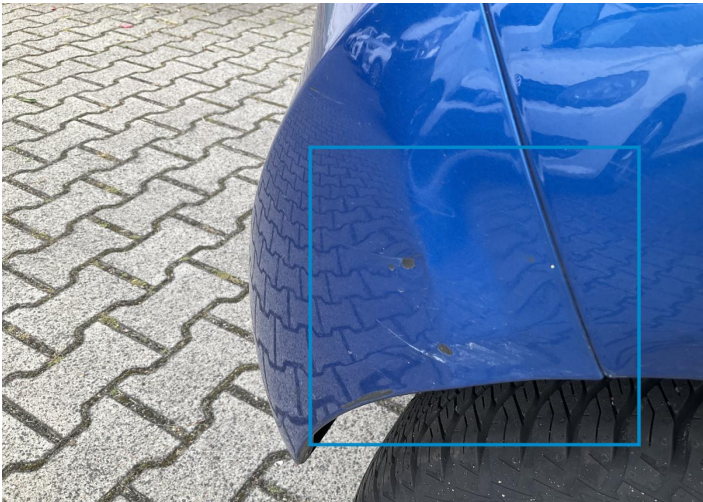
4. Corner Bumper / Back Right
Paint / Scratch / Scuff -

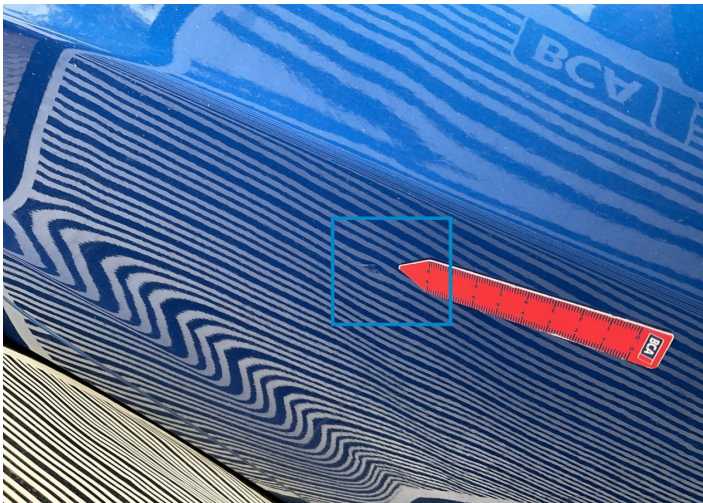
5. Door / Back Right
Bodywork / Dent / Dent -

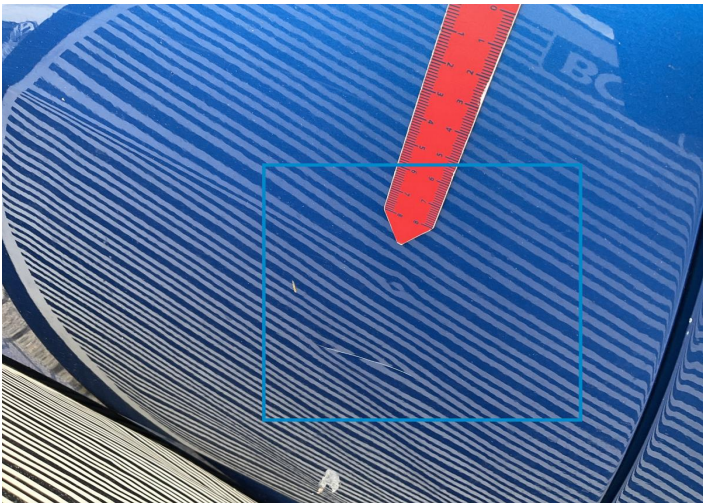
6. Door / Back Right
Bodywork / Dent / Dent -

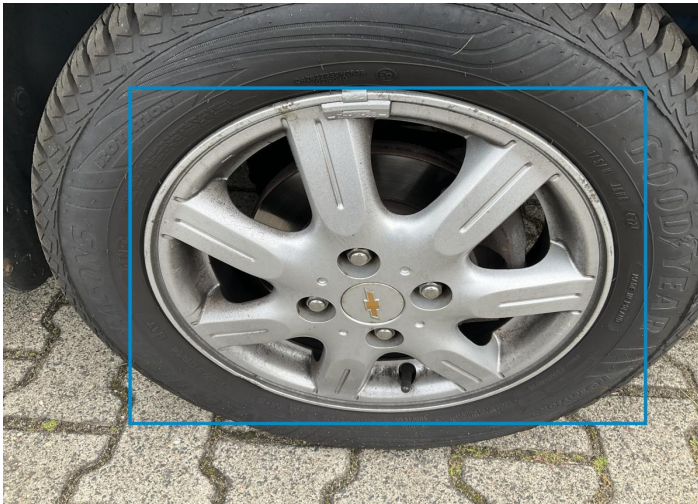
7. Rim / Front Right
Out of Bodywork / Scratch -

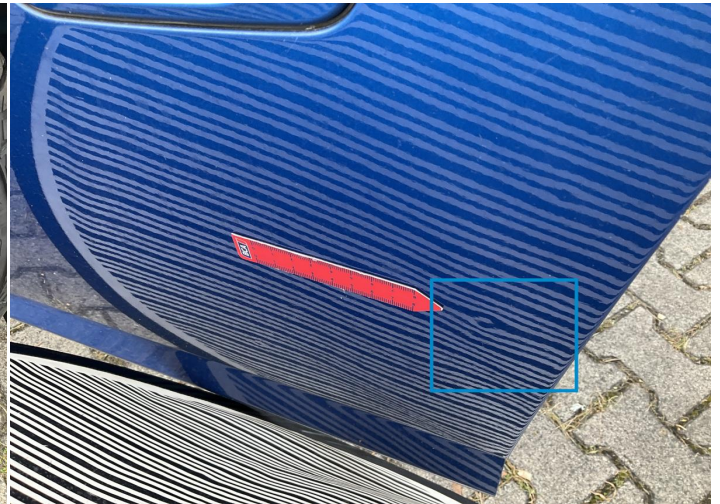
8. Door / Front Left
Bodywork / Dent / Dent -
