## status report

**customer:** Santander Consumer Bank AG

#### Hyundai Ioniq Style Hybrid

| Vehicle identification number | <b>KMHC851CGNU287621</b> | mileage read: | <b>244419 km</b> |

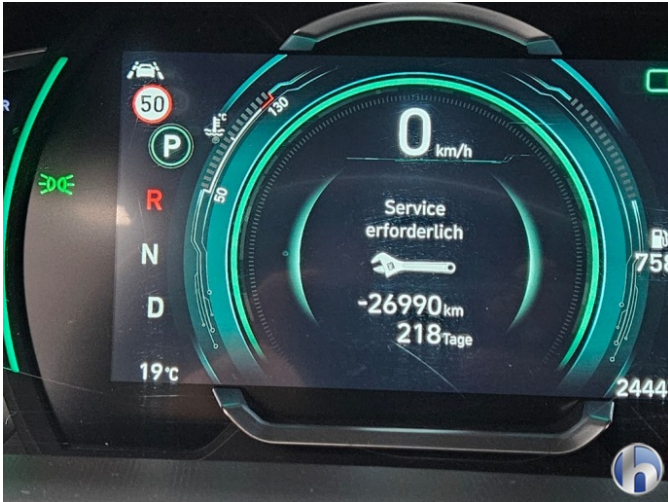
| component | Damage | Rep kind |
|---|---|---|
| 1. maintenance | Due | Replace |

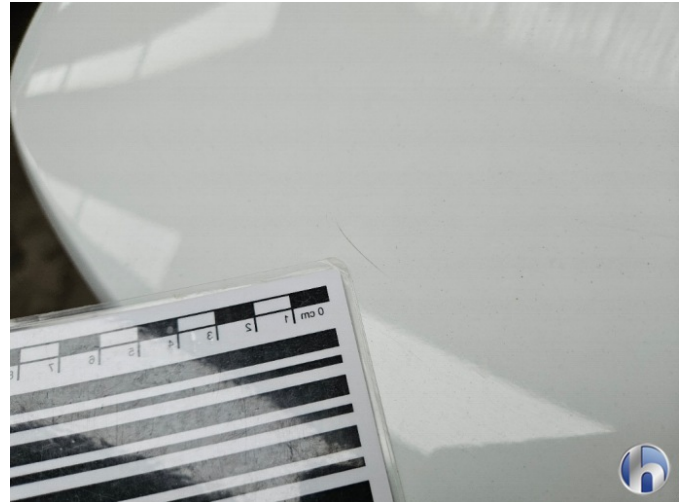
| component | Damage | Rep kind |
|---|---|---|
| 2. tailgate | Wear and tear | acceptable |

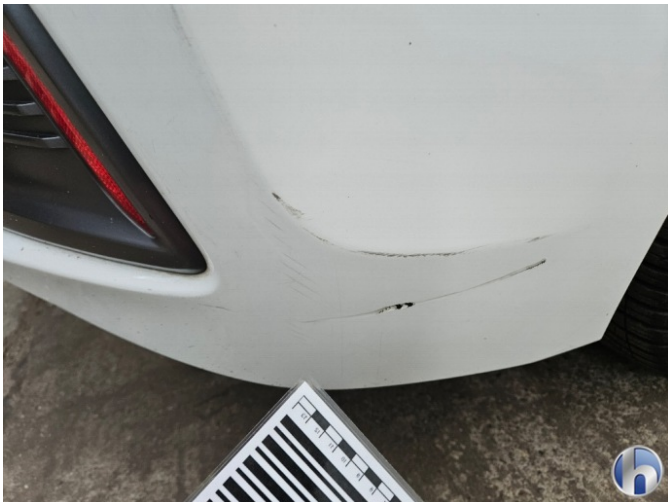
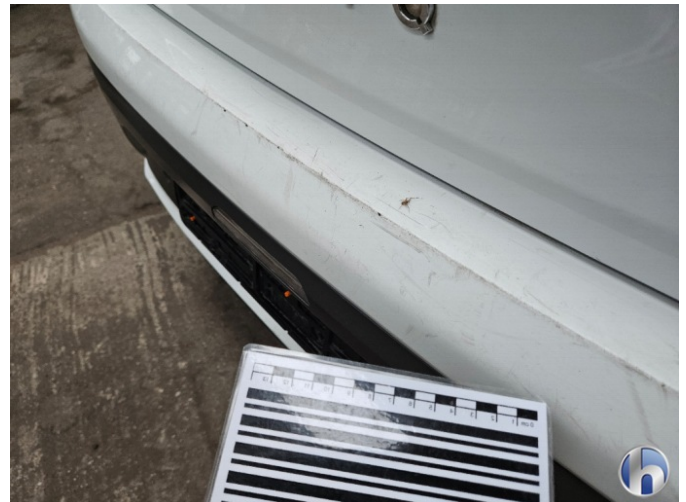
| component | Damage | Rep kind |
|---|---|---|
| 3. Rear bumper | Scratch(es) | Paint |

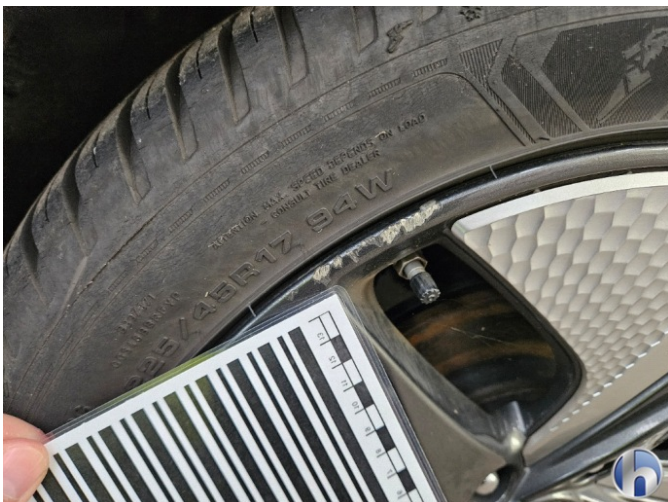
| component | Damage | Rep kind |
|---|---|---|
| 4. | Scratch(es) | Smart repair |

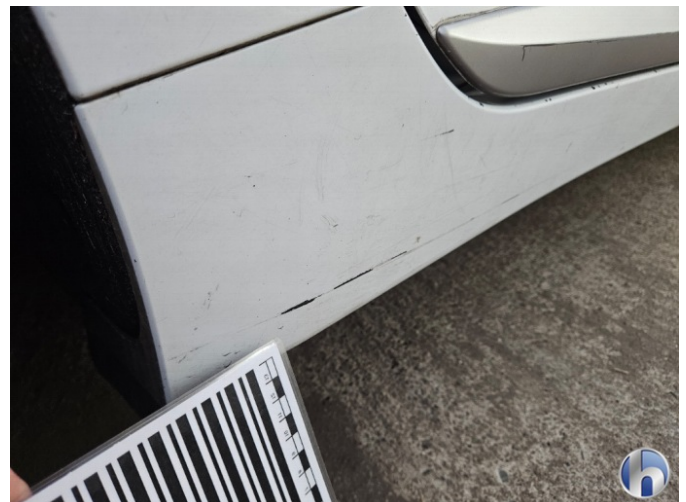
| component | Damage | Rep kind |
|---|---|---|
| 5. side skirt - right | Scratch(es) | Paint |

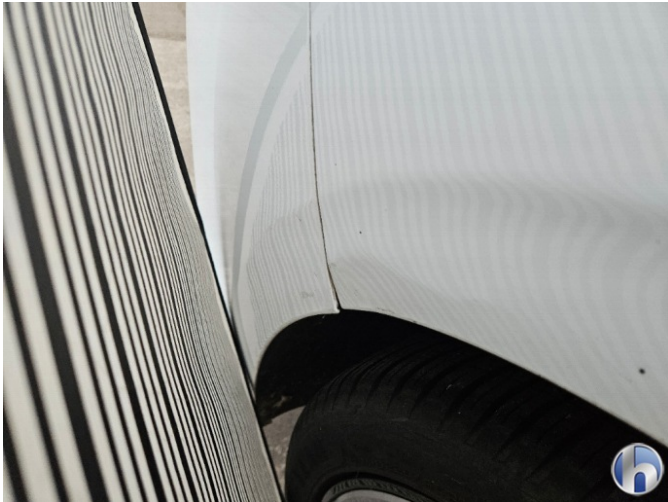
| component | Damage | Rep kind |
|---|---|---|
| 6. Sidewall - Rear - right | Deformed (slightly) | Refurbish and paint |

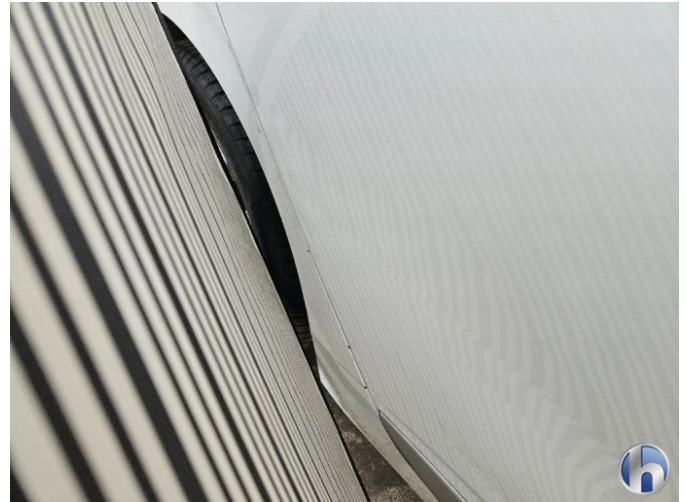
| component | Damage | Rep kind |
|---|---|---|
| 7. Door Rear - right | Deformed | Refurbish and paint |

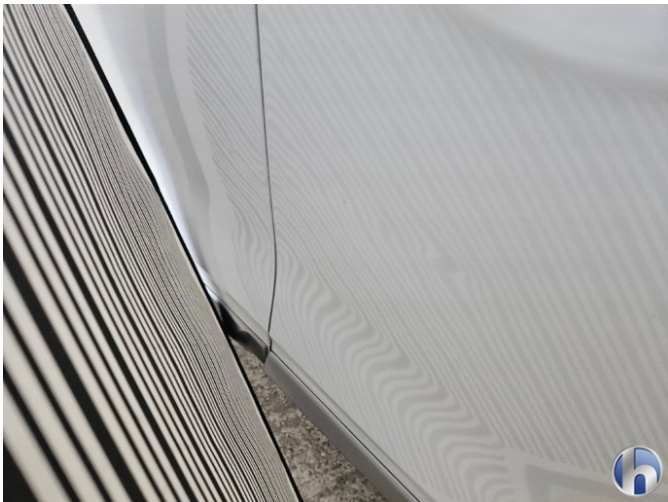
| component | Damage | Rep kind |
|---|---|---|
| 8. Front door - right | Deformed (slightly) | Refurbish and paint |

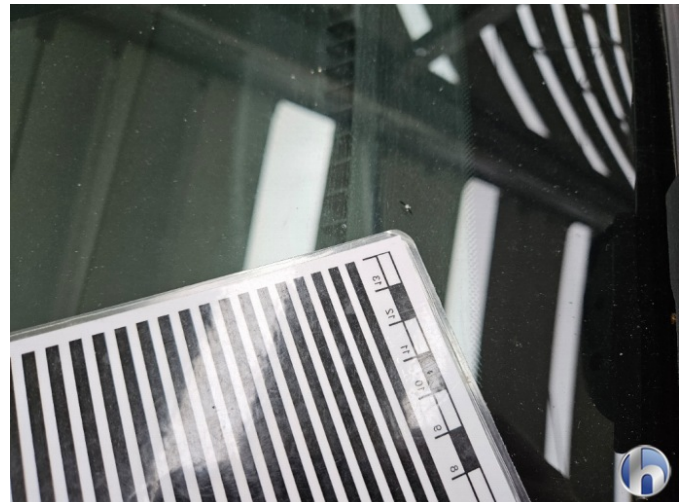
| component | Damage | Rep kind |
|---|---|---|
| 9. Windshield | Wear and tear | acceptable |

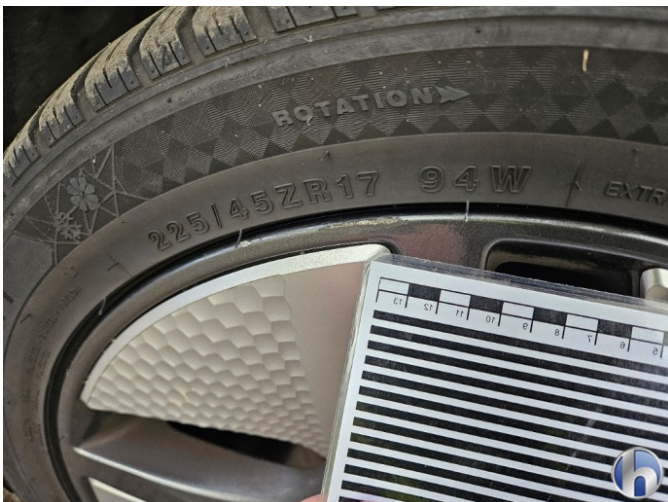
| component | Damage | Rep kind |
|---|---|---|
| 10. | Scratch(es) | Smart repair |

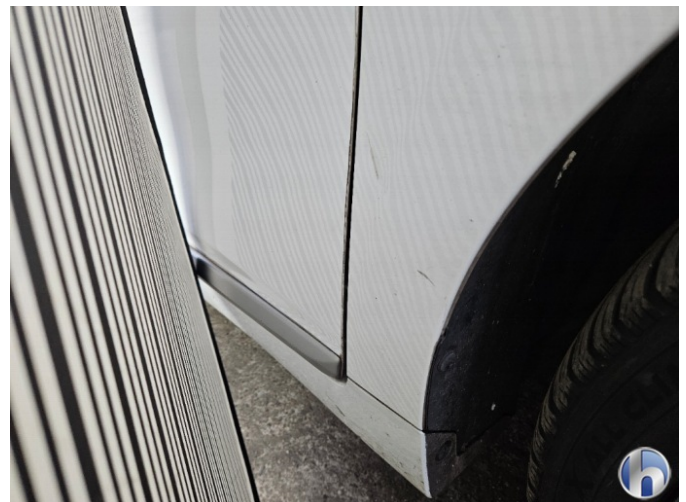
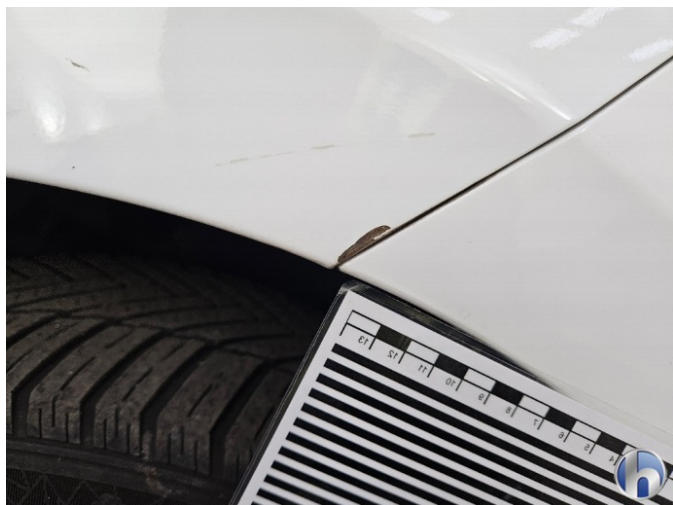
| component | Damage | Rep kind |
|---|---|---|
| 11. Front fender - right | Damaged | Refurbish and paint |

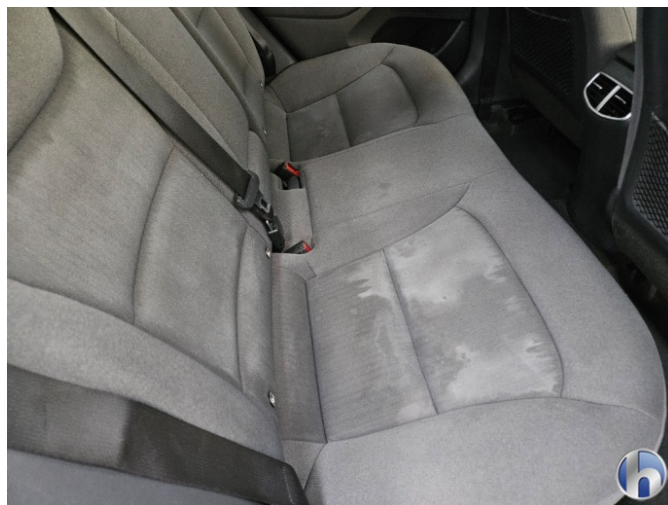
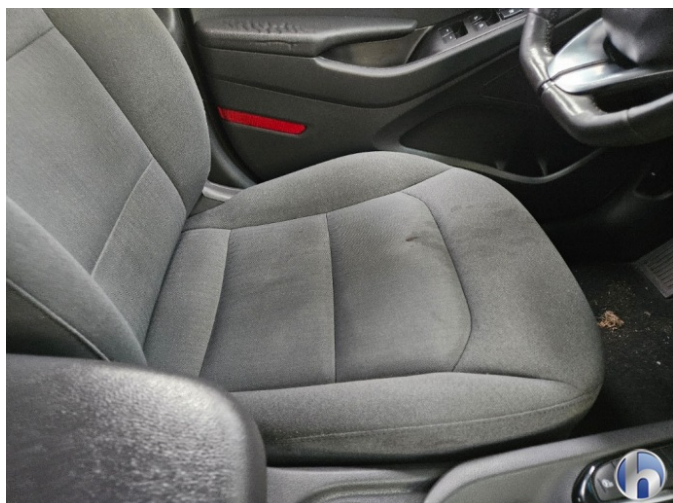
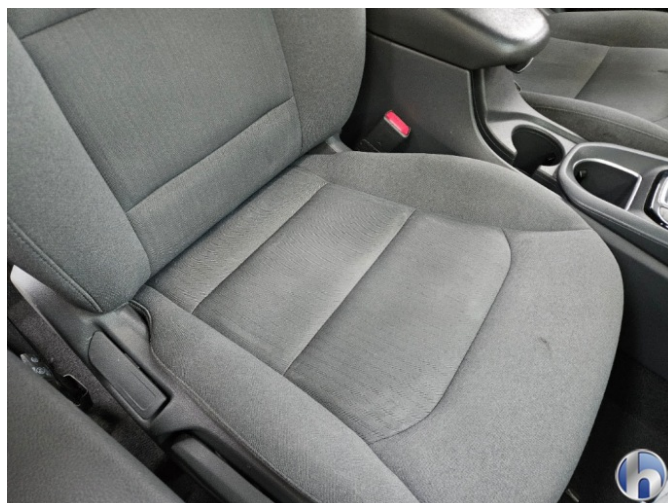
| component | Damage | Rep kind |
|---|---|---|
| 12. | Dirty | |

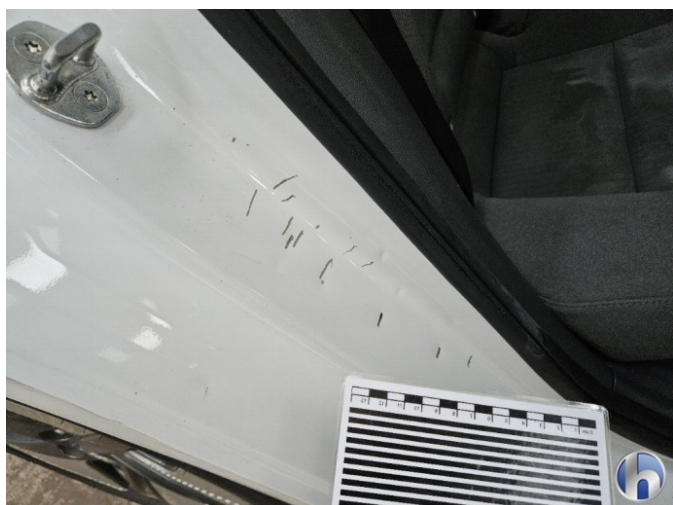
| component | Damage | Rep kind |
|---|---|---|
| 13. Türeinstieg Hinten - Rechts | Damaged | Refurbish and paint |

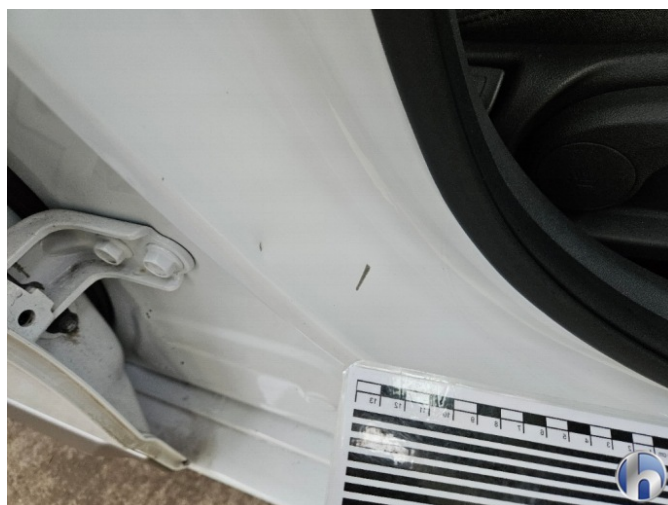
| component | Damage | Rep kind |
|---|---|---|
| 14. Türeinstieg Vorne - Rechts | Wear and tear | acceptable |

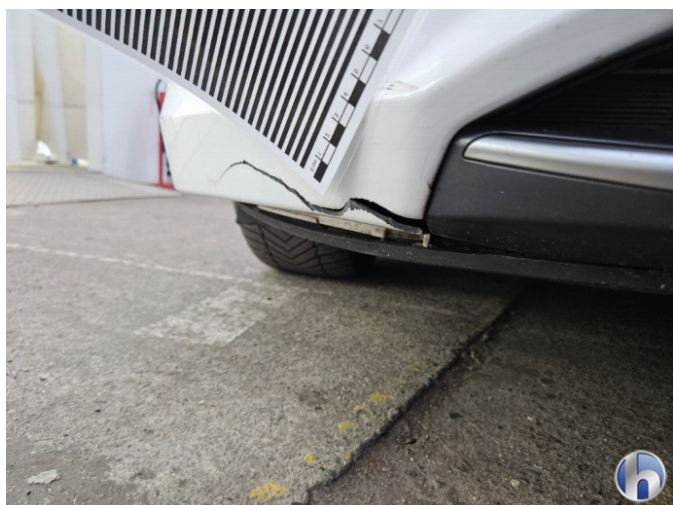
| component | Damage | Rep kind |
|---|---|---|
| 15. Front bumper | Breakage | Replace |

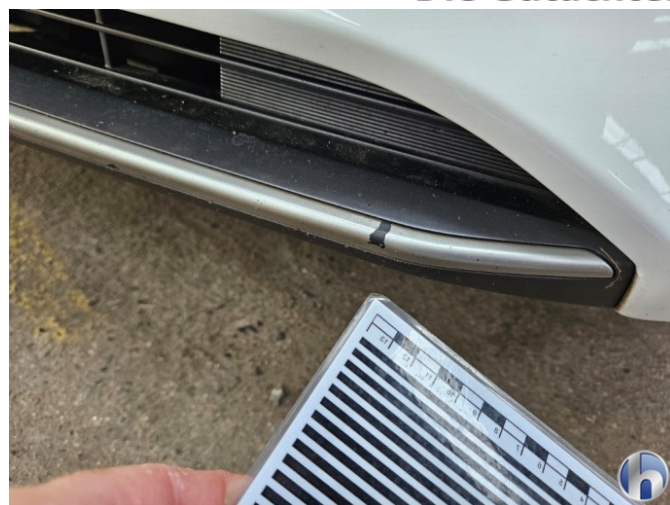
| component | Damage | Rep kind |
|---|---|---|
| 16. spoiler | Wear and tear | acceptable |

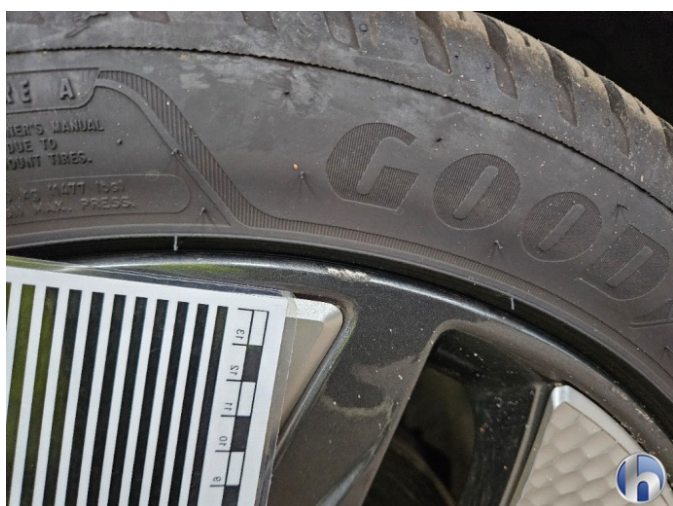
| component | Damage | Rep kind |
|---|---|---|
| 17. | Wear and tear | acceptable |

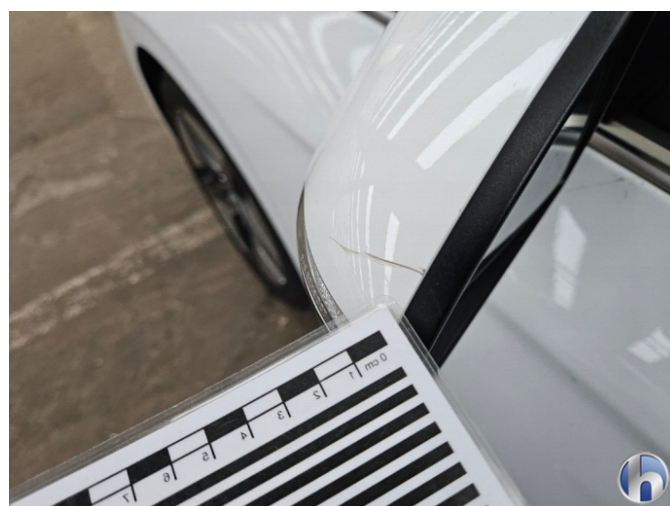
| component | Damage | Rep kind |
|---|---|---|
| 18. | Wear and tear | acceptable |

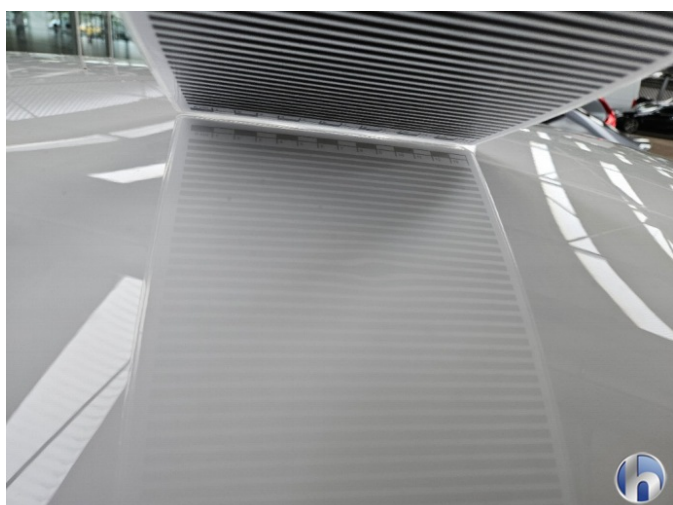
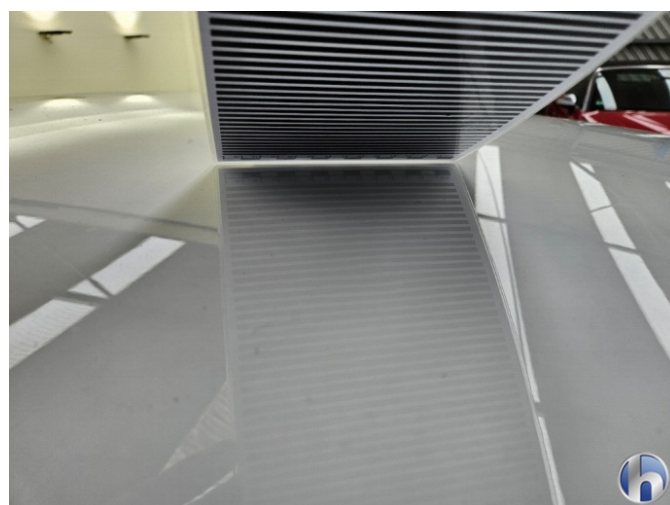
| component | Damage | Rep kind |
|---|---|---|
| 19. roof | Wear and tear | acceptable |

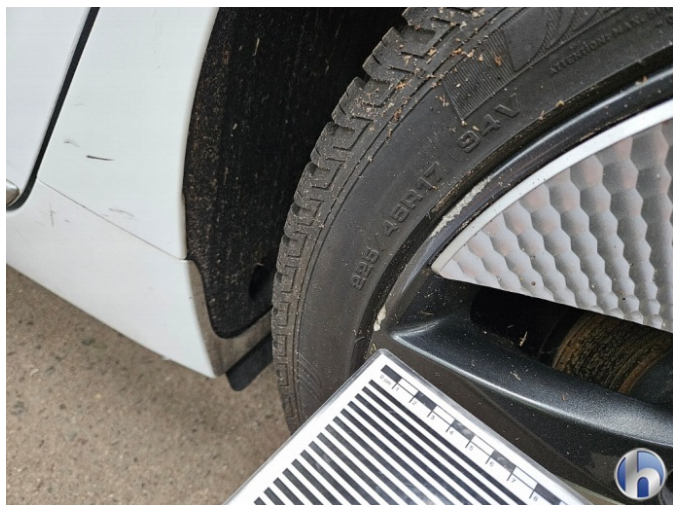
| component | Damage | Rep kind |
|---|---|---|
| 20. | Scratch(es) | Paint |

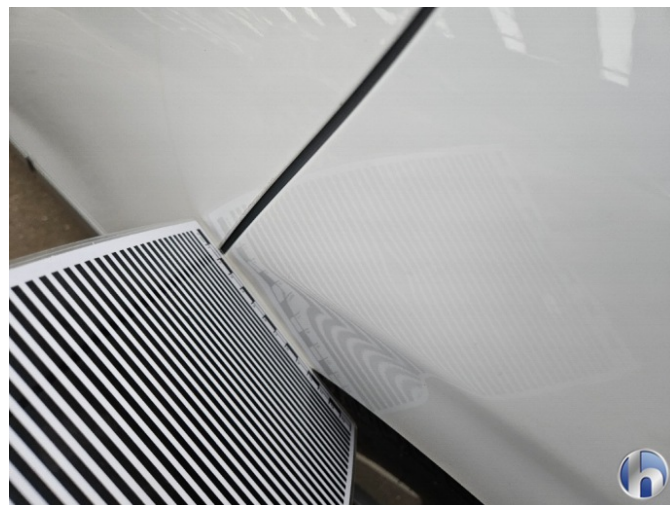
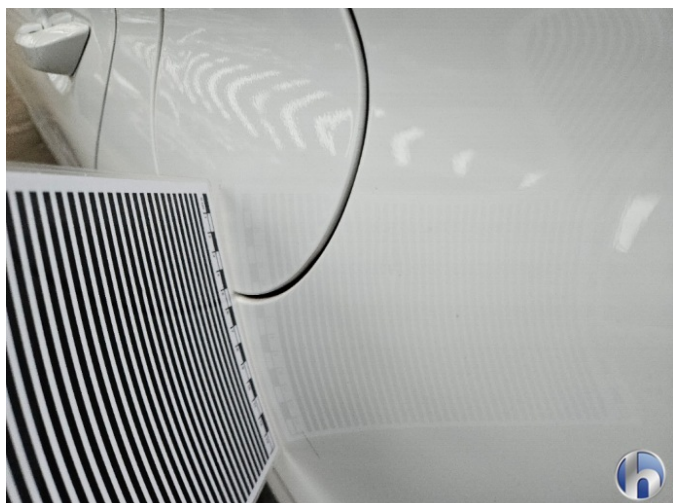
| component | Damage | Rep kind |
|---|---|---|
| 21. Sidewall - Rear - Left | Wear and tear | acceptable |

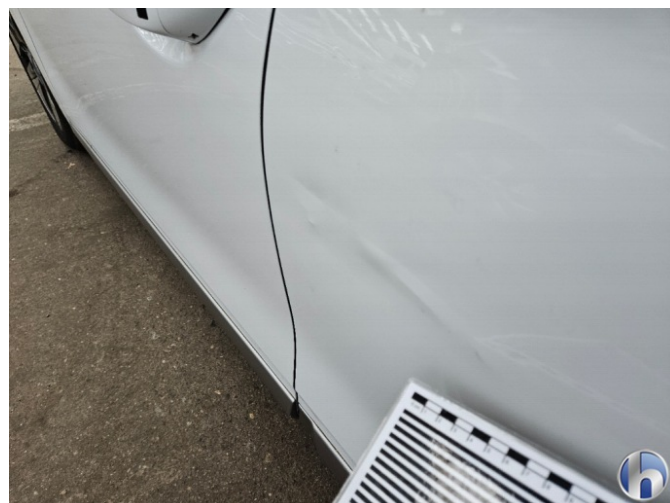
| component | Damage | Rep kind |
|---|---|---|
| 22. Rear door - left | Deformed | Refurbish and paint |

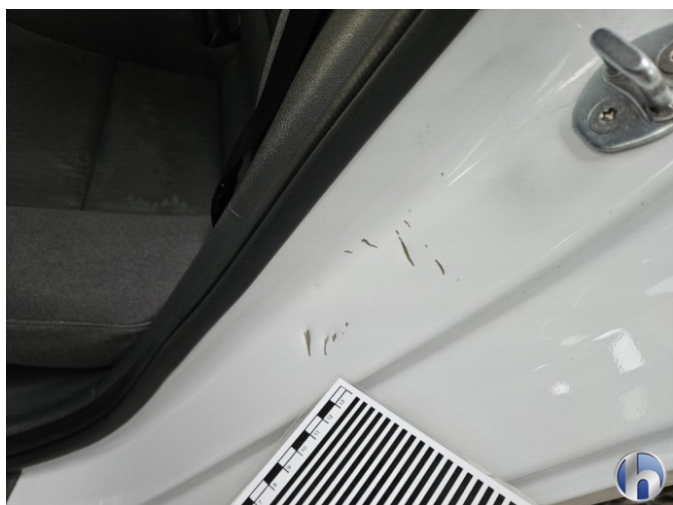
| component | Damage | Rep kind |
|---|---|---|
| 23. Türeinstieg Hinten - Links | Damaged | Refurbish and paint |

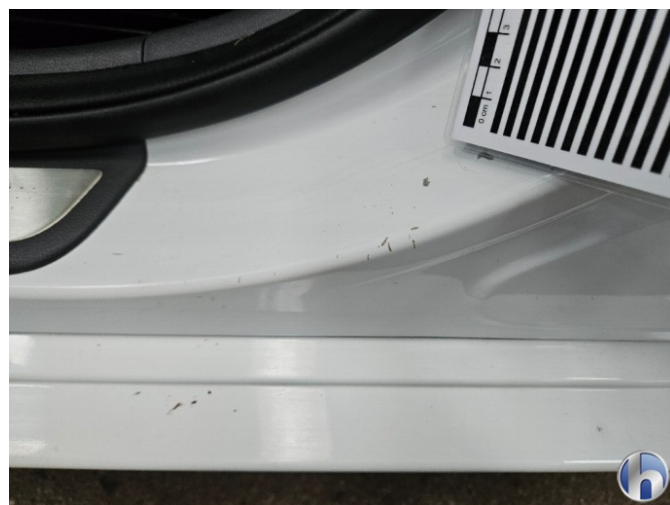
| component | Damage | Rep kind |
|---|---|---|
| 24. Türeinstieg Vorne - Links | Wear and tear | acceptable |

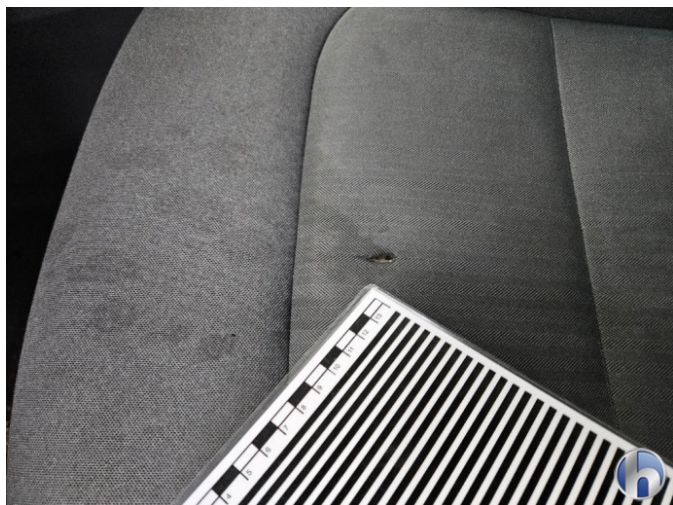
| component | Damage | Rep kind |
|---|---|---|
| 25. | Burn hole | Smart repair |

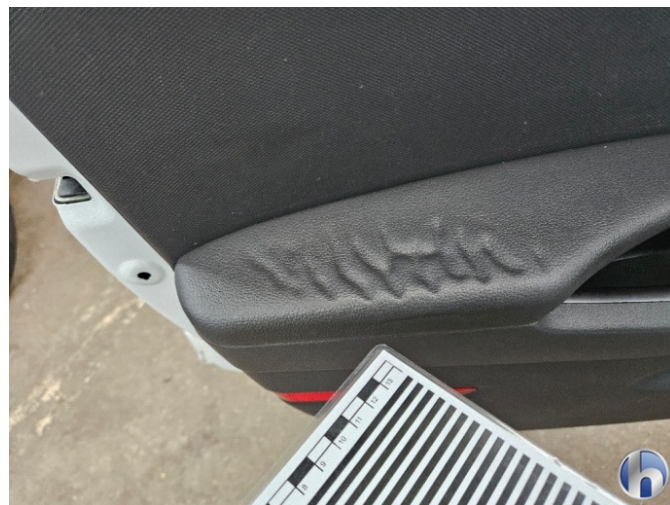
| component | Damage | Rep kind |
|---|---|---|
| 26. Front door trim - left | Wear and tear | acceptable |

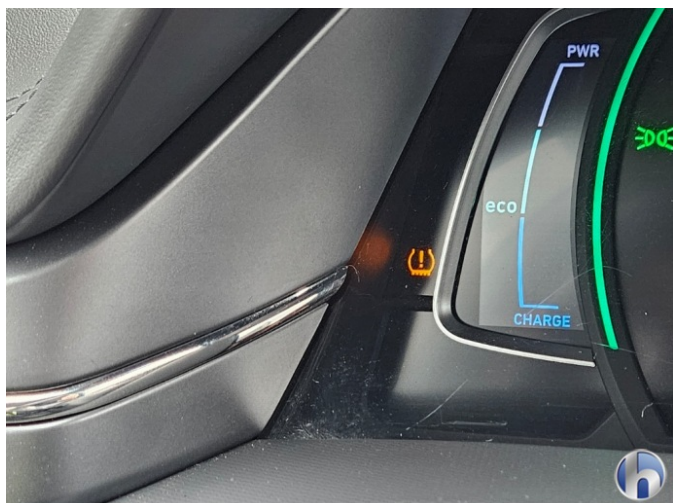
| component | Damage | Rep kind |
|---|---|---|
| 27. Reifendrucküberwachung | Error message | Carry out a fault diagnosis |
