HYUNDAI i30

i30 1.4

VIN NO KMHDB51CP8U103998
Registration Number CP8U103998

Inspection Report Summary

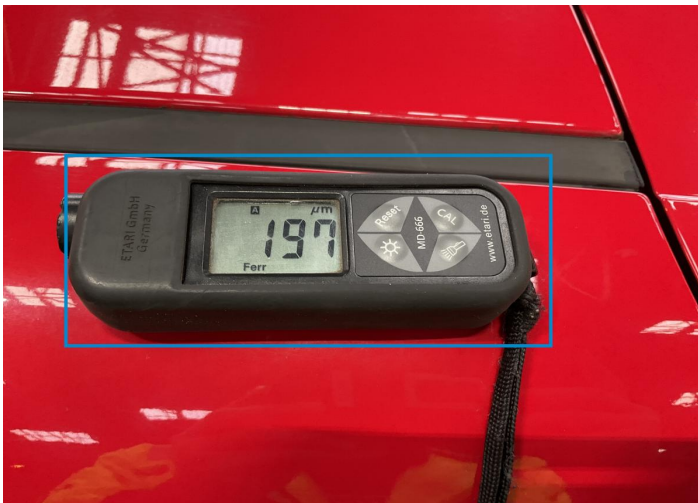
1. Side Panel / Back Left
Paint / Poor Previous Repair -

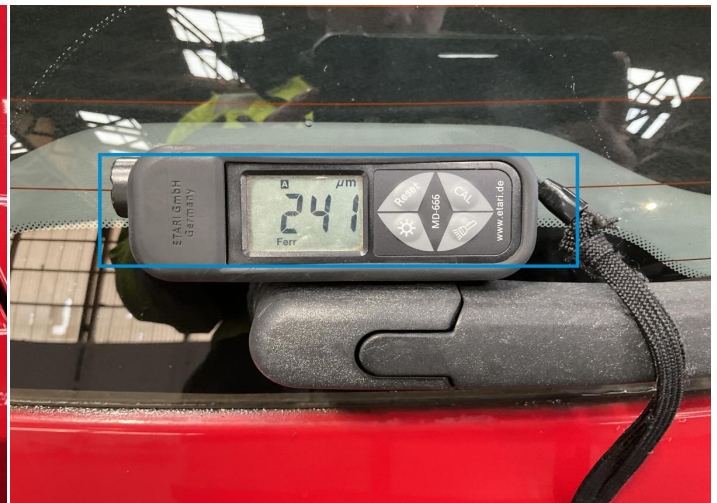
2. Tailgate
Paint / Poor Previous Repair -

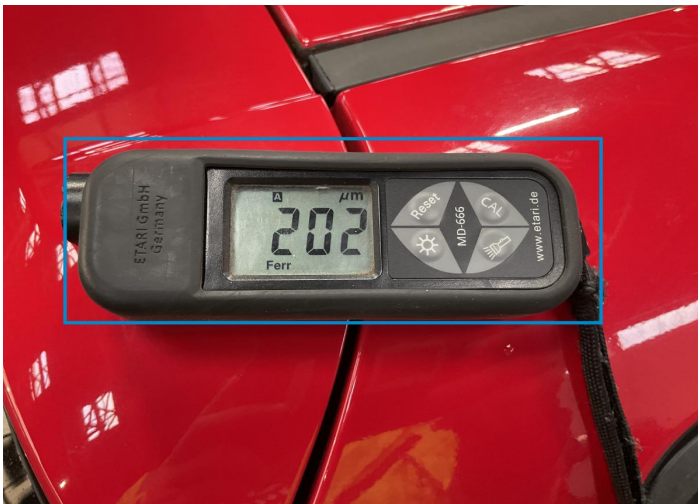
3. Side Panel / Back Right
Paint / Poor Previous Repair -

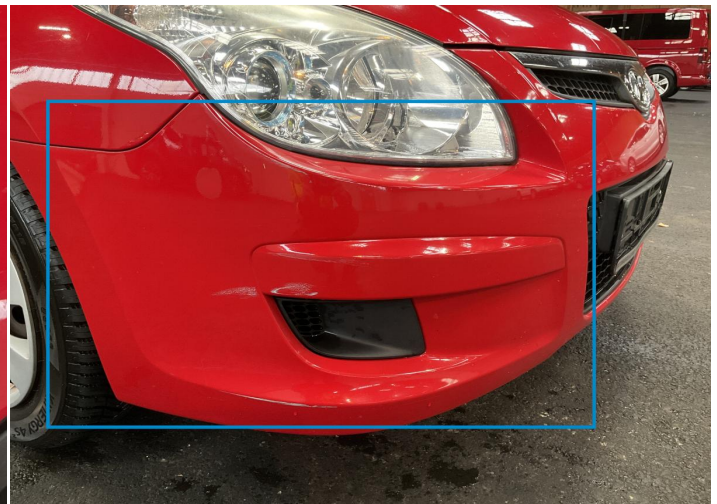
4. Bumper / Front
Paint / Scratch / Scuff -

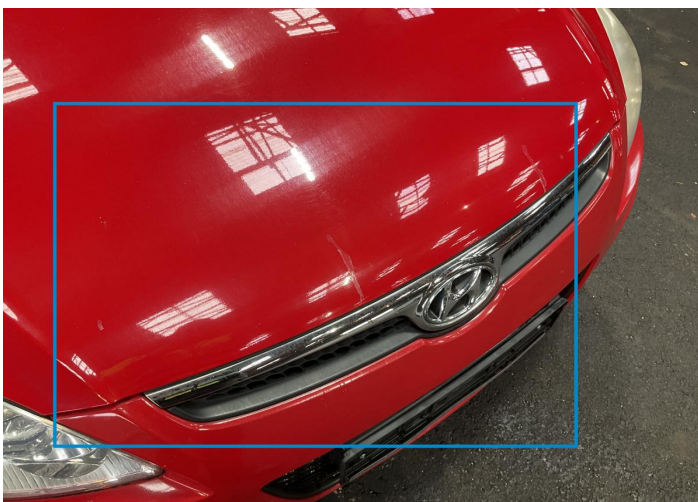
5. Hood
Paint / Poor Previous Repair -

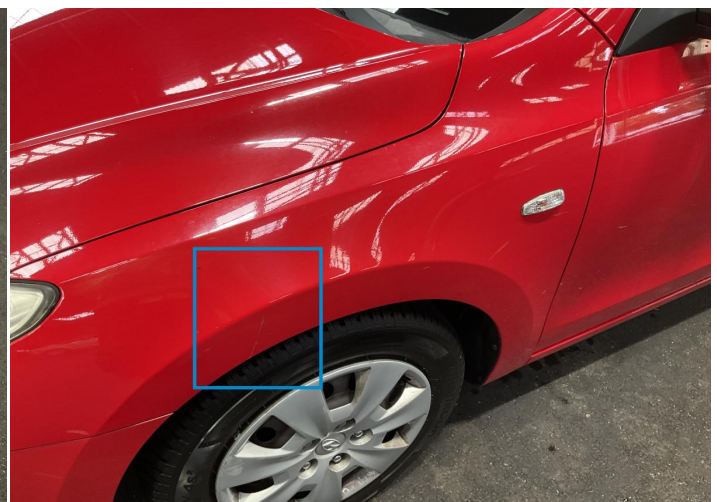
6. Fender / Front Left
Paint / Scratch / Scuff -

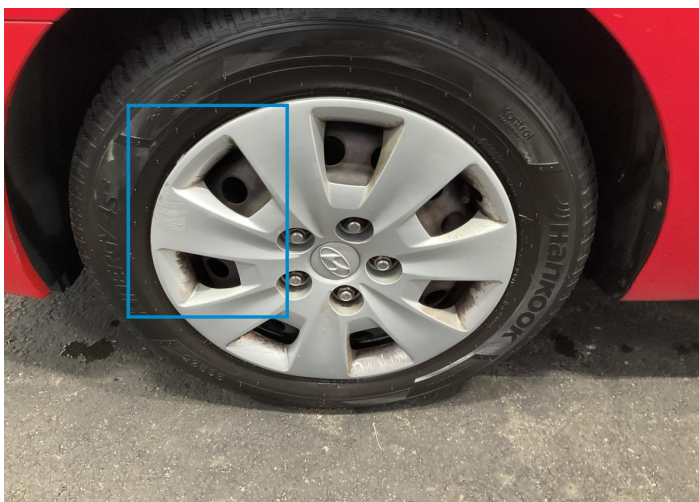
7. Hubcap / Front Left
Out of Bodywork / Scratch -

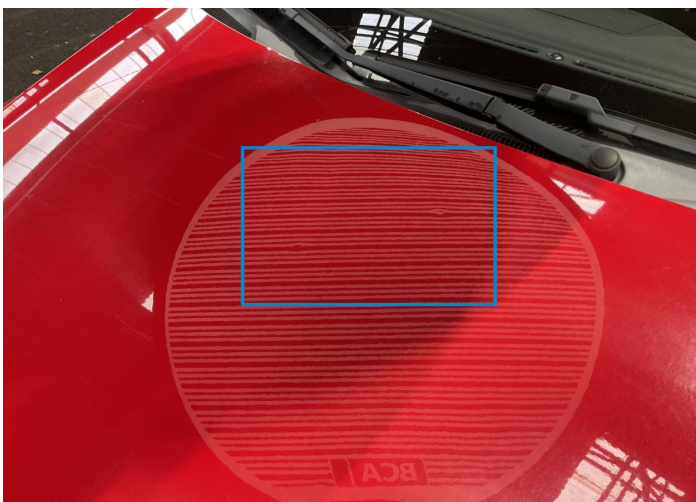
8. Hood
Bodywork / Dent / Dent -

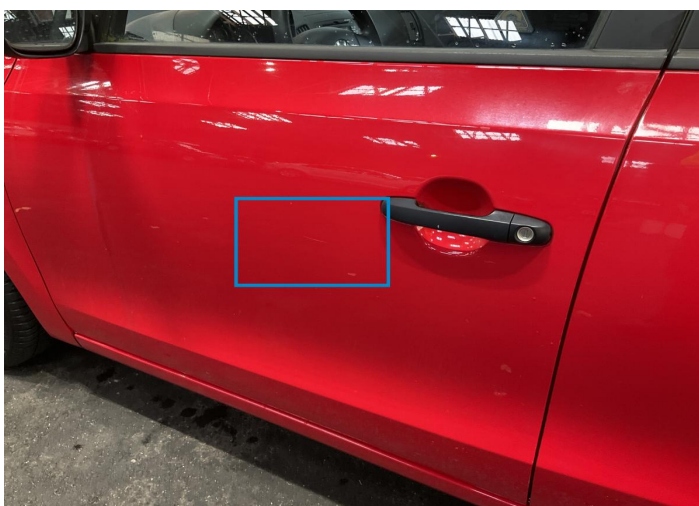
9. Door / Front Left
Paint / Scratch / Scuff -

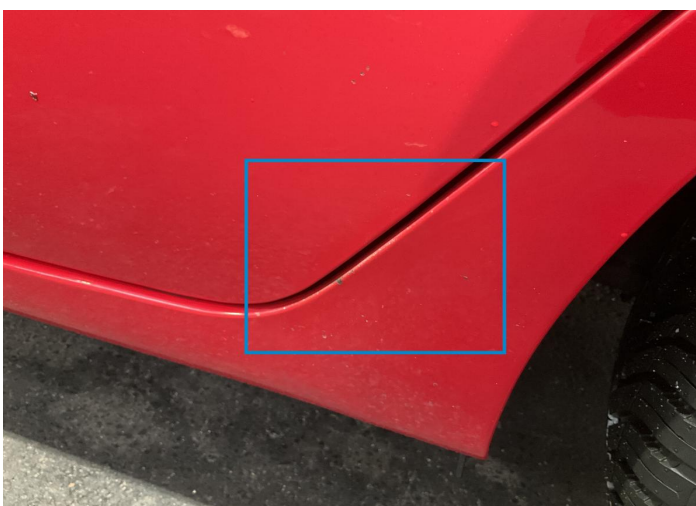
10. Side Panel / Back Left
Paint / Scratch / Scuff -

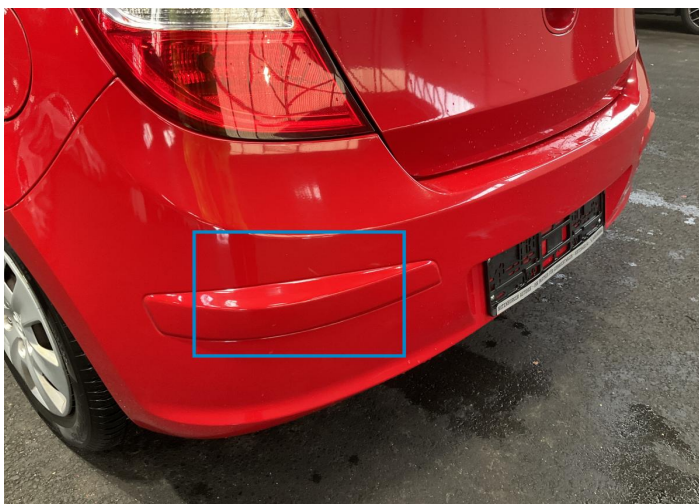
11. Bumper / Back
Paint / Scratch / Scuff -

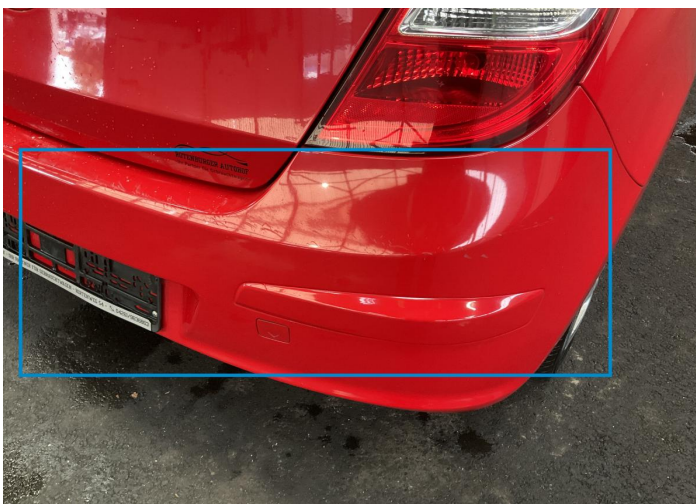
12. Bumper / Back
Paint / Scratch / Scuff -

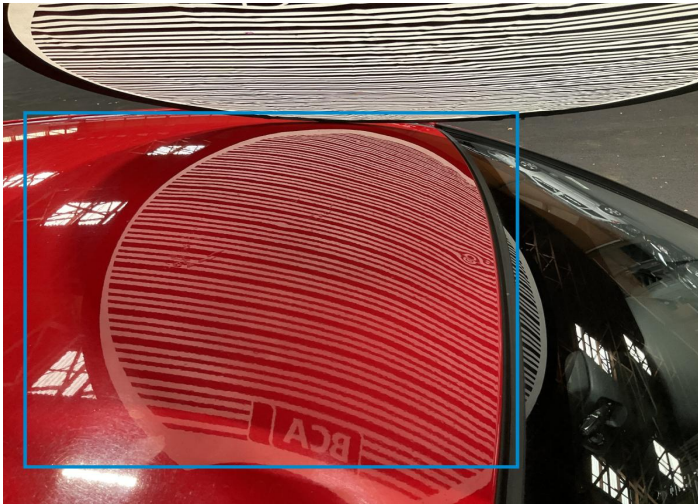
13	Roof	Bodywork / Dent / Hail Area
----	------	-----------------------------

13. Roof
Bodywork / Dent / Hail Area -

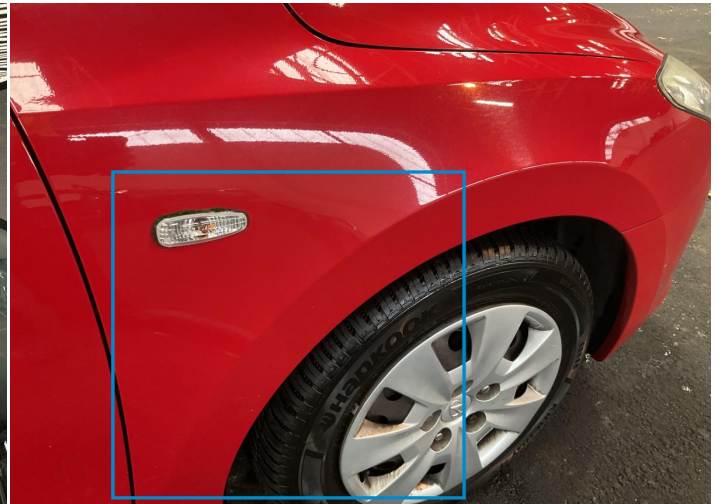
14	Fender / Front Right	Paint / Scratch / Scuff
----	----------------------	-------------------------

14. Fender / Front Right
Paint / Scratch / Scuff -
