### HYUNDAI KONA KONA 1.6 GDI DCT Hybrid

VIN NO KMHK581EGMU058450 Registration Number EGMU058450

### **Inspection Report Summary**

Customer	BCA Online	Report Number	P20251006134134
Inspection Date / Place	2025-10-06 / BCA Neuss	Cosmetic Grade	4

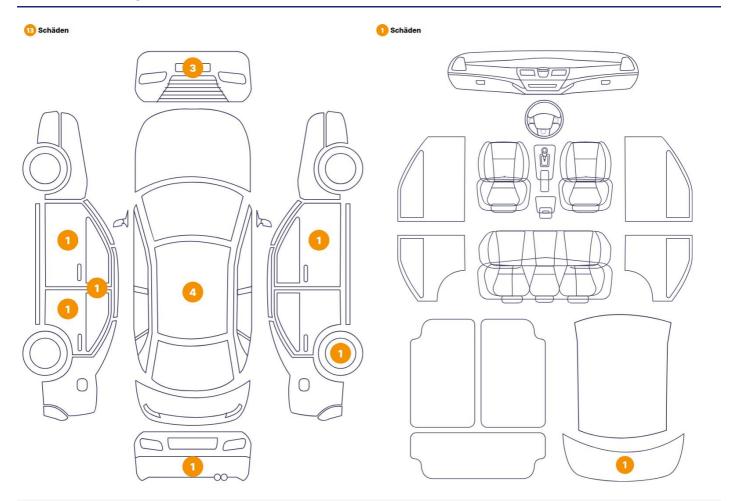
Component	Damage	Comments
1	B Pillar / Center Left	Bodywork / Dent / Dent	
2	Pillar / Back Left	Paint / Scratch / Scuff	
3	Tailgate Upholstery / Back	Interior / Broken	
4	Door / Front Left	Paint / Poor Previous Repair	
5	Corner Bumper / Front Right	Paint / Scratch / Scuff	
6	Bumper / Front	Paint / Scratch / Scuff	
7	Corner Bumper / Front Left	Paint / Scratch / Scuff	
8	Roof	Bodywork / Dent / Dent	
9	Roof	Bodywork / Dent / Dent	
10	Roof	Bodywork / Dent / Dent	
11	Roof	Bodywork / Dent / Dent	
12	Bumper / Back	Paint / Scratch / Scuff

14 Mirror Shell / Front Right Bodywork / Breakage

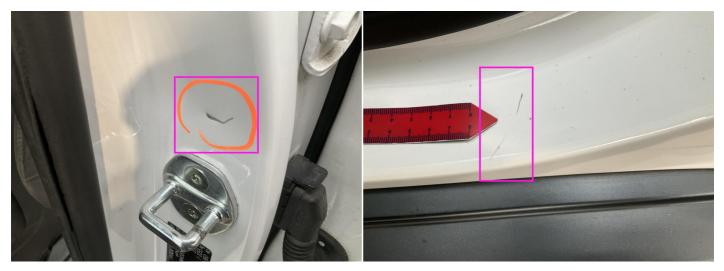
1. B Pillar / Center Left Bodywork / Dent / Dent -

2. Pillar / Back Left Paint / Scratch / Scuff -

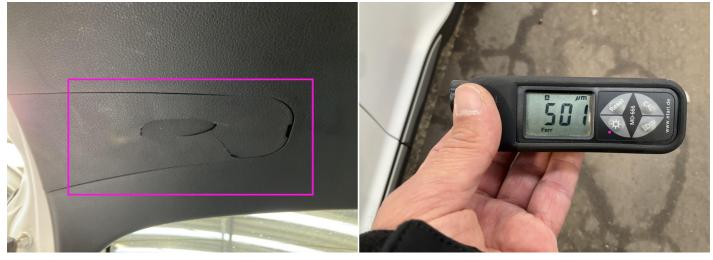
3. Tailgate Upholstery / Back Interior / Broken -

4. Door / Front Left
Paint / Poor Previous Repair -

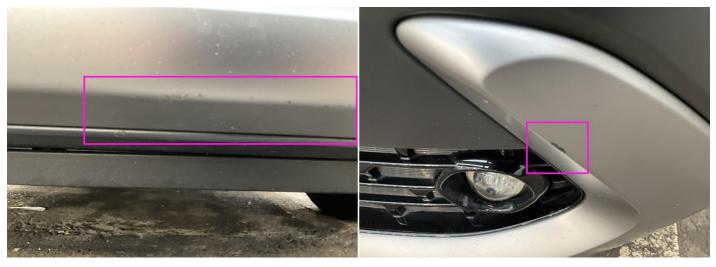
6. Bumper / Front Paint / Scratch / Scuff -

7. Corner Bumper / Front Left Paint / Scratch / Scuff -

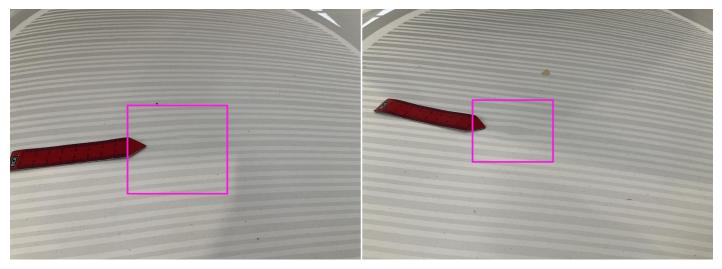
8. Roof Bodywork / Dent / Dent -

9. Roof Bodywork / Dent / Dent -

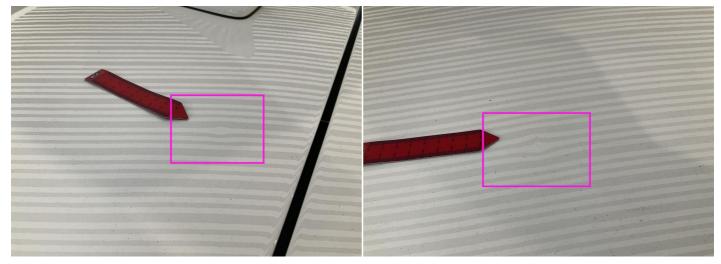
10. Roof Bodywork / Dent / Dent -

11. Roof Bodywork / Dent / Dent -

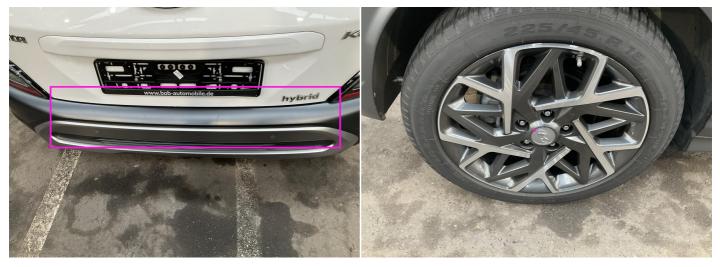
12. Bumper / Back Paint / Scratch / Scuff -

13. Rim / Back Right Out of Bodywork / Scratch -

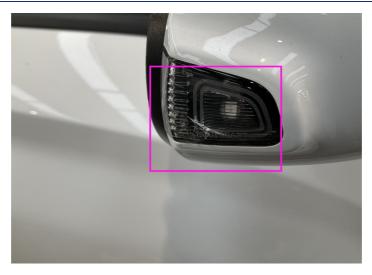
14. Mirror Shell / Front Right Bodywork / Breakage -
