Hüsge Gruppe®  
Die Gutachter

## status report

| vehicle data | | | |
|---|---|---|---|
| <b>Hyundai Santa Fe</b> | | | |
| Vehicle identification number | <b>KMHS381CBLU286843</b> | mileage read: | <b>15242 km</b> |

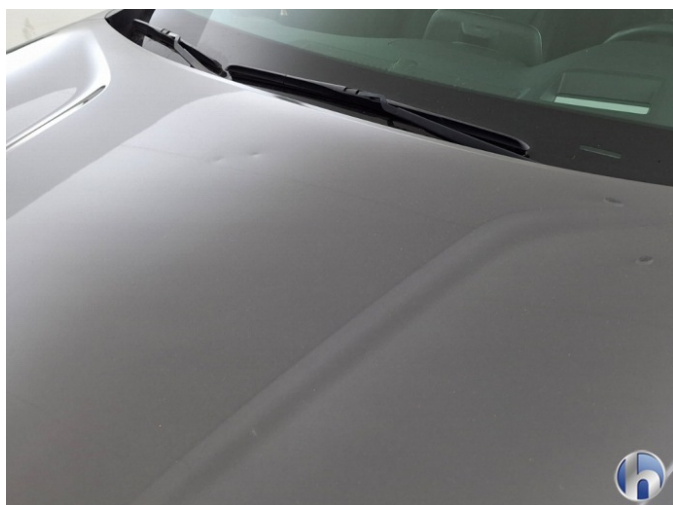
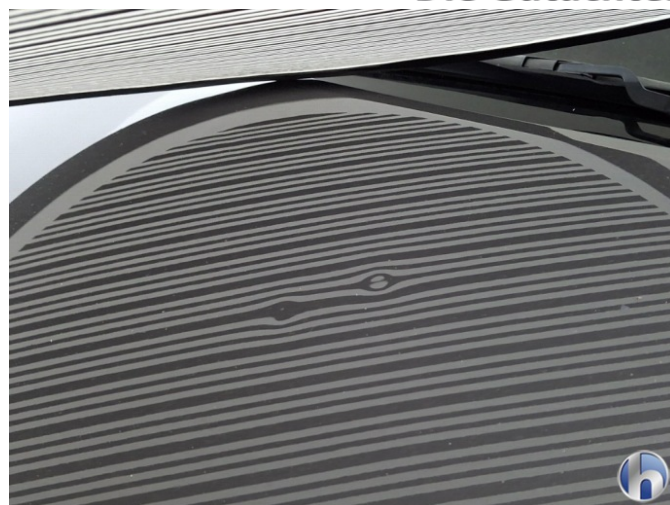
| component | Damage | Rep kind |
|---|---|---|
| 1. hood | | Smart repair |

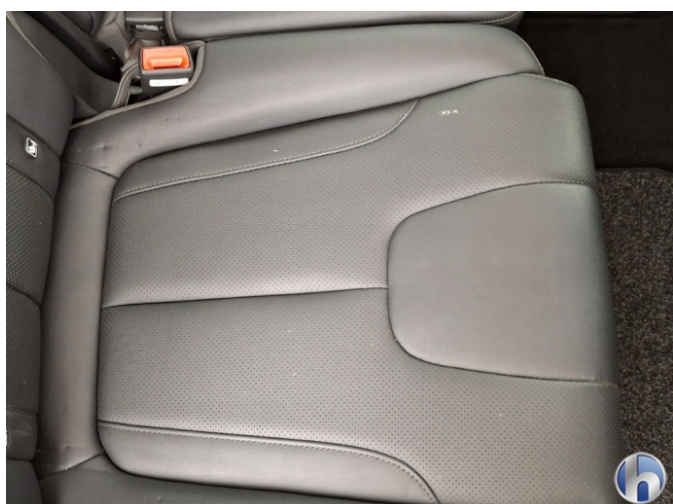
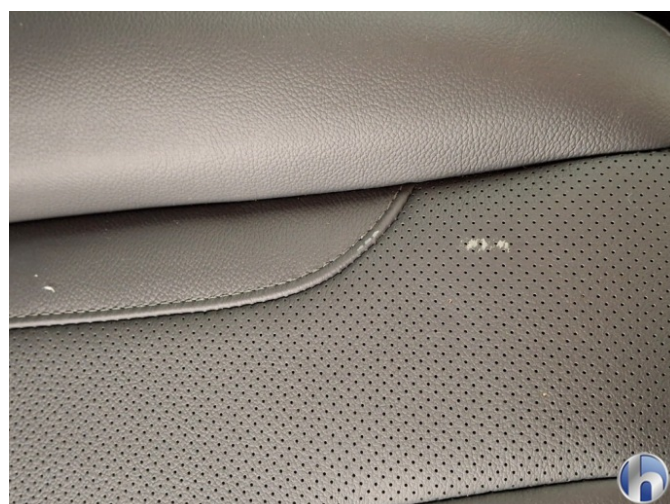
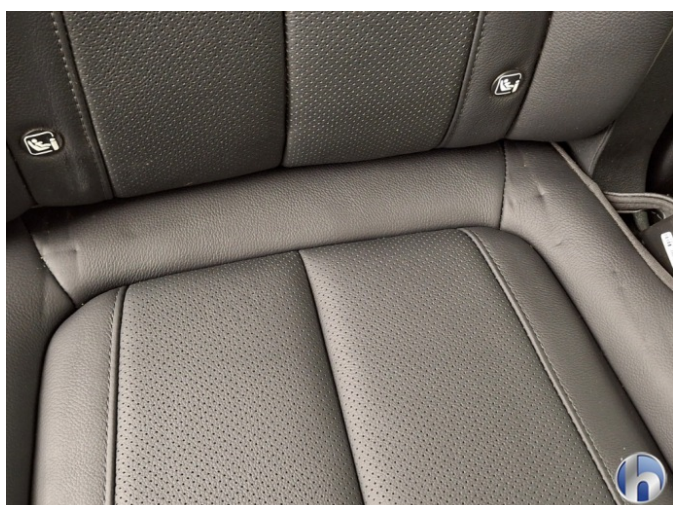
| component | Damage | Rep kind |
|---|---|---|
| 2. Sitz hinten rechts | Scrape | Smart repair |

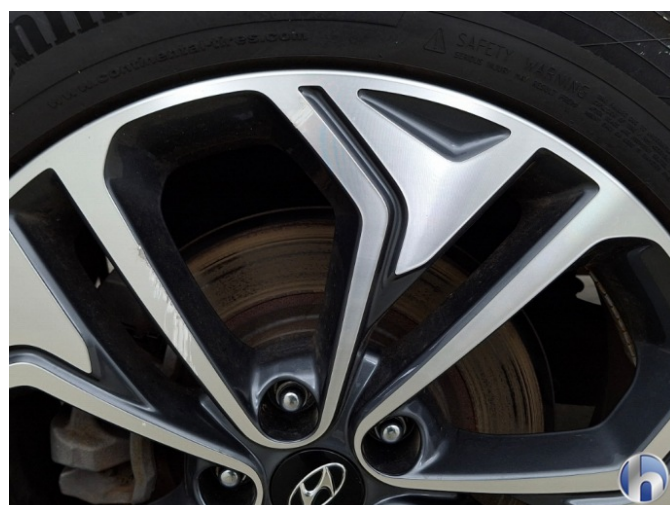
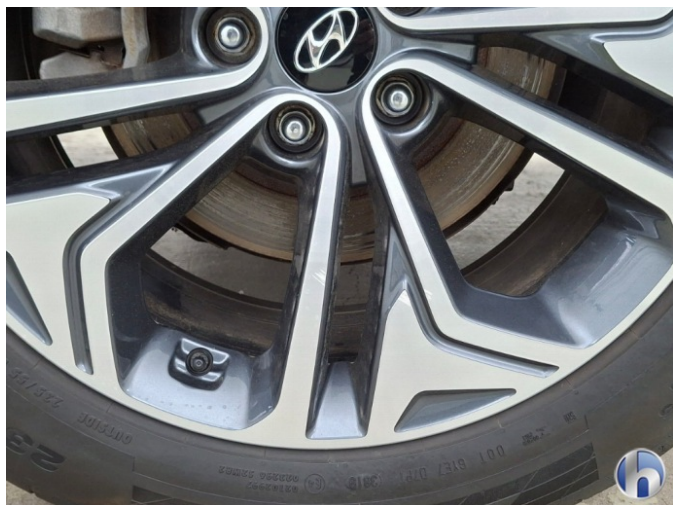
| component | Damage | Rep kind |
|---|---|---|
| 3. Felge hinten rechts | Scratch(es) | Refurbish and paint |

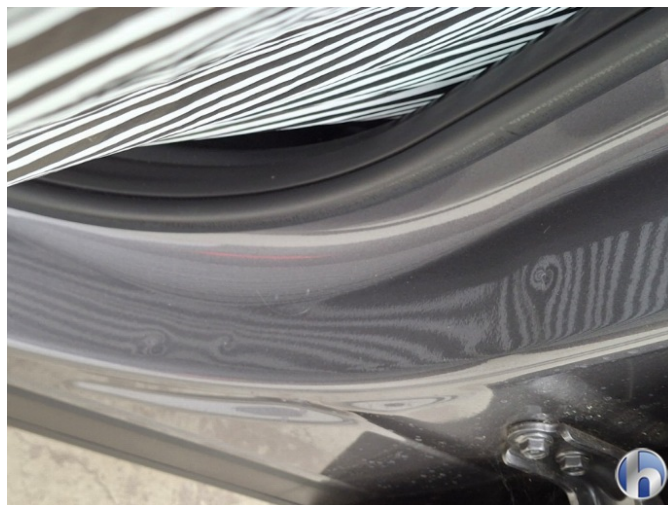
| component | Damage | Rep kind |
|---|---|---|
| 4. Einstieg Fahrerseite vorne | | Refurbish and paint |

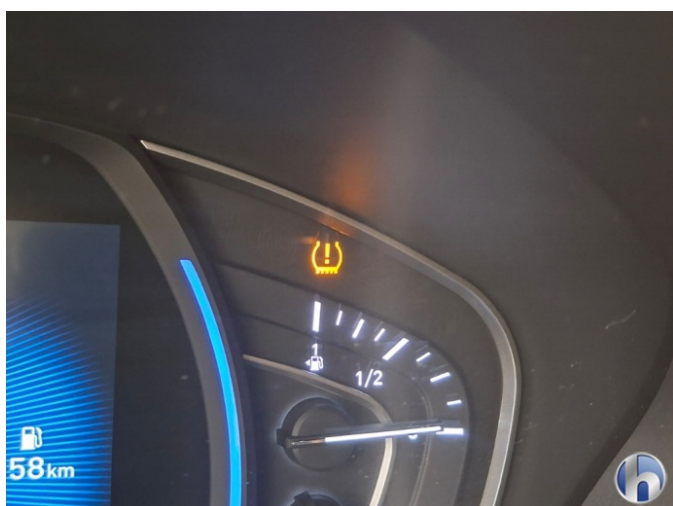
| component | Damage | Rep kind |
|---|---|---|
| 5. RDK aktiv | Error message | Carry out a fault diagnosis |
