# KIA Picanto

## Picanto 1.1

VIN NO KNABA24329T672489

### Inspection Report Summary

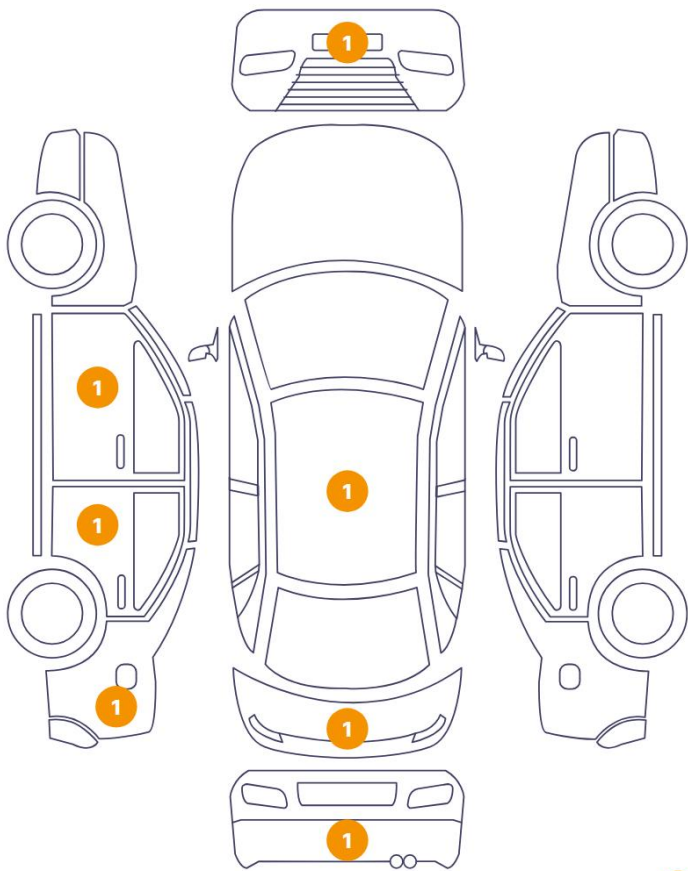
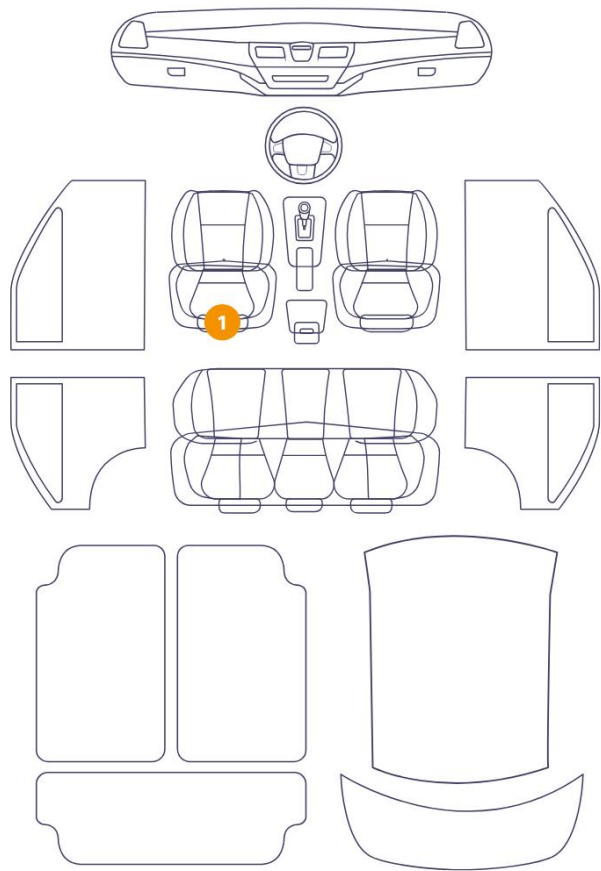
Component		Damage	Comments
1	Roof	Paint / Scratch / Scuff	
2	Bumper / Front	Paint / Scratch / Scuff	
3	Other	Paint / Scratch / Scuff	
4	Mirror / Front Left	Paint / Scratch / Scuff	
5	Fender / Back Left	Bodywork / Dent / Dent	
6	Bumper / Back	Bodywork / Breakage / Crack	
7	Tailgate	Paint / Scratch / Scuff	
8	Door / Back Left	Paint / Scratch / Scuff	
9	Seat / Front Left	Interior / Ripped

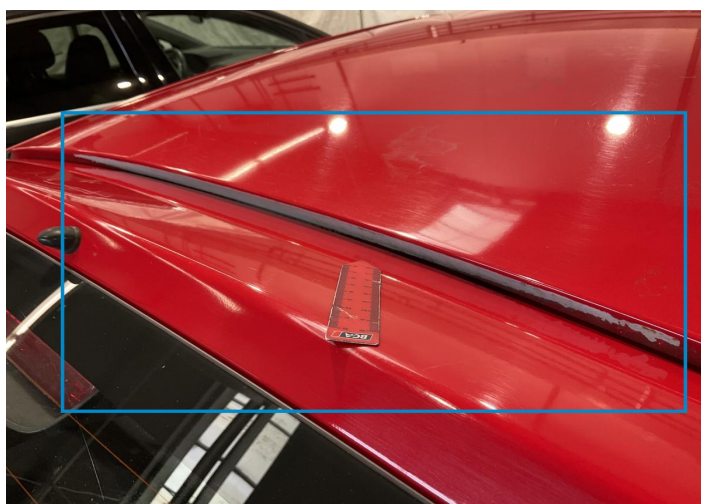
1. Roof  
Paint / Scratch / Scuff -

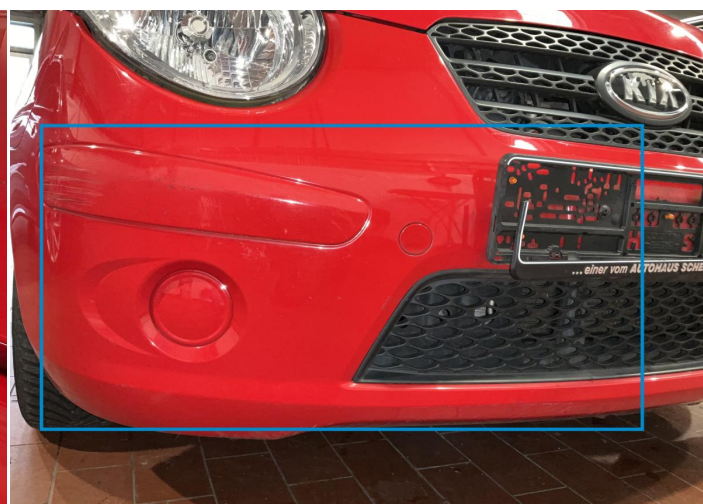
2. Bumper / Front  
Paint / Scratch / Scuff -

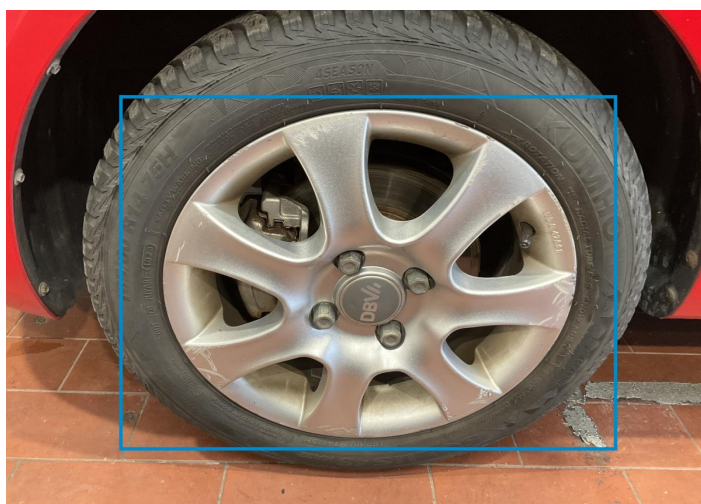
3.  
Paint / Scratch / Scuff -

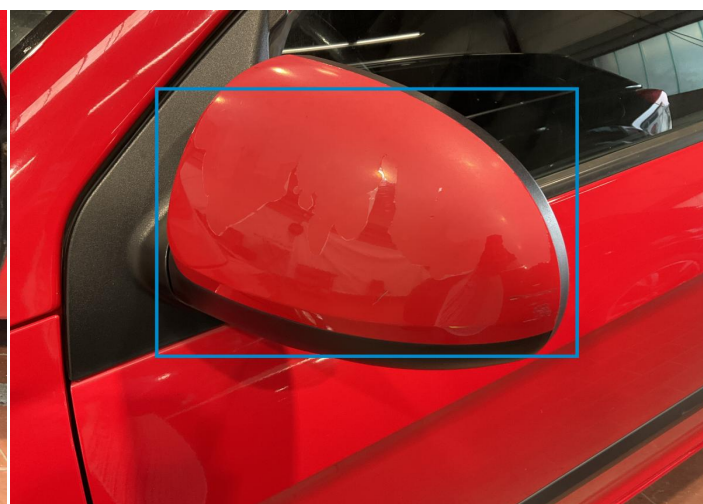
4. Mirror / Front Left  
Paint / Scratch / Scuff -

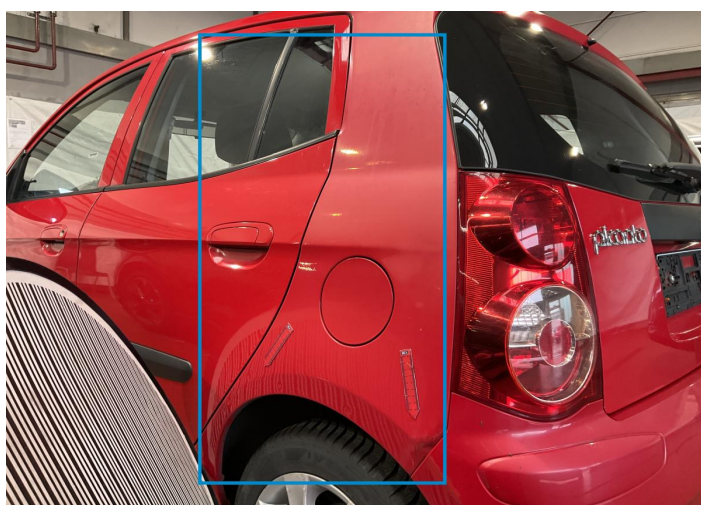
5. Fender / Back Left  
Bodywork / Dent / Dent -

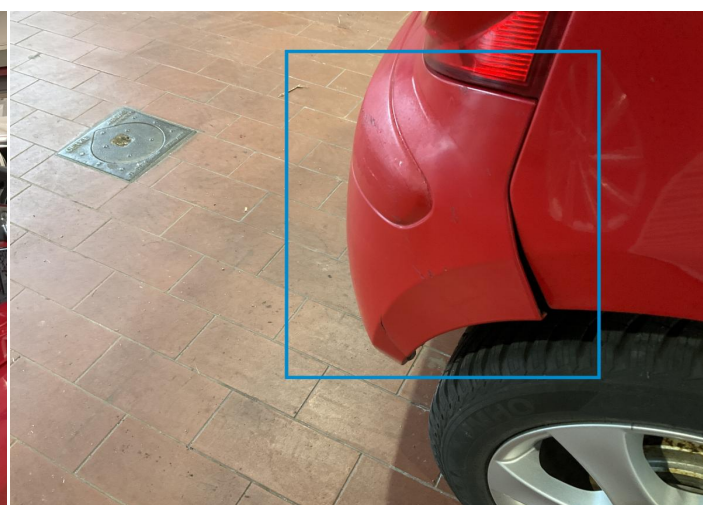
6. Bumper / Back  
Bodywork / Breakage / Crack -

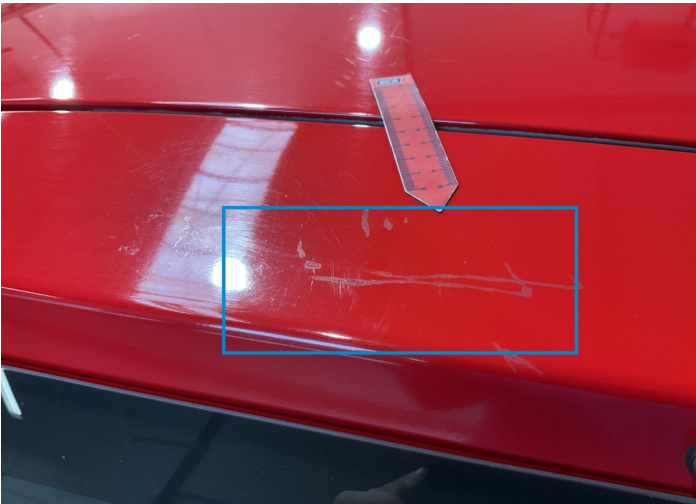
7. Tailgate  
Paint / Scratch / Scuff -

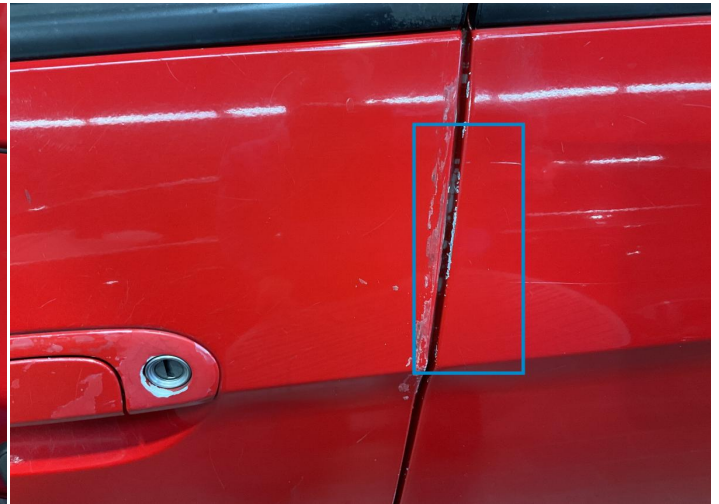
8. Door / Back Left  
Paint / Scratch / Scuff -

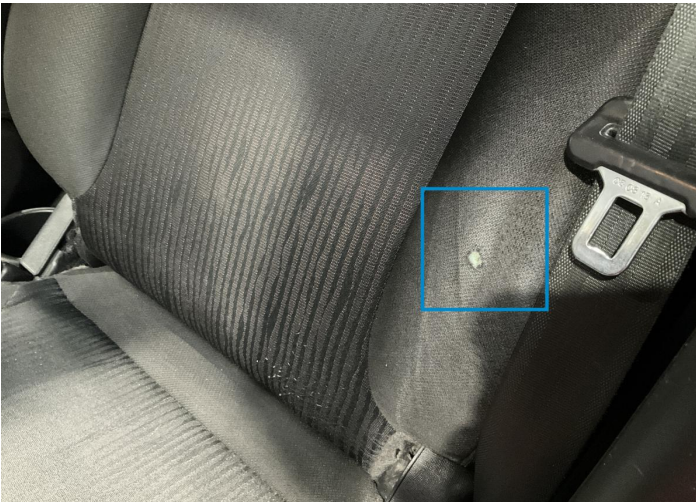
9. Seat / Front Left  
Interior / Ripped -
