## status report

**customer:** Bank 11, Neuss  
**contract number:** 1065801730  
**reference:**

#### Kia Rio Dream Team

| Vehicle identification number | <b>KNADC512AJ6130205</b> | mileage read: | <b>62153 km</b> |

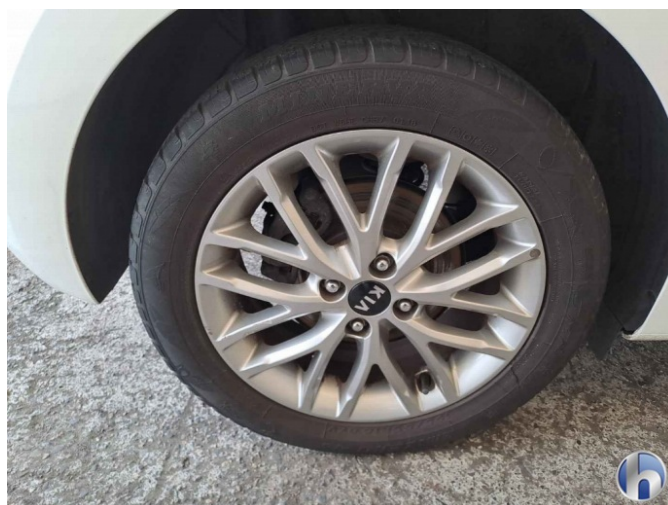
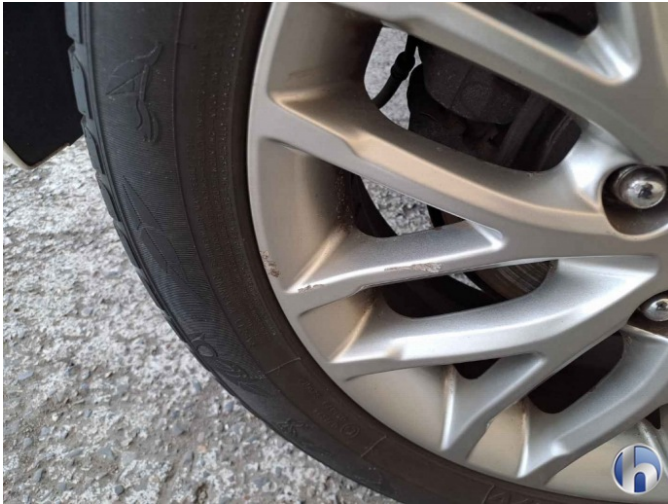
| component | Damage | Rep kind |
|---|---|---|
| 1. Rim rear - right | Scratch(es) | Smart repair |

1. Rim rear - right

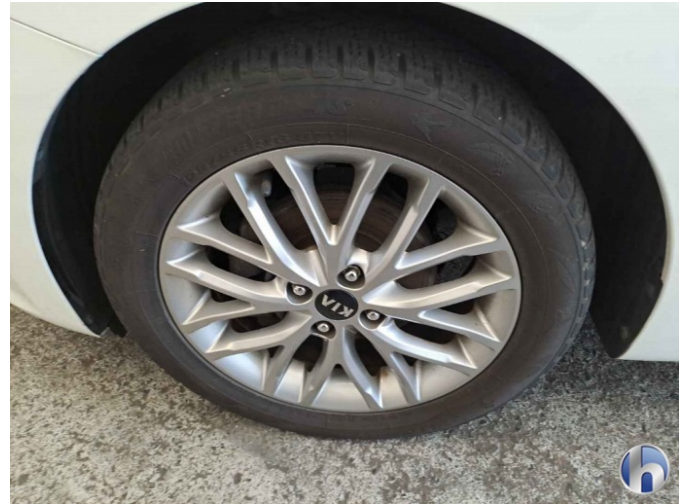
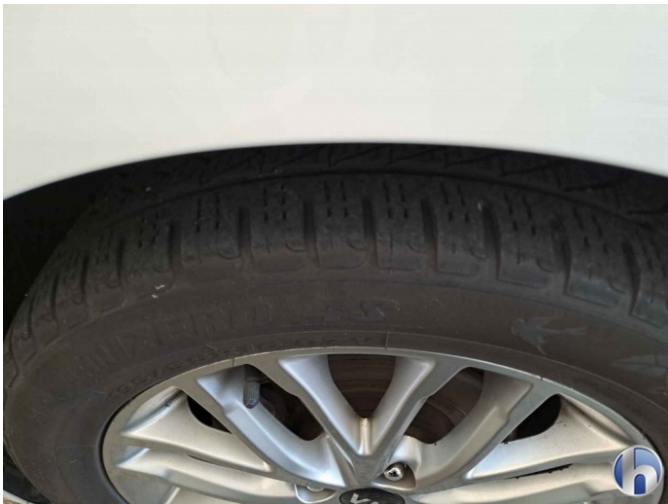
| component | Damage | Rep kind |
|---|---|---|
| 2. tire front - left | Worn | Replace |

2. tire front - left

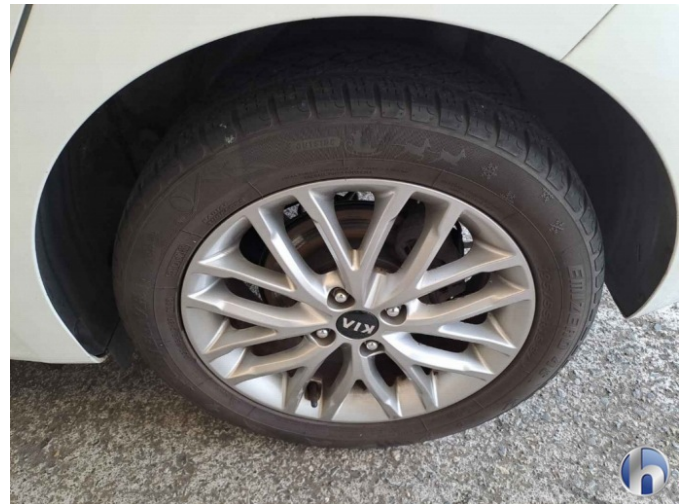
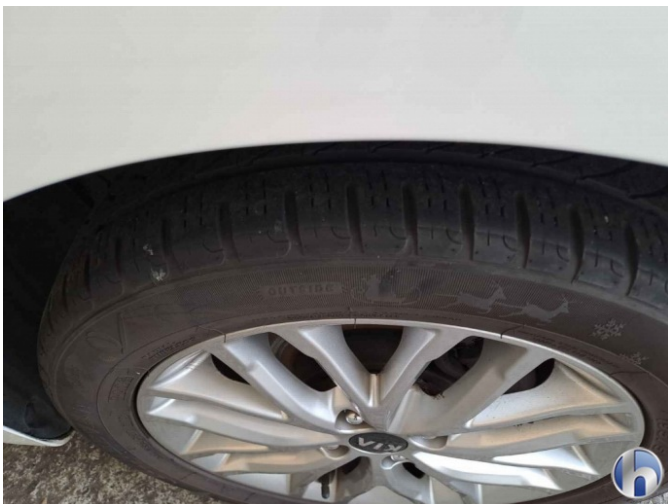
| component | Damage | Rep kind |
|---|---|---|
| 3. tire rear - left | Worn | Replace |

3. tire rear - left

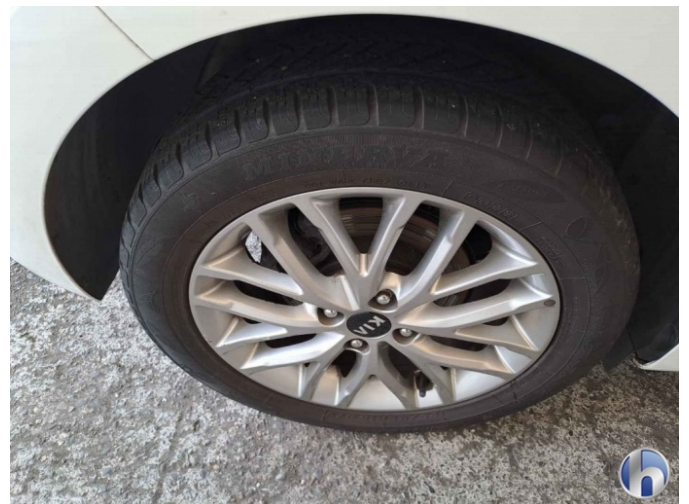
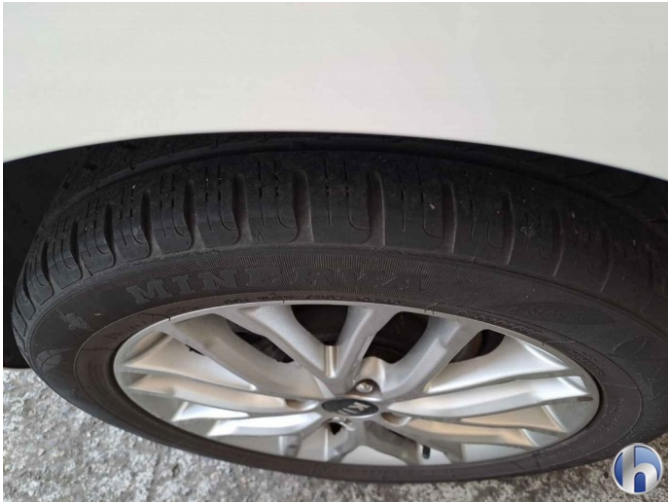
| component | Damage | Rep kind |
|---|---|---|
| 4. tire rear - right | Worn | Replace |

4. tire rear - right

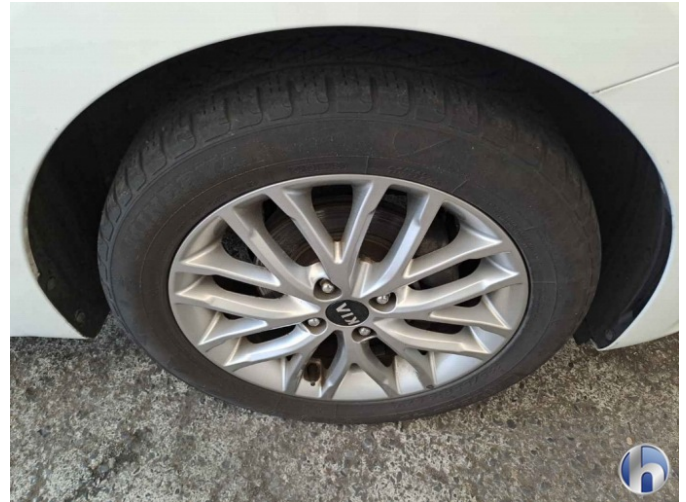
| component | Damage | Rep kind |
|---|---|---|
| 5. tire front - right | Worn | Replace |

5. tire front - right

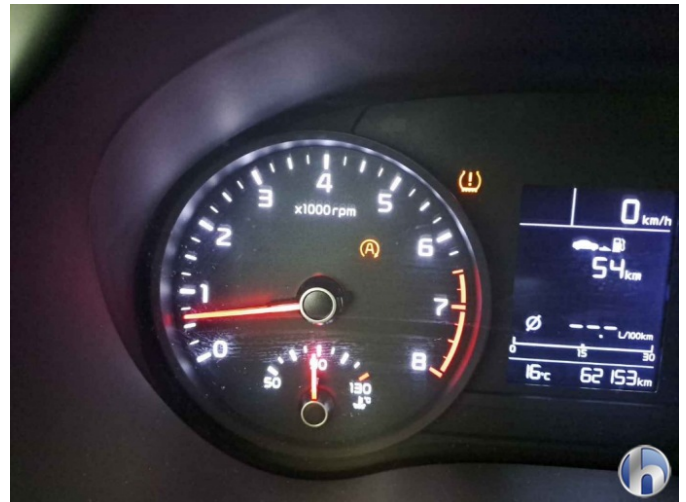
| component | Damage | Rep kind |
|---|---|---|
| 10. warning light | Error message | Carry out a fault diagnosis |

10. warning light

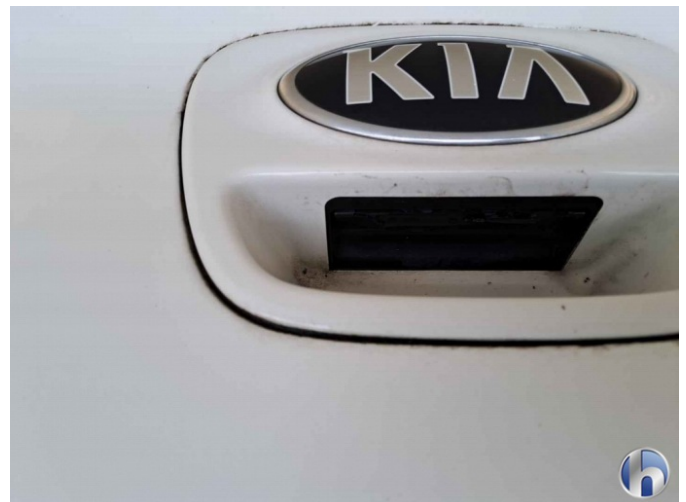
| component | Damage | Rep kind |
|---|---|---|
| 12. Heckklappenschalter | Damaged | Replace |

12. Heckklappenschalter

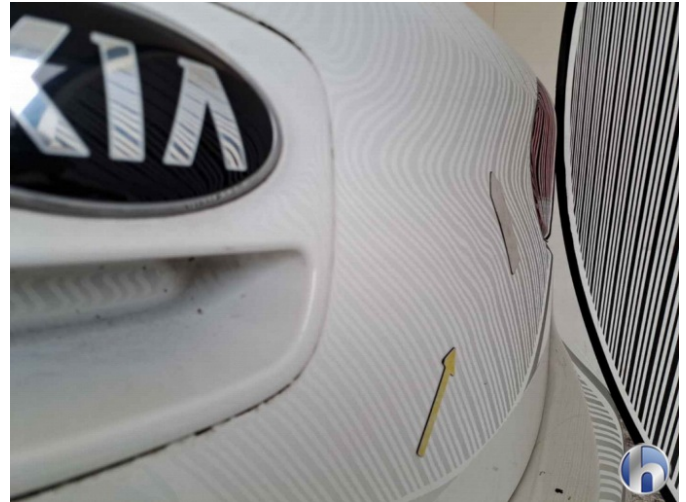
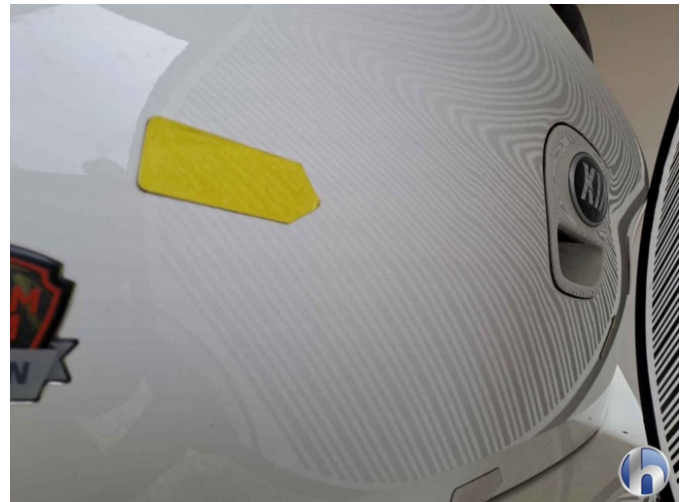
| component | Damage | Rep kind |
|---|---|---|
| 13. tailgate | Damaged | Refurbish and paint |

13. tailgate

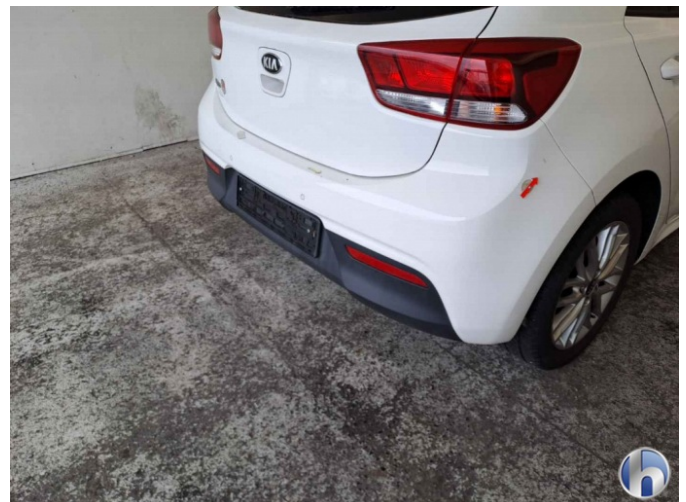
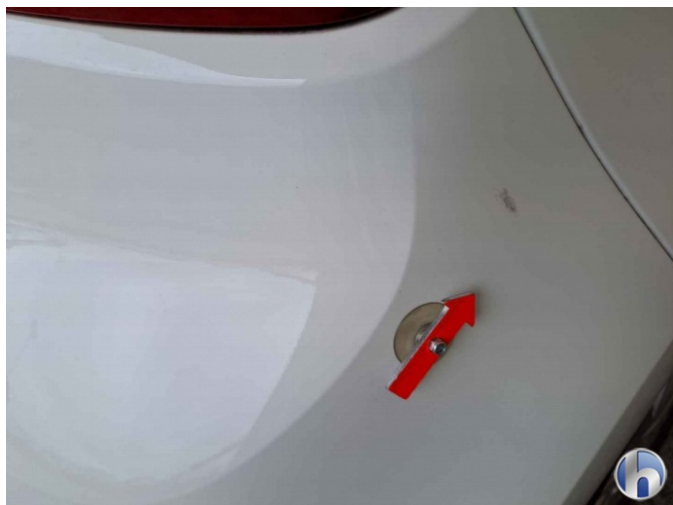
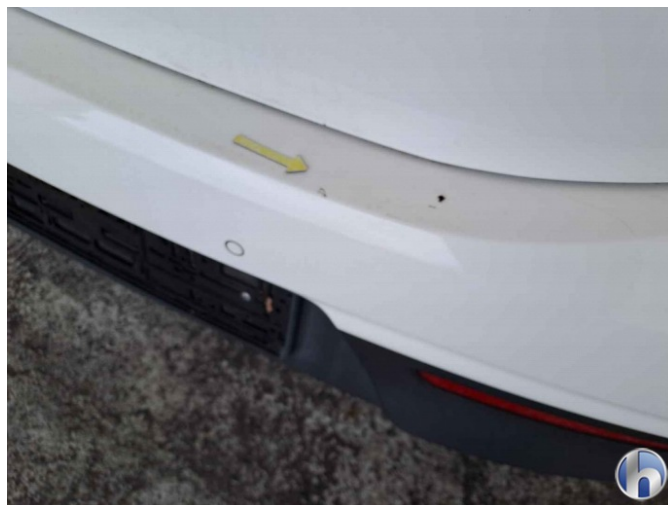
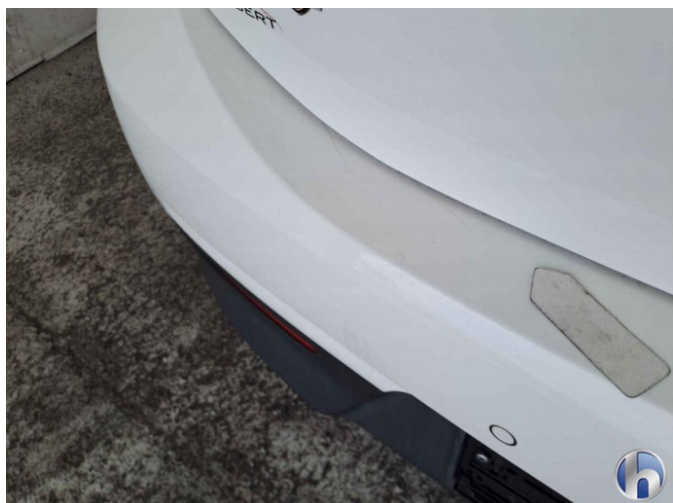
| component | Damage | Rep kind |
|---|---|---|
| 15. Rear bumper | Execution defect | Refurbish and paint |

15. Rear bumper

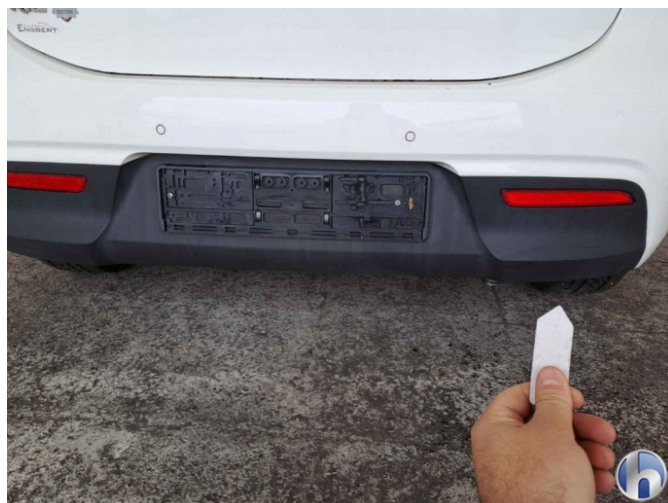
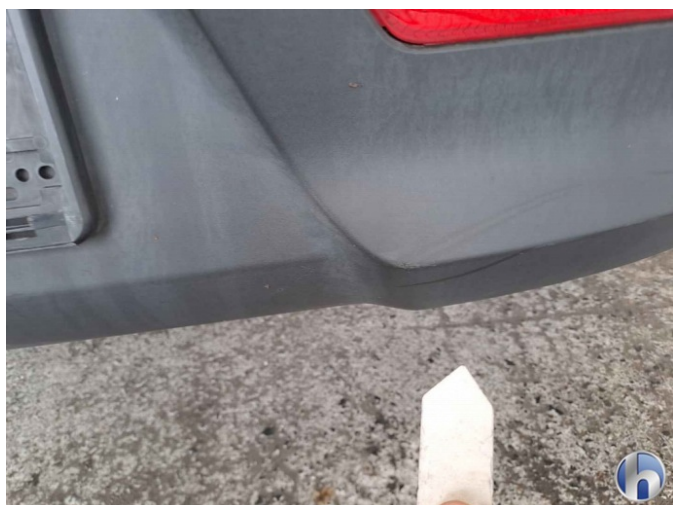
| component | Damage | Rep kind |
|---|---|---|
| 16. Diffusor | Scrape | Replace |

16. Diffusor

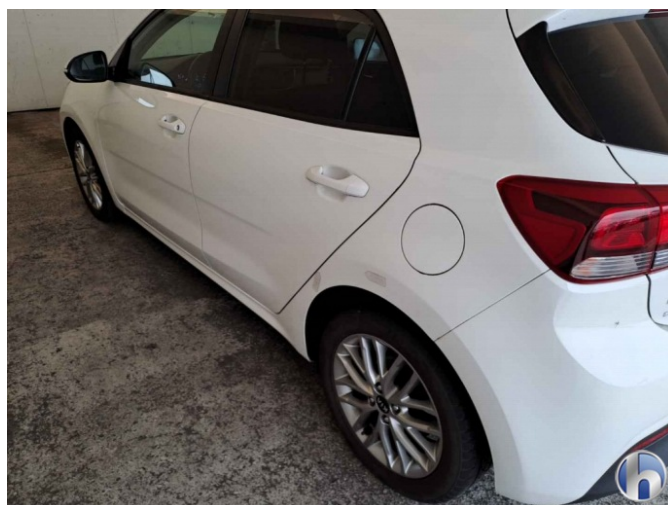
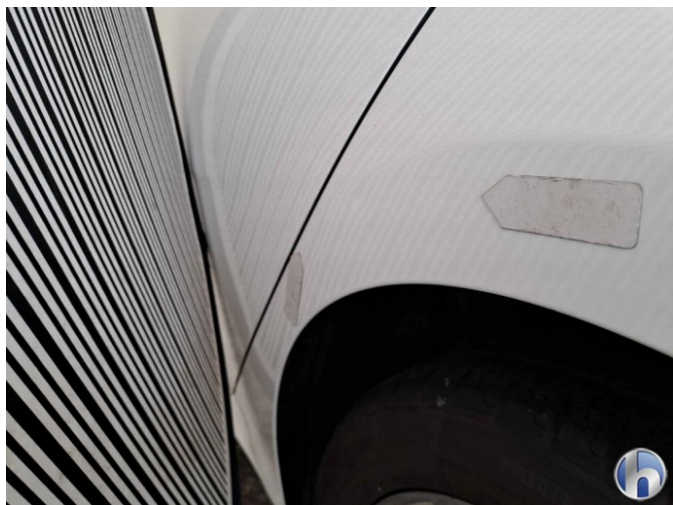
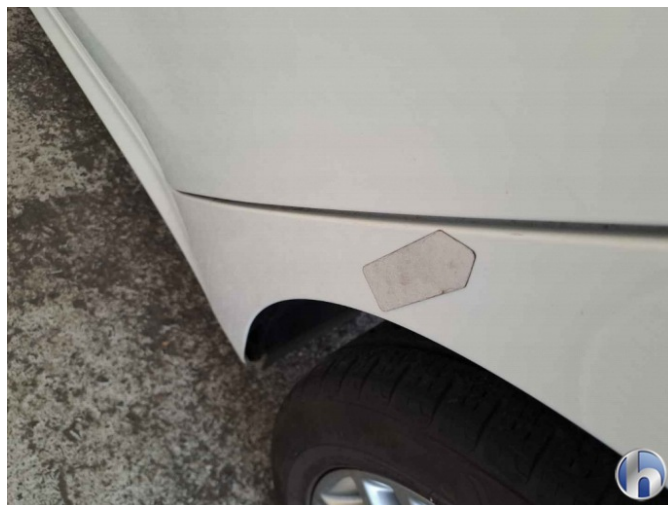
| component | Damage | Rep kind |
|---|---|---|
| 17. Sidewall - Rear - Left | Damaged | Refurbish and paint |

17. Sidewall - Rear - Left

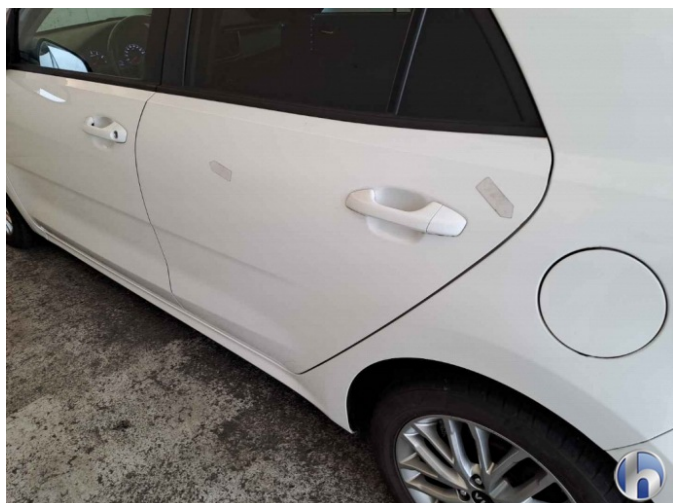
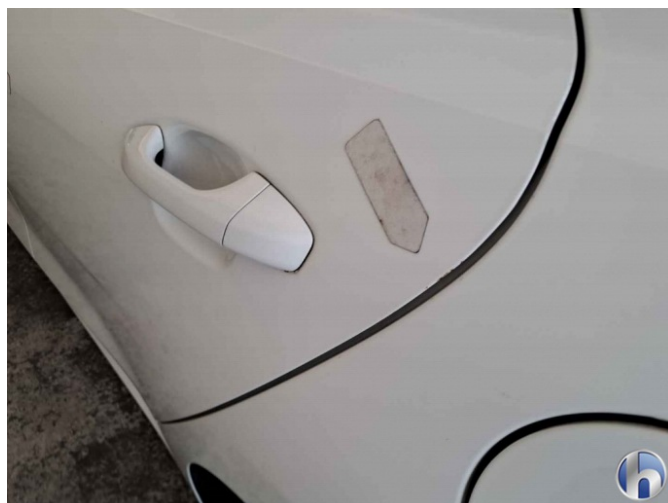
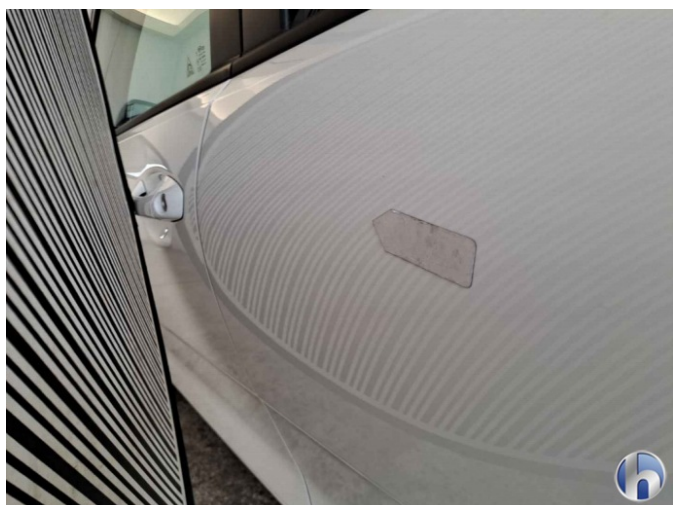
| component | Damage | Rep kind |
|---|---|---|
| 18. Rear door - left | Damaged | Refurbish and paint |

18. Rear door - left

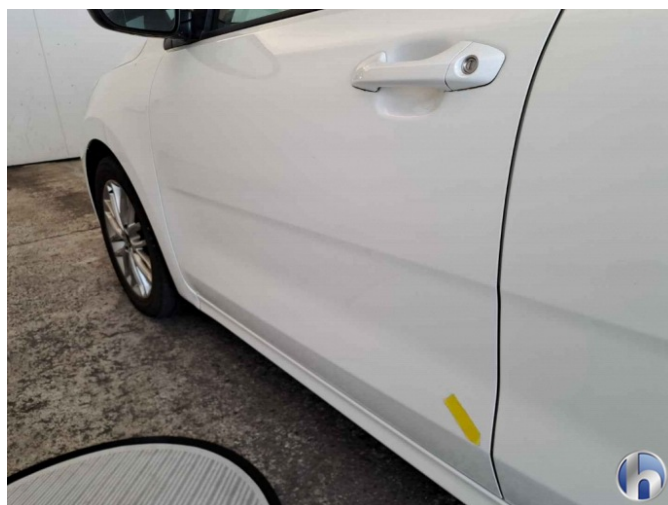
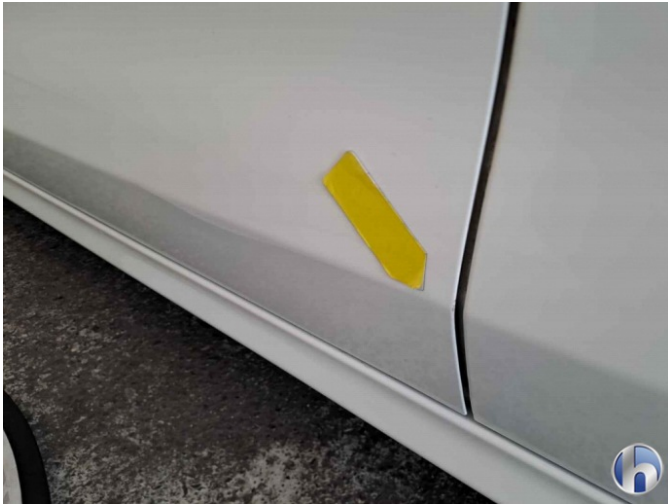
| component | Damage | Rep kind |
|---|---|---|
| 19. Front door - left | Scratch(es) | Paint |

19. Front door - left

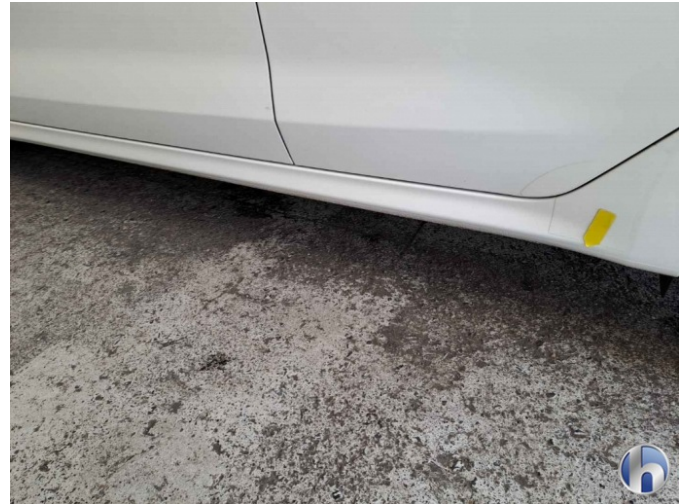
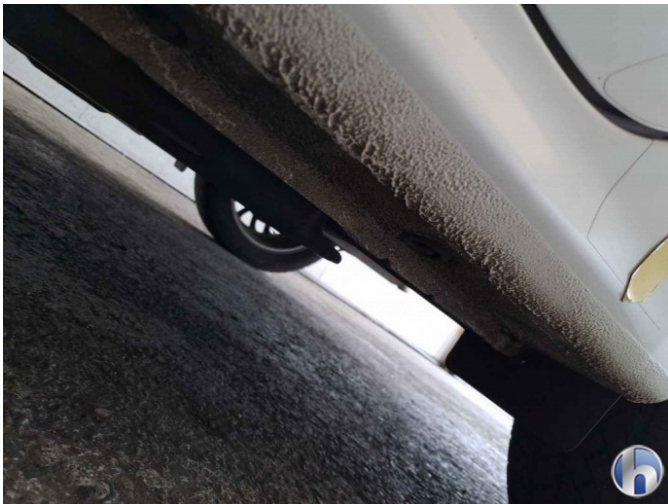
| component | Damage | Rep kind |
|---|---|---|
| 20. side skirt - left | Damaged | Refurbish and paint |

20. side skirt - left

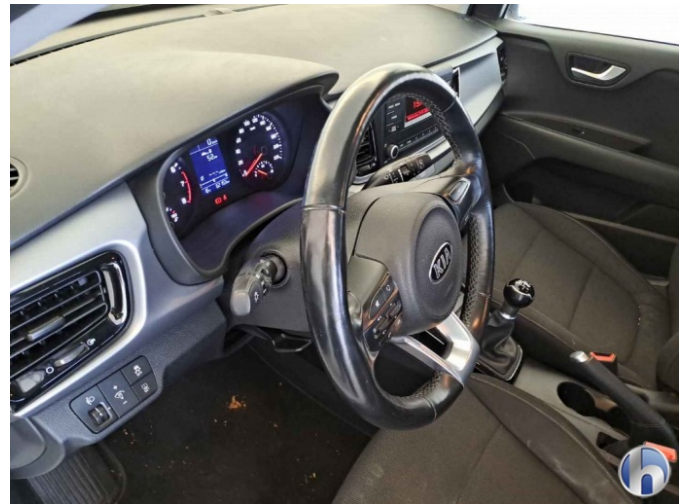
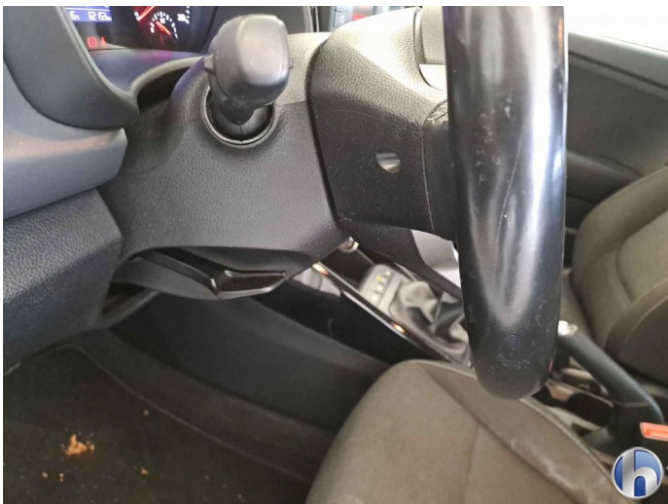
| component | Damage | Rep kind |
|---|---|---|
| 21. Steering wheel (leather) | Scratch(es) | Replace |

21. Steering wheel (leather)

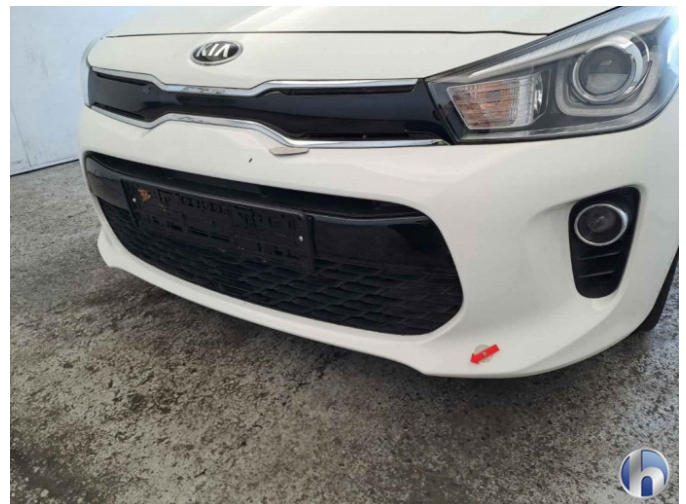
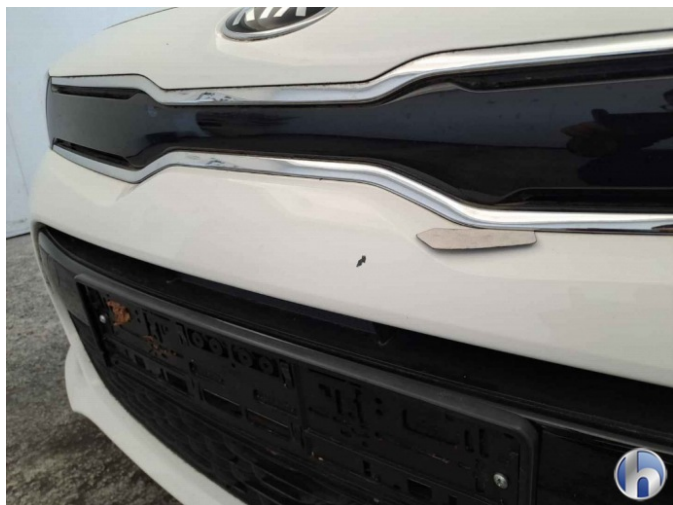
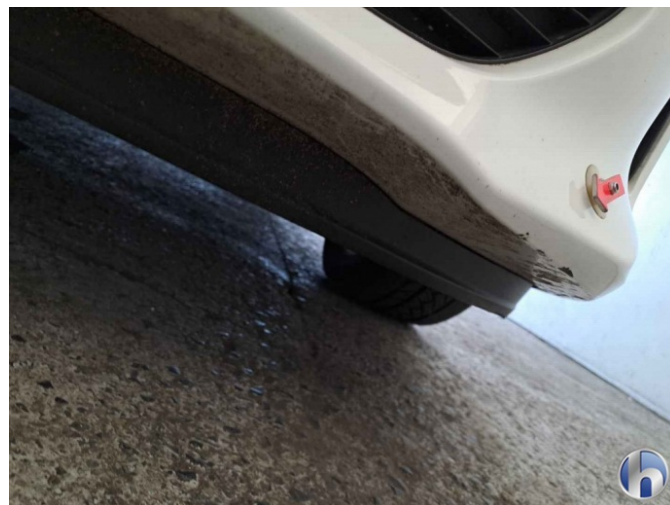
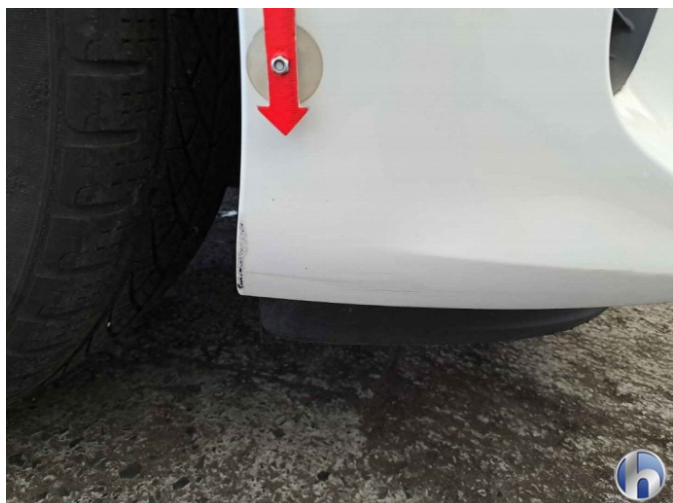
| component | Damage | Rep kind |
|---|---|---|
| 22. Front bumper | Scrape | Refurbish and paint |

22. Front bumper

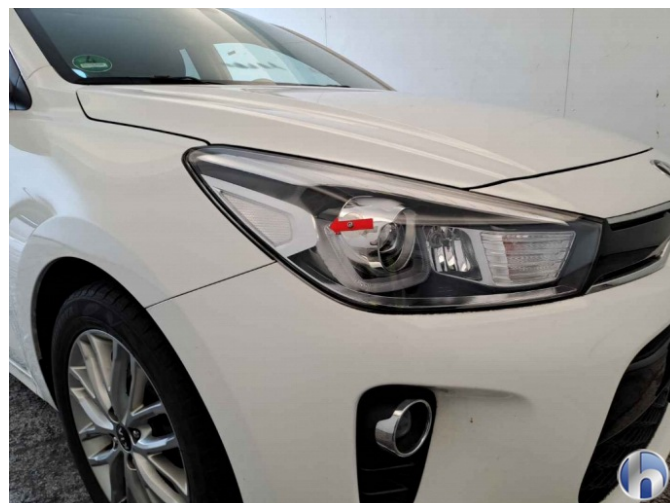
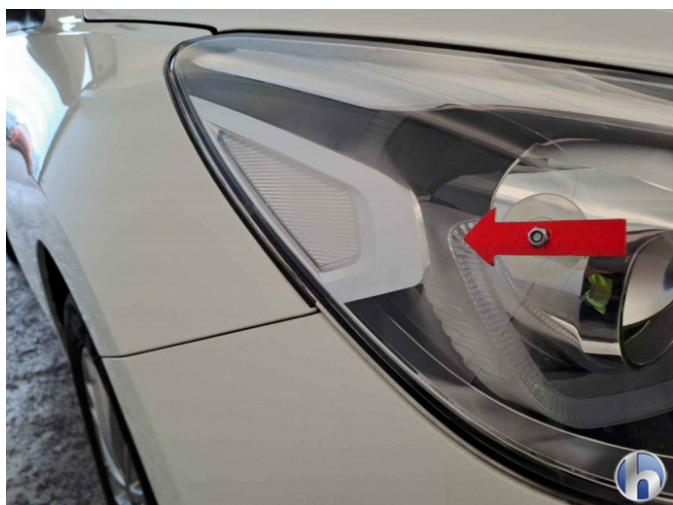
| component | Damage | Rep kind |
|---|---|---|
| 23. Scheinwerfer - Rechts | Leaky | Replace |

23. Scheinwerfer - Rechts

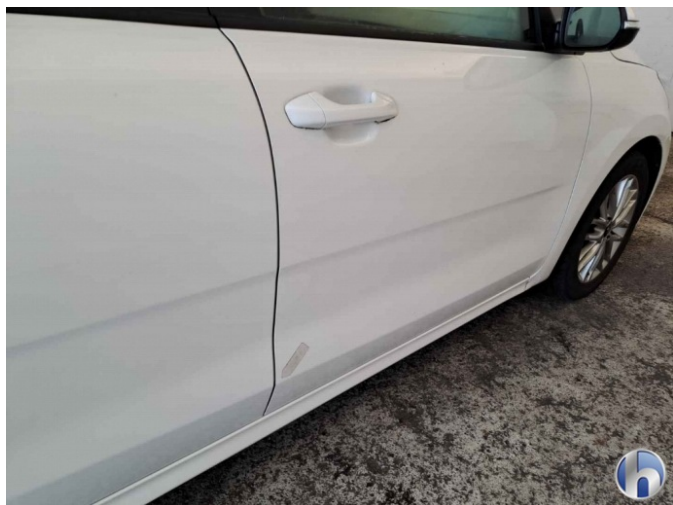
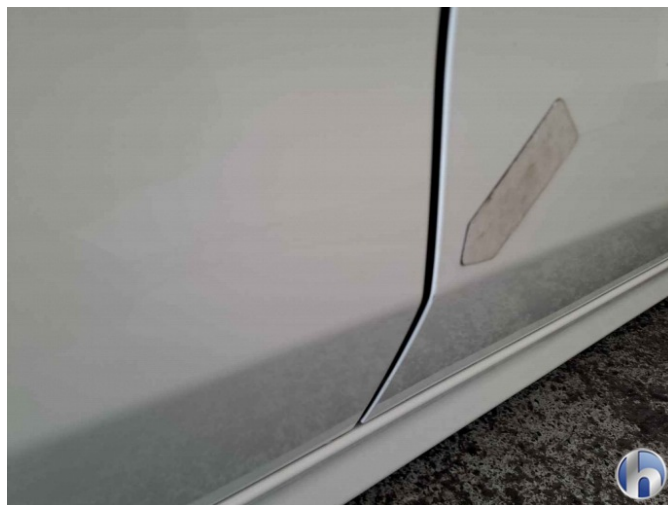
| component | Damage | Rep kind |
|---|---|---|
| 25. Front door - right | Scratch(es) | Paint |

25. Front door - right

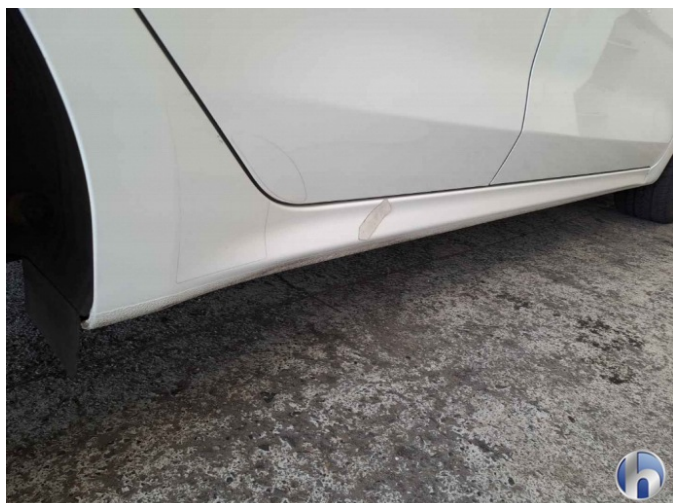
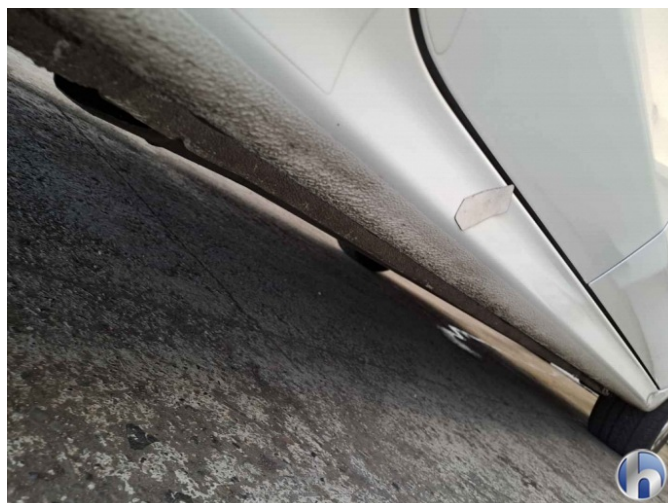
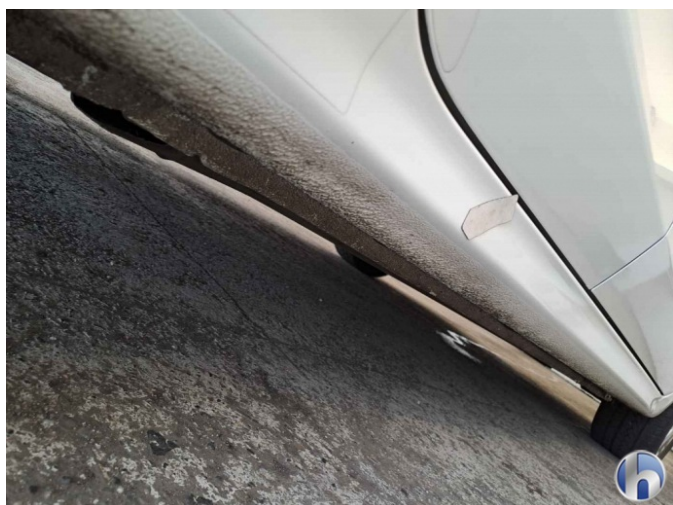
| component | Damage | Rep kind |
|---|---|---|
| 26. side skirt - right | Damaged | Refurbish and paint |

26. side skirt - right

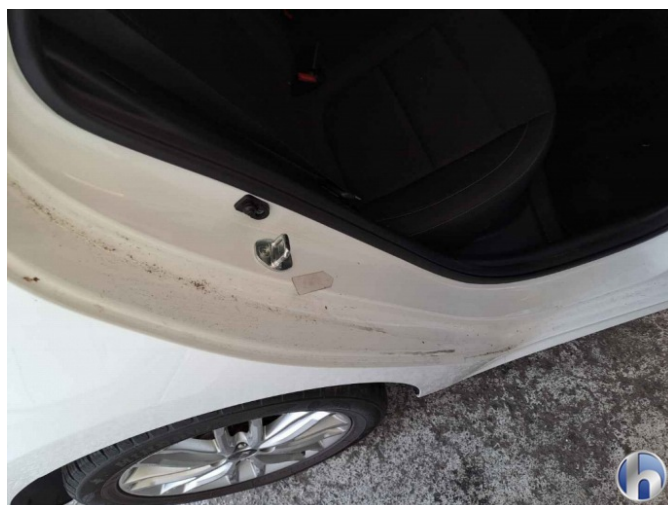
| component | Damage | Rep kind |
|---|---|---|
| 27. Türeinstieg Hinten - Rechts | Damaged | Refurbish and paint |

27. Türeinstieg Hinten - Rechts

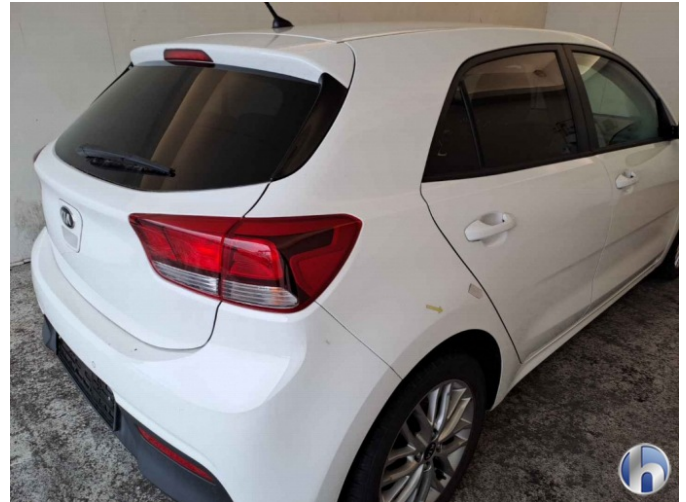
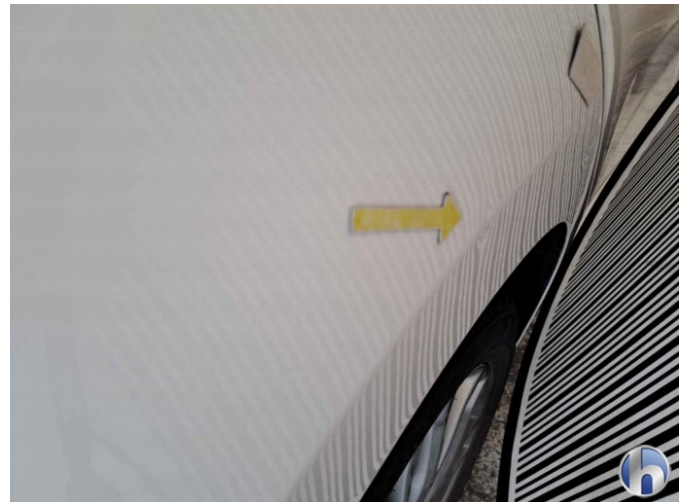
| component | Damage | Rep kind |
|---|---|---|
| 28. Sidewall - Rear - right | Damaged | Refurbish and paint |

28. Sidewall - Rear - right

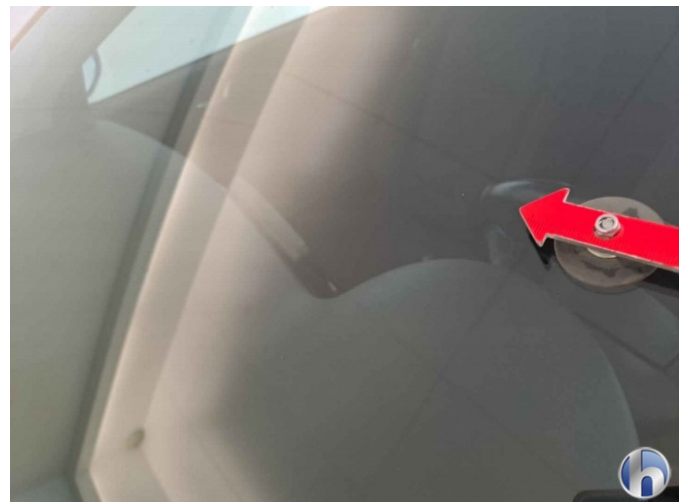
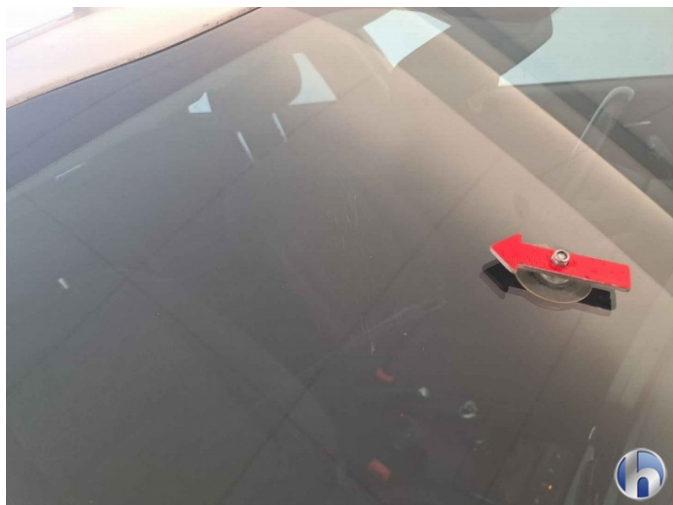
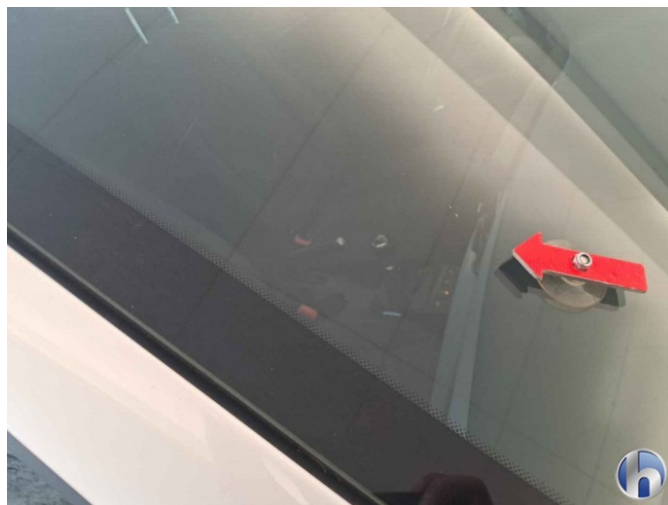
| component | Damage | Rep kind |
|---|---|---|
| 29. Windshield | Damaged | Replace |

29. Windshield
