Expertise

Protocol number: 39158774
Order No. / Reference: 24590609
Inspection date: 1 Apr 2025

Manufacturer: Kia

Model: Sorento 1.6 T-GDI PHEV AWD Aut. Spirit

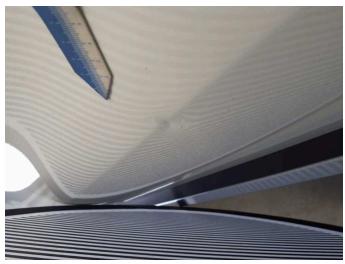
Damage 2: Door - front left side: Door - dent(s) - Smart repair

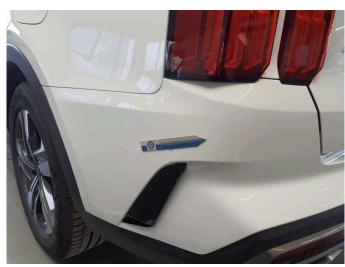
Damage 3: Rear bumper: Bumper - rear left side - Scratch(es) - Smart repair

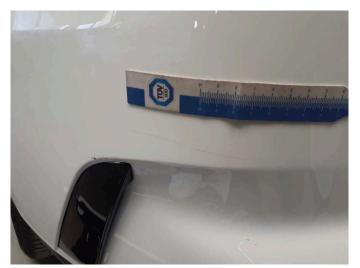
Damage 3: Rear bumper: Bumper - rear left side - Scratch(es) - Smart repair

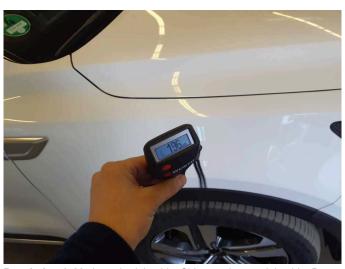
Mudguard - right side	196 µm	Side panel - rear right side	225 µm
Door - rear right side	170 µm	Door - front right side	172 µm

Repainting 1: Mudguard - right side, Side panel - rear right side, Door - rear right side, Door - front right side

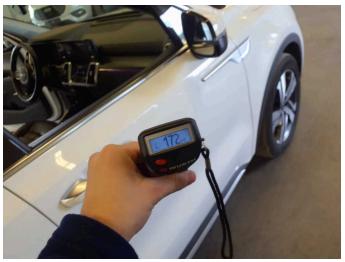
Repainting 1: Mudguard - right side, Side panel - rear right side, Door - rear right side, Door - front right side

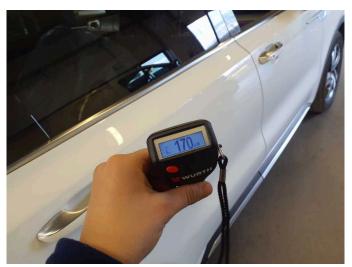
Repainting 1: Mudguard - right side, Side panel - rear right side, Door - rear right side, Door - front right side

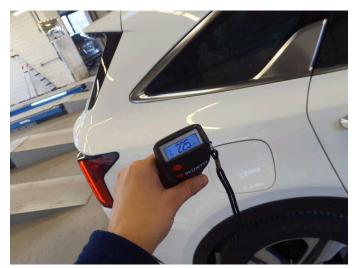
Repainting 1: Mudguard - right side, Side panel - rear right side, Door - rear right side, Door - front right side
