## BYD

ATTO 3 COMFORT

VIN: LGXCE4CBXP2063966

Estimated repair cost

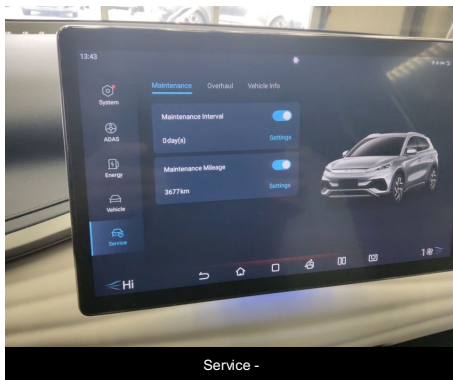
Service -

| Element | Position | Defect | Correction | net cost |
|---|---|---|---|---|
| Service<br>Service type : Maintenance level 1 | - | Missing | Carry out | - EUR |

Wartungsintervallanzeige ausgeschaltet

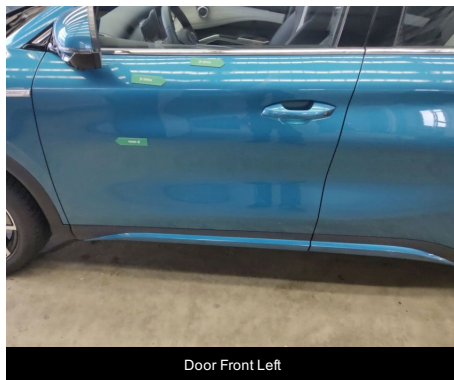
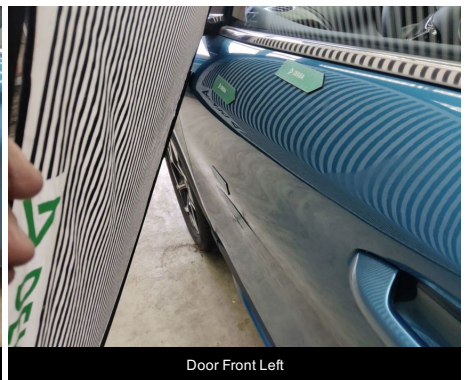
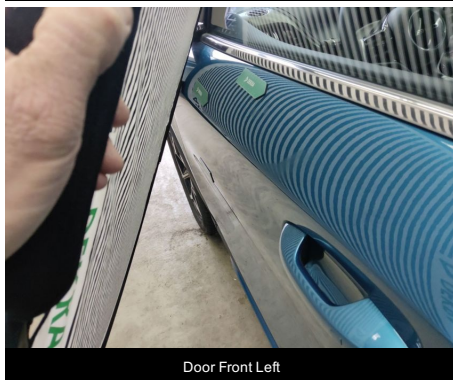
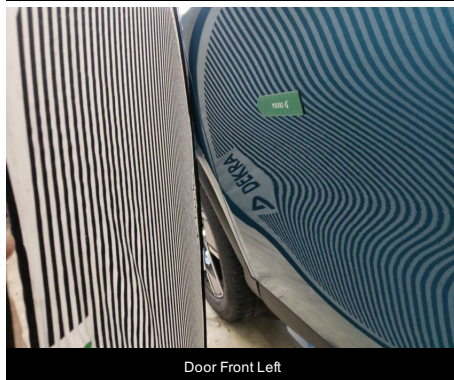
Door Front Left

| Element | Position | Defect | Correction | net cost |
|---|---|---|---|---|
| Door<br>Material : Metal / Windowed | Front Left | Dent | Smart repair | 52.5 EUR |

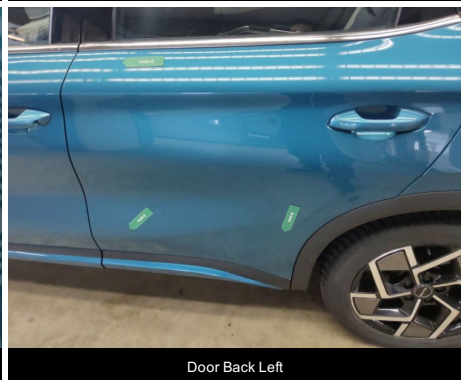
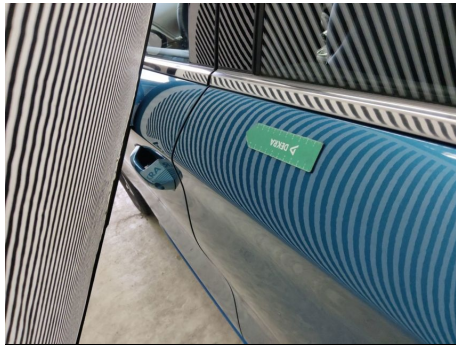
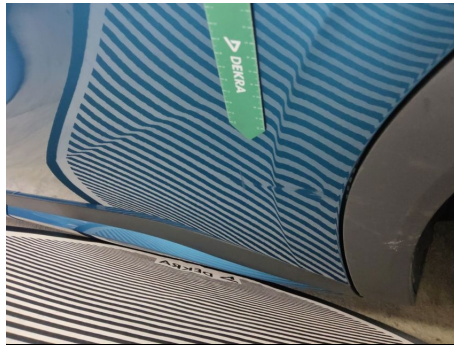
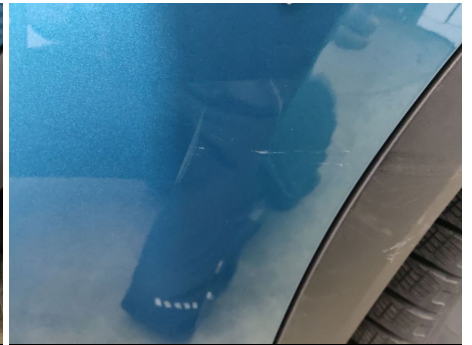
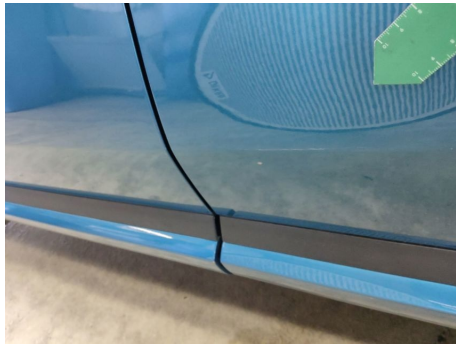
Door Back Left

| Element | Position | Defect | Correction | net cost |
|---|---|---|---|---|
| Door<br>Material : Metal / Windowed | Back Left | Dent | Repair | 360 EUR |

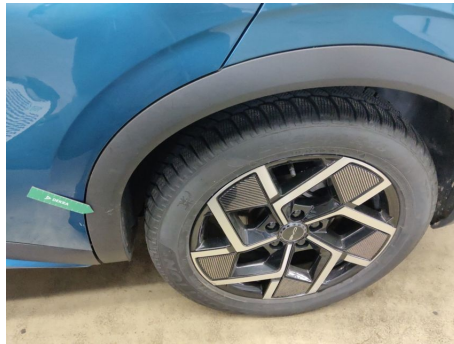
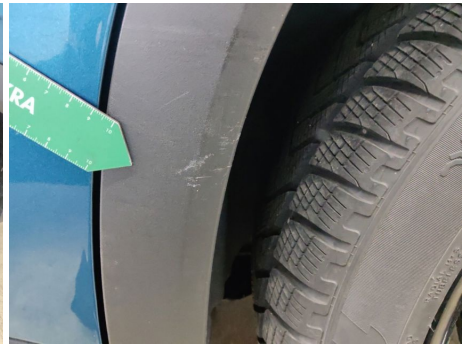
Wing extension moulding Back Left

| Element | Position | Defect | Correction | net cost |
|---|---|---|---|---|
| Wing extension moulding<br>Painted | Back Left | Scratched | Replace | 69.62 EUR |

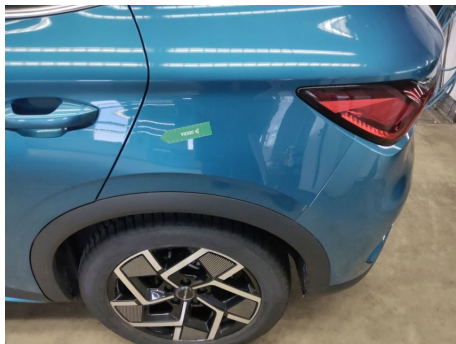
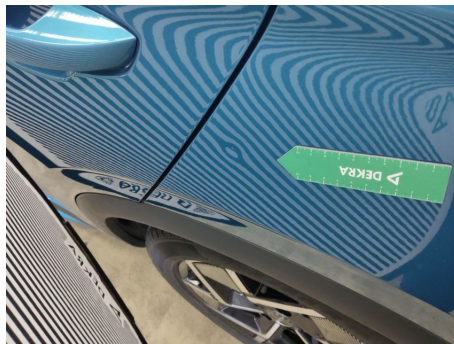
Wing Back Left

| Element | Position | Defect | Correction | net cost |
|---|---|---|---|---|
| Wing<br>Material : Metal / Windowed | Back Left | Dent | Smart repair | 37.5 EUR |

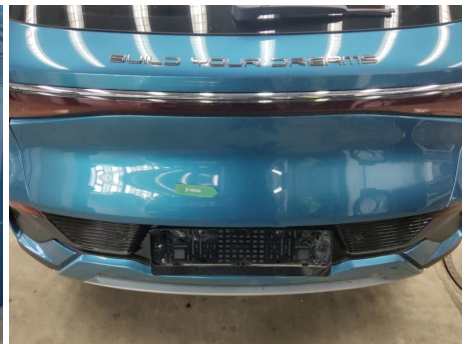
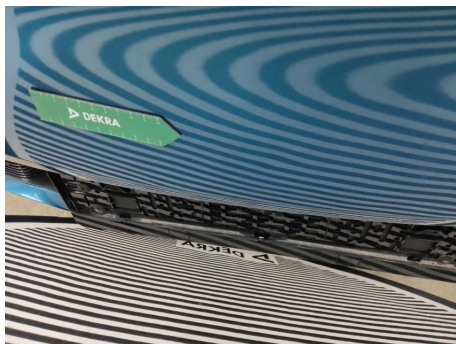
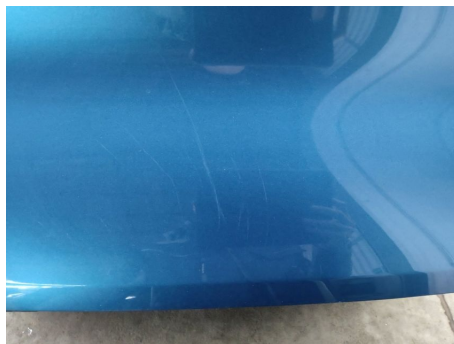
Tailgate / Boot door -

| Element | Position | Defect | Correction | net cost |
|---|---|---|---|---|
| Tailgate / Boot door<br>Material : Metal / Windowed | - | Dent | Smart repair | 60 EUR |

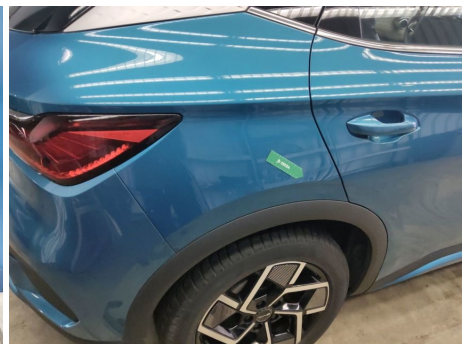
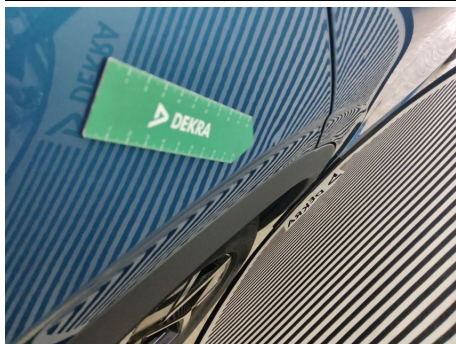
Wing Back Right

| Element | Position | Defect | Correction | net cost |
|---|---|---|---|---|
| Wing<br>Material : Metal / Windowed | Back Right | Dent | Smart repair | 45 EUR |

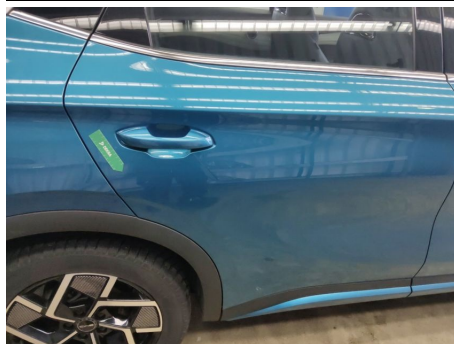
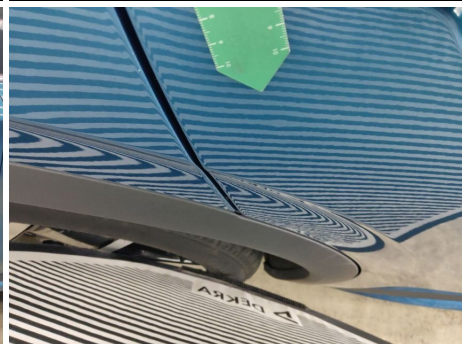
Door Back Right

| Element | Position | Defect | Correction | net cost |
|---|---|---|---|---|
| Door<br>Material : Metal / Windowed | Back Right | Dent | Smart repair | 37.5 EUR |

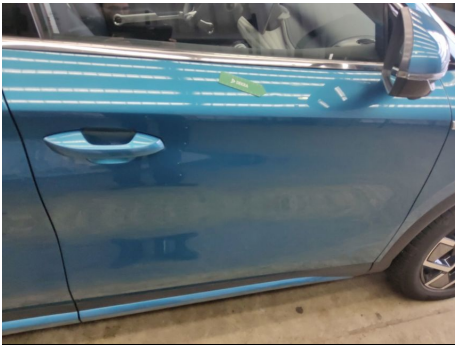
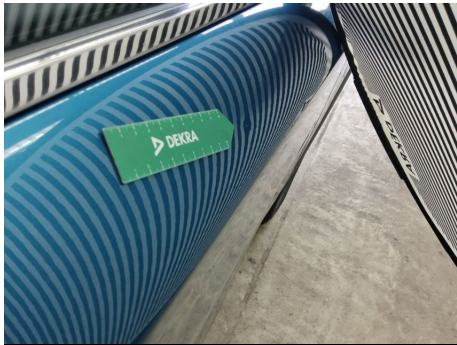
Door Front Right

| Element | Position | Defect | Correction | net cost |
|---|---|---|---|---|
| Door<br>Material : Metal / Windowed | Front Right | Dent | Smart repair | 37.5 EUR |
