Expertise

Protocol number: 41600433  
Order No. / Reference: 25233331  
Inspection date: 18 Sept 2025

Manufacturer: Tesla

Model: Model Y RWD

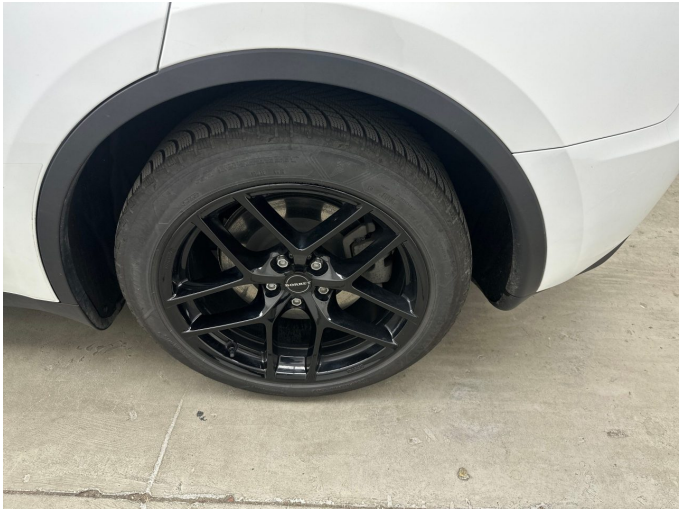
Figure 12: Mounted tyres

#	Tyre size	Type of tyre	Manufacturer	Tread depth
1)	255/45 R19 104V	Winter tyres on Light alloy	Goodyear	5mm / 5mm
2)	255/45 R19 104V	Winter tyres on Light alloy	Goodyear	5mm / 5mm

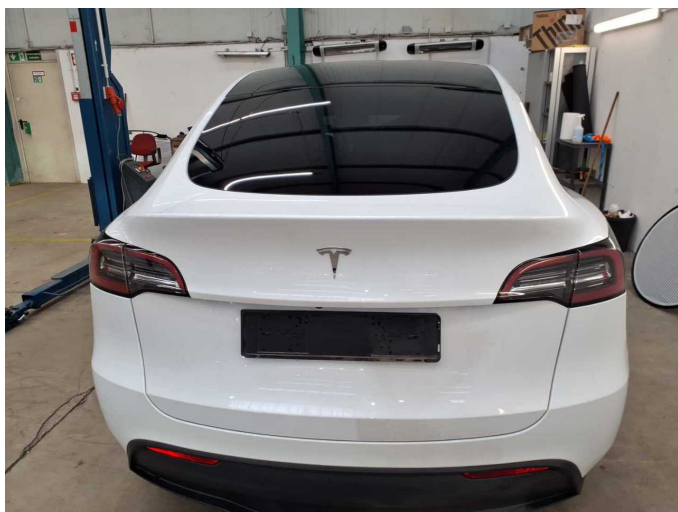
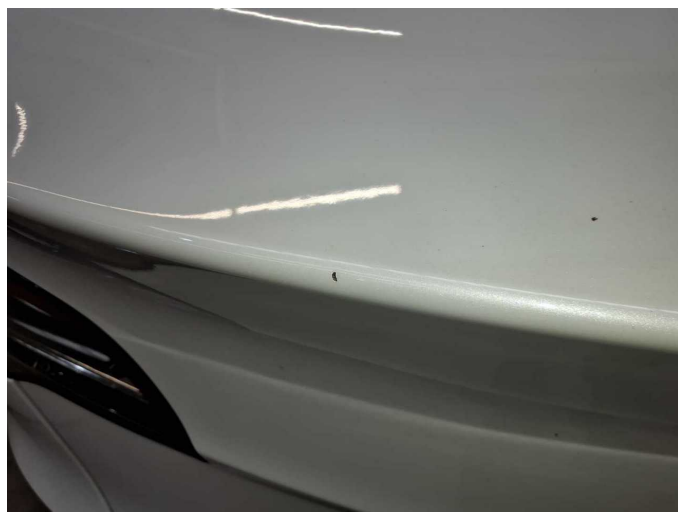
No.	Component group	Description
1	Boot lid / rear door	Boot lid - Stone chips - Smart repair
2	Front bumper	Front bumper - Scratched - Paint
3	Door - rear left side	Door - Scratch(es) - Paint

Damage 1: Boot lid / rear door: Boot lid - Stone chips - Smart repair

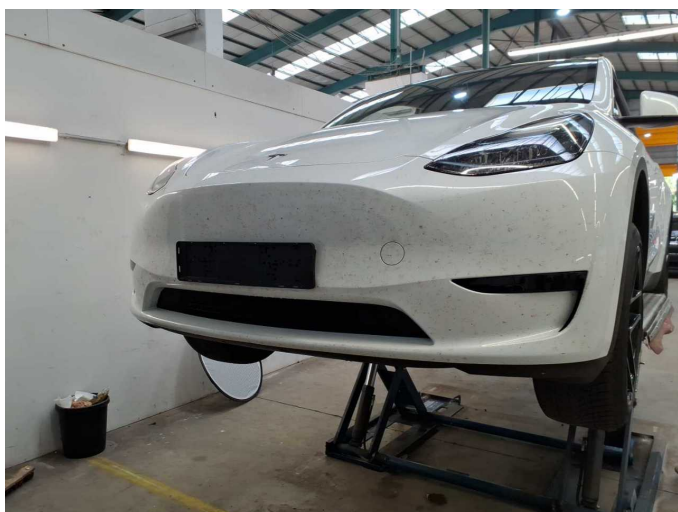
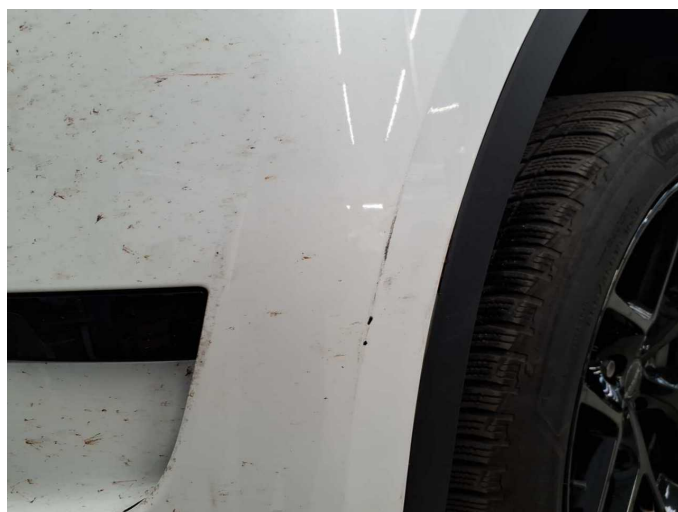
Damage 2: Front bumper: Front bumper - Scratched - Paint

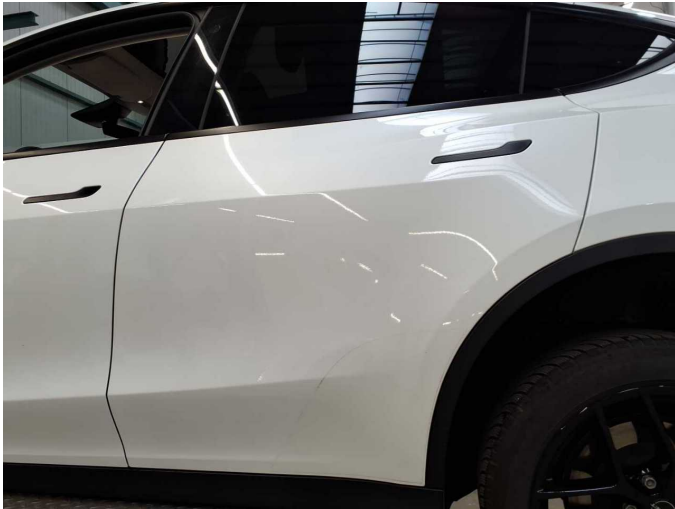
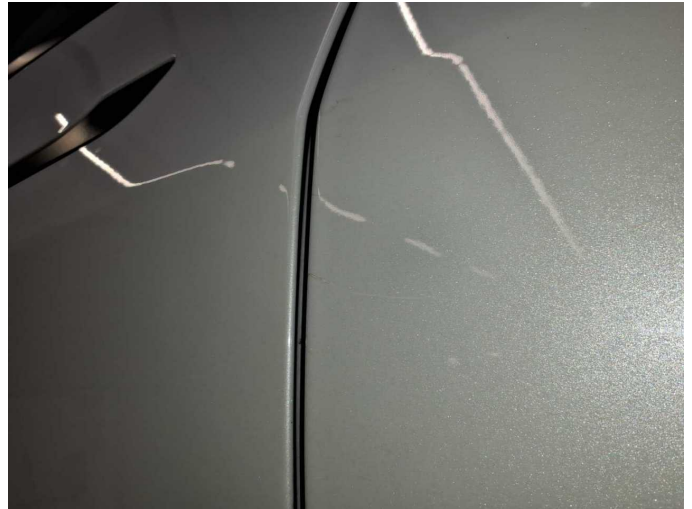
**Damage 3:** Door - rear left side: Door - Scratch(es) - Paint
