Expertise

Protocol number: 41470144
Order No. / Reference: 25161314
Inspection date: 9 Sept 2025

Manufacturer: Volvo	Model: XC60 T6 AWD Recharge Geartronic R-Design
VIN: LYVUZH1UDNB043417

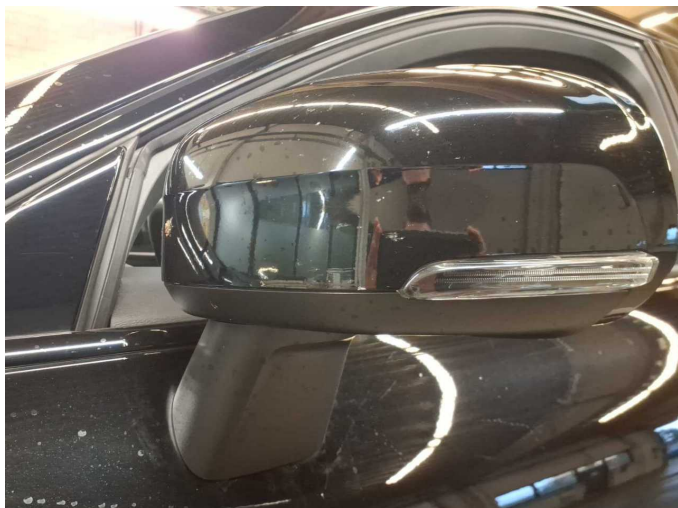
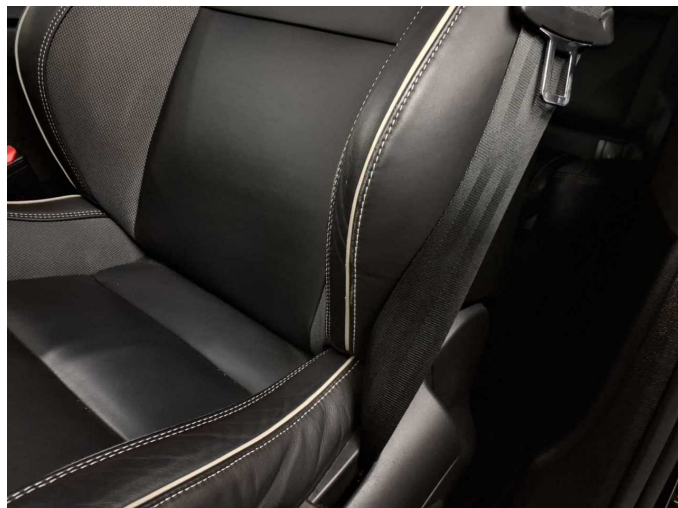
Damage 1: Wing mirror - left side: Cap - Scratch(es) - Smart repair

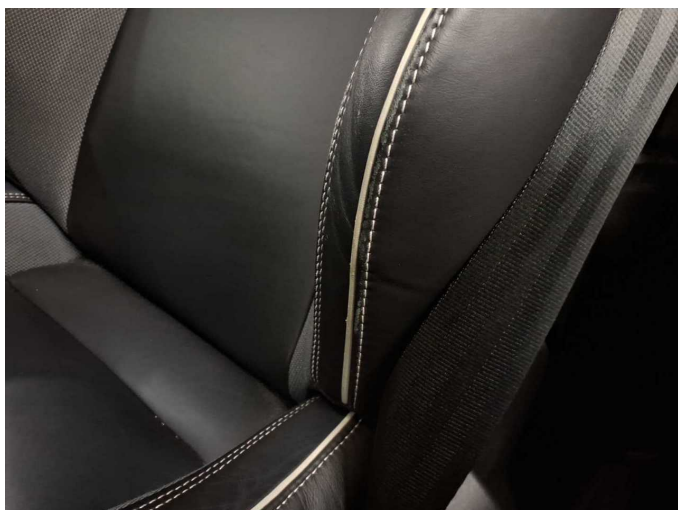
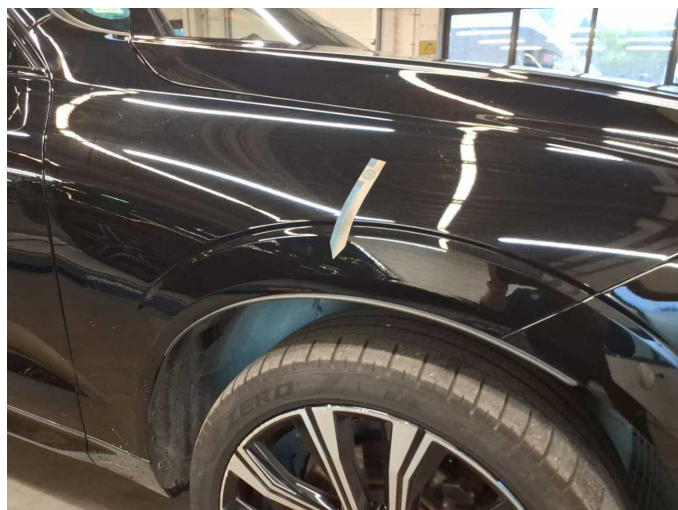
Damage 2: Seat - front: Backrest cover - left side - Scratch(es) - Smart repair

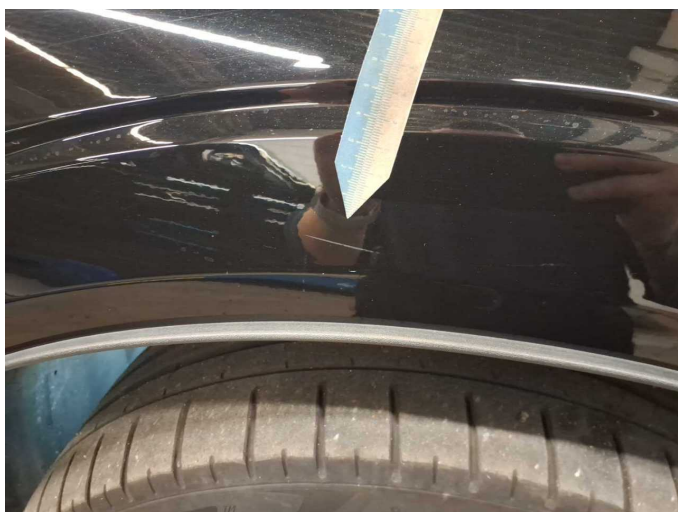
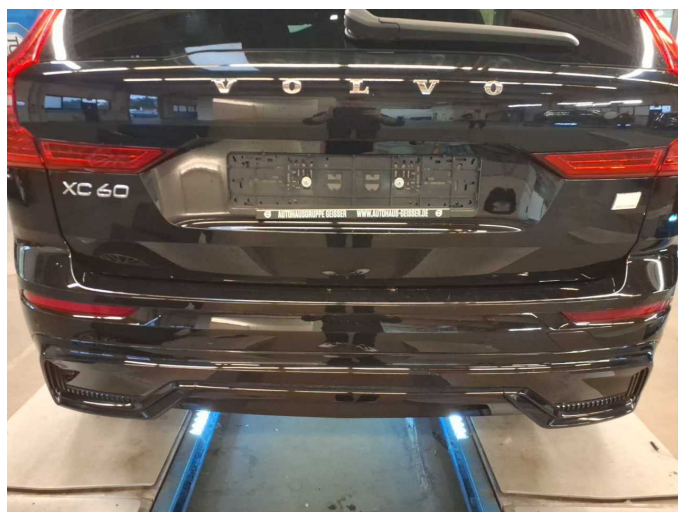
Damage 3: Mudguard - right side: Mudguard - right side - Scratch(es) - Smart repair

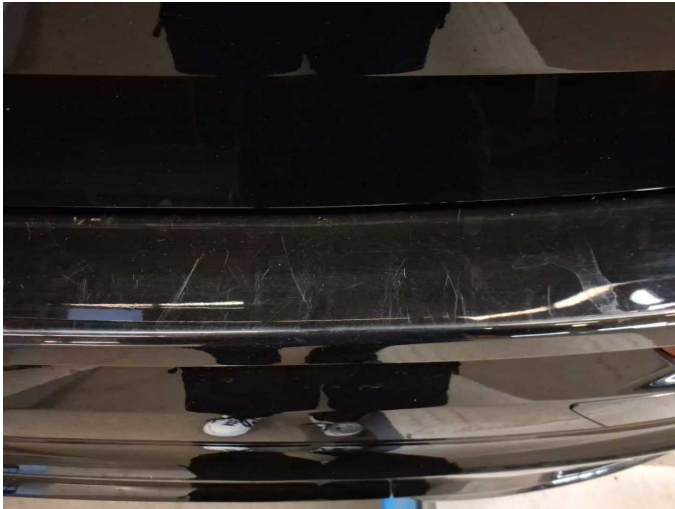
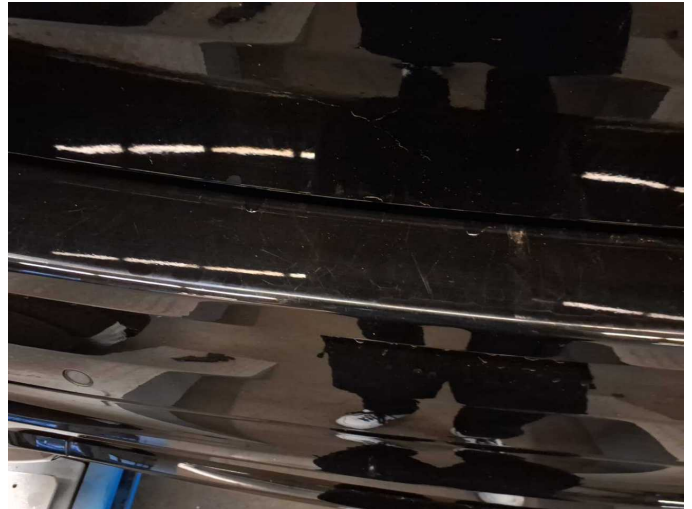
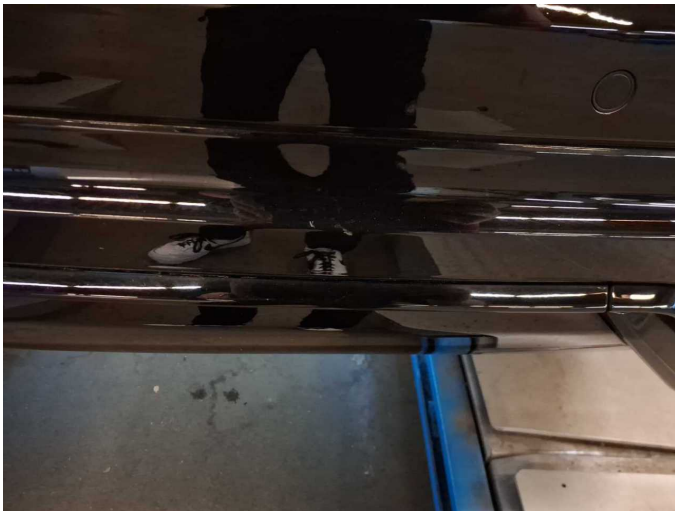
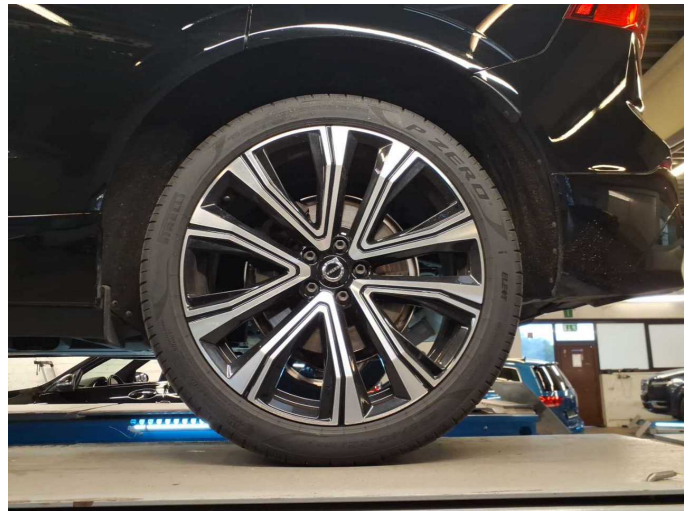
Damage 4: Rear bumper: Rear bumper - Scratch(es) - Smart repair

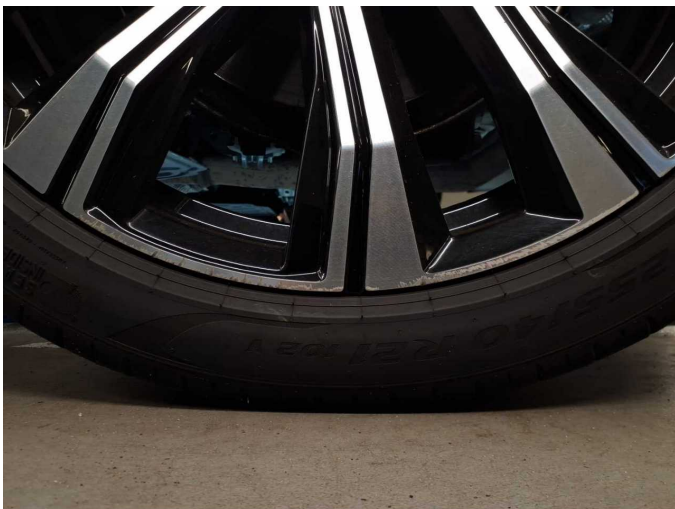
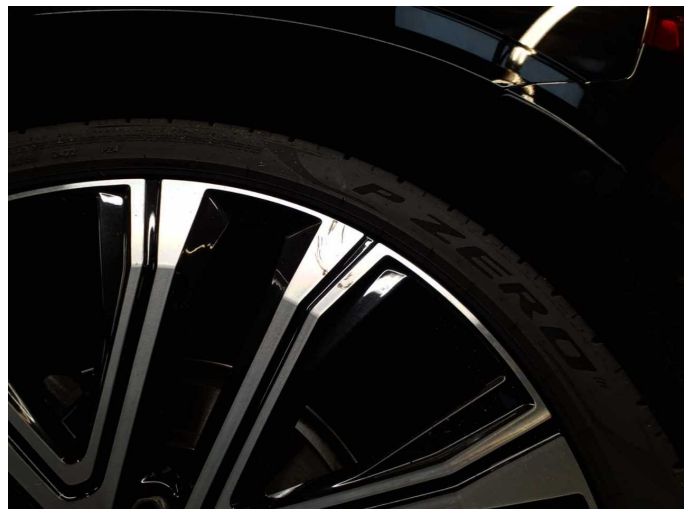
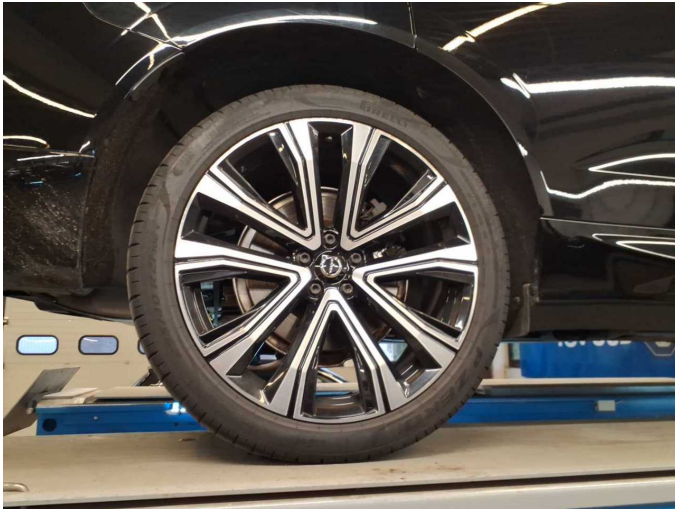
Damage 5: Wheel / tyres: Alloy rim - rear left side - Scratch(es) - Loss in value

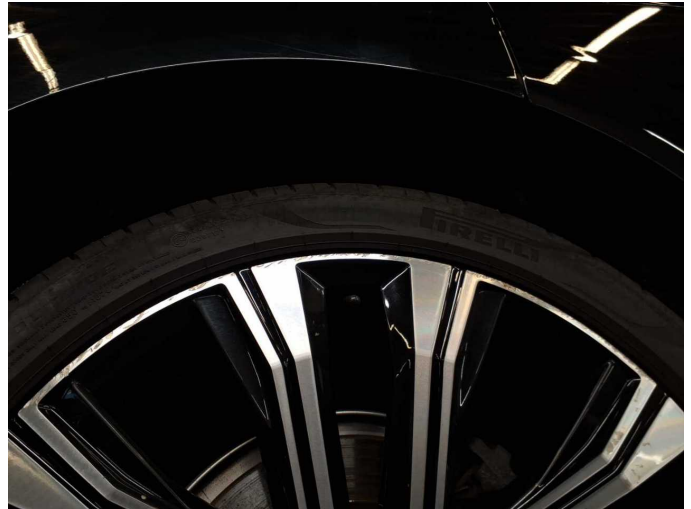
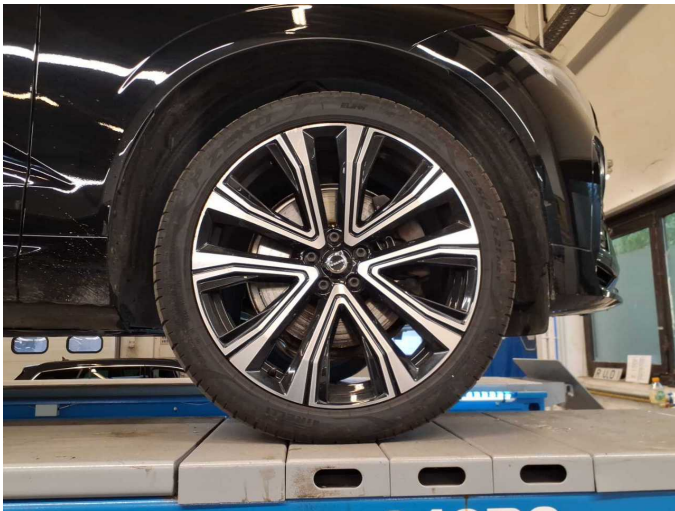
Damage 6: Wheel / tyres: Alloy rim - rear right side - Scratch(es) - Loss in value

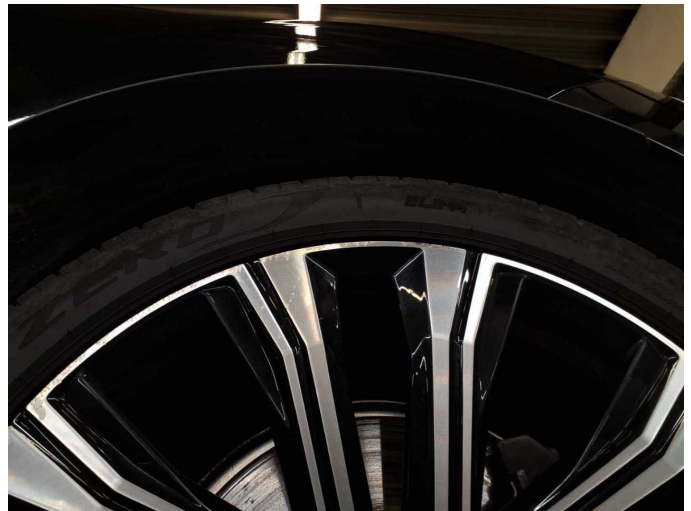
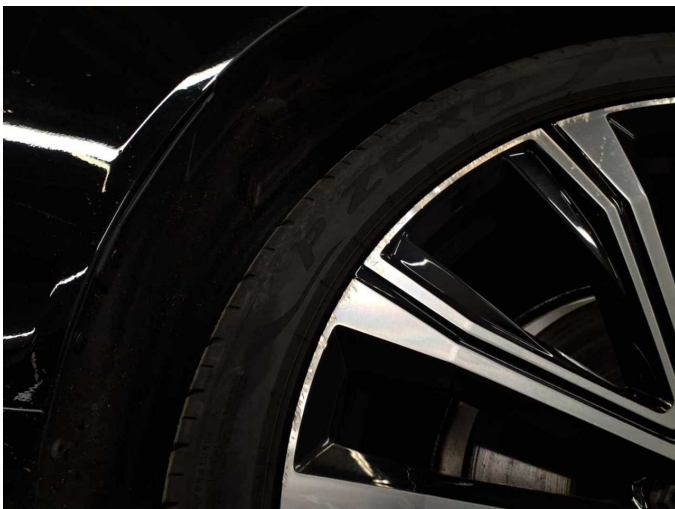
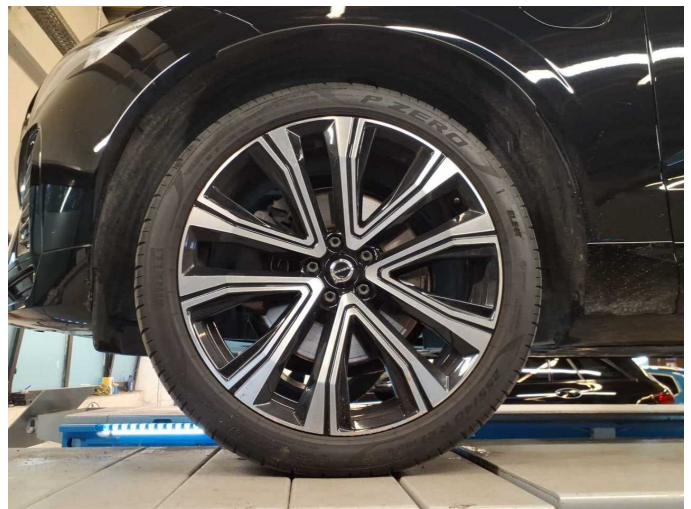
Damage 7: Wheel / tyres: Alloy rim - front right side - Scratch(es) - Loss in value

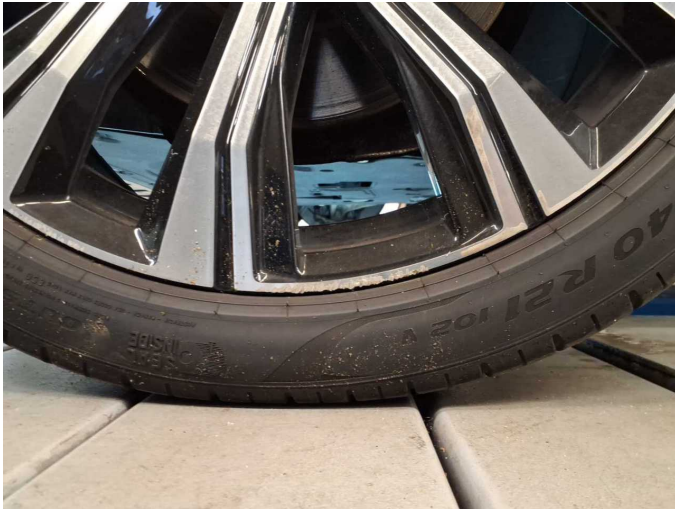
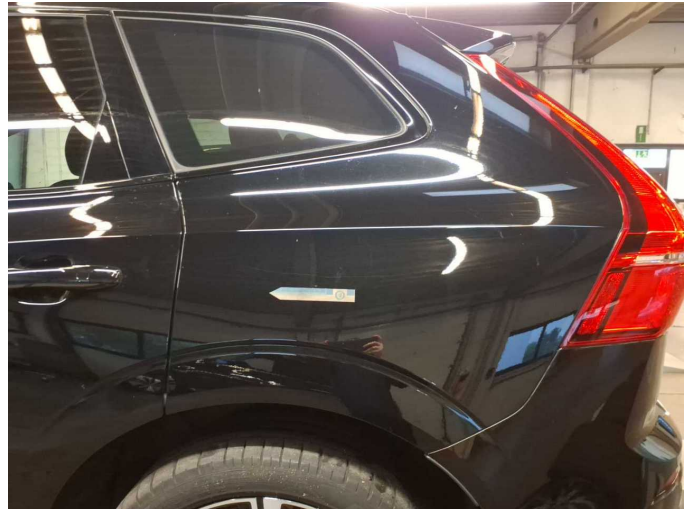
Damage 8: Wheel / tyres: Alloy rim - front left side (Materialabtrag) - Scratch(es) - Loss in value

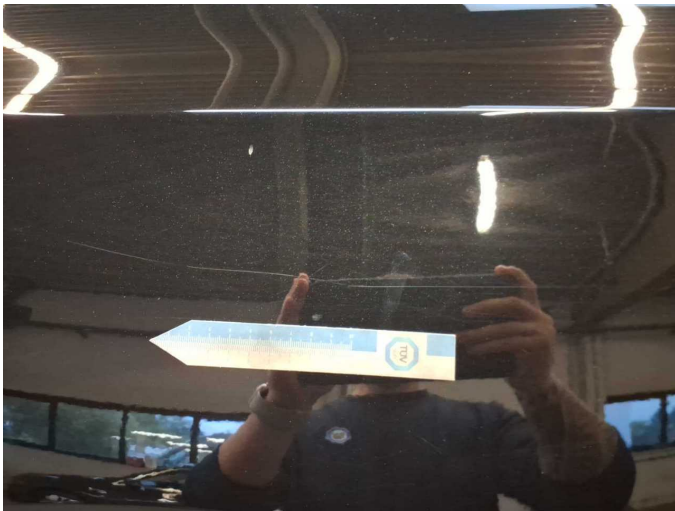
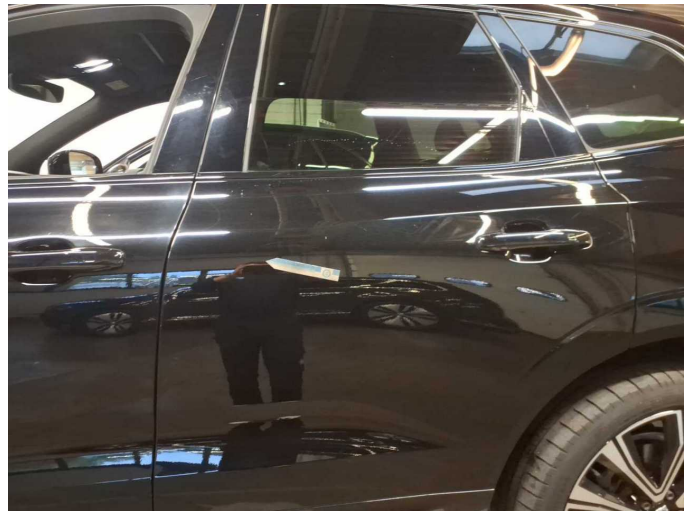
Damage 9: Side panel - rear left side: Side panel - Scratch(es) - Paint

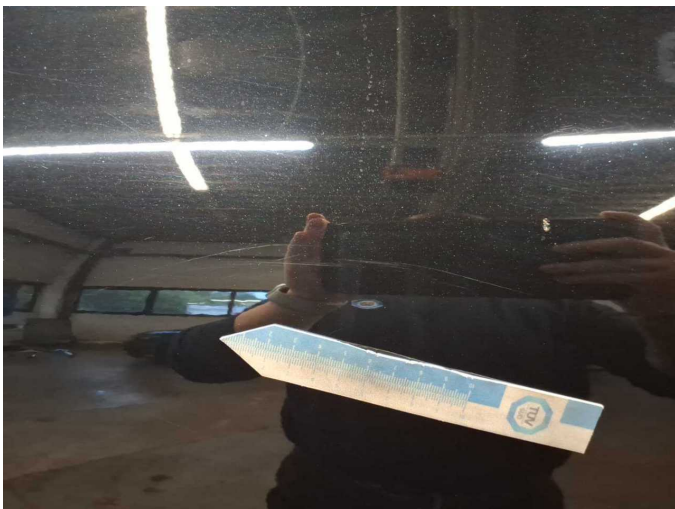
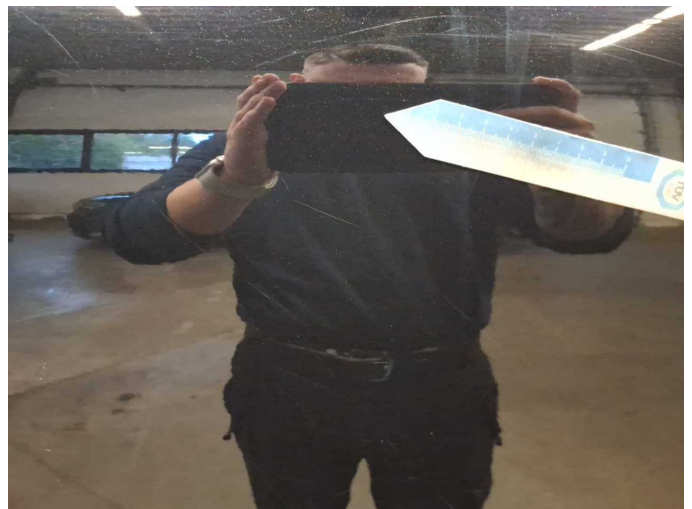
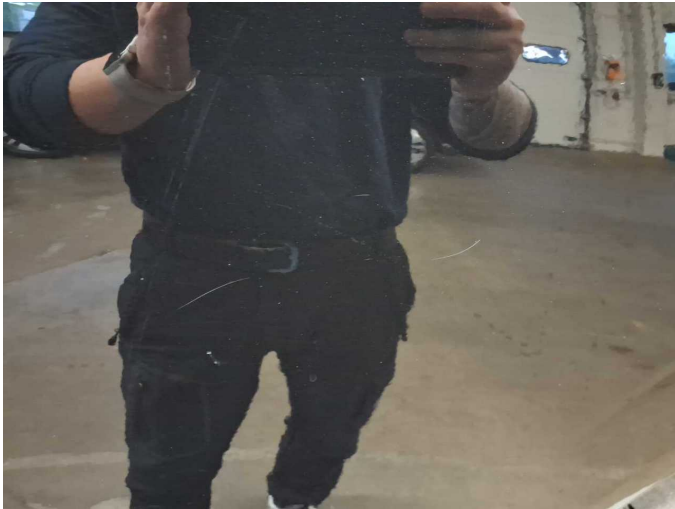
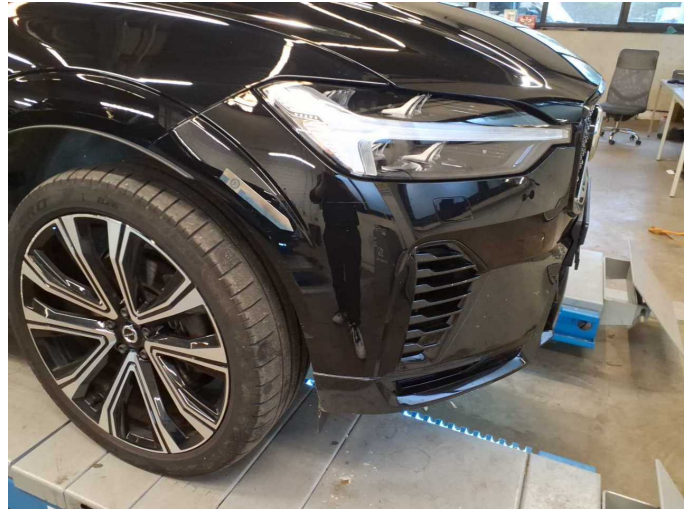
Damage 10: Door - rear left side: Door - Scratch(es) - Paint

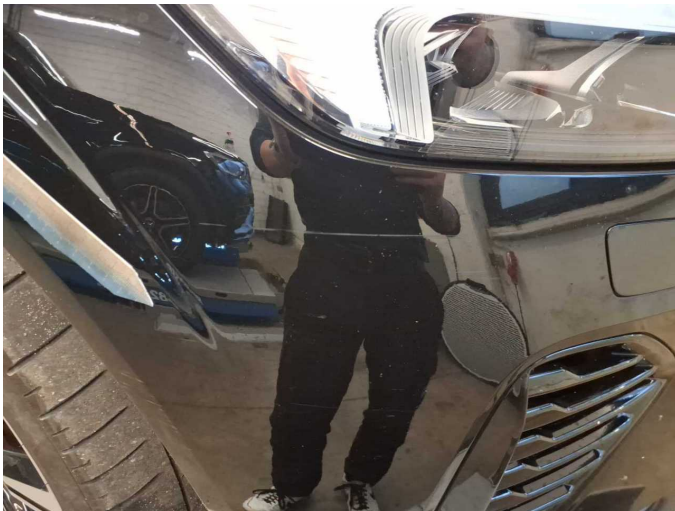
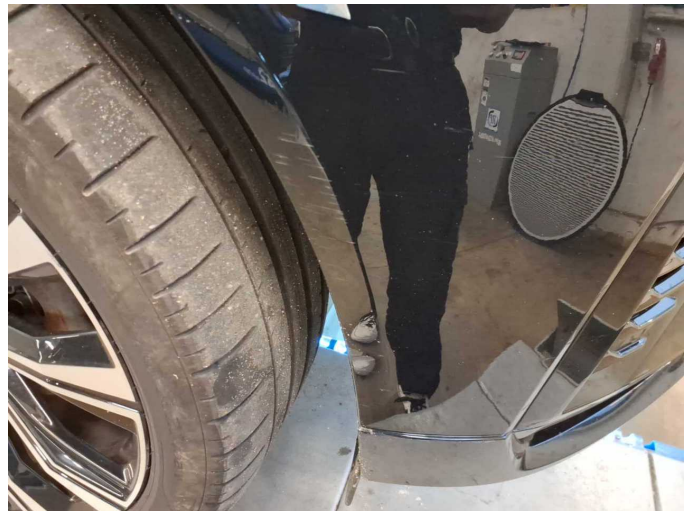
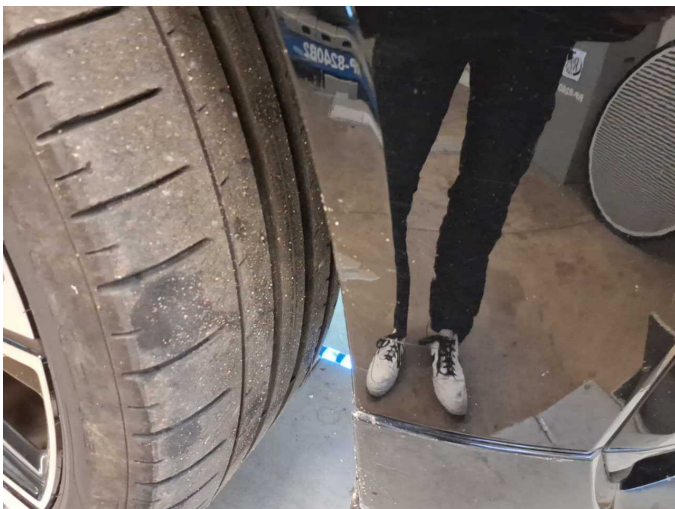
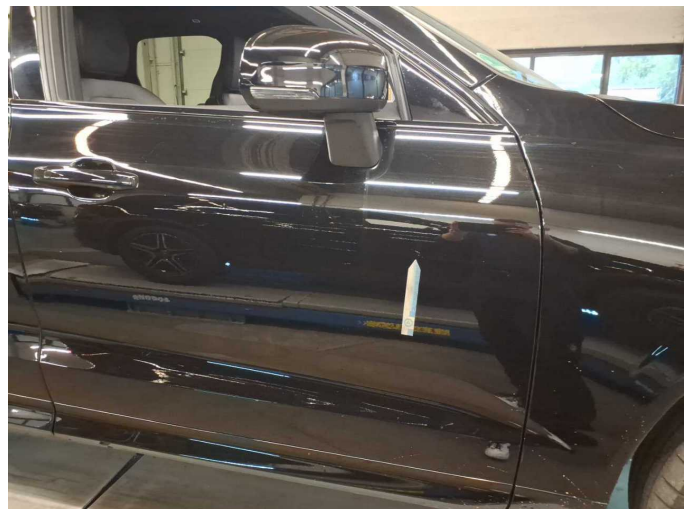
Damage 11: Front bumper: Front bumper - Scratch(es) - Paint

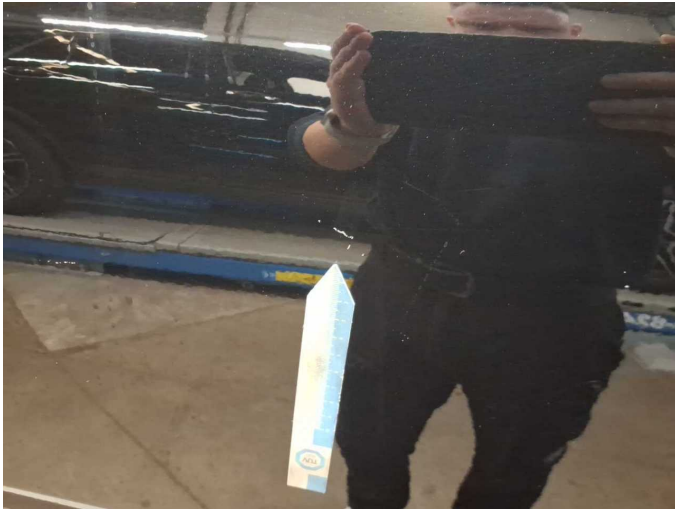
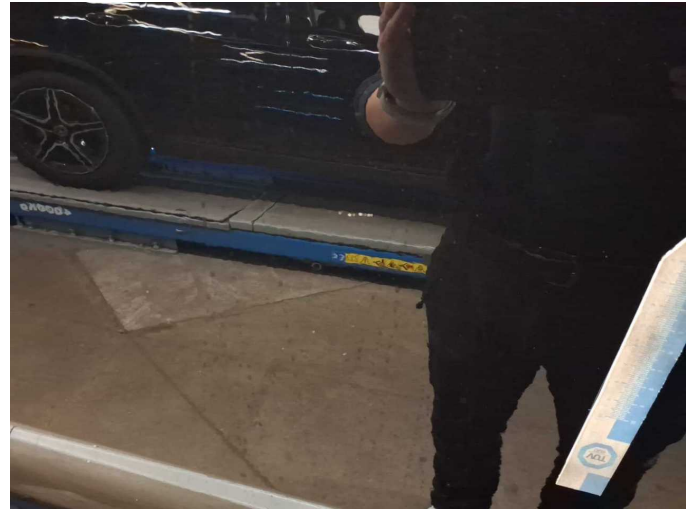
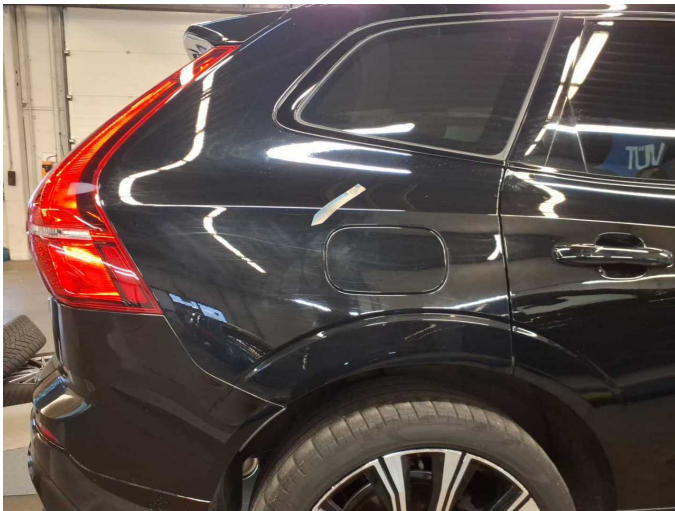
Damage 12: Door - front right side: Door - Scratch(es) - Paint

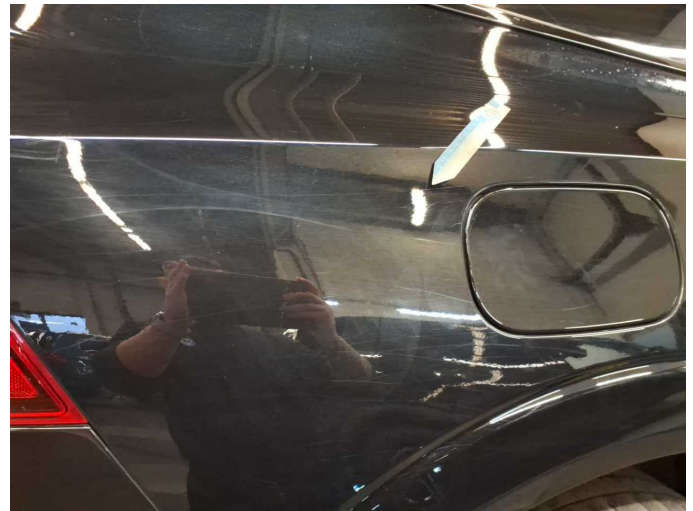
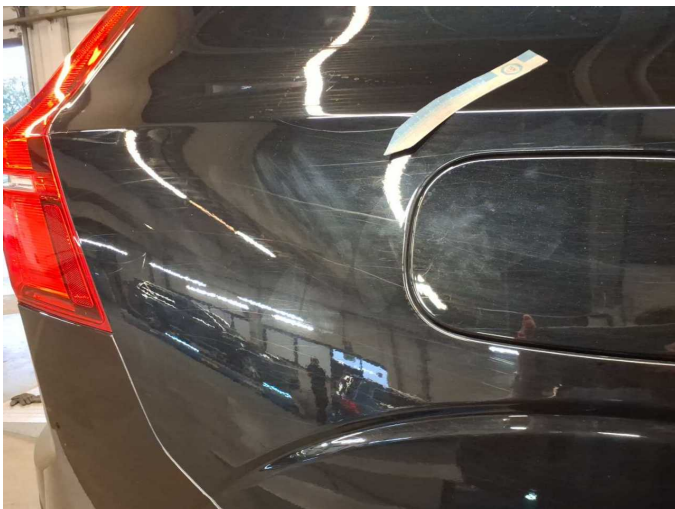
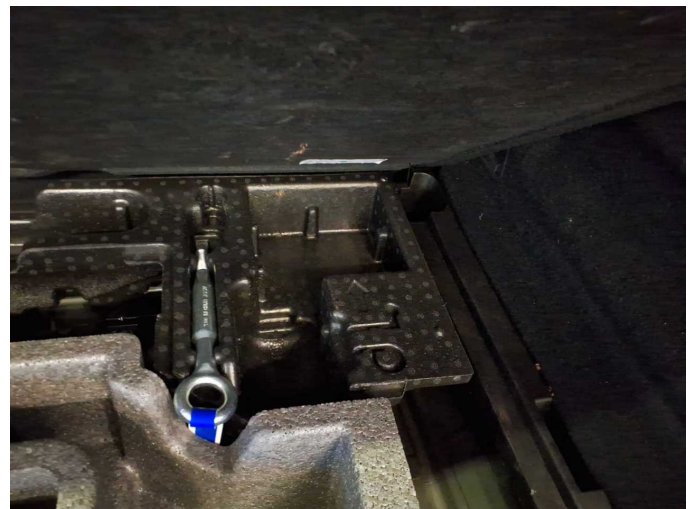
1 Side panel - rear right side, Unprofessionally carried out, Invoice of repair done Non-existent

Side panel - rear right side 195 µm |

Damage 13: Side panel - rear right side: Side panel (+ Kratzer) - Paint defect - Repair and paint

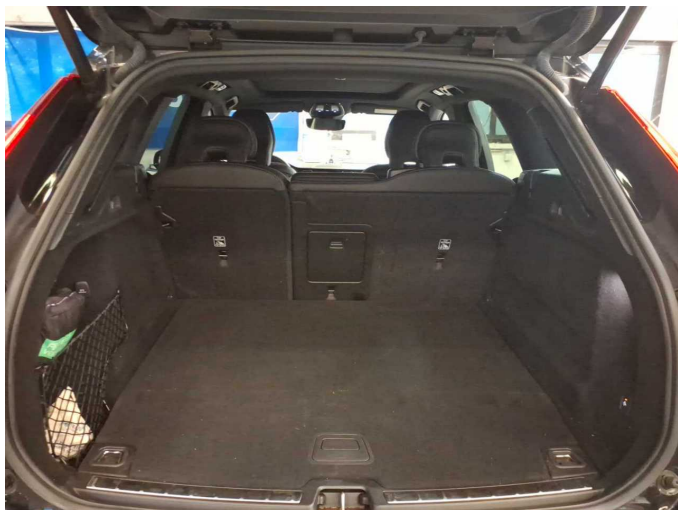
Missing part 1: Equipment: Tirefit complete - Missing - Replace

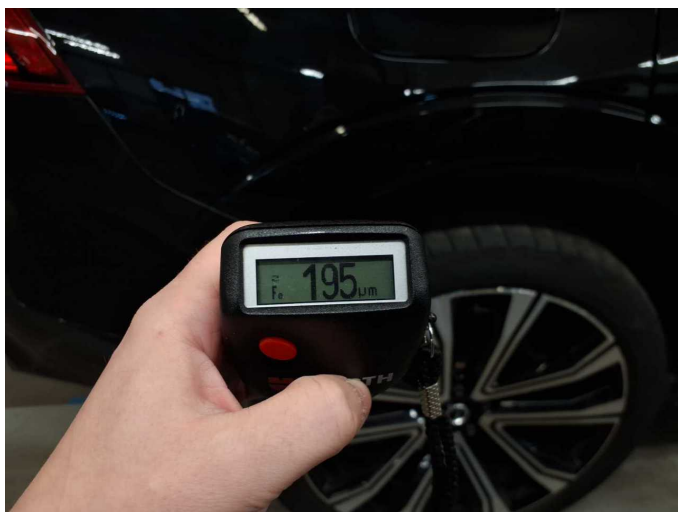
Repainting 1: Side panel - rear right side
