Expertise

Protocol number: 40020809
Order No. / Reference: 24848410
Inspection date: 4 Jun 2025

Manufacturer: Volvo

Model: XC60 T6 AWD Recharge Geartronic Inscription Expression

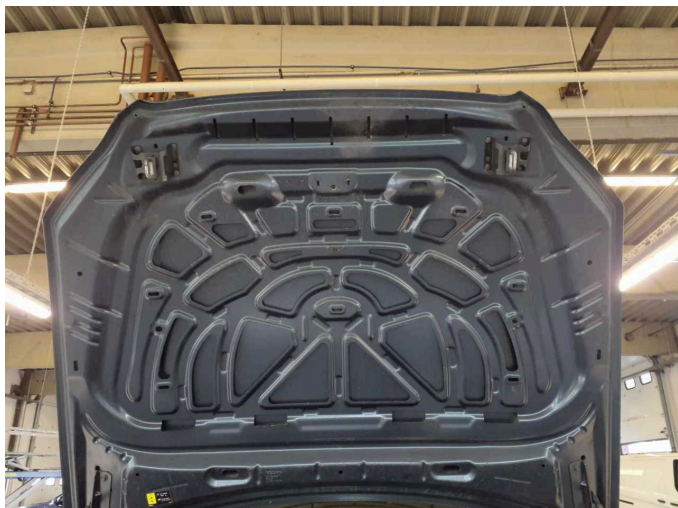
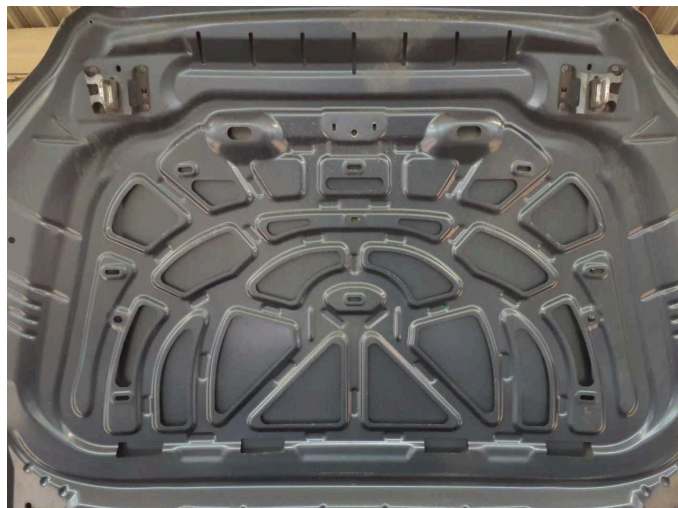
No.	Component group	Description
1	Bonnet	Insulation lining - Missing - Replace
2	Side panel - rear left side	Side panel (Farbnebel+Pickel) - Unprofessionally repaired - Paint
3	Bonnet	Bonnet (Sandstrahleffekt) - Scratch(es) - Paint
4	Front bumper	Front bumper - Scratch(es) - Paint

Damage 1: Bonnet: Insulation lining - Missing - Replace

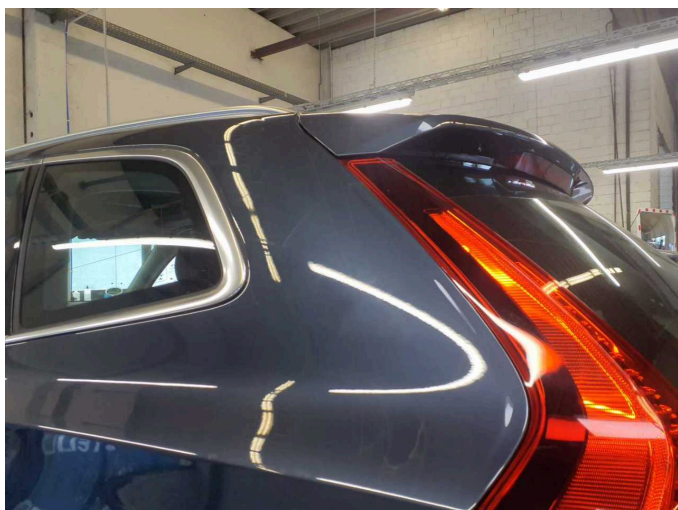
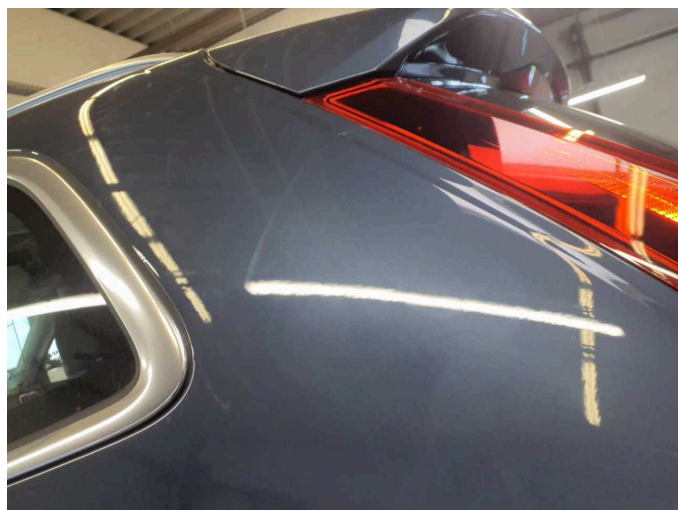
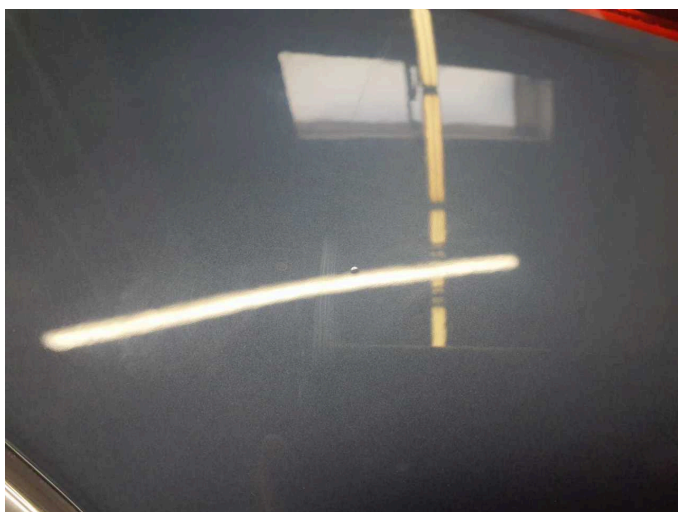
No.	Repainting
1	Roof rail - left side, Mudguard - left side, Door - front left side, Professionally carried out
2	Side panel - rear left side, Unprofessionally carried out

Roof rail - left side	181 µm	Mudguard - left side	248 µm
Side panel - rear left side	242 µm	Door - front left side	191 µm

Damage 2: Side panel - rear left side: Side panel (Farbnebel+Pickel) - Unprofessionally repaired - Paint

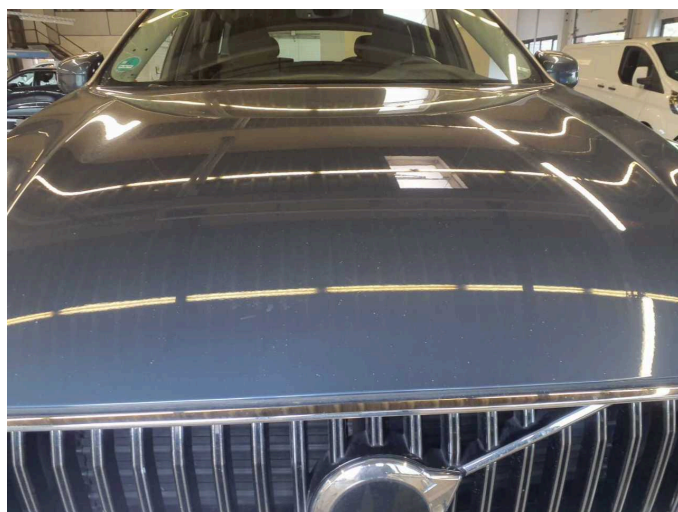
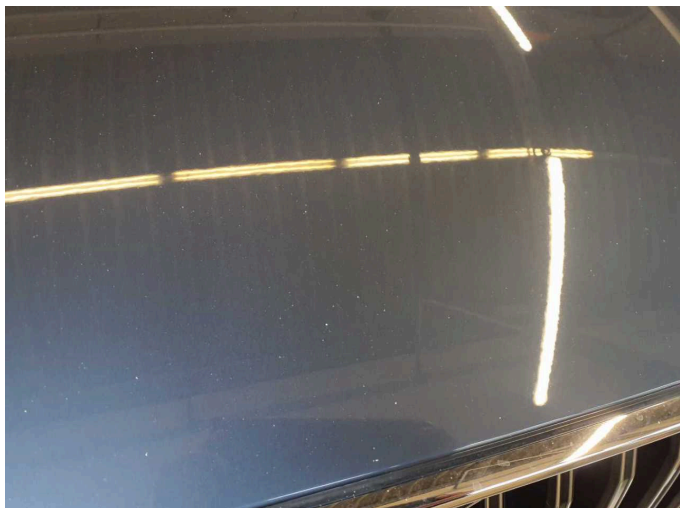
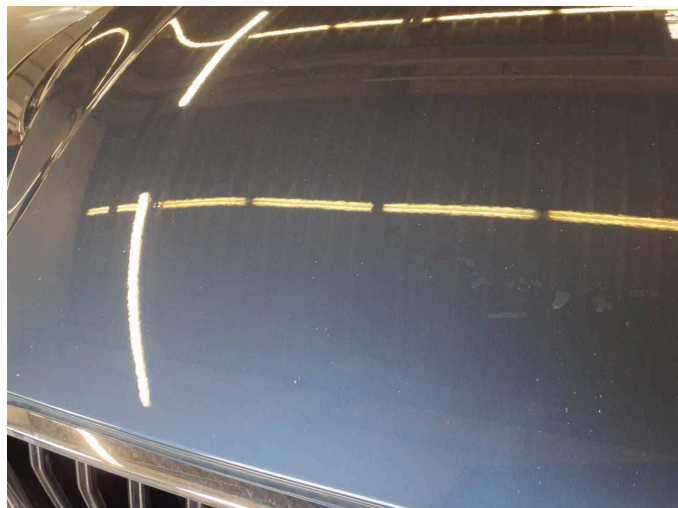
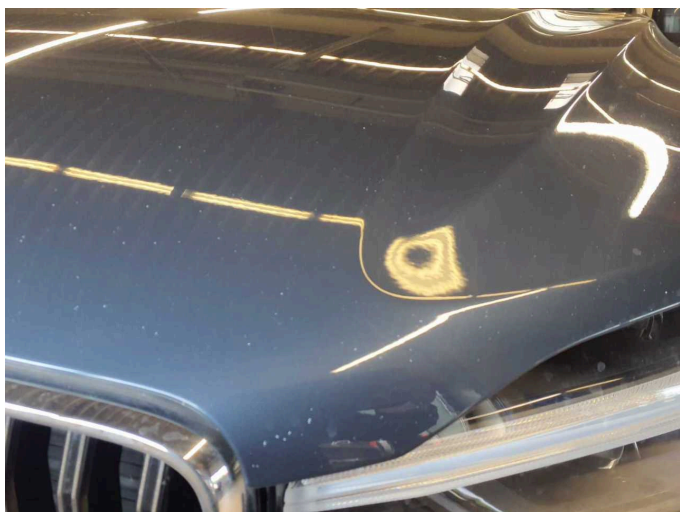
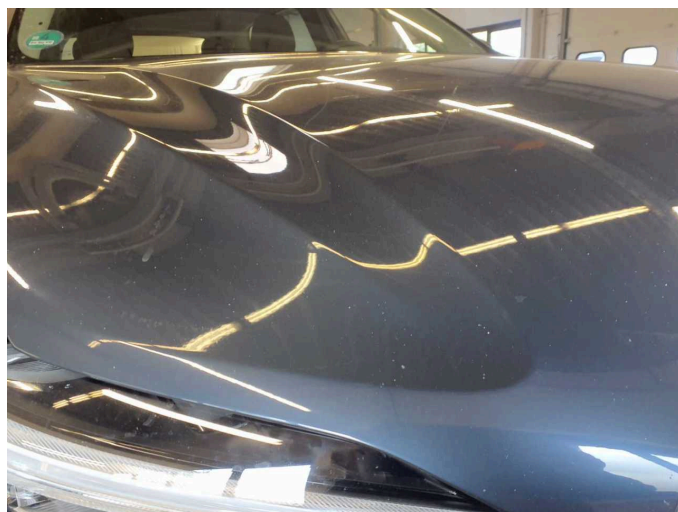
Damage 3: Bonnet: Bonnet (Sandstrahleffekt) - Scratch(es) - Paint

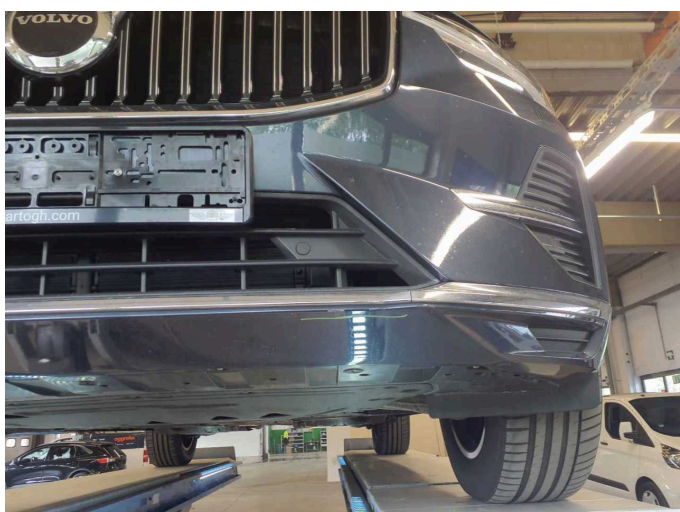
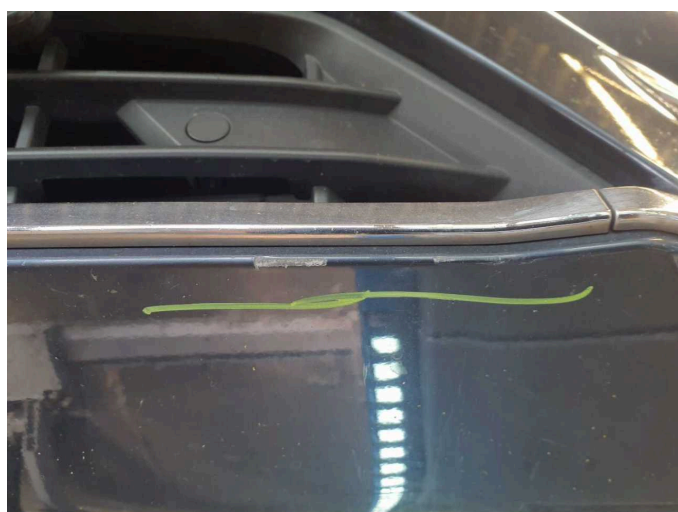
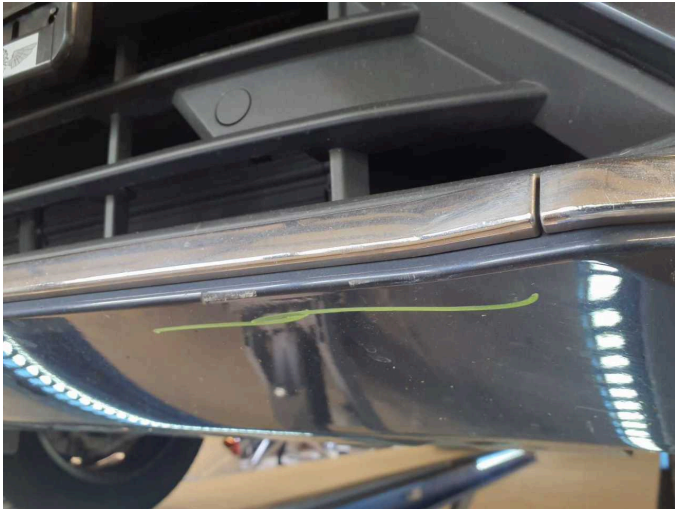
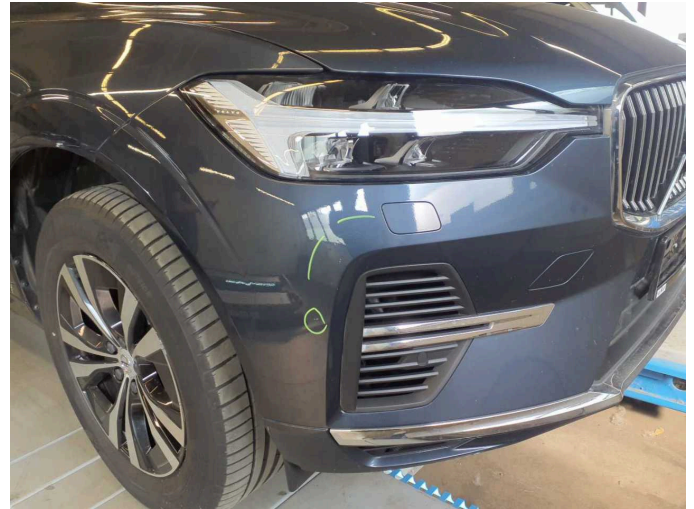
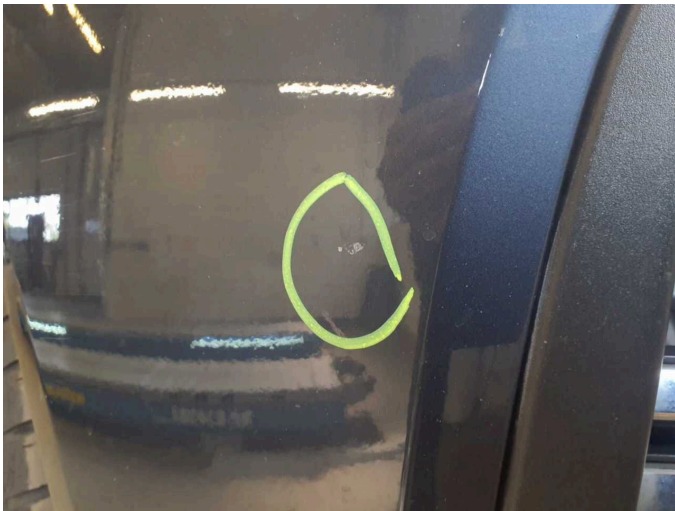
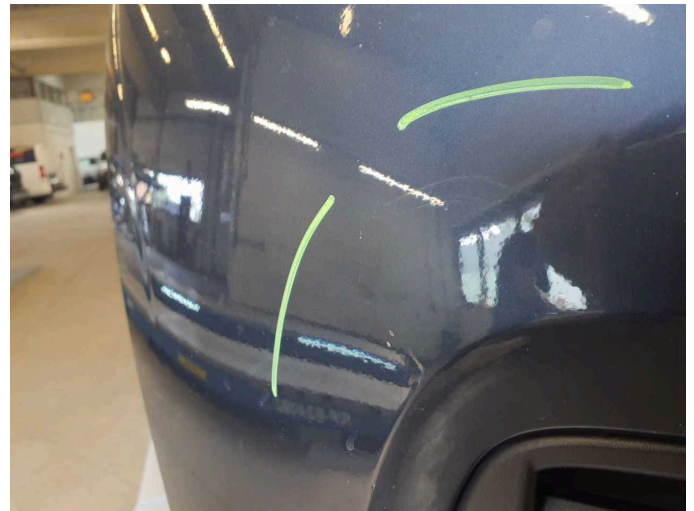
Damage 4: Front bumper: Front bumper - Scratch(es) - Paint

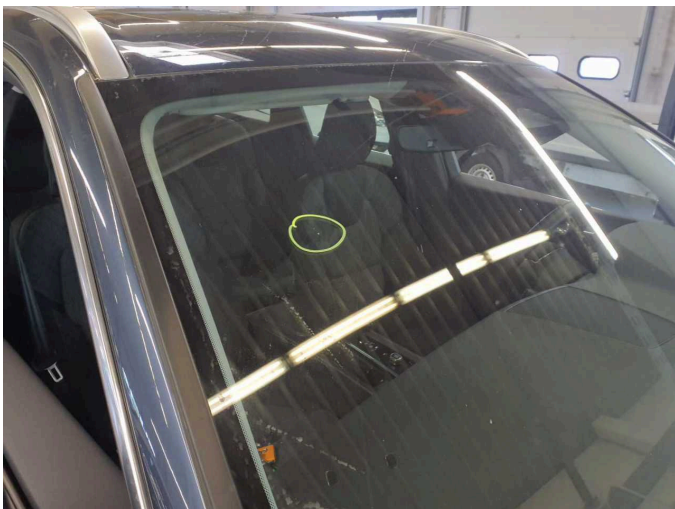
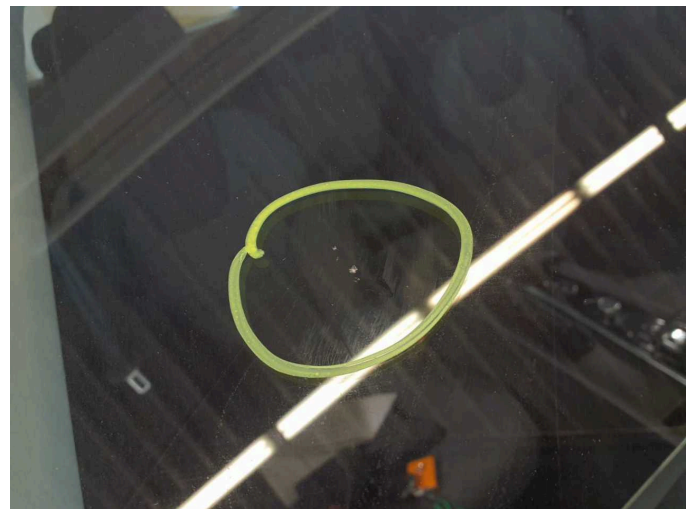
No.	Component group	Description
1	Vehicle glazing	Windscreen - Stone chips - No deduction

Wear and tear 1: Vehicle glazing: Windscreen - Stone chips - No deduction

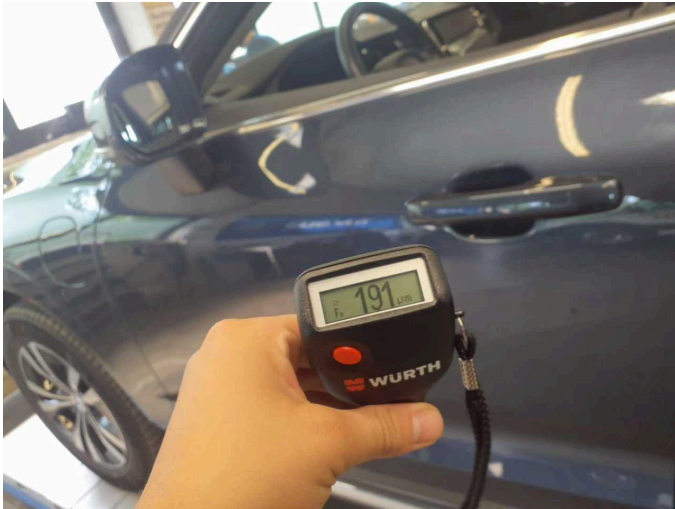
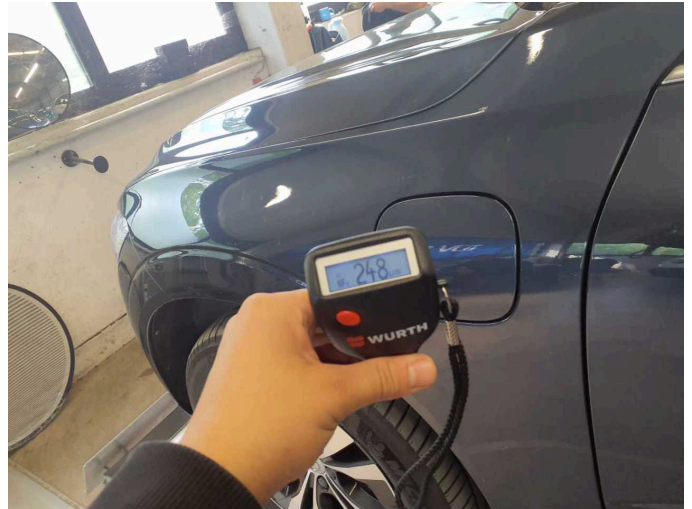
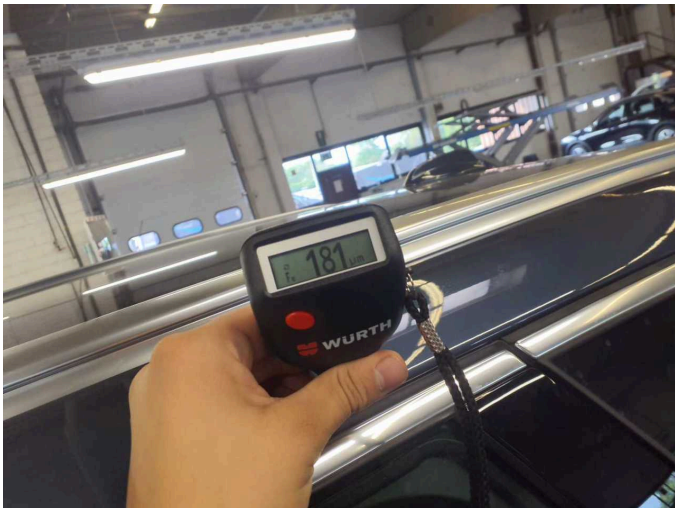
Repainting 1: Roof rail - left side, Mudguard - left side, Door - front left side

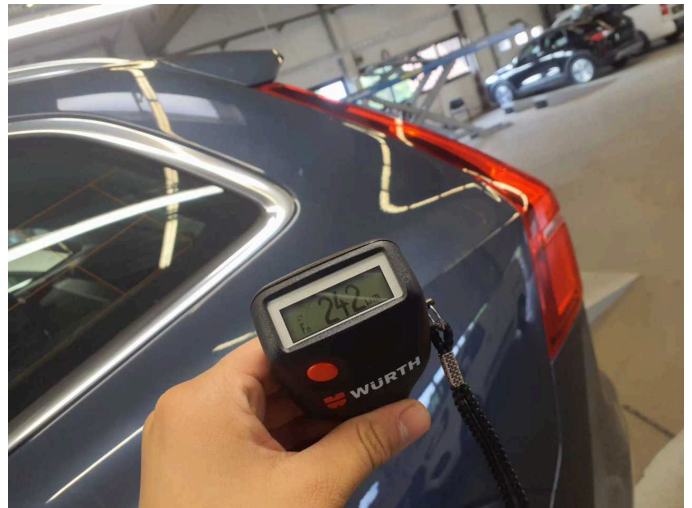
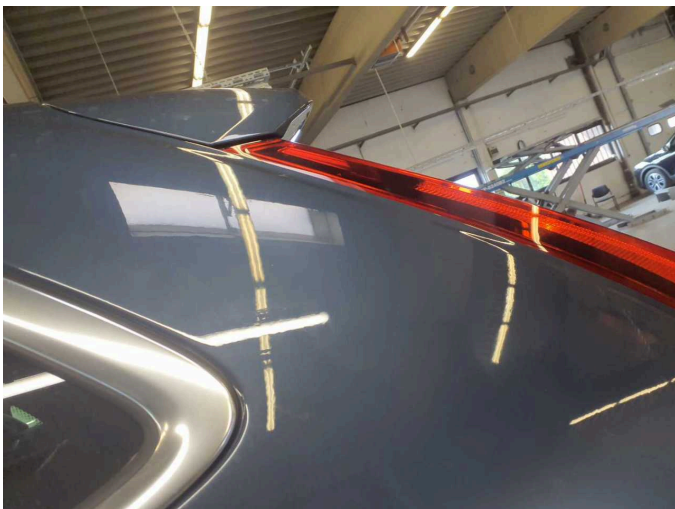
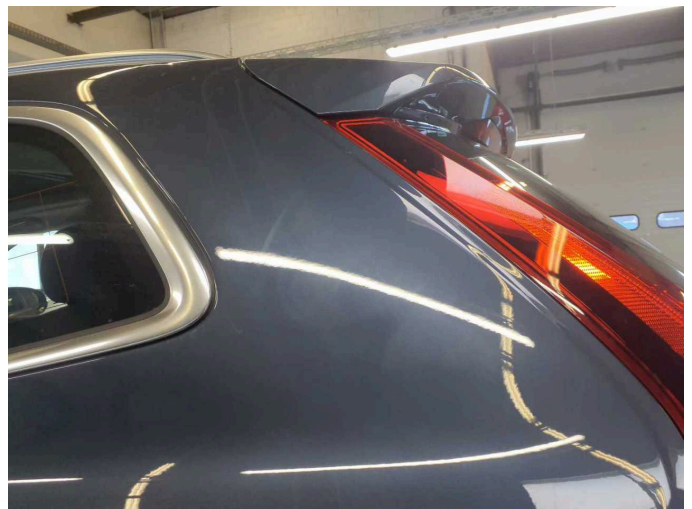
Repainting 2: Side panel - rear left side
