Expertise

Protocol number: 41419817 Order No. / Reference: 25197895 Inspection date: 9 Sept 2025

Manufacturer: Volvo

Model: XC60 T6 AWD Recharge Geartronic RDesign

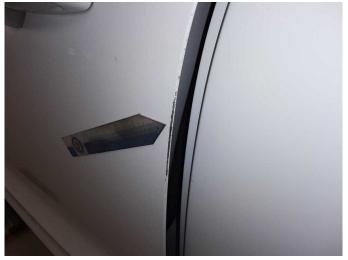
| NO. | Component group | Description |
|---|---|--|
| 1 | Door - front left side | Door - Scratch(es) - Smart repair |

Damage 1: Door - front left side: Door - Scratch(es) - Smart repair

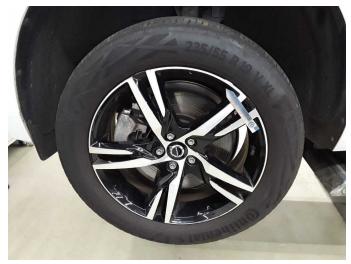
| NO. | Component group | Description |
|---|---|--|
| 2 | Wheel / tyres | Alloy rim - front left side - Scratched - Replace |

Damage 2: Wheel / tyres: Alloy rim - front left side - Scratched - Replace

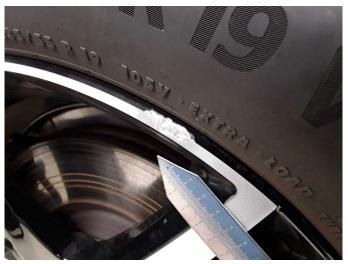
Damage 2: Wheel / tyres: Alloy rim - front left side - Scratched - Replace

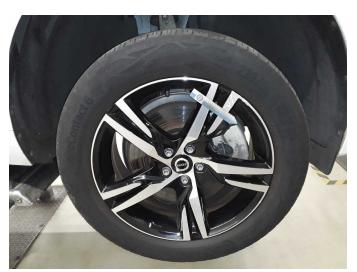
| NO. | Component group | Description |
|---|---|--|
| 3 | Wheel / tyres | Alloy rim - front right side - Scratched - Replace |

Damage 3: Wheel / tyres: Alloy rim - front right side - Scratched - Replace

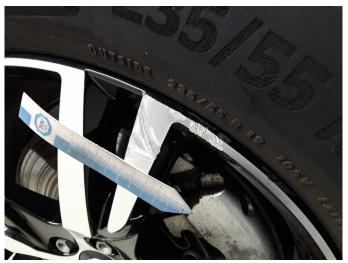
Damage 3: Wheel / tyres: Alloy rim - front right side - Scratched - Replace

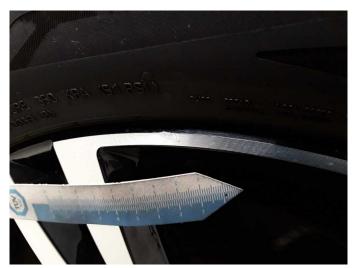
Damage 3: Wheel / tyres: Alloy rim - front right side - Scratched - Replace

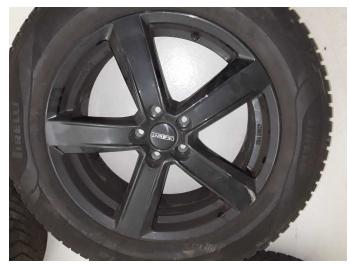
| No. | Component group | Description |
|---|---|---|
| 4 | 2nd wheel set | 1 alloy rim - Scratched - No deduction |

Wear and tear 4: 2nd wheel set: 1 alloy rim - Scratched - No deduction

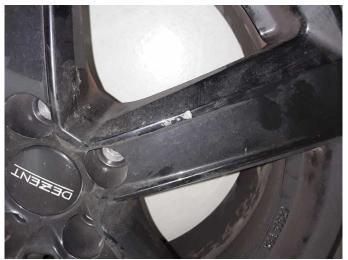
Wear and tear 4: 2nd wheel set: 1 alloy rim - Scratched - No deduction

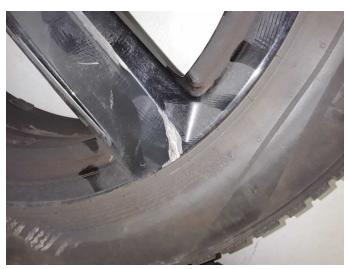
Wear and tear 4: 2nd wheel set: 1 alloy rim - Scratched - No deduction

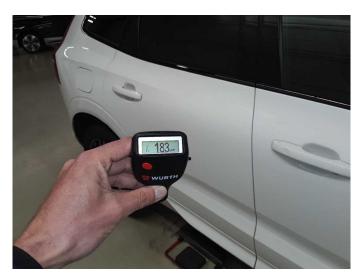
1 Door - rear right side, Professionally carried out

Door - rear right side: 183 μm
