## FORD Ka+ Ka+ 1.2 Ti-VCT

VIN NO MAJUXXMTKUH79053

### Inspection Report Summary

Customer	BCA Online	Report Number	P20250925125950
Inspection Date / Place	2025-09-25 / ARS Altmann AG Wolnzach	Cosmetic Grade	3

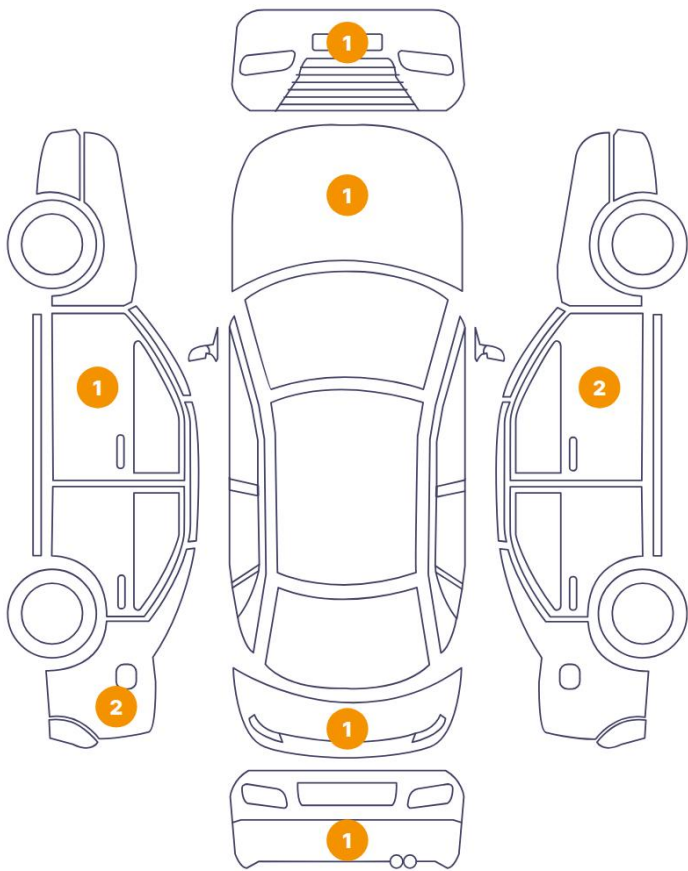
9 Schäden

Component	Damage	Comments
1 Hood	Bodywork / Dent / Dent	
2 Door / Front Left	Paint / Scratch / Scuff	
3 Side Panel / Back Left	Bodywork / Dent / Dent	
4 Side Panel / Back Left	Paint / Scratch / Scuff	
5 Bumper / Back	Paint / Scratch / Scuff	
6 Tailgate	Bodywork / Dent / Dent	
7 Door Handle / Front Right	Paint / Scratch / Scuff	
8 Mirror Shell / Front Right	Paint / Scratch / Scuff	
9 Bumper / Front	Paint / Stone Chip

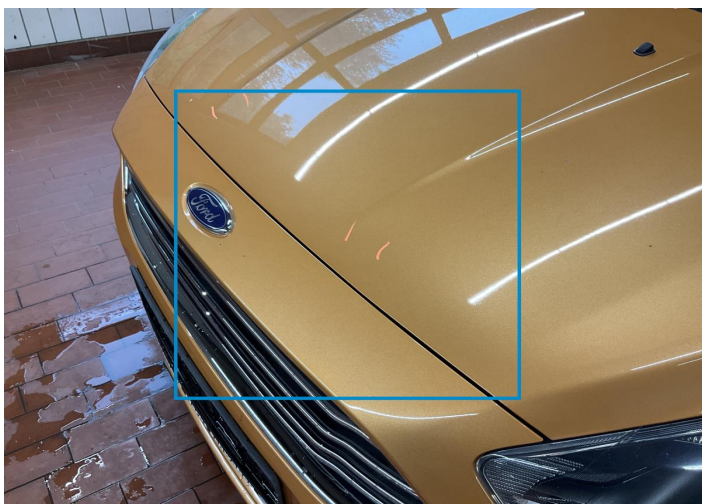
1. Hood  
Bodywork / Dent / Dent -

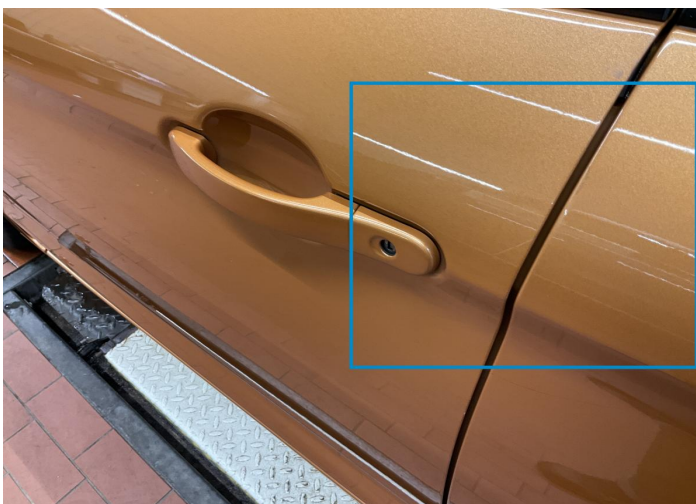
2. Door / Front Left  
Paint / Scratch / Scuff -

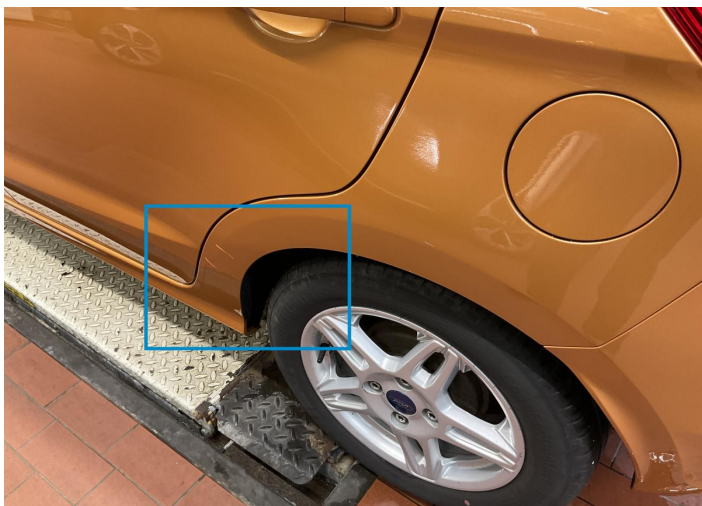
3. Side Panel / Back Left  
Bodywork / Dent / Dent -

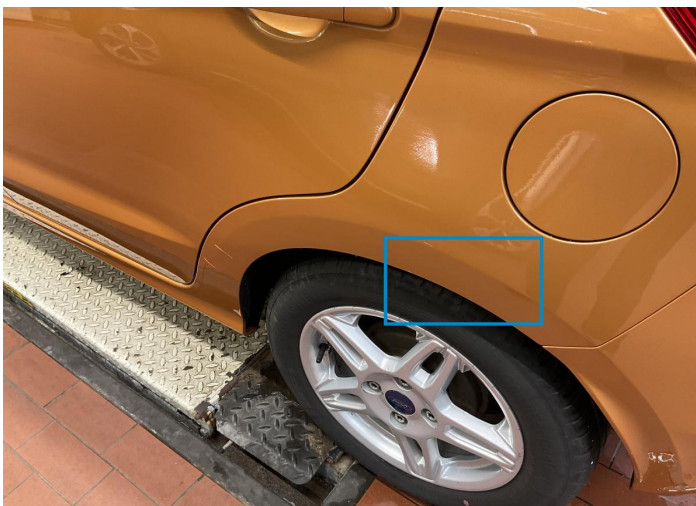
4. Side Panel / Back Left  
Paint / Scratch / Scuff -

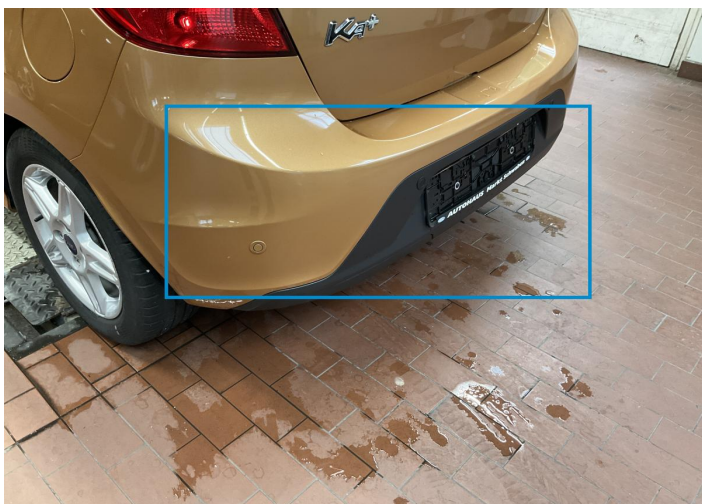
5. Bumper / Back  
Paint / Scratch / Scuff -

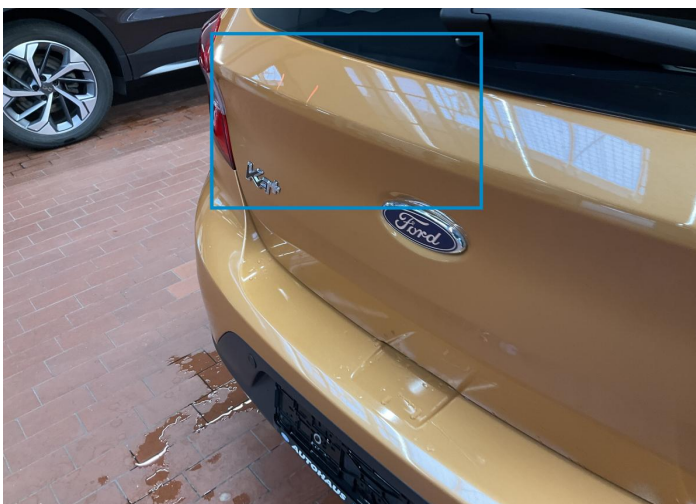
6. Tailgate  
Bodywork / Dent / Dent -

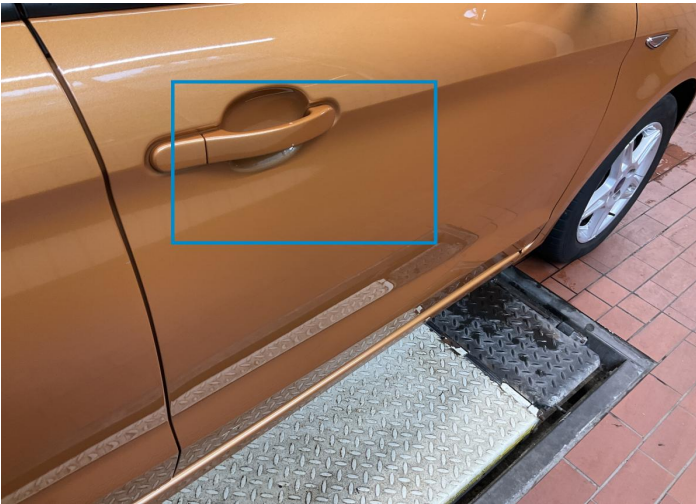
7. Door Handle / Front Right  
Paint / Scratch / Scuff -

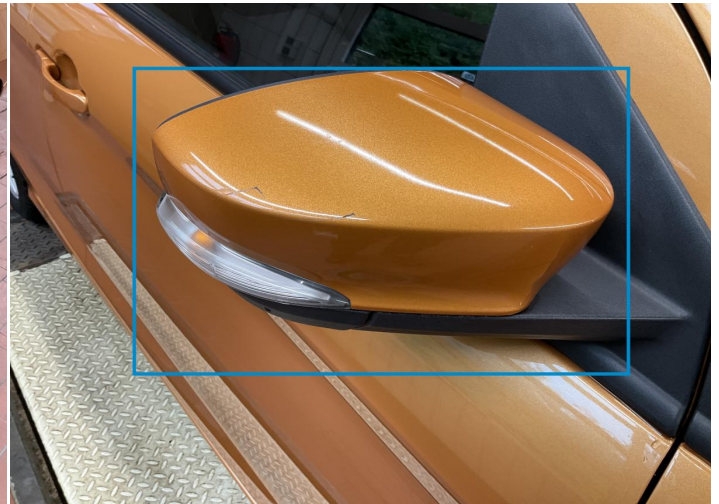
8. Mirror Shell / Front Right  
Paint / Scratch / Scuff -

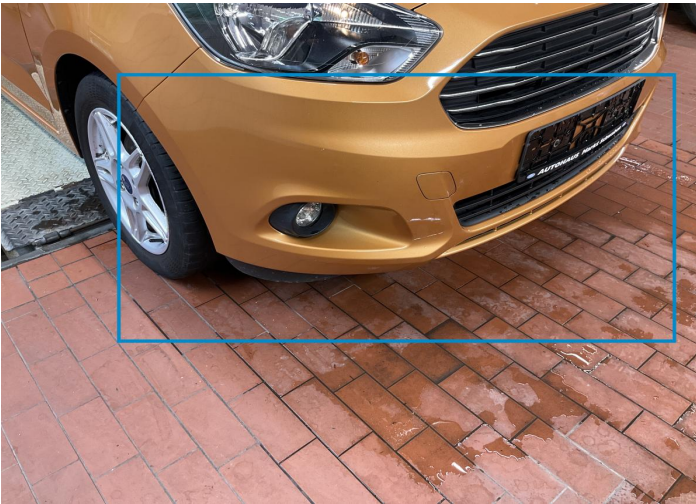
9. Bumper / Front  
Paint / Stone Chip -
