# HYUNDAI BAYON

## Bayon 1.0 T-GDi 100 Hybrid 48V Creative

VIN NO NLHBR81G0SZ559854

### Inspection Report Summary

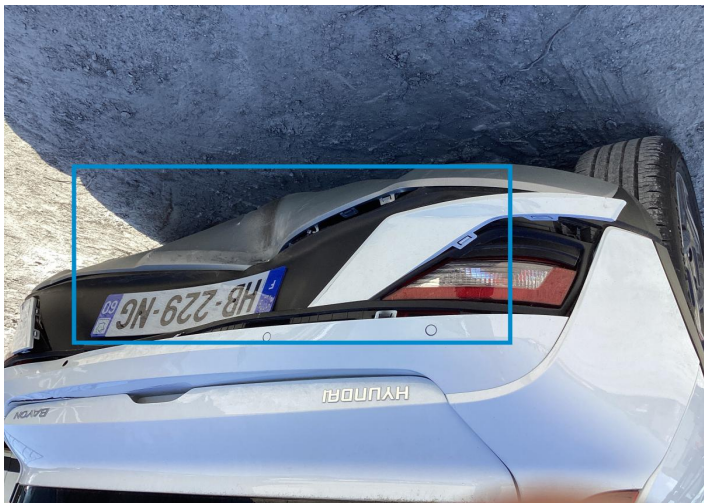
| Component | | Damage | Comments |
|---|---|---|---|
| 1 | Bumper / Back | Bodywork / Dent / Deformation | |

1. Bumper / Back  
Bodywork / Dent / Deformation -

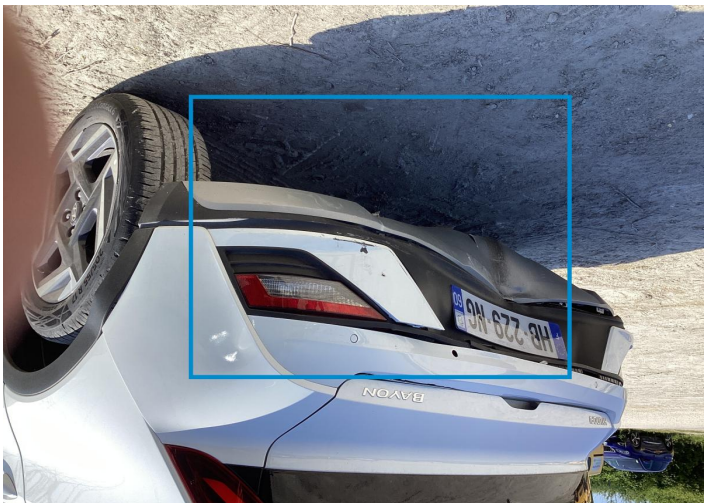
| Component | | Damage | Comments |
|---|---|---|---|
| 2 | Bumper / Back | Bodywork / Dent / Deformation | |

2. Bumper / Back  
Bodywork / Dent / Deformation -

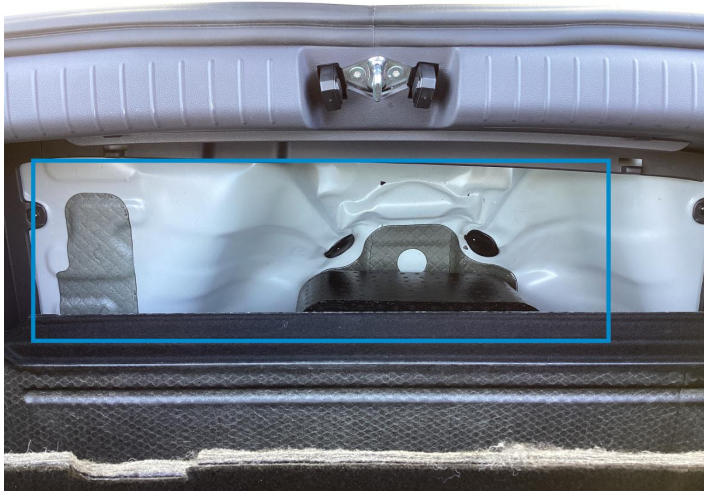
| Component | | Damage | Comments |
|---|---|---|---|
| 3 | Trunk Upholstery / Back | Interior / Dented | |

3. Trunk Upholstery / Back  
Interior / Dented -
