## TOYOTA Auris Auris 1.33 Dual-VVT-i

VIN NO NMTJT56E30R003224
Registration Number E30R003224

### **Inspection Report Summary**

Customer	BCA Online	Report Number	P20250819122929
Inspection Date / Place	2025-08-19 / BCA Berlin	Cosmetic Grade	5

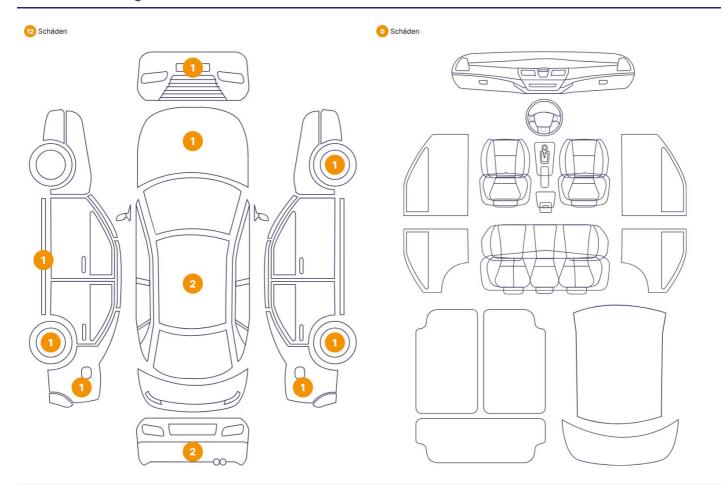
Component	Damage	Comments
1	Hood	Paint / Chipping	
2	Roof	Bodywork / Dent / Dent	
3	Rocker Panel / Center Left	Paint / Scratch / Scuff	
4	Side Panel / Back Left	Paint / Scratch / Scuff	
5	Rim / Back Left	Out of Bodywork / Scratch	
6	Bumper / Back	Bodywork / Breakage / Crack	
7	Roof	Bodywork / Dent / Dent	
8	Bumper / Back	Bodywork / Breakage / Crack	
9	Side Panel / Back Right	Bodywork / Breakage / Crack	
10	Rim / Back Right	Out of Bodywork / Scratch	
11	Bumper / Front	Paint / Scratch / Scuff	
12	Rim / Front Right	Out of Bodywork / Scratch

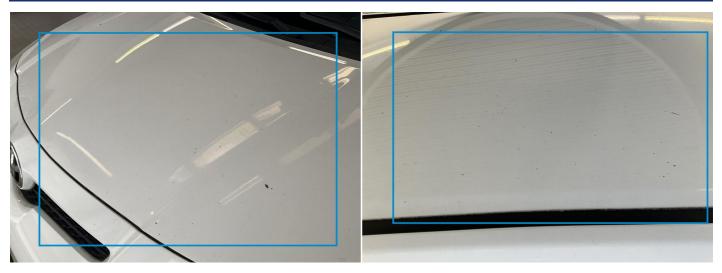
1. Hood Paint / Chipping -

2. Roof Bodywork / Dent / Dent -

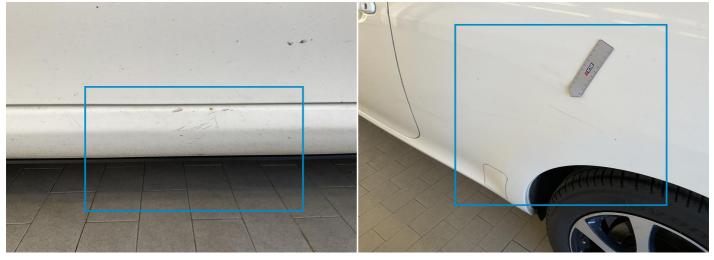
3. Rocker Panel / Center Left Paint / Scratch / Scuff -

4. Side Panel / Back Left Paint / Scratch / Scuff -

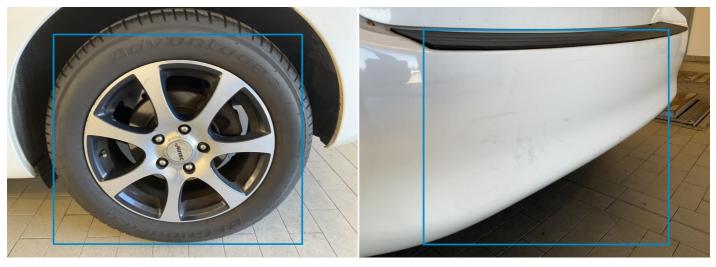
5. Rim / Back Left Out of Bodywork / Scratch -

6. Bumper / Back Bodywork / Breakage / Crack -

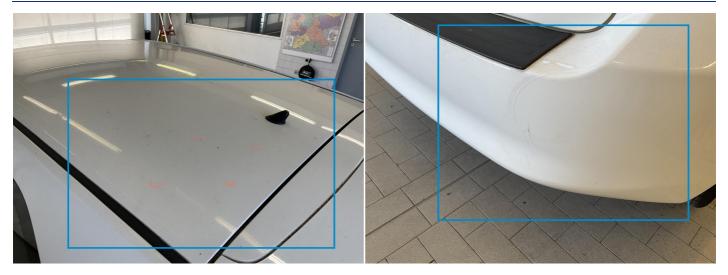
7. Roof Bodywork / Dent / Dent -

8. Bumper / Back Bodywork / Breakage / Crack -

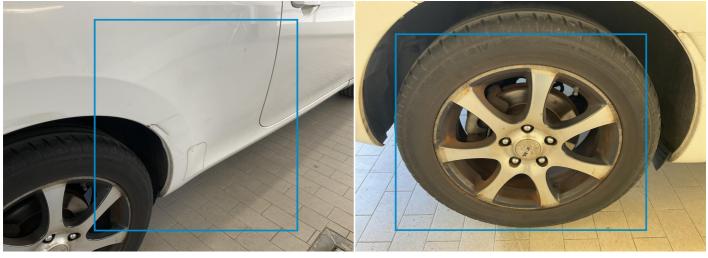
9. Side Panel / Back Right Bodywork / Breakage / Crack -

10. Rim / Back Right Out of Bodywork / Scratch -

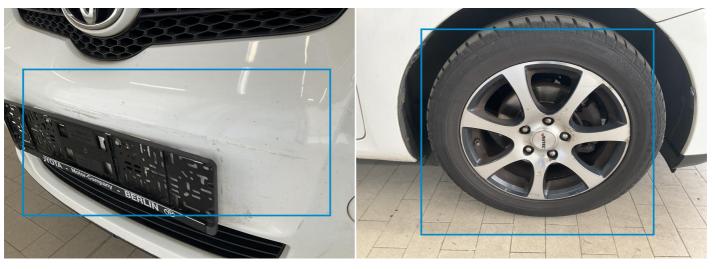
11. Bumper / Front Paint / Scratch / Scuff -

12. Rim / Front Right
Out of Bodywork / Scratch -
