# TOYOTA Auris

## Auris 1.33 Dual-VVT-i

VIN NO NMTJT56E30R003224  
Registration Number E30R003224

| Customer | BCA Online | Report Number | P20250819122929 |

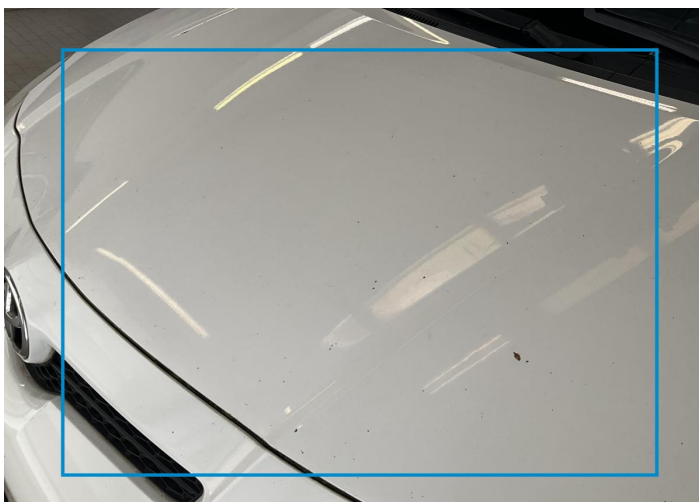
| Component | | Damage | Comments |
|---|---|---|---|
| 1 | Hood | Paint / Chipping | |

1. Hood  
Paint / Chipping -

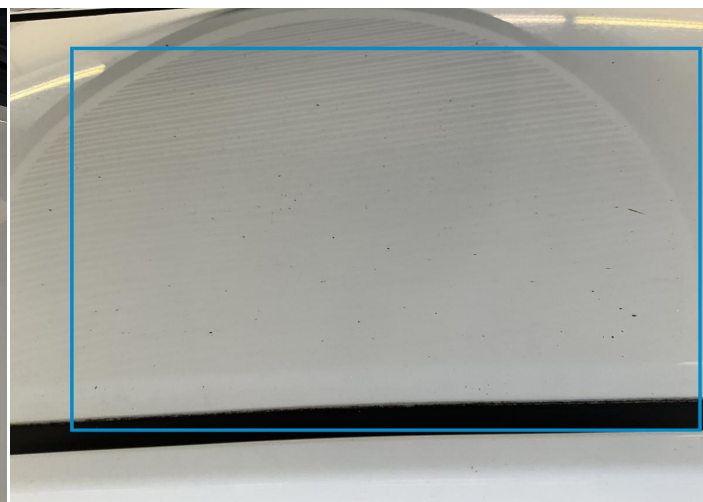
| Component | | Damage | Comments |
|---|---|---|---|
| 2 | Roof | Bodywork / Dent / Dent | |

2. Roof  
Bodywork / Dent / Dent -

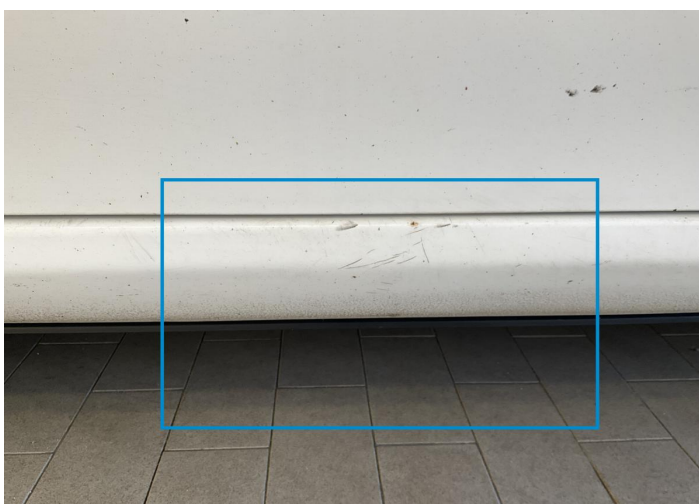
| Component | | Damage | Comments |
|---|---|---|---|
| 3 | Rocker Panel / Center Left | Paint / Scratch / Scuff | |

3. Rocker Panel / Center Left  
Paint / Scratch / Scuff -

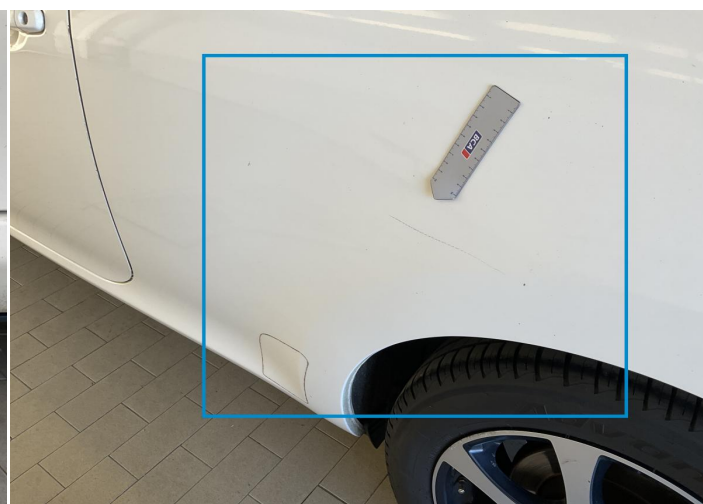
| Component | | Damage | Comments |
|---|---|---|---|
| 4 | Side Panel / Back Left | Paint / Scratch / Scuff | |

4. Side Panel / Back Left  
Paint / Scratch / Scuff -

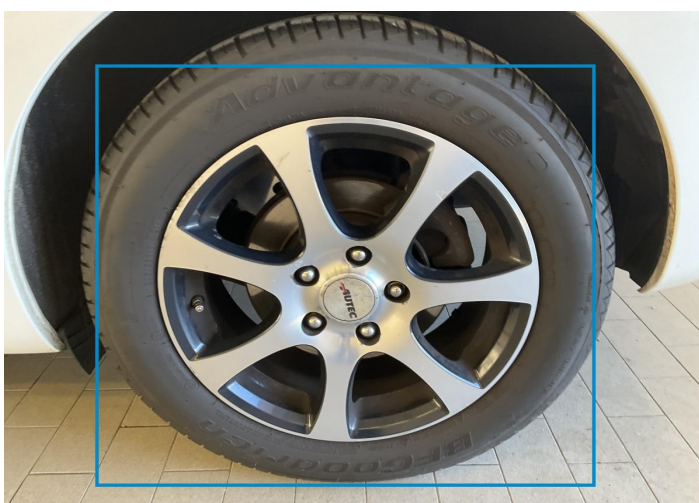
| Component | | Damage | Comments |
|---|---|---|---|
| 5 | Rim / Back Left | Out of Bodywork / Scratch | |

5. Rim / Back Left  
Out of Bodywork / Scratch -

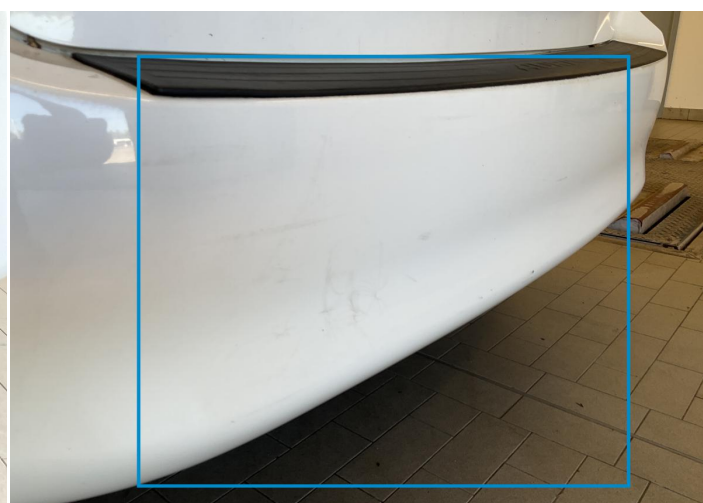
| Component | | Damage | Comments |
|---|---|---|---|
| 6 | Bumper / Back | Bodywork / Breakage / Crack | |

6. Bumper / Back  
Bodywork / Breakage / Crack -

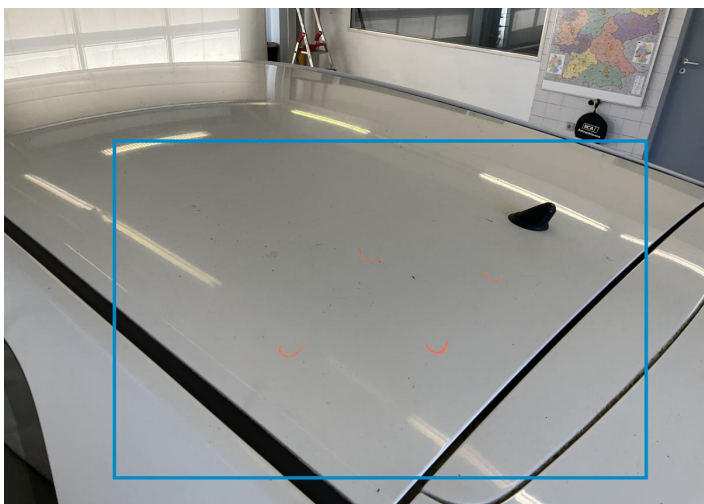
| Component | | Damage | Comments |
|---|---|---|---|
| 7 | Roof | Bodywork / Dent / Dent | |

7. Roof  
Bodywork / Dent / Dent -

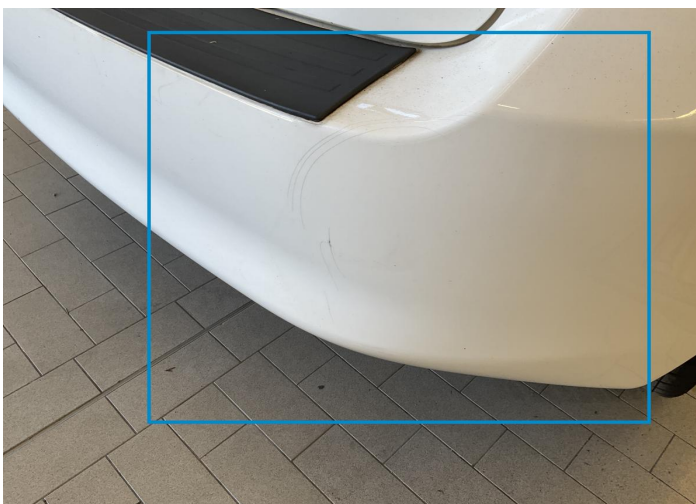
| Component | | Damage | Comments |
|---|---|---|---|
| 8 | Bumper / Back | Bodywork / Breakage / Crack | |

8. Bumper / Back  
Bodywork / Breakage / Crack -

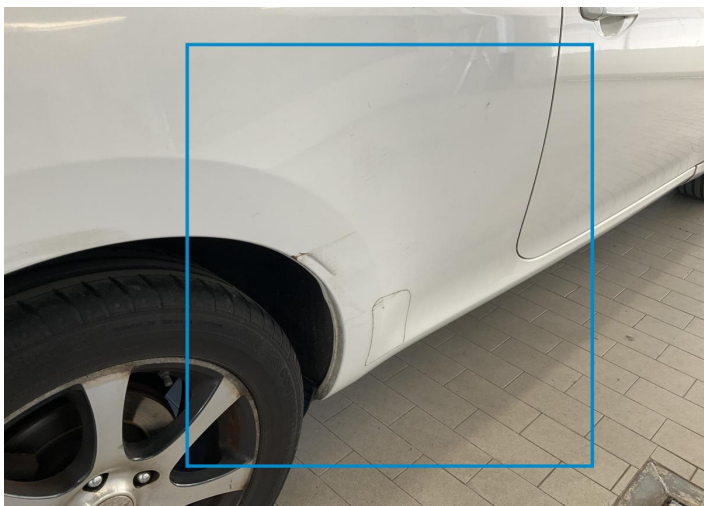
| Component | | Damage | Comments |
|---|---|---|---|
| 9 | Side Panel / Back Right | Bodywork / Breakage / Crack | |

9. Side Panel / Back Right  
Bodywork / Breakage / Crack -

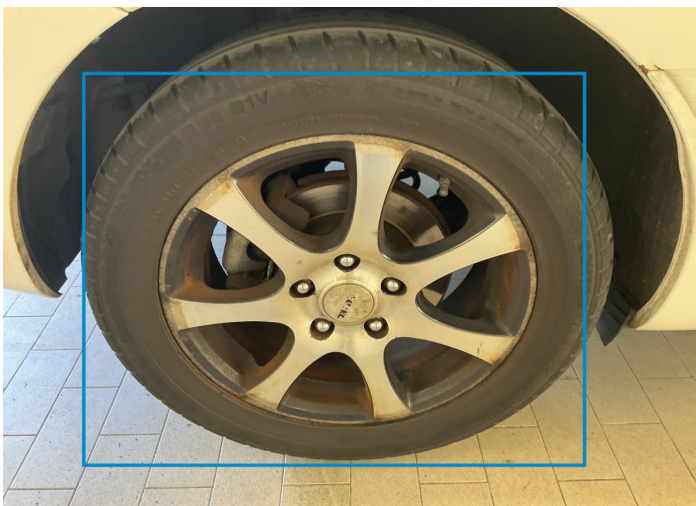
| Component | | Damage | Comments |
|---|---|---|---|
| 10 | Rim / Back Right | Out of Bodywork / Scratch | |

10. Rim / Back Right  
Out of Bodywork / Scratch -

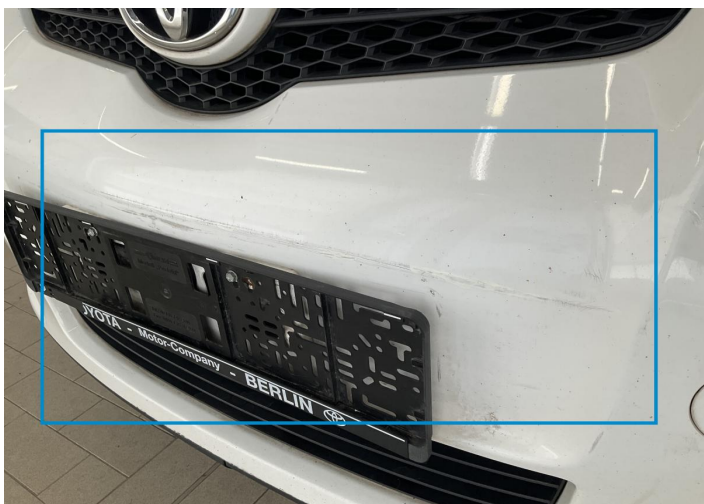
| Component | | Damage | Comments |
|---|---|---|---|
| 11 | Bumper / Front | Paint / Scratch / Scuff | |

11. Bumper / Front  
Paint / Scratch / Scuff -

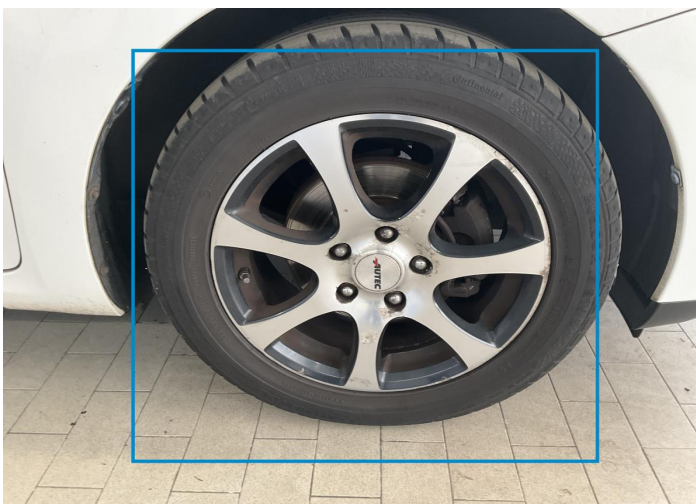
| Component | | Damage | Comments |
|---|---|---|---|
| 12 | Rim / Front Right | Out of Bodywork / Scratch | |

12. Rim / Front Right  
Out of Bodywork / Scratch -
