# TOYOTA Auris

## Auris 1.33 Dual-VVT-i

VIN NO NMTJT56E30R003224  
Registration Number E30R003224

### Inspection Report Summary

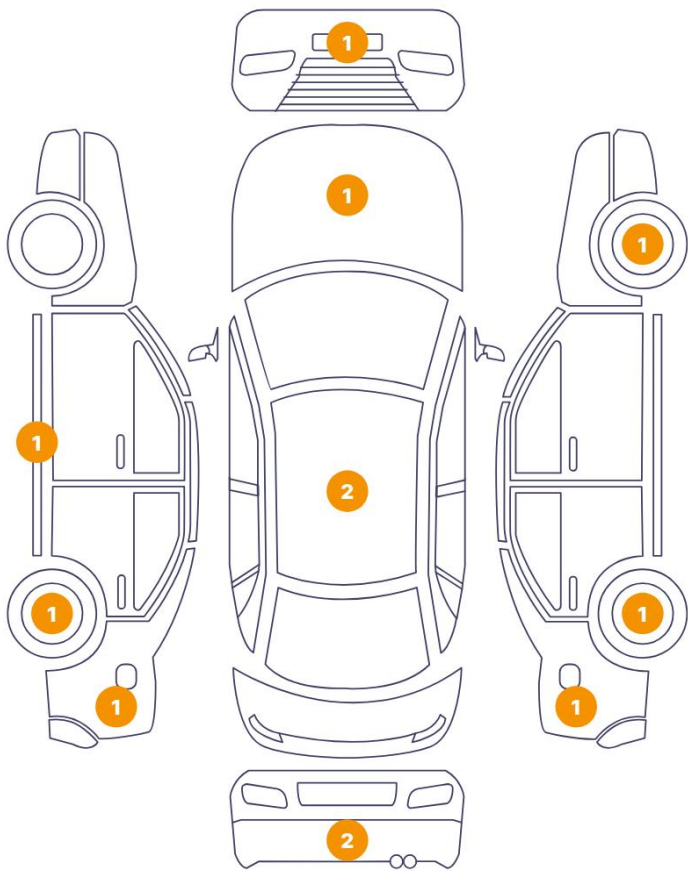
12 Schäden

Component		Damage	Comments
1	Hood	Paint / Chipping	
2	Roof	Bodywork / Dent / Dent	
3	Rocker Panel / Center Left	Paint / Scratch / Scuff	
4	Side Panel / Back Left	Paint / Scratch / Scuff	
5	Rim / Back Left	Out of Bodywork / Scratch	
6	Bumper / Back	Bodywork / Breakage / Crack	
7	Roof	Bodywork / Dent / Dent	
8	Bumper / Back	Bodywork / Breakage / Crack	
9	Side Panel / Back Right	Bodywork / Breakage / Crack	
10	Rim / Back Right	Out of Bodywork / Scratch	
11	Bumper / Front	Paint / Scratch / Scuff	
12	Rim / Front Right	Out of Bodywork / Scratch

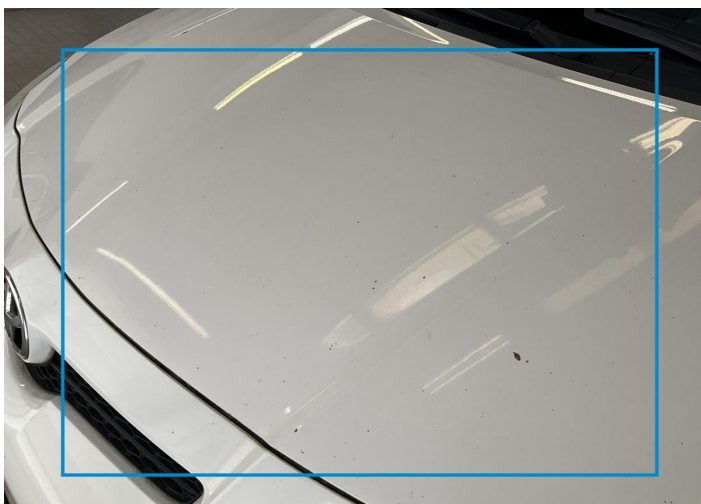
1. Hood  
Paint / Chipping -

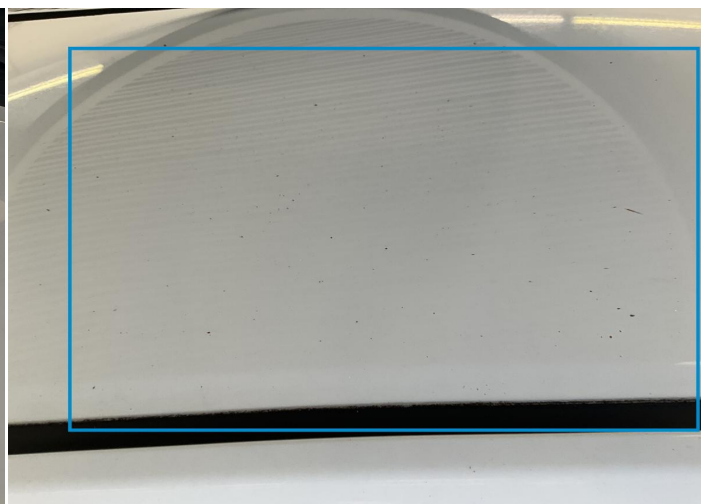
2. Roof  
Bodywork / Dent / Dent -

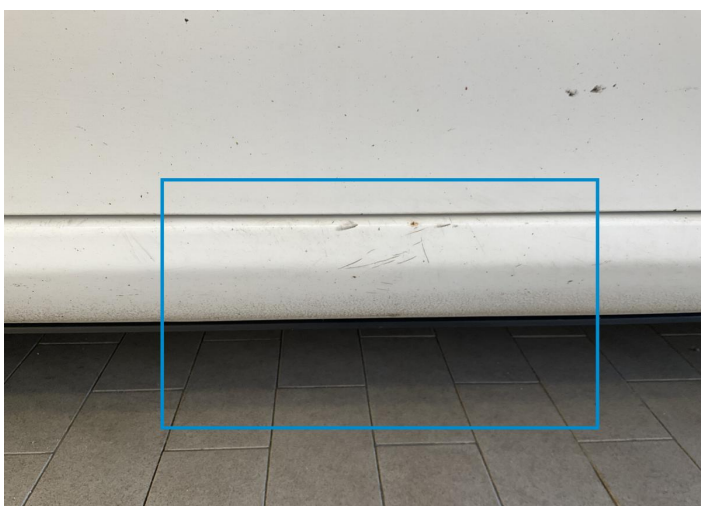
3. Rocker Panel / Center Left  
Paint / Scratch / Scuff -

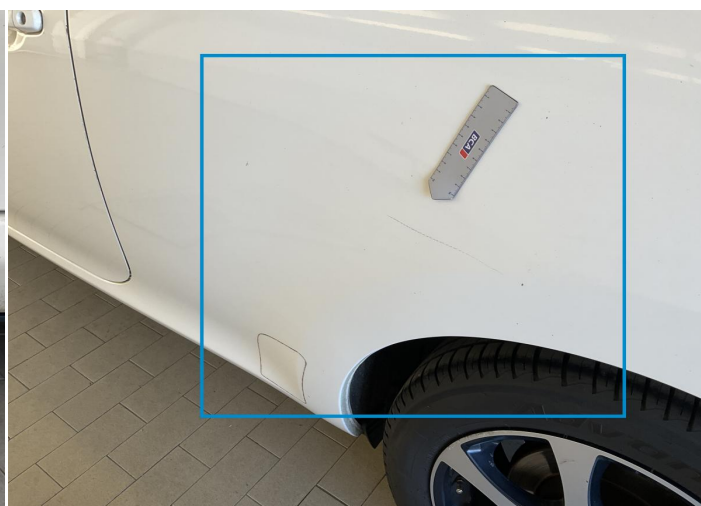
4. Side Panel / Back Left  
Paint / Scratch / Scuff -

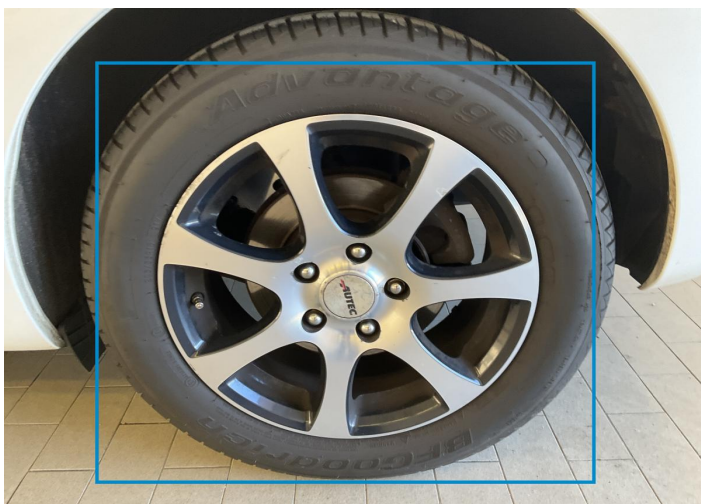
5. Rim / Back Left  
Out of Bodywork / Scratch -

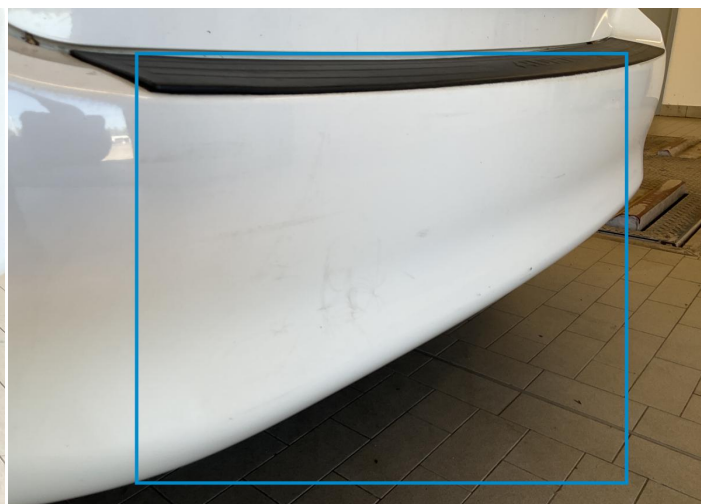
6. Bumper / Back  
Bodywork / Breakage / Crack -

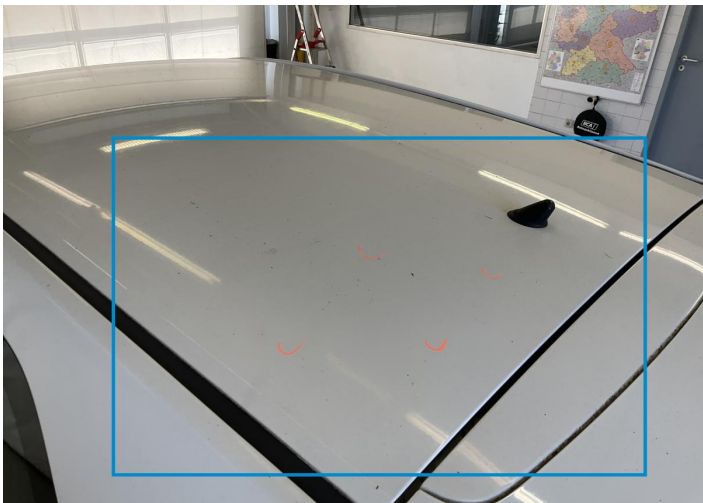
7. Roof  
Bodywork / Dent / Dent -

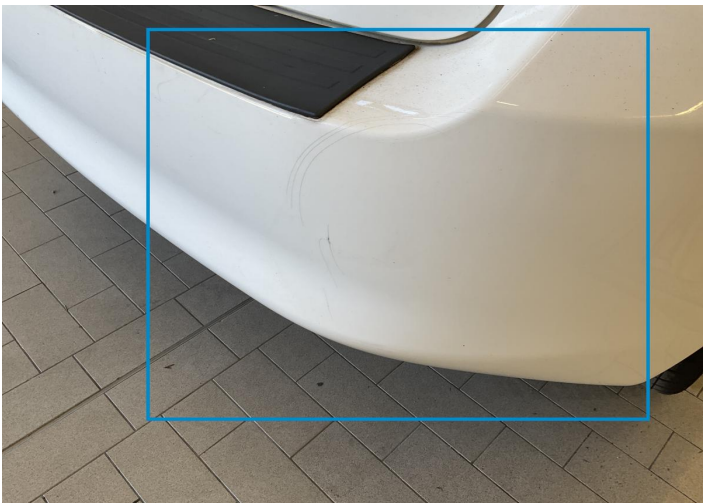
8. Bumper / Back  
Bodywork / Breakage / Crack -

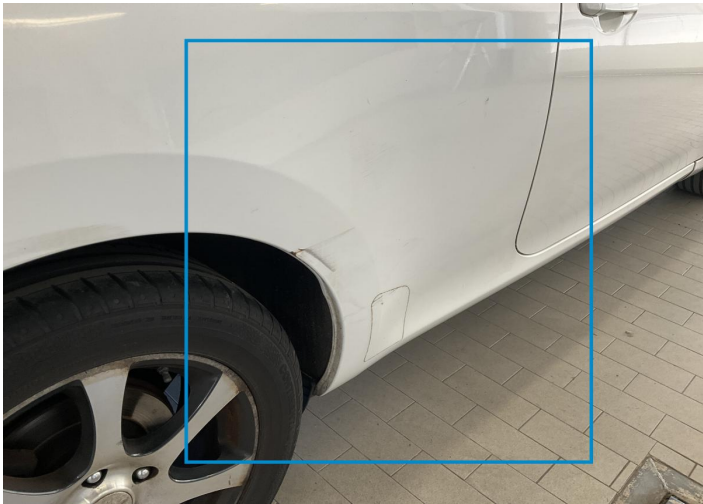
9. Side Panel / Back Right  
Bodywork / Breakage / Crack -

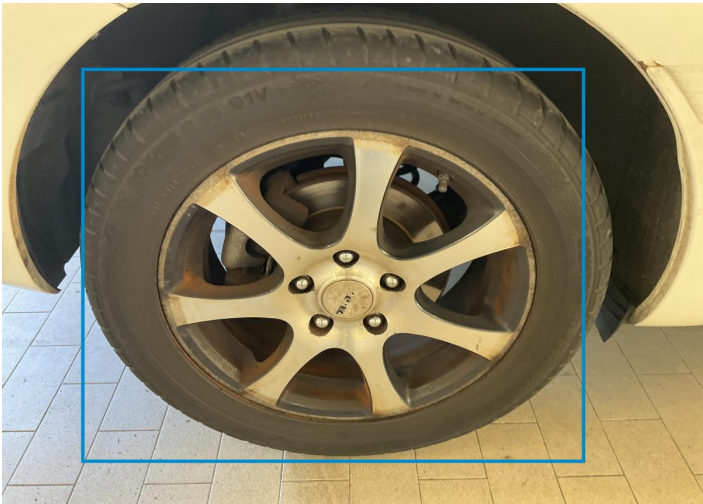
10. Rim / Back Right  
Out of Bodywork / Scratch -

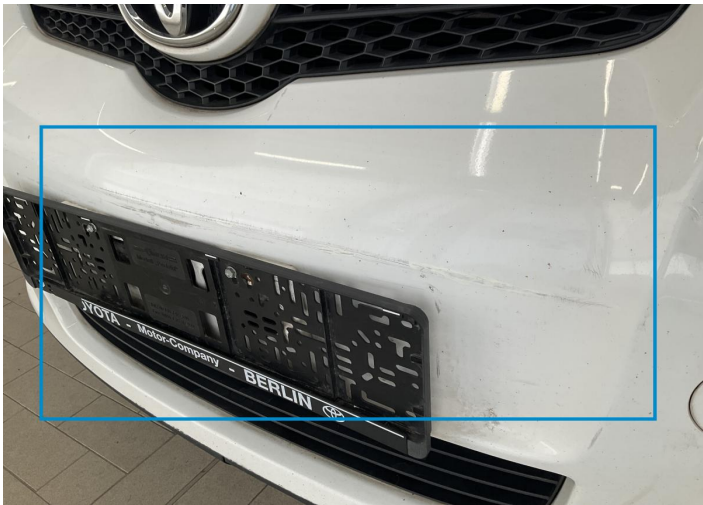
11. Bumper / Front  
Paint / Scratch / Scuff -

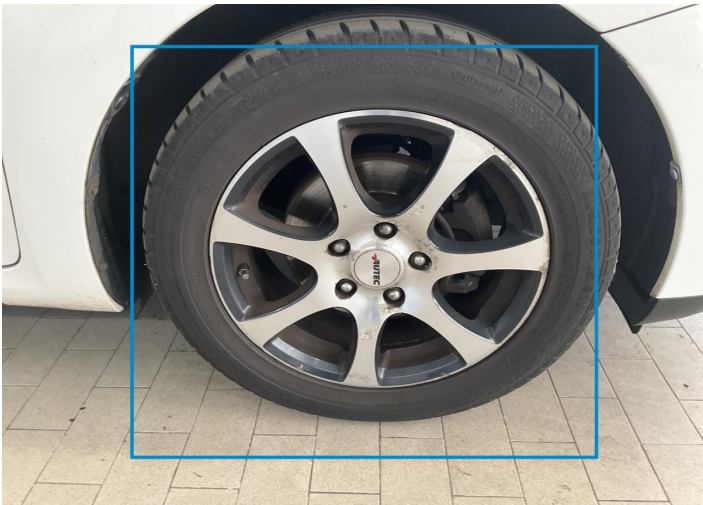
12. Rim / Front Right  
Out of Bodywork / Scratch -
