## status report

#### Jaguar F-Pace

| Vehicle identification number | <b>SADCA2BX2KA394621</b> | mileage read: | <b>99231 km</b> |

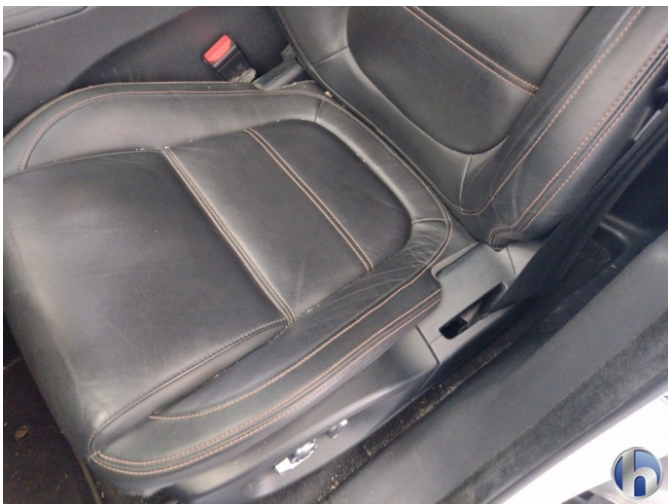
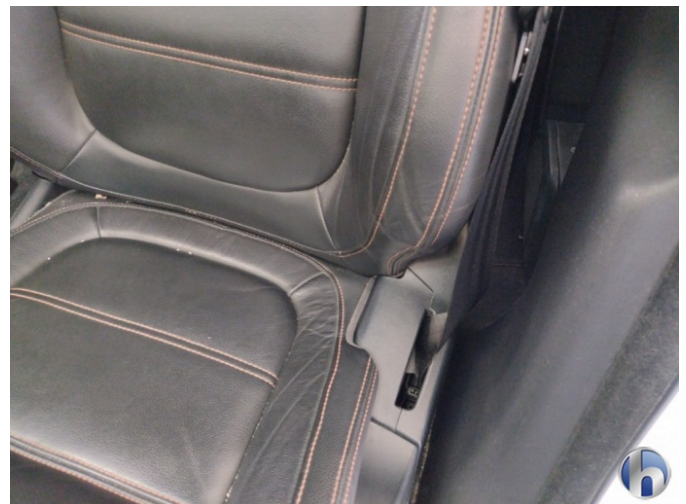
1. Sitz Vorne Links

| | component | Damage | Rep kind |
|---|---|---|---|
| 1. | Sitz Vorne Links | Damaged | Smart repair |

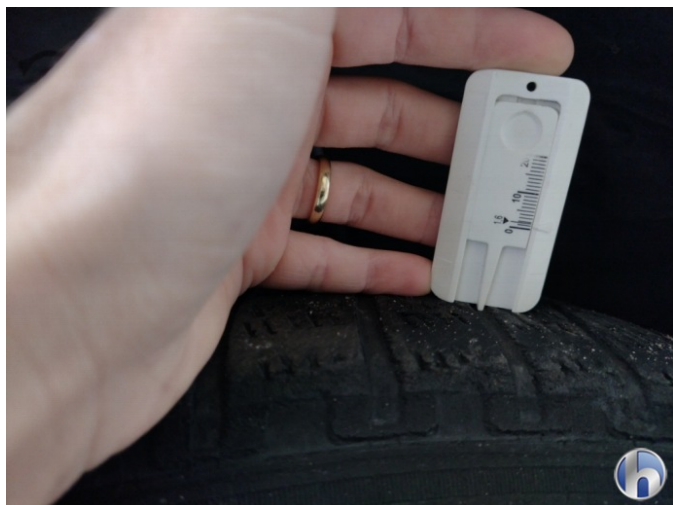
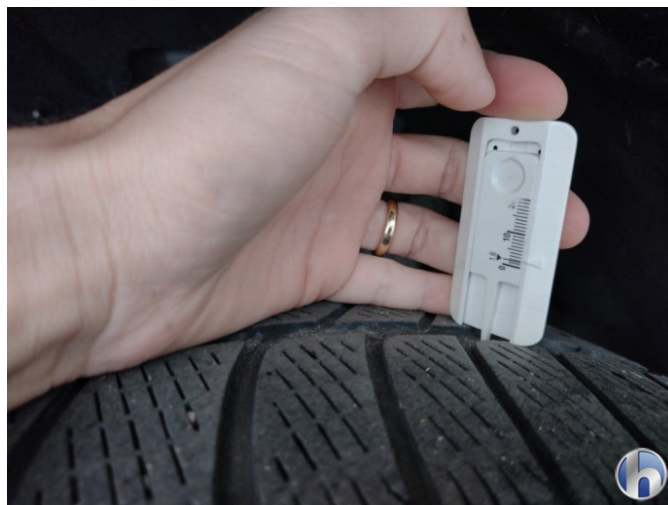
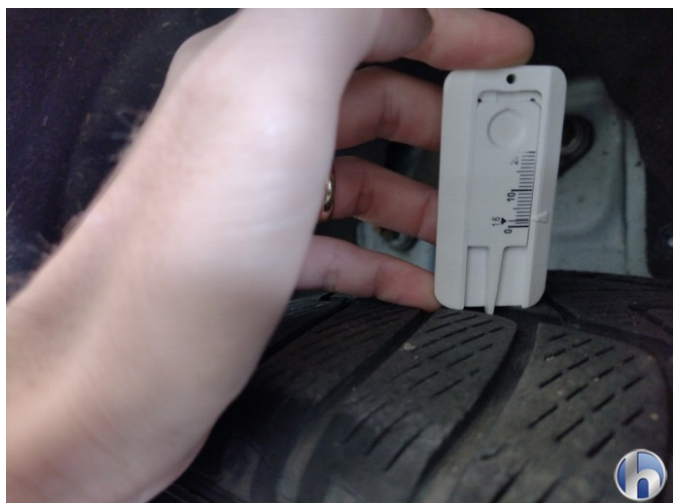
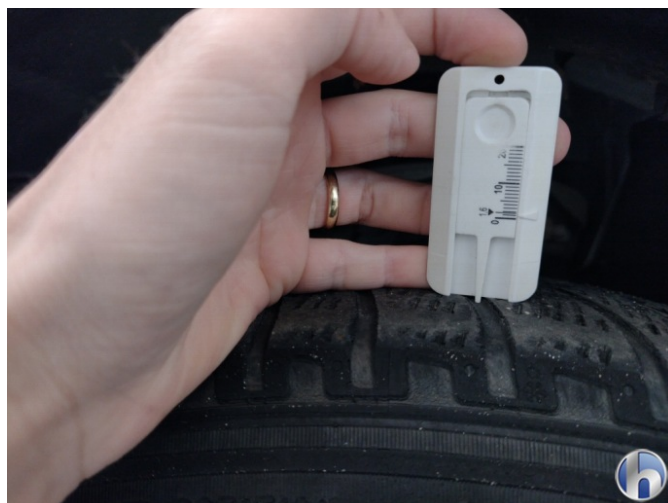
5. 4x Reifen

| mounted tires | | |
|---|---|---|
| 1st axis - Left / states . | <b>Pirelli</b> | <b>255/55/R19/111V 1 mm</b> |
| 1st axis - right / states . | <b>Pirelli</b> | <b>255/55/R19/111V 1 mm</b> |
| 2nd axis - Left / states . | <b>Pirelli</b> | <b>255/55/R19/111V 2 mm</b> |
| 2nd axis - right / states . | <b>Pirelli</b> | <b>255/55/R19/111V 2 mm</b> |
| traffic Safety: | <b>not roadworthy</b> | |

| General examination | |
|---|---|
| <b>Note Road Safe:</b> | Beide Reifen Vorne Verschlissen |

| | component | Damage | Rep kind |
|---|---|---|---|
| 5. | 4x Reifen | Worn | Replace |

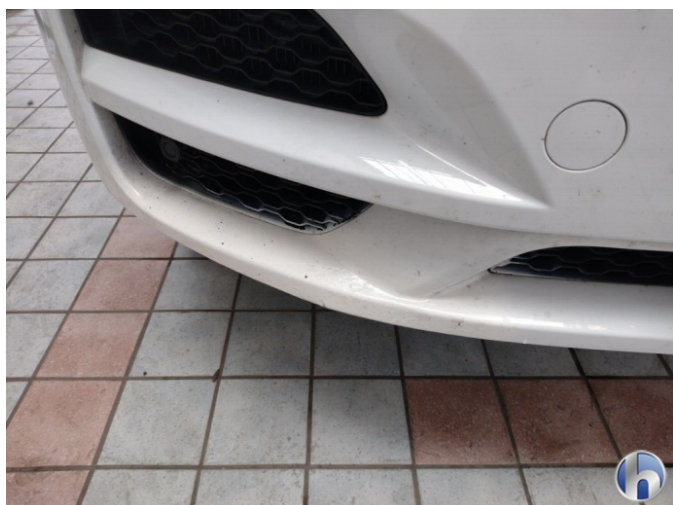
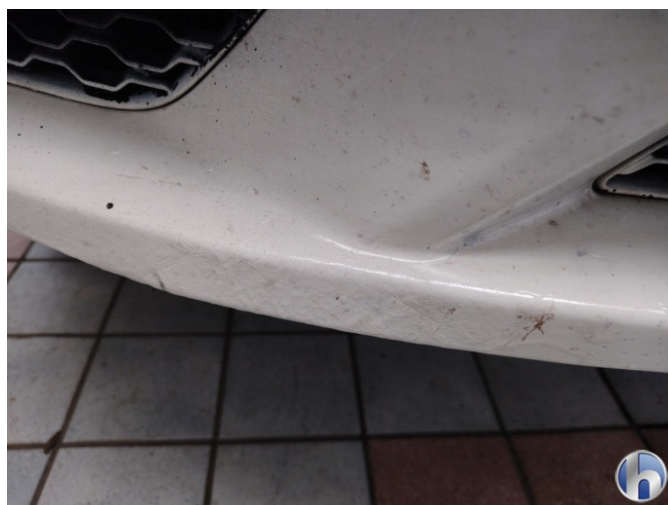
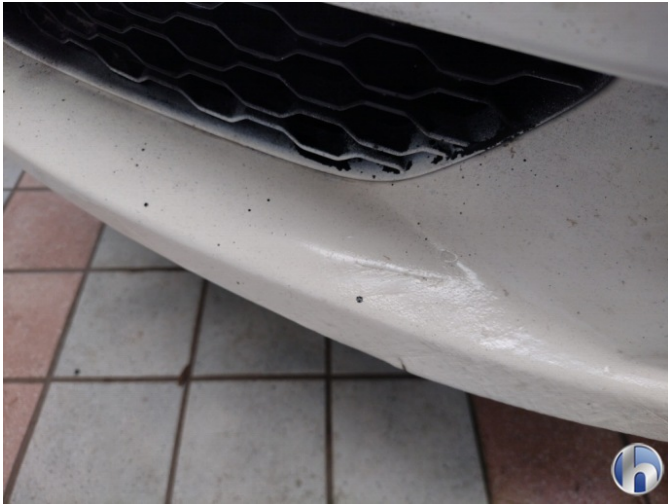
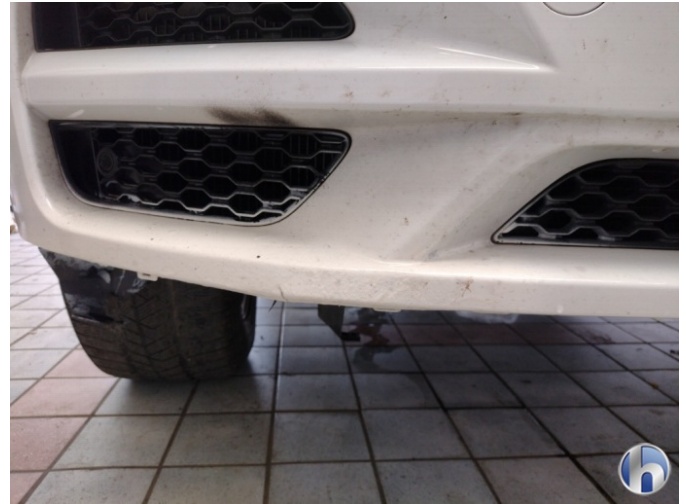
6. Front bumper

| | component | Damage | Rep kind |
|---|---|---|---|
| 6. | Front bumper | Damaged | Replace |

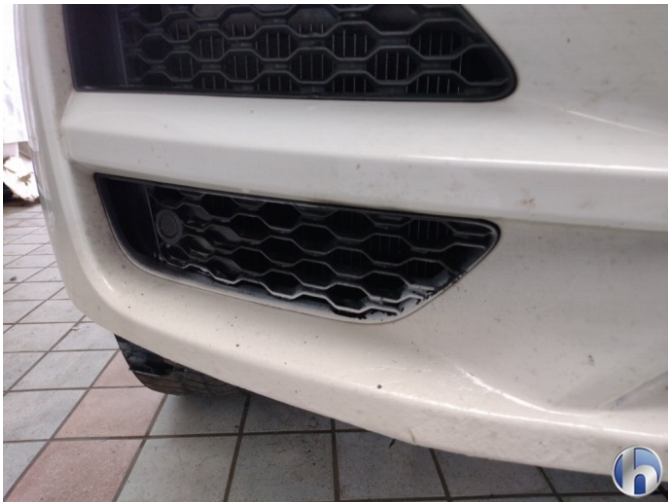
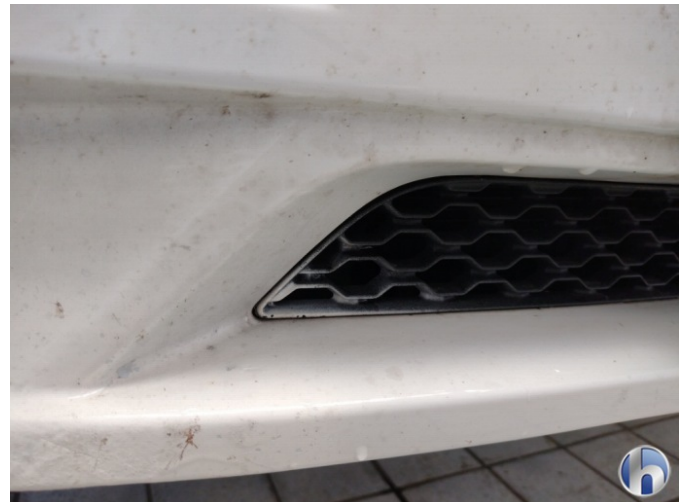
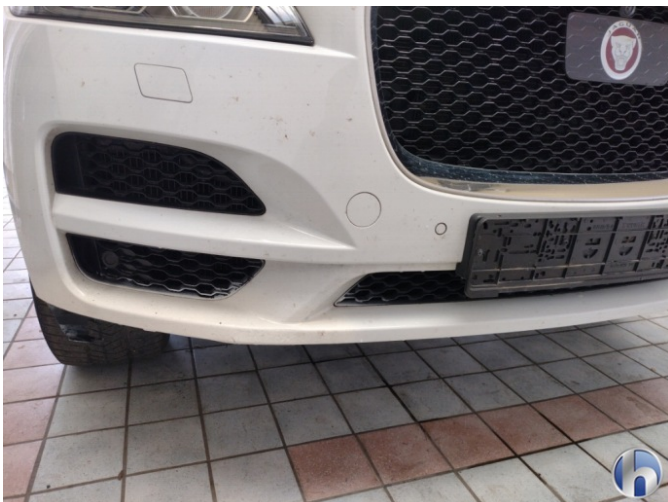
7. Stoßfänger Vorne 2x Grill

| | component | Damage | Rep kind |
|---|---|---|---|
| 7. | Stoßfänger Vorne 2x Grill | Damaged | Replace |

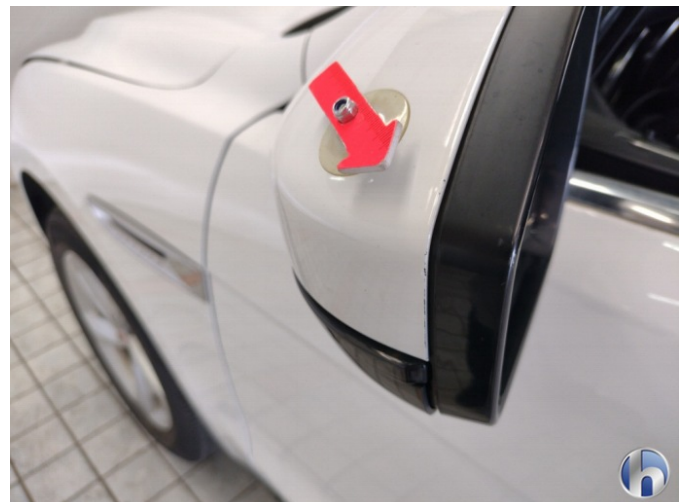
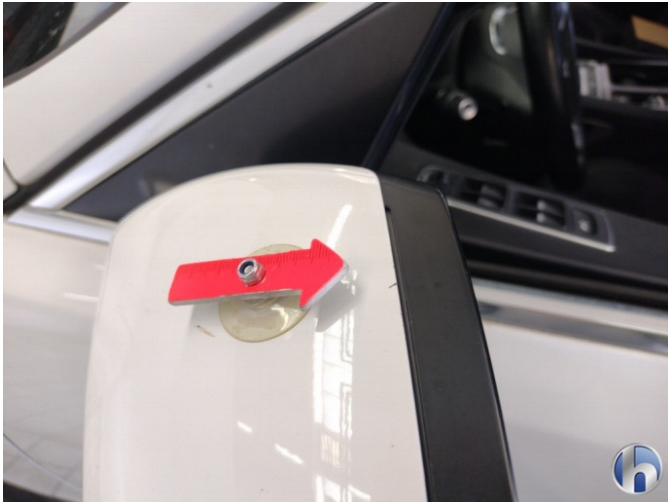
8. Outside mirror - right

| | component | Damage | Rep kind |
|---|---|---|---|
| 8. | Outside mirror - right | Scratch(es) | Paint |

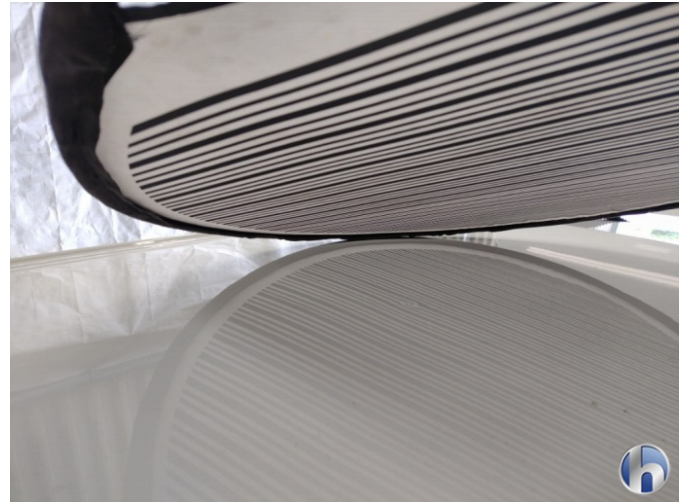
9. roof

| | component | Damage | Rep kind |
|---|---|---|---|
| 9. | roof | Delle | Smart repair |

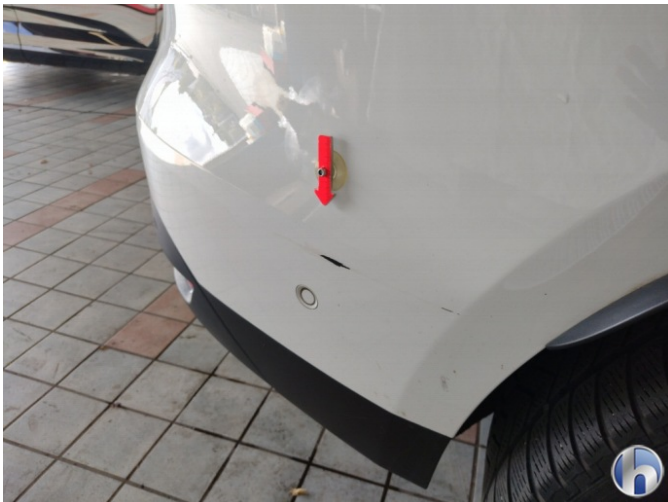
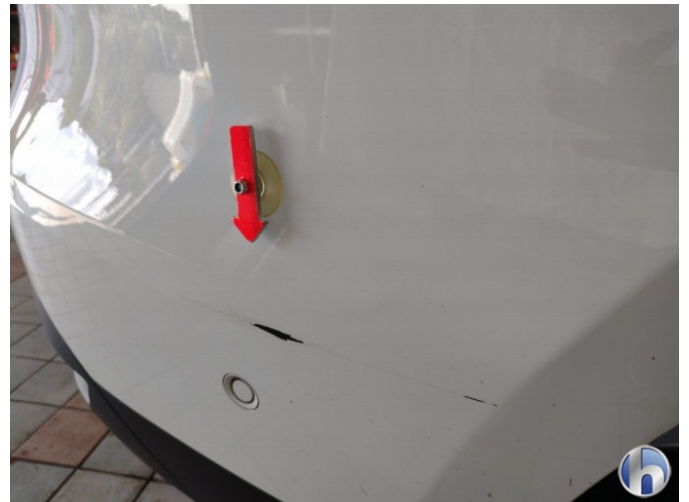
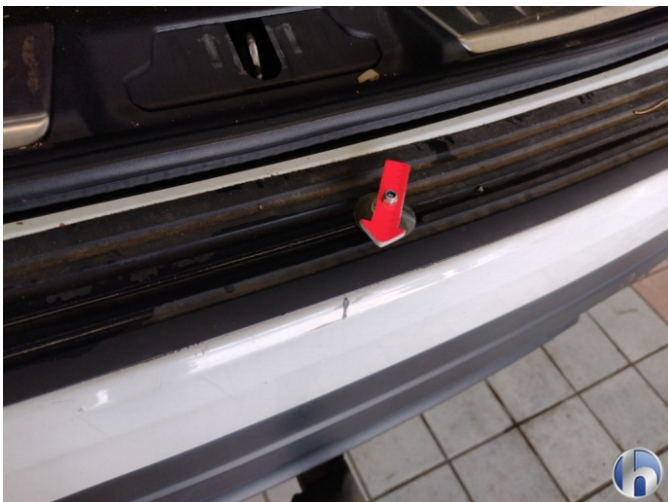
10. Rear bumper

| | component | Damage | Rep kind |
|---|---|---|---|
| 10. | Rear bumper | Scrape | Paint |

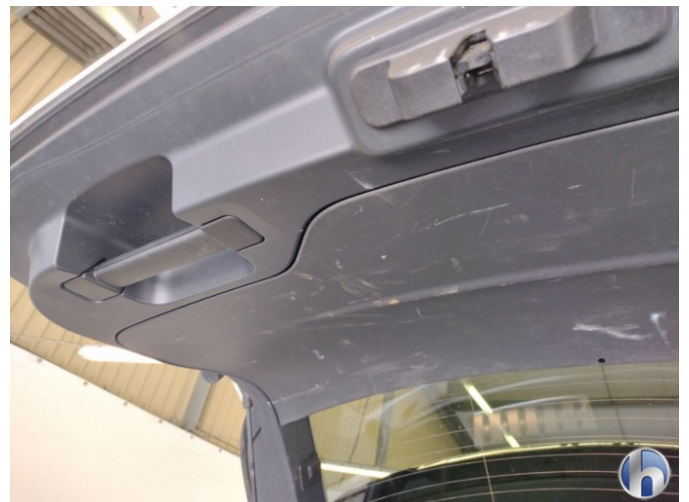
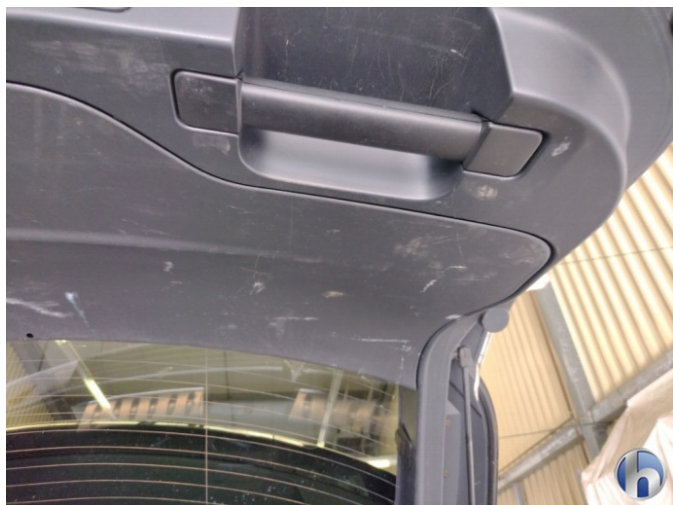
11. tailgate trim

| | component | Damage | Rep kind |
|---|---|---|---|
| 11. | tailgate trim | Damaged | Smart repair |

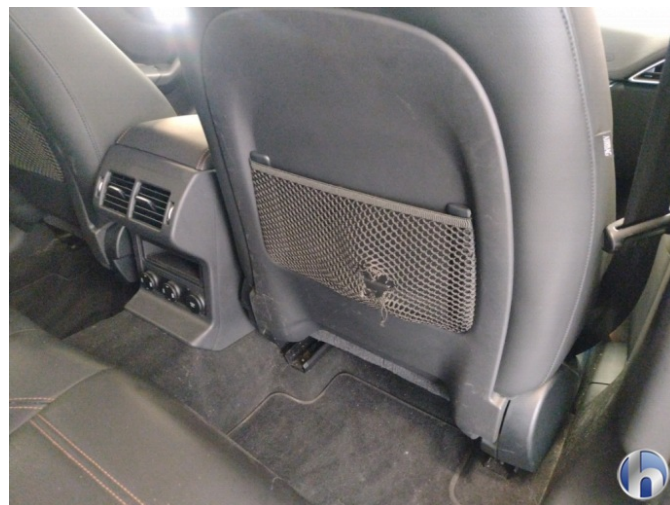
12. Sitz Vorne Rechts Gepäcknetz Rückseite

| | component | Damage | Rep kind |
|---|---|---|---|
| 12. | Sitz Vorne Rechts Gepäcknetz Rückseite | Damaged | Replace |

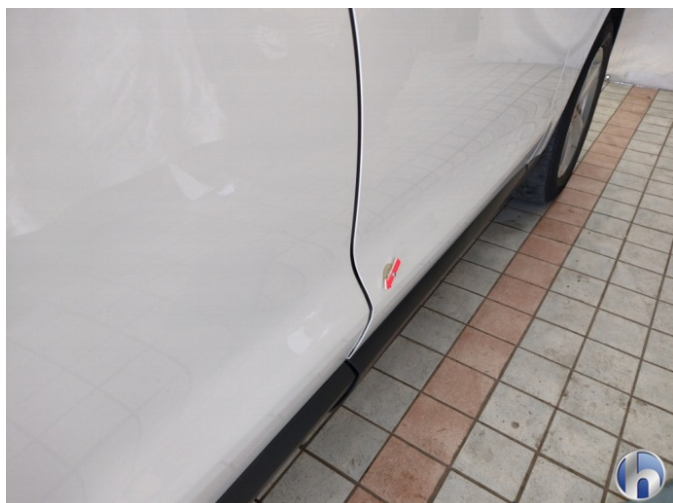
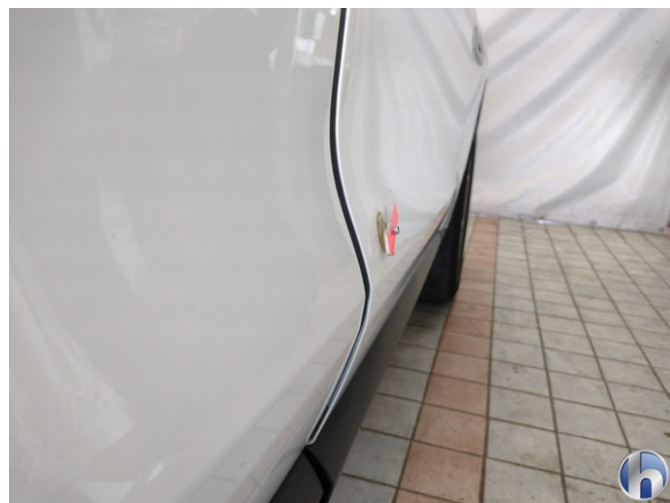
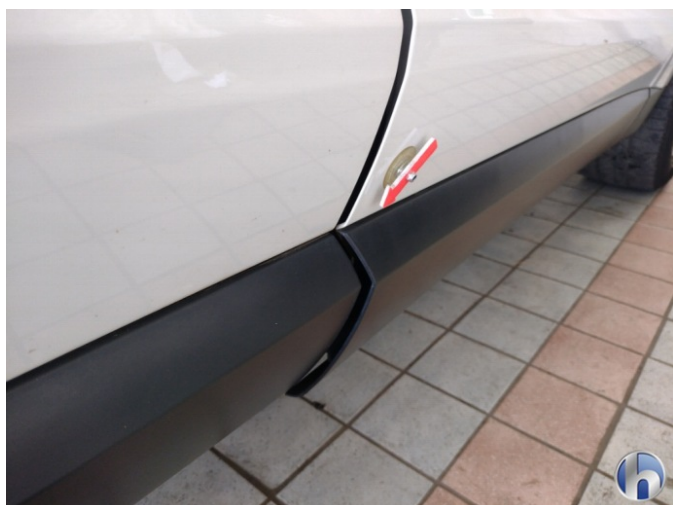
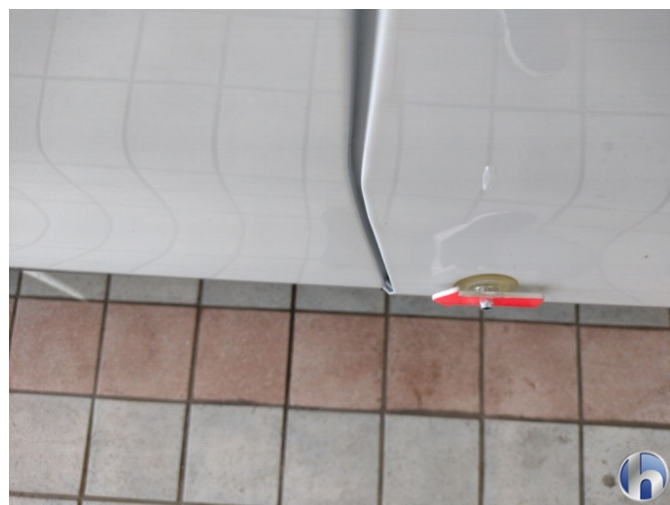
13. Front door - right

| | component | Damage | Rep kind |
|---|---|---|---|
| 13. | Front door - right | Clearance not exact | Uninstall/install |

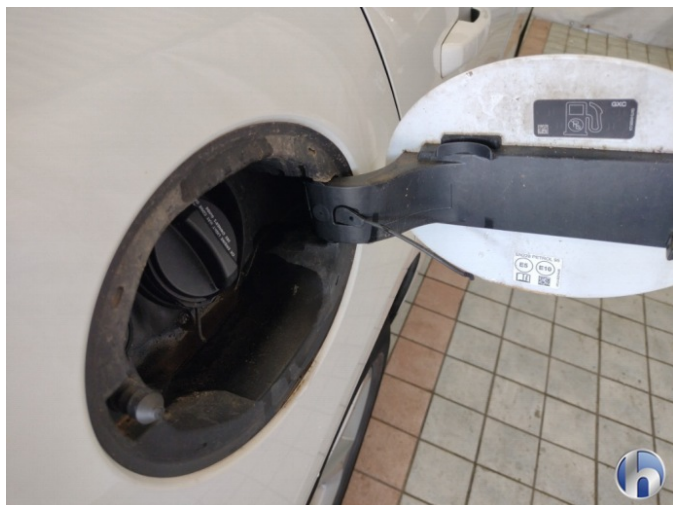
14. Tankdeckel Fangband

| | component | Damage | Rep kind |
|---|---|---|---|
| 14. | Tankdeckel Fangband | Damaged | Replace |

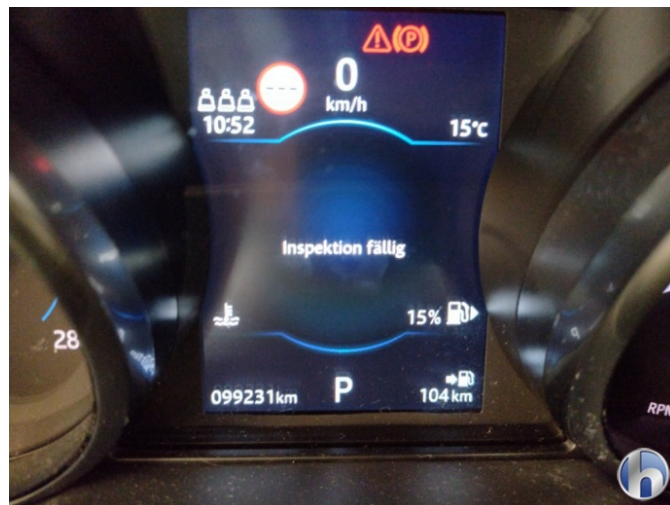
15. maintenance

| | component | Damage | Rep kind |
|---|---|---|---|
| 15. | maintenance | Due | Replace |

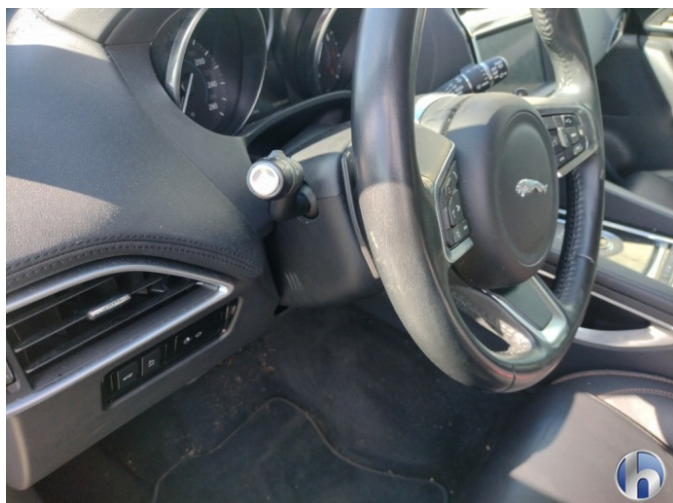
16. steering wheel

| | component | Damage | Rep kind |
|---|---|---|---|
| 16. | steering wheel | Damaged | Smart repair |
