Expertise

Protocol number: 41196429
Order No. / Reference: 25104261
Inspection date: 21 Aug 2025

Manufacturer: Land Rover

Model: Discovery Sport D200 R-Dynamic SE

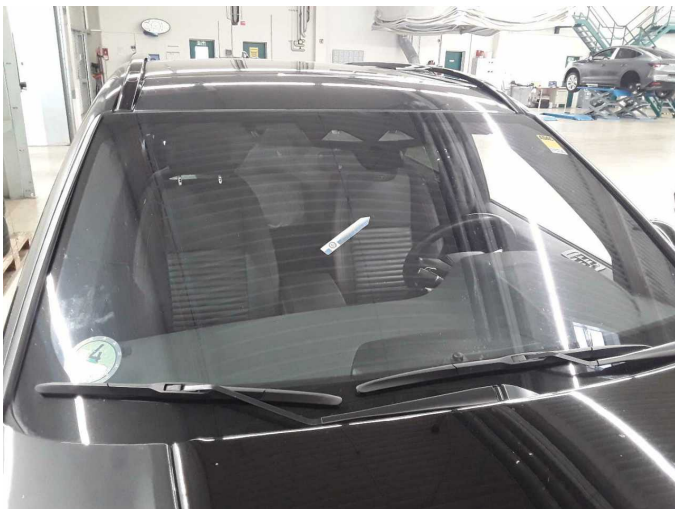
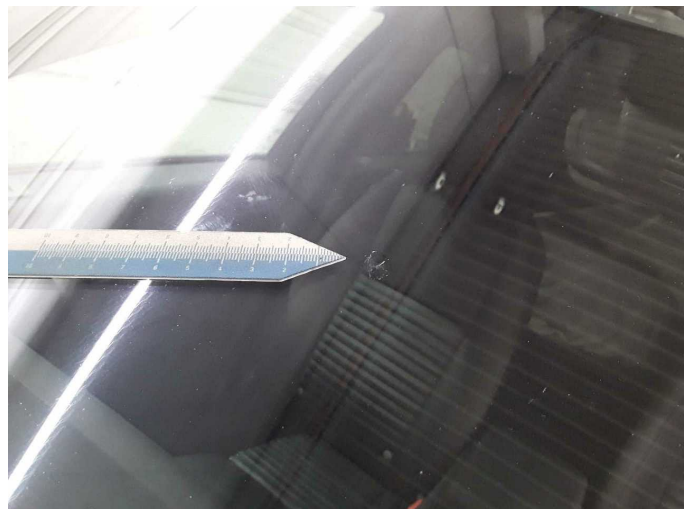
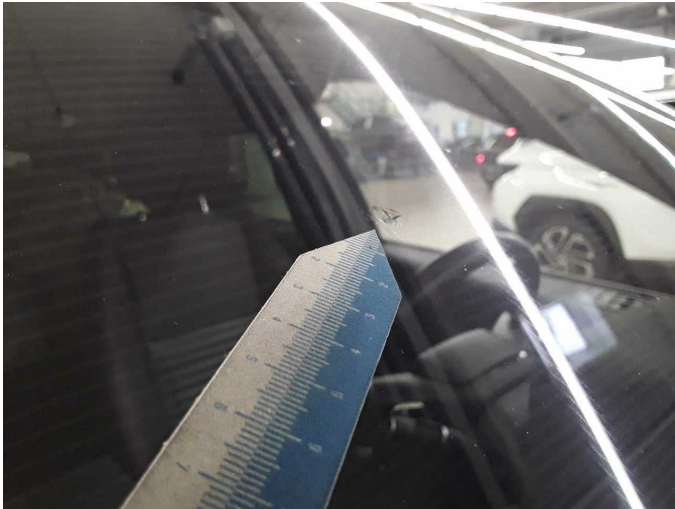
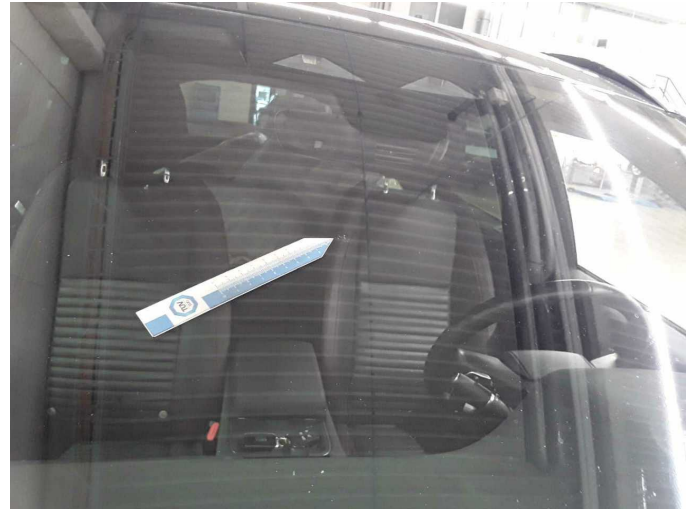
Damage 1: Vehicle glazing: Windscreen (Steinschlag wurde repariert) - Stone chips - No deduction

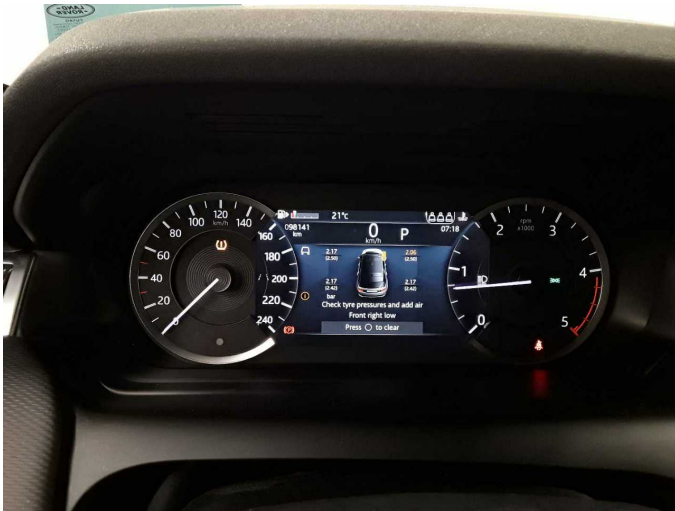
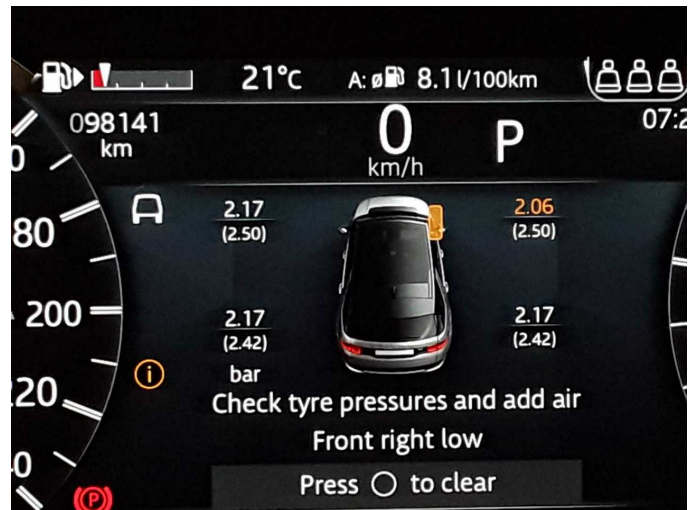
Damage 3: Instrument panel: Indicator light (Reifendruckkontrollleuchte) - on - Diagnosed and repair if necessary

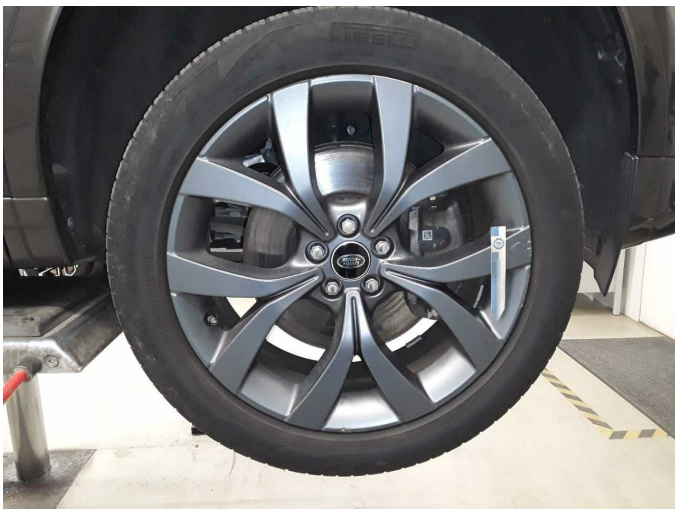
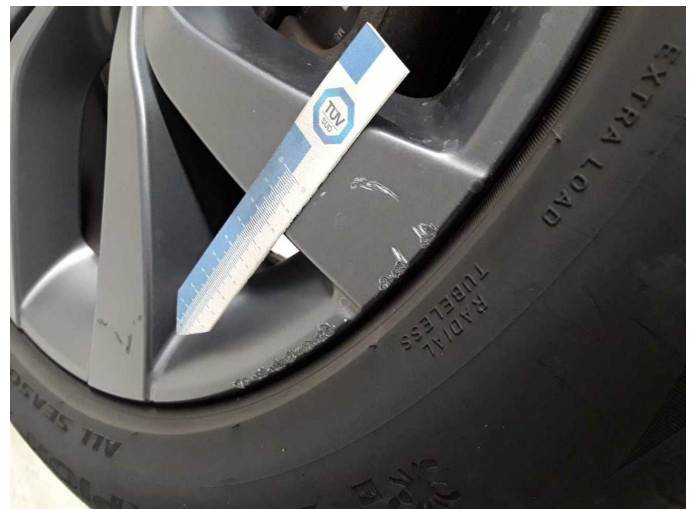
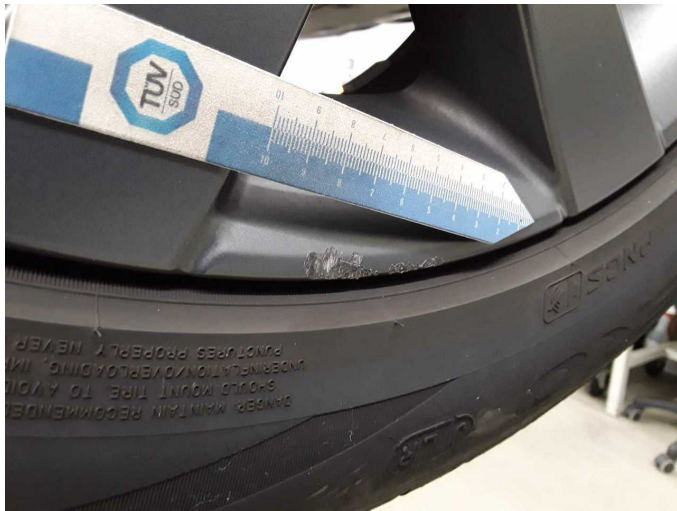
Damage 4: Wheel / tyres: Alloy rim - front right side - Scratched - Loss in value

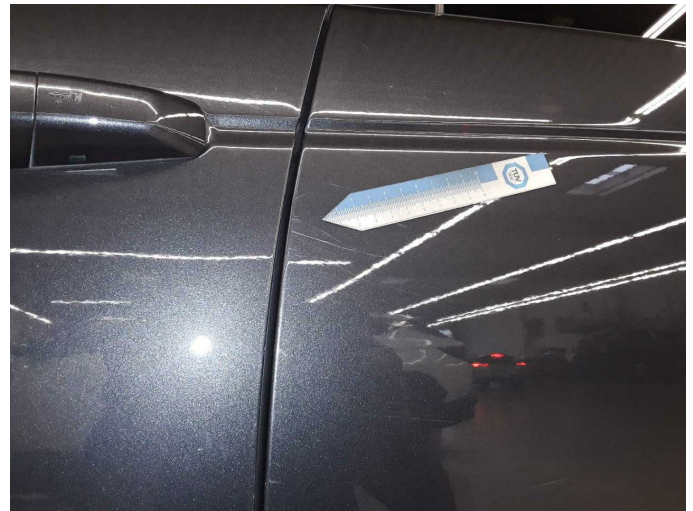
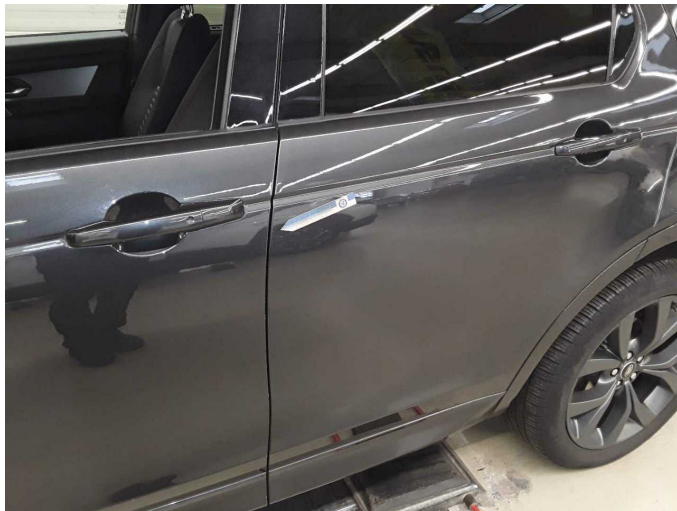
Damage 5: Door - rear left side: Door - Scratch(es) - Smart repair

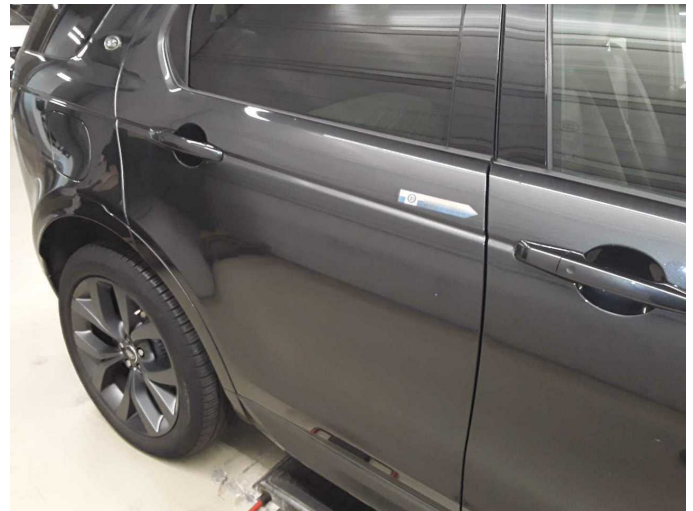
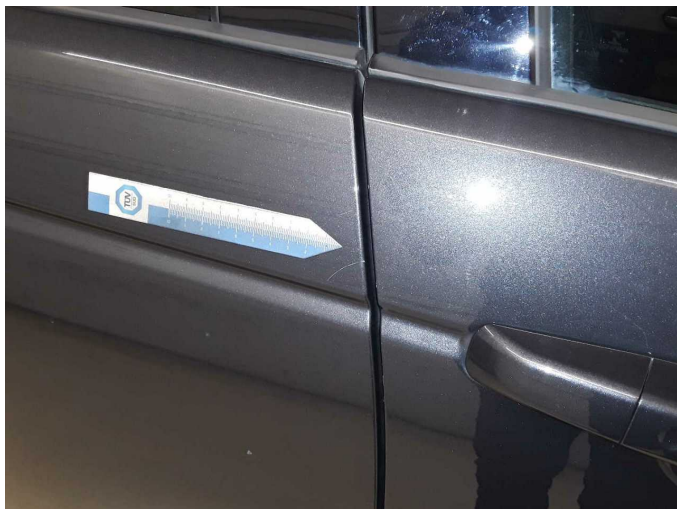
Damage 6: Door - rear right side: Door - Scratch(es) - Smart repair

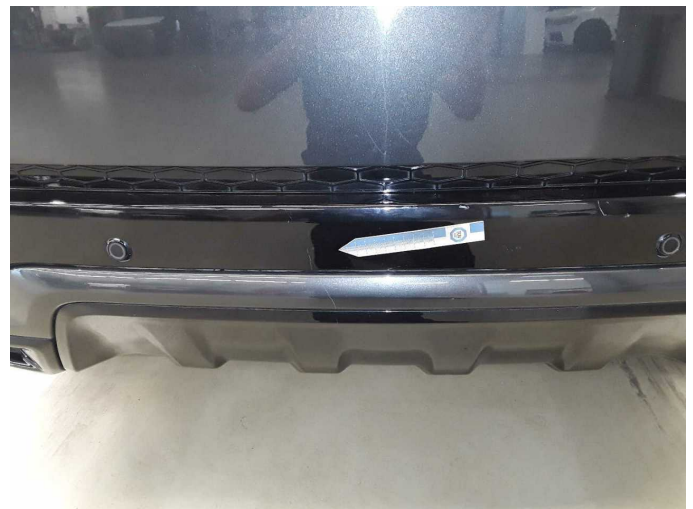
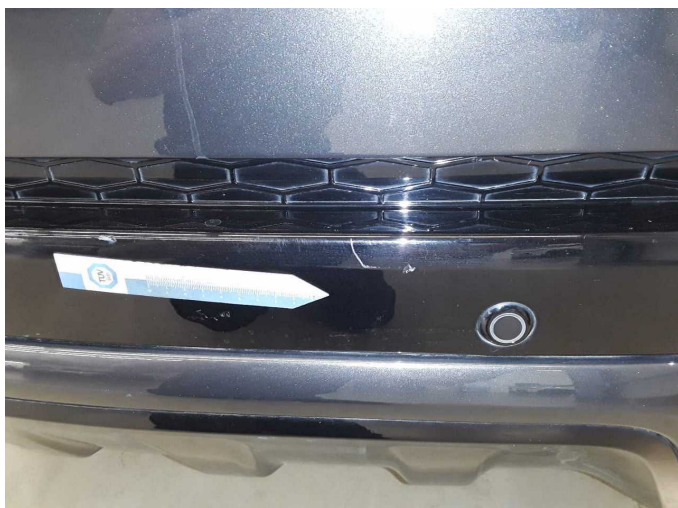
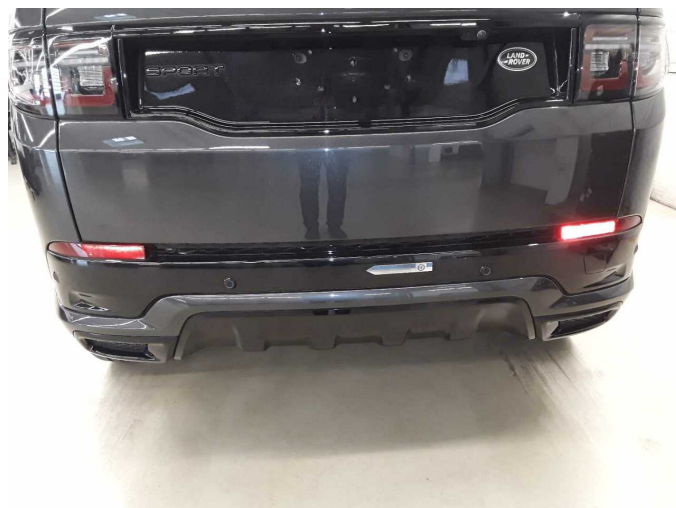
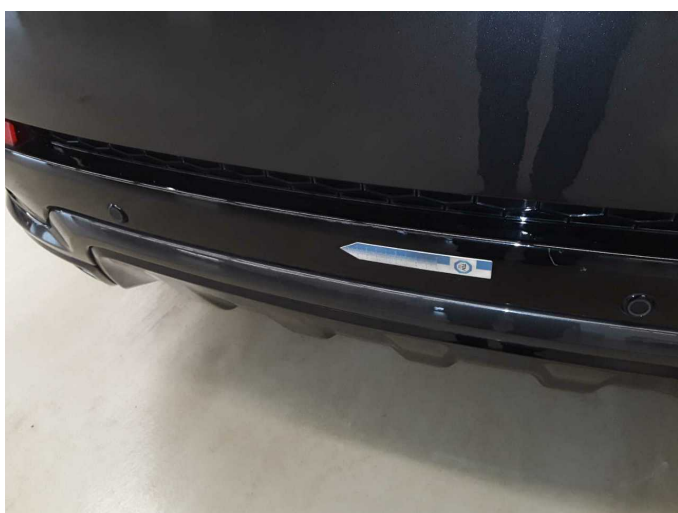
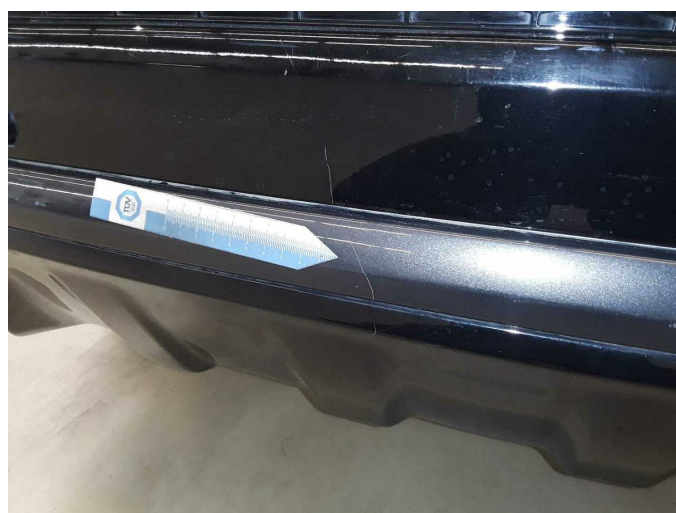
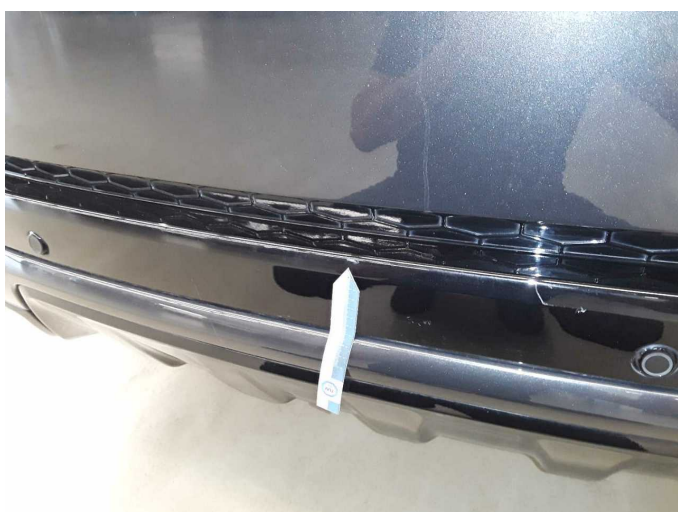
Damage 7: Rear bumper: Rear bumper - Scratch(es) - Smart repair

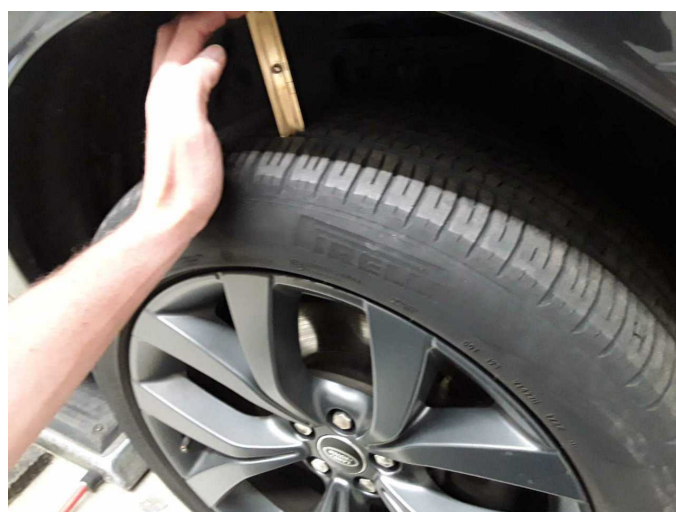
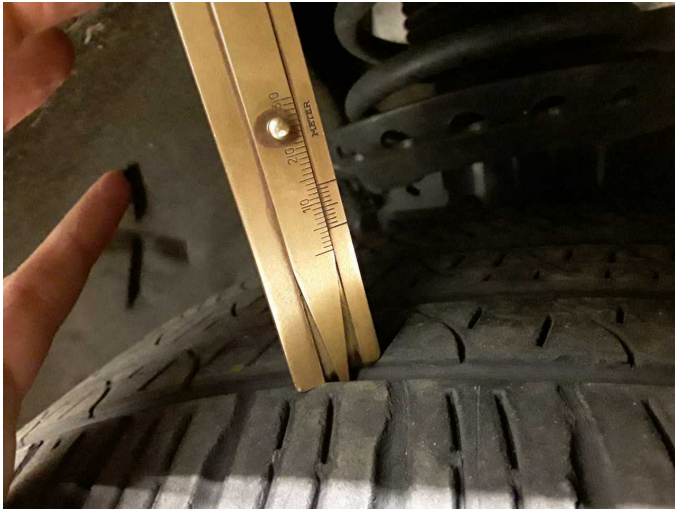
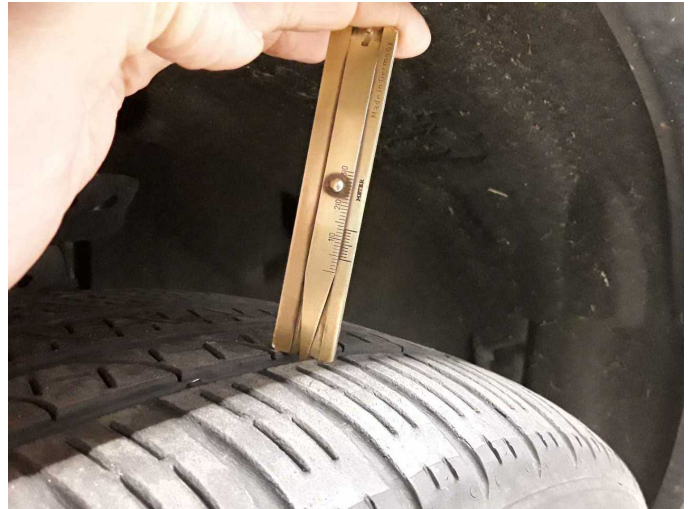
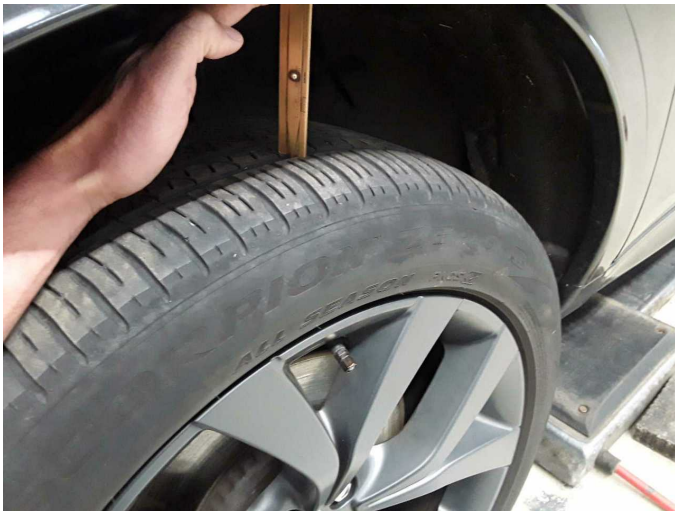
Damage 8: Wheel / tyres: Tyre - front - Does not meet the leasing specifications - Replace

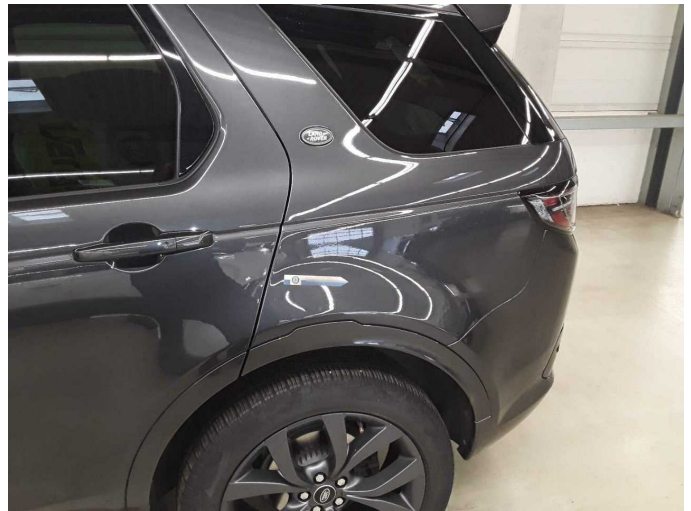
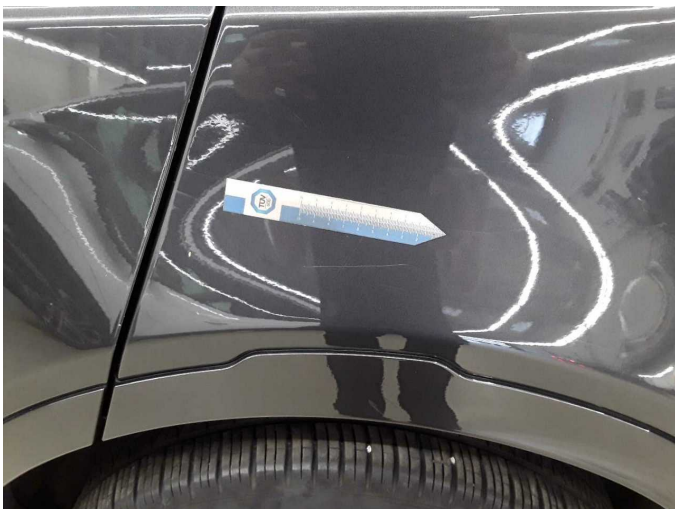
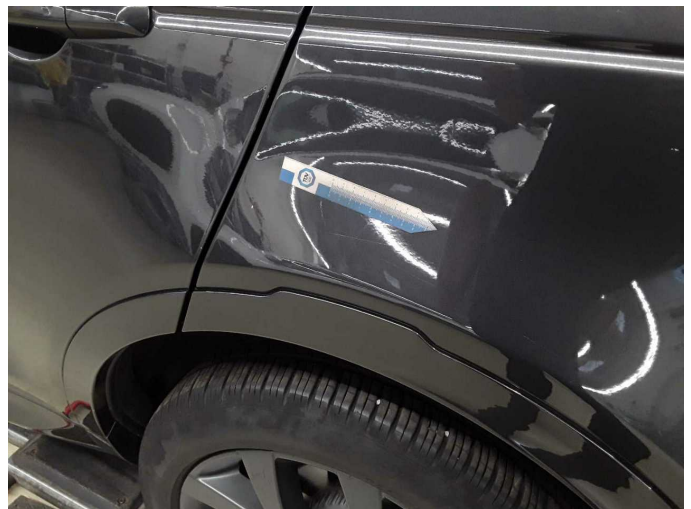
Damage 9: Side panel - rear left side: Side panel - Scratch(es) - Repair and paint

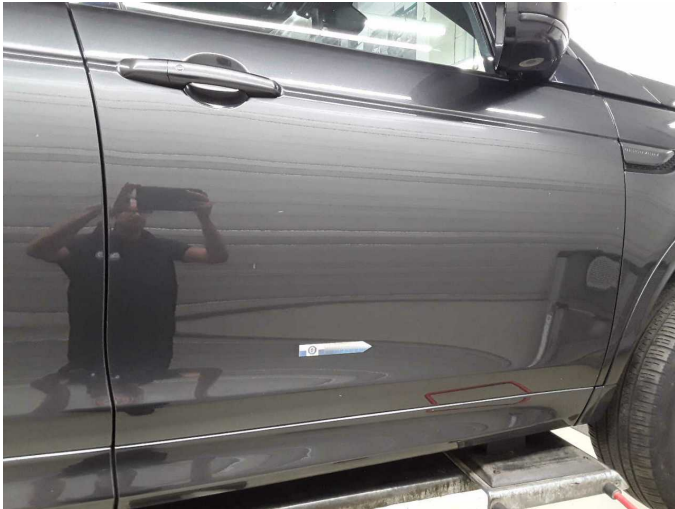
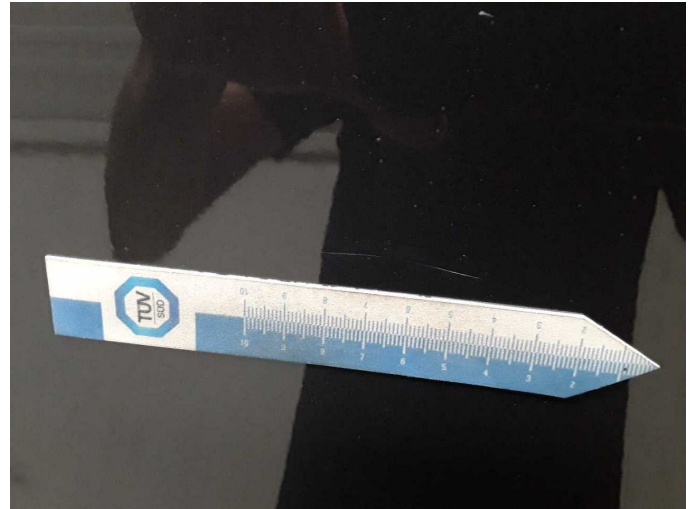
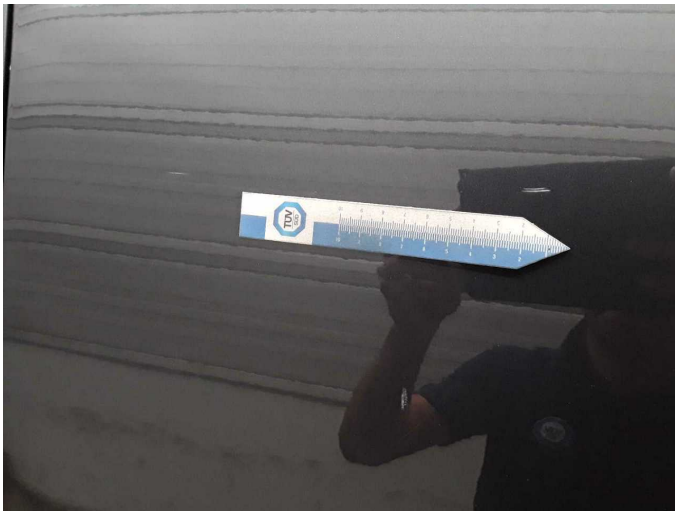
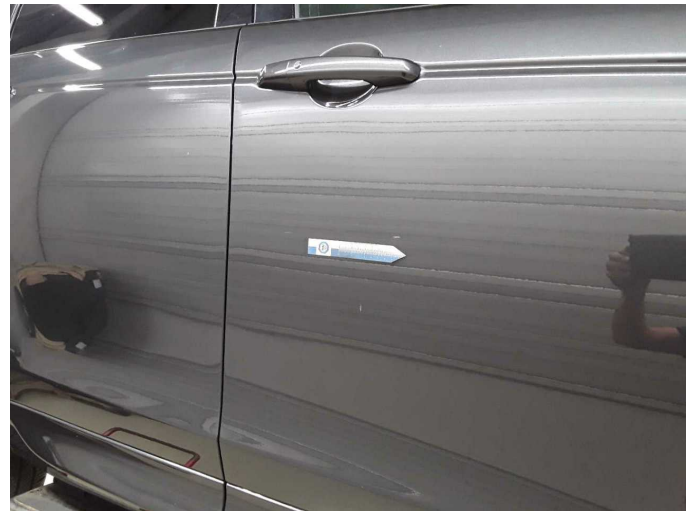
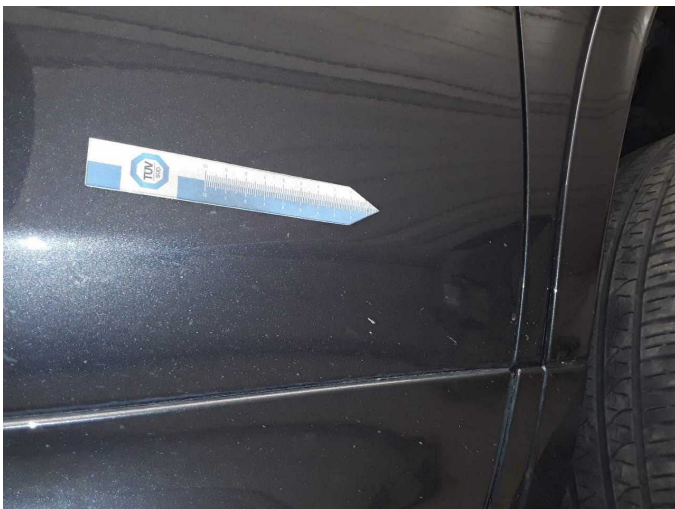
Damage 10: Door - front right side: Door - Scratch(es) - Repair and paint

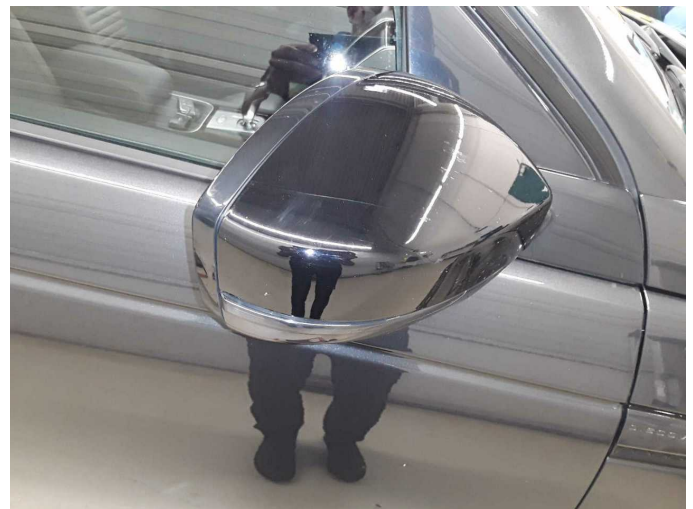
Wear and tear 1: Body: Body - Scratch(es) - No deduction

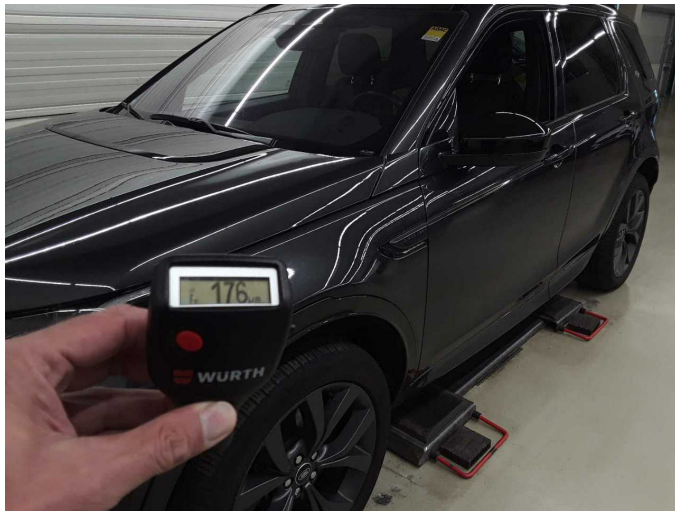
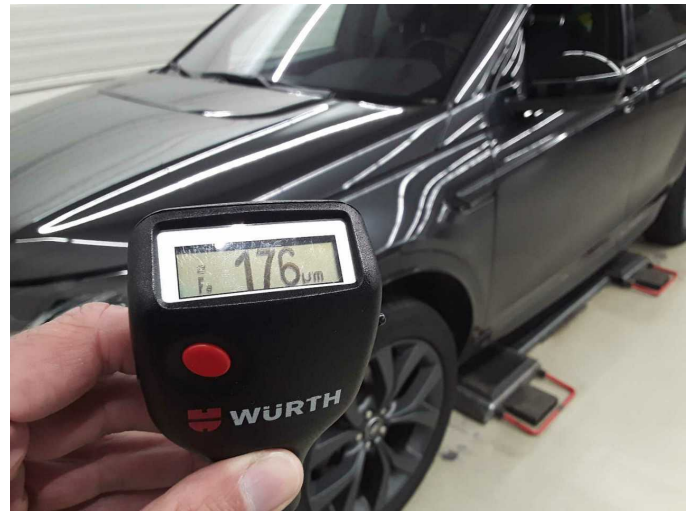
| 1 | Mudguard - left side, Professionally carried out |

Mudguard - left side: 176 µm
