Expertise

Protocol number: 41294149  
Order No. / Reference: 25137643  
Inspection date: 28 Aug 2025

Manufacturer: Land Rover	Model: Defender 90 P400 SE AWD
VIN: SALEA6BU4P2130330

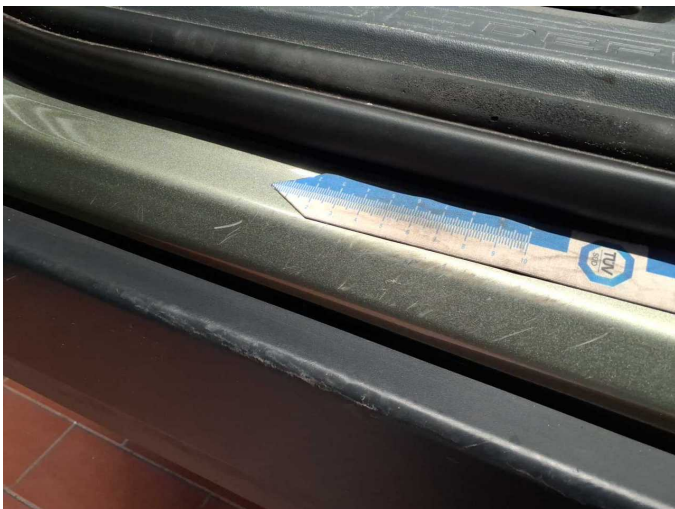
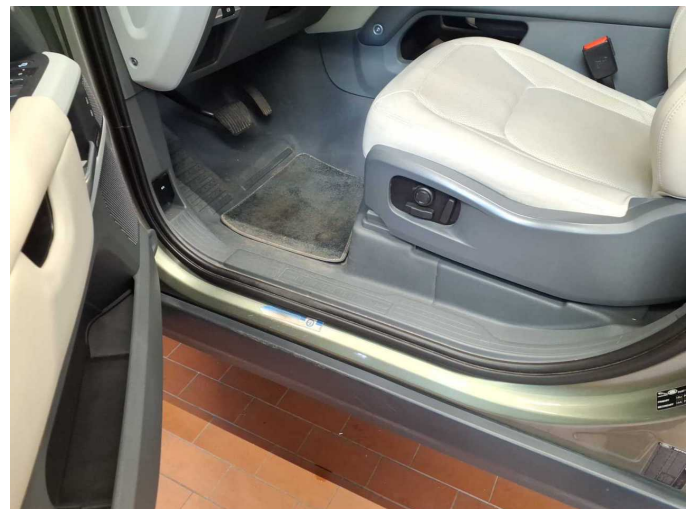
Damage 1: Sill - left side: Sill - Scratch(es) - Smart repair

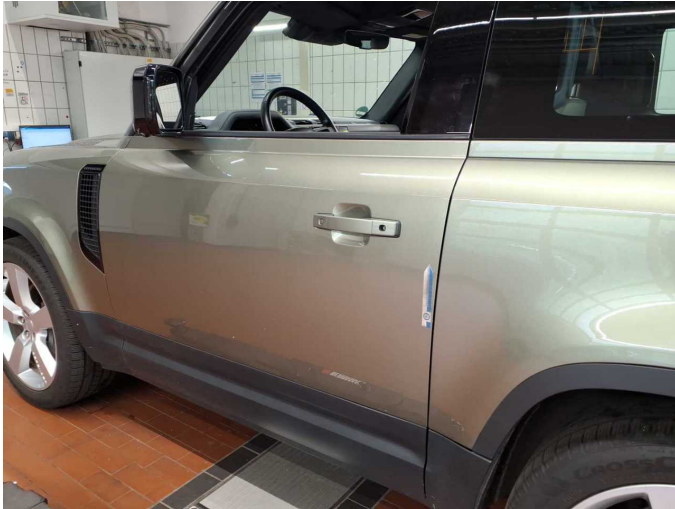
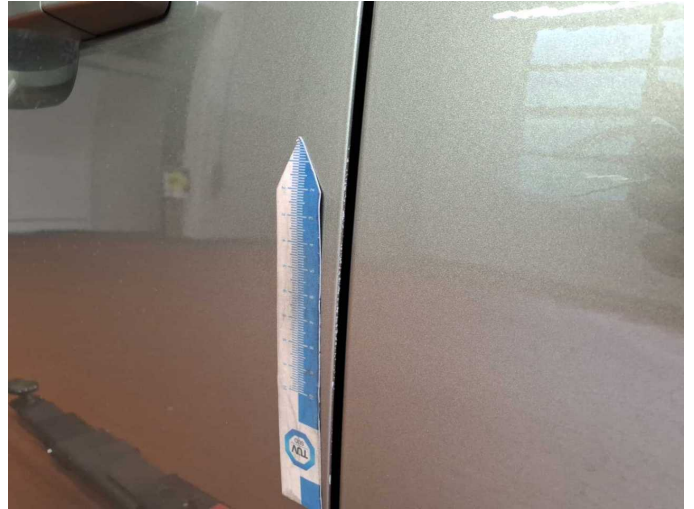
**Damage 2:** Door - front left side: Door edge - Scratch(es) - Smart repair

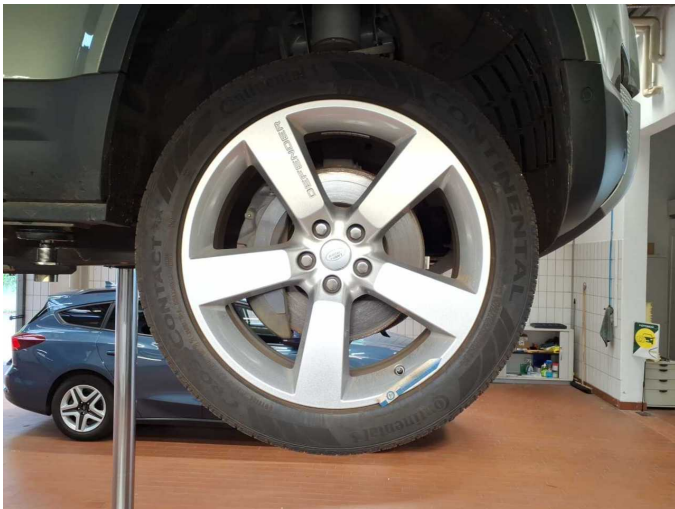
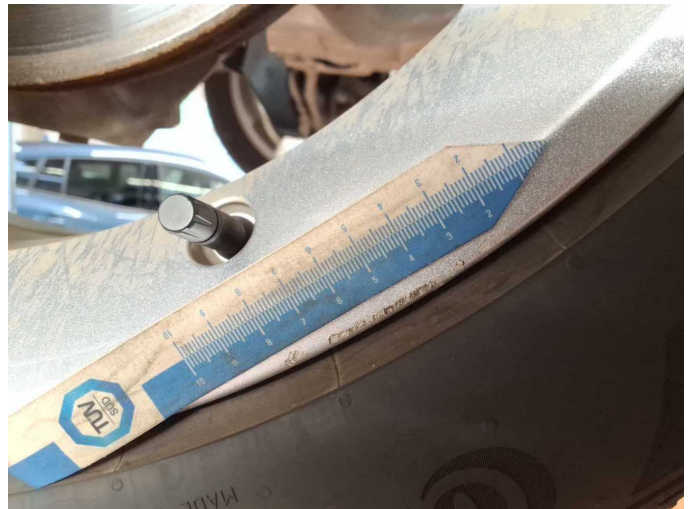
**Damage 3:** Wheel / tyres: Alloy rim - front right side - Scratched - Smart repair

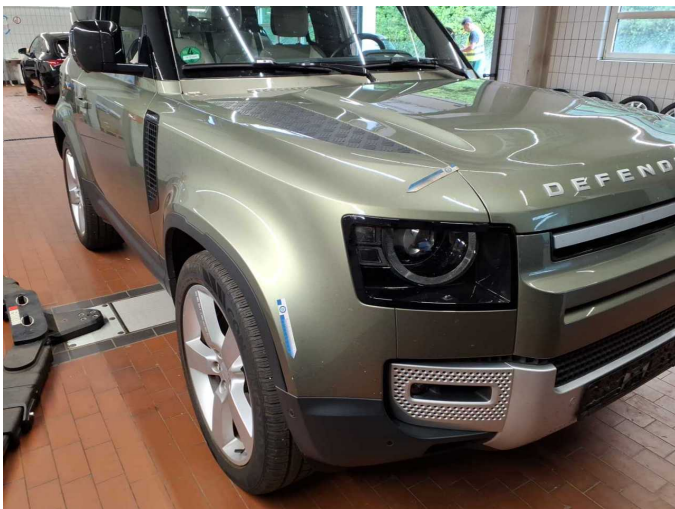
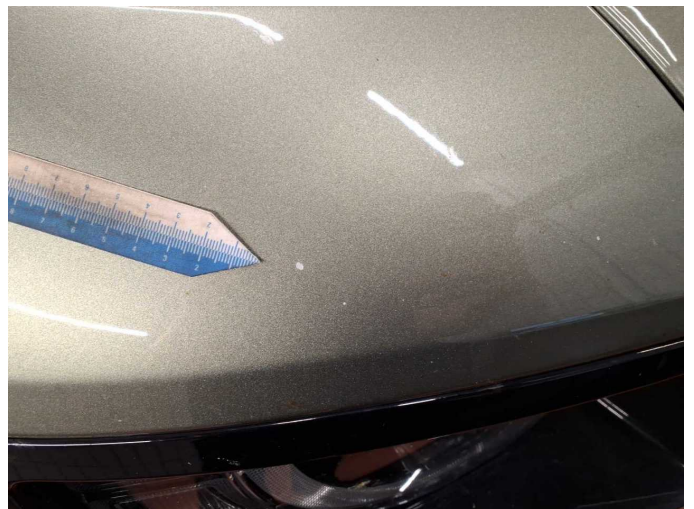
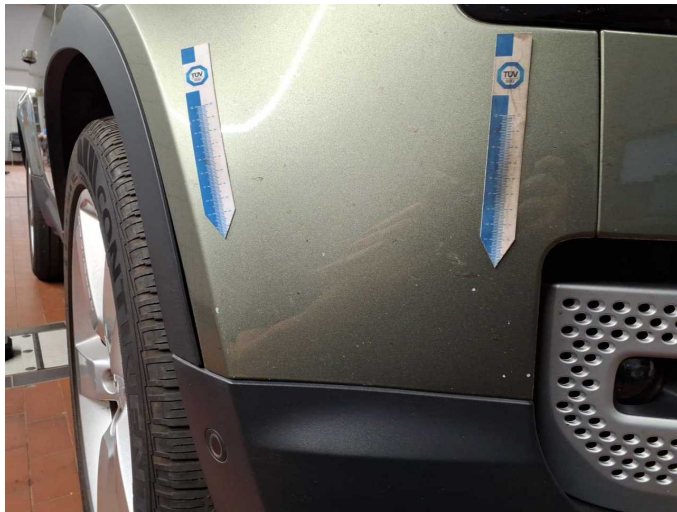
**Damage 4:** Mudguard - right side: Mudguard - right side - Stone chips - Paint

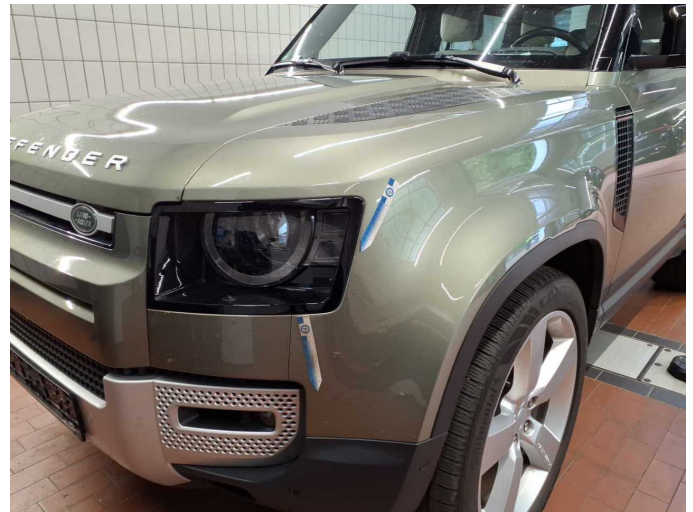
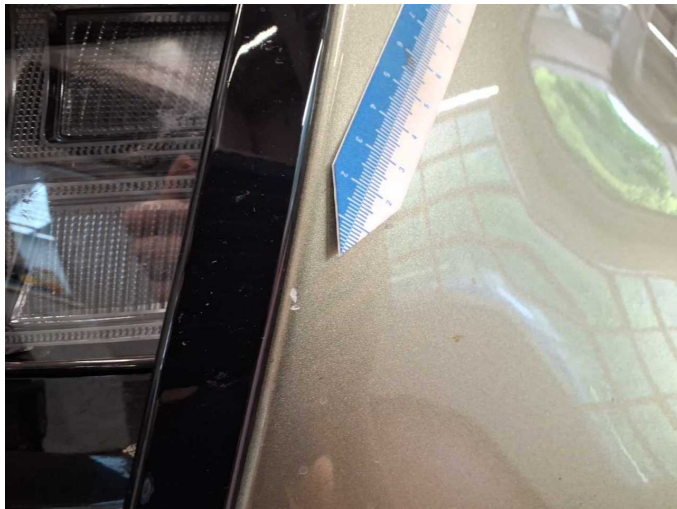
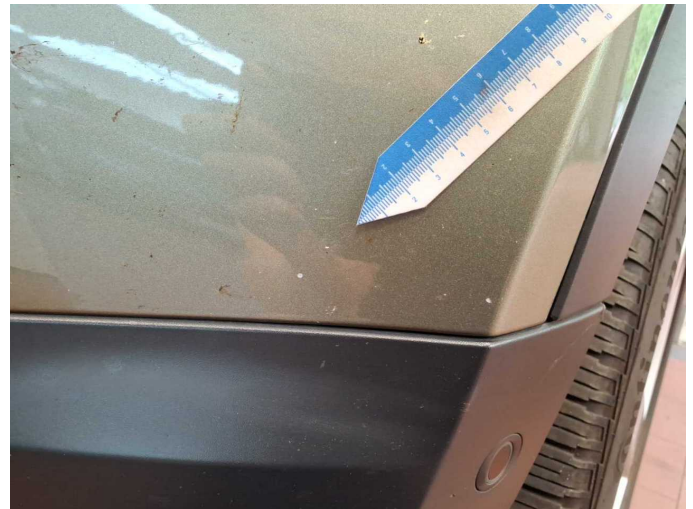
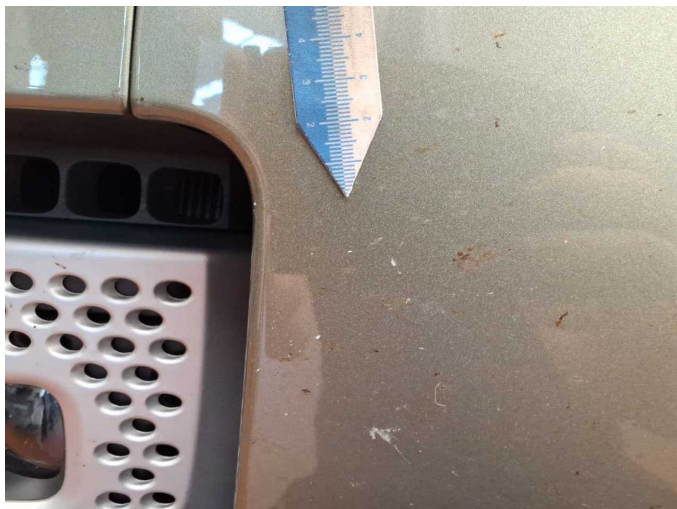
**Damage 5:** Mudguard - left side: Mudguard - left side - Stone chips - Paint

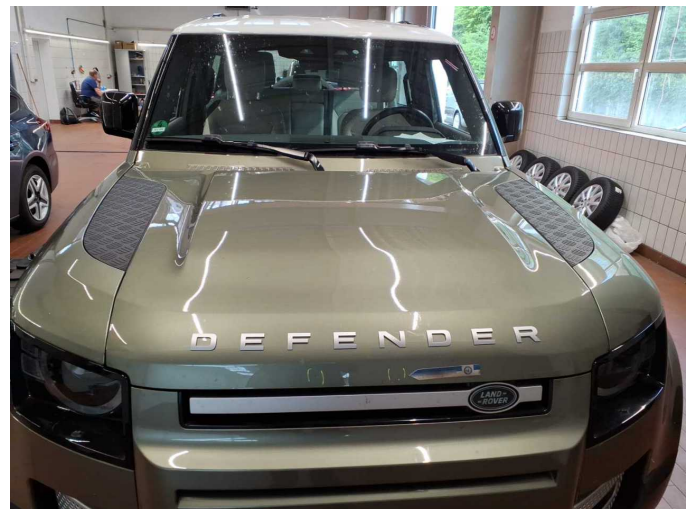
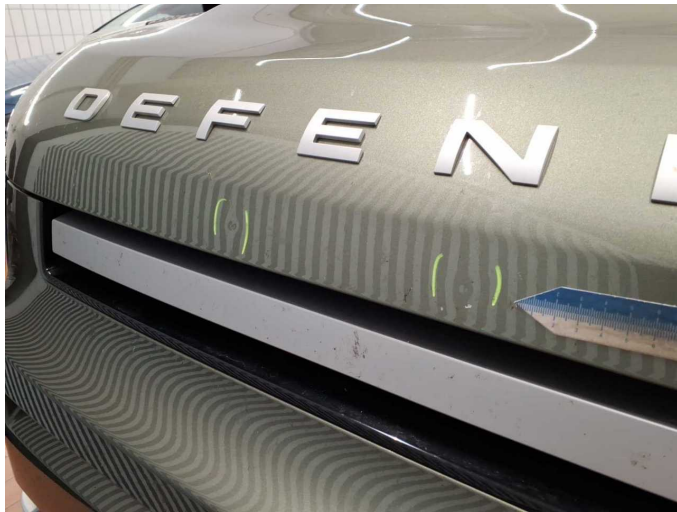
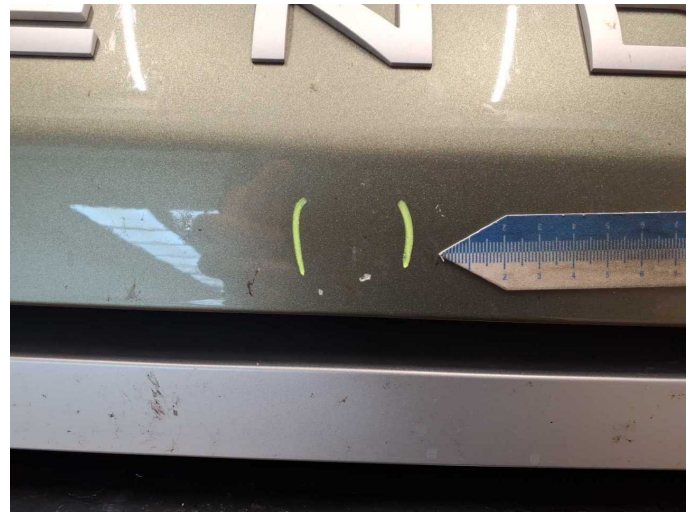
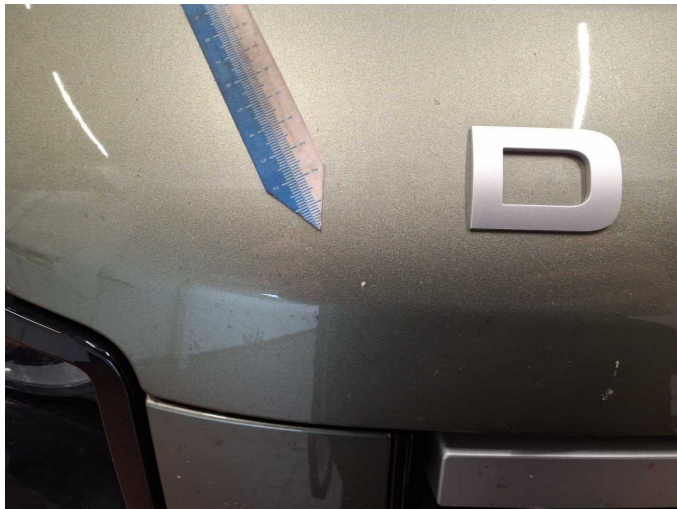
**Damage 6:** Bonnet: Bonnet - Dent / paintcoat damage - Repair and paint

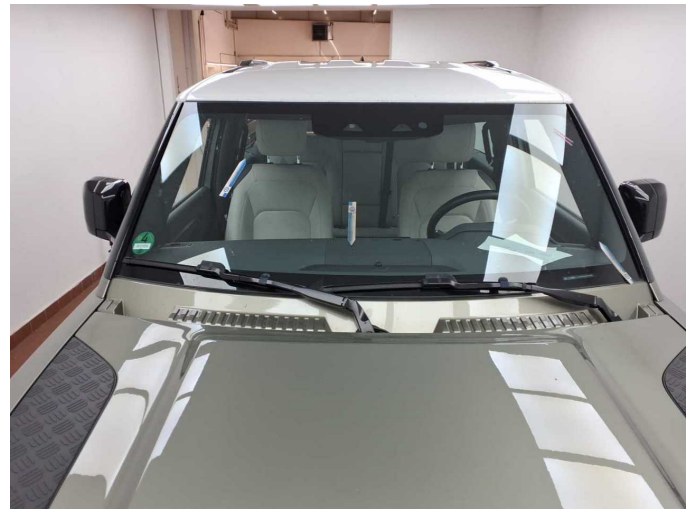
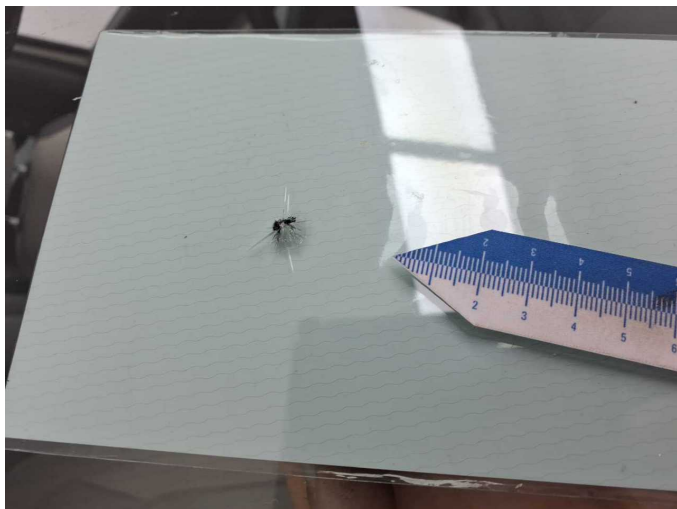
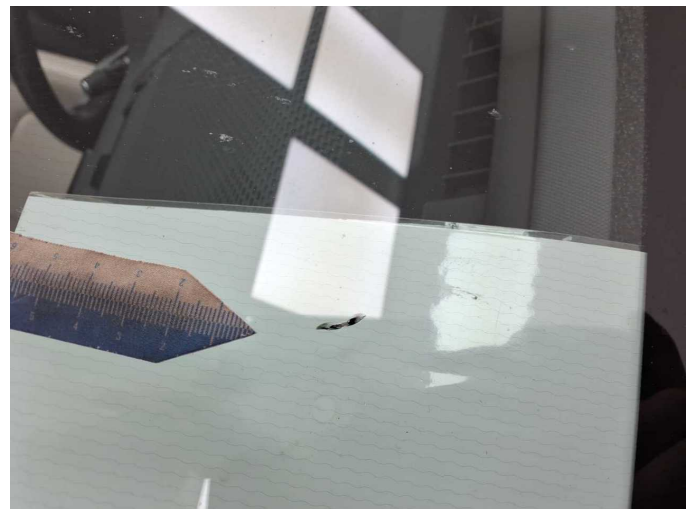
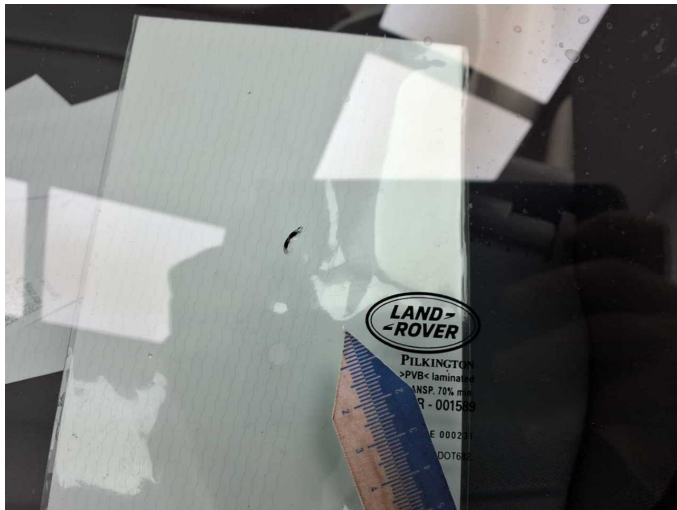
**Damage 7:** Vehicle glazing: Windscreen (mit Rissbildung) - Stone chips - Replace

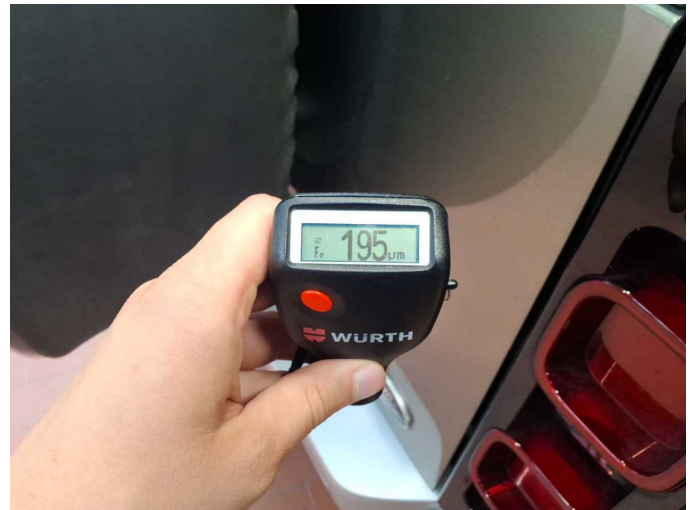
**Repainting 1:** Boot lid / rear door

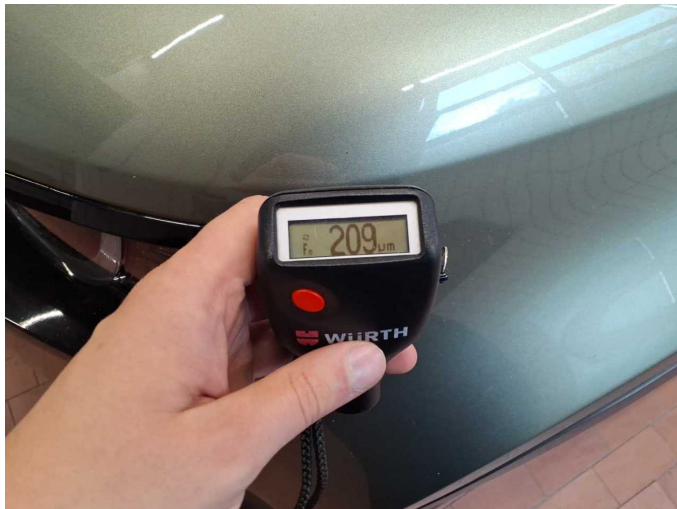
**Repainting 2:** Mudguard - left side

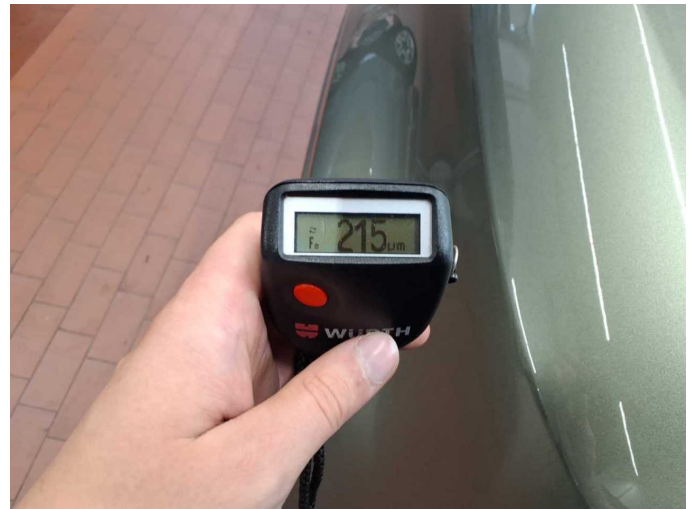
**Repainting 3:** Mudguard - right side

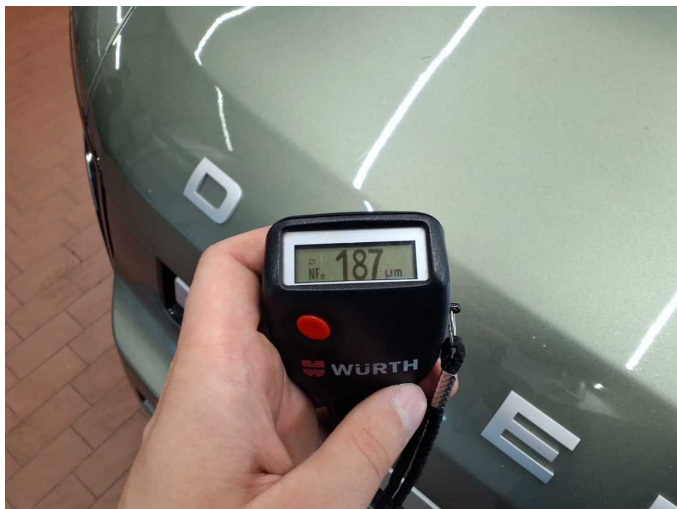
**Repainting 4:** Bonnet

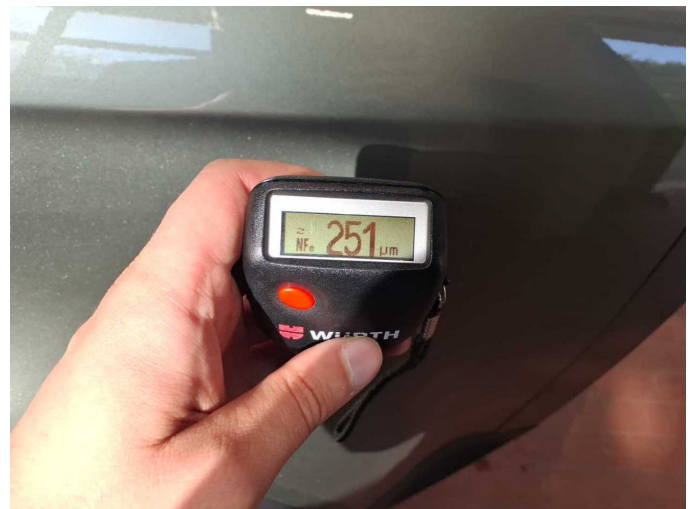
**Repainting 5:** Side panel - rear left side

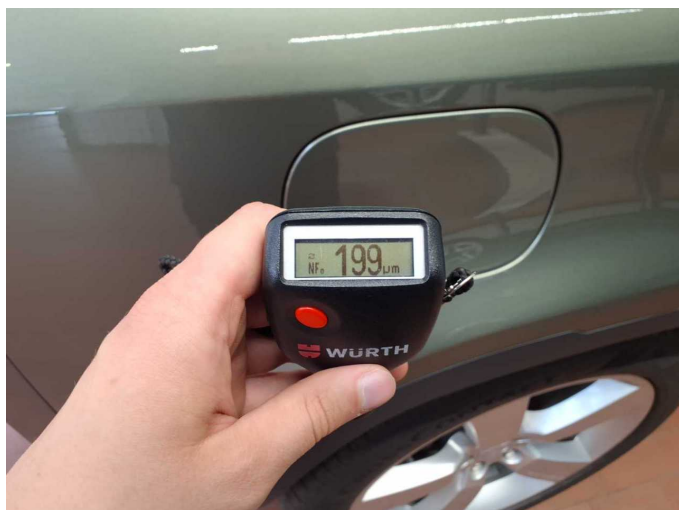
**Repainting 6:** Side panel - rear side

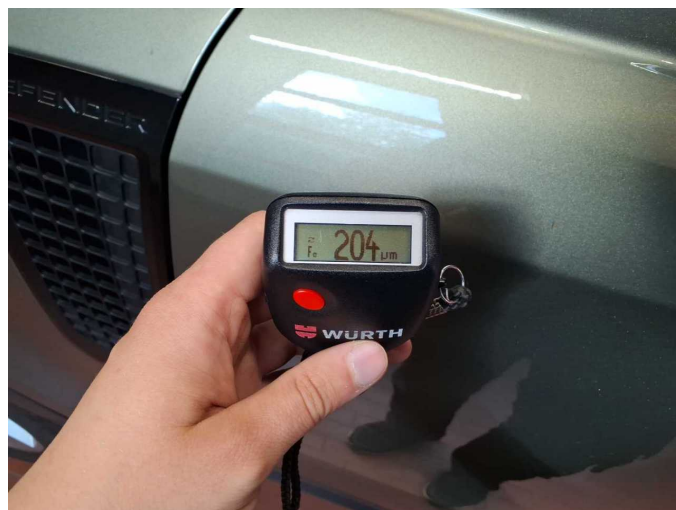
**Repainting 7:** Door - front left side

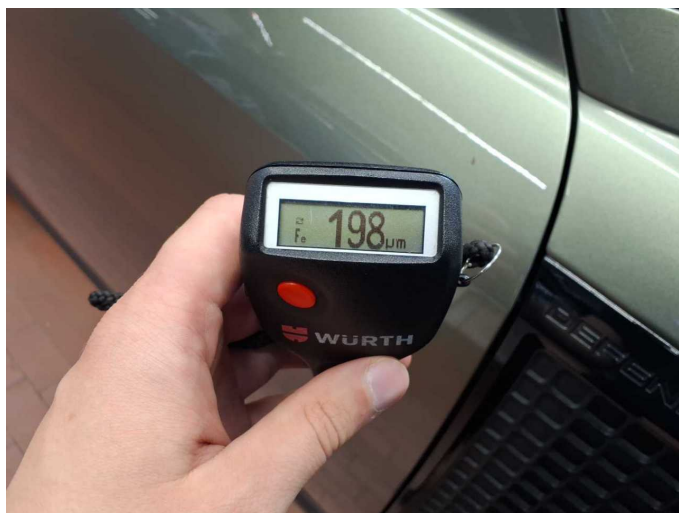
**Repainting 8:** Door - front right side
