LAND ROVER RANGE ROVER EVOQUE Range Rover Evoque Mark VI TD4 150 BVA SE Dynamic

VIN NO SALVA2BN0KH341581 Registration Number FF268SD

Inspection Report Summary

Customer	BCAuto Encheres	Report Number	P20250919115225
Inspection Date / Place	2025-09-19 / BCA MITRY	Cosmetic Grade	2

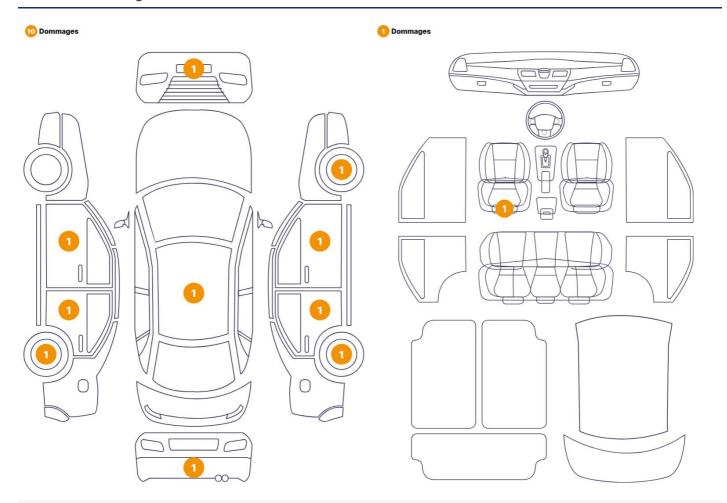
Cosmetic Damage

Component	Damage	Comments
1	Bumper / Back	Paint / Scratch / Line	
2	Rim Brake pads	Out of Bodywork / Scratch	
3	Door / Back Right	Paint / Scratch / Line	
4	Door / Front Right	Bodywork / Dent / Dent	
5	Rim	Out of Bodywork / Scratch	
6	Bumper / Front	Paint / Scratch / Line	
7	Door / Front Left	Paint / Scratch / Line	
8	Door / Back Left	Paint / Scratch / Line	
9	Rim	Out of Bodywork / Scratch	
10	Seat / Front Left	Interior / Scraped	
11	Roof	Paint / Scratch / Line

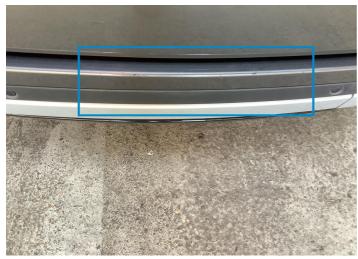
1. Bumper / Back Paint / Scratch / Line -

2. Rim Brake pads Out of Bodywork / Scratch -

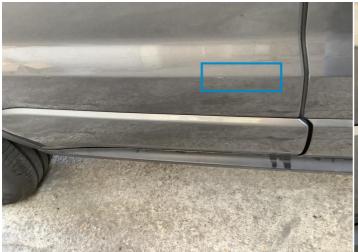
3. Door / Back Right Paint / Scratch / Line -

4. Door / Front Right Bodywork / Dent / Dent -

5. Rim Out of Bodywork / Scratch -

6. Bumper / Front Paint / Scratch / Line -

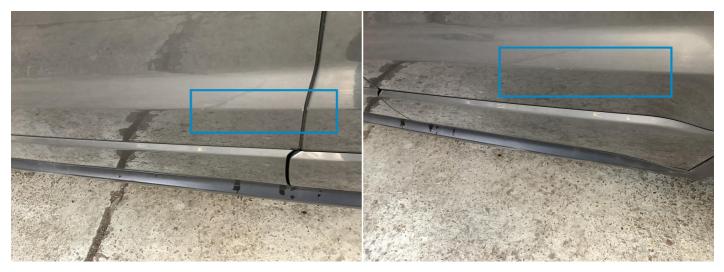
7. Door / Front Left Paint / Scratch / Line -

8. Door / Back Left Paint / Scratch / Line -

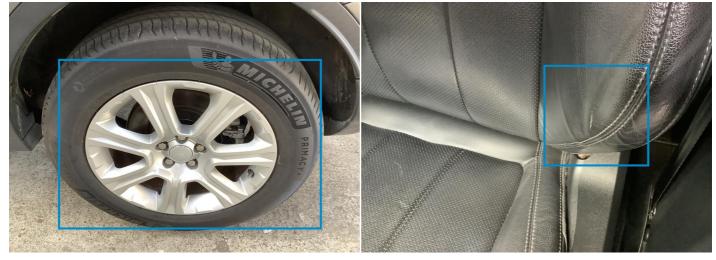
9. Rim Out of Bodywork / Scratch -

11. Roof Paint / Scratch / Line -

10. Seat / Front Left Interior / Scraped -
