LAND ROVER Range Rover Sport II 2018 Die.

Range Rover Sport 3.0d i6 mhev HSE Dynamic 249cv a

Inspection Report Summary

Customer	BCA Lodi	Report Number	P20251002102442
Inspection Date / Place	2025-10-02 / BCA Lodi	Cosmetic Grade	2

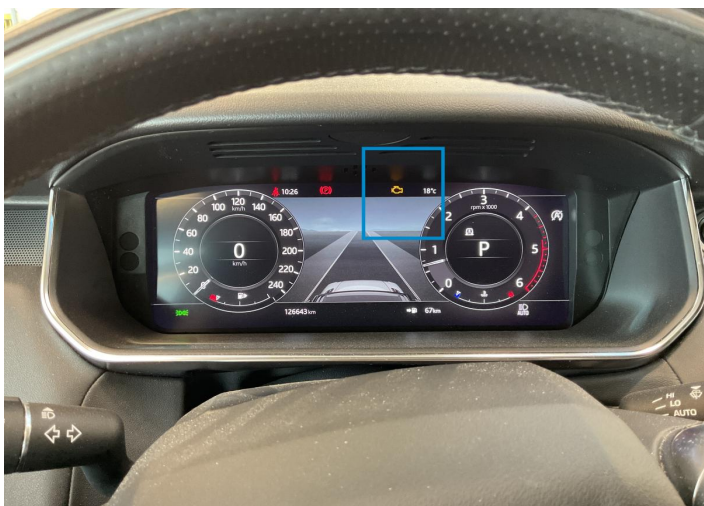
1. Dashboard / Front Interior / Warning Light ON -

Other Checks			
Brakes	✓	Steering	✓
Suspension	!		
Gearbox			
Manual Gearbox	✓		
General			
Test Driven Status	✓	Test Drive Comment	SPIA AVARIA GENERICA MOTORE ACCESA
Equipments Test			
Steering Noise / Anomaly	✓		
Engine			
Power Loss	✓	Fume Quantity	✓
Engine Noise	✓		
✓ No troubles detected, good condition or correct tests, according to vehicle age and mileage			
! Damages or malfunction detected that requires repairs by the buyer			
NA Not applicable			
☐ Not tested

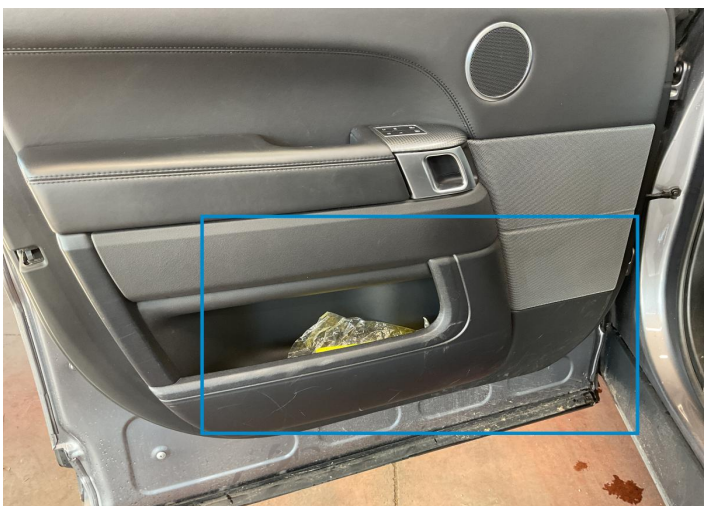
2. Panel Filling / Front Left Interior / Scratched -

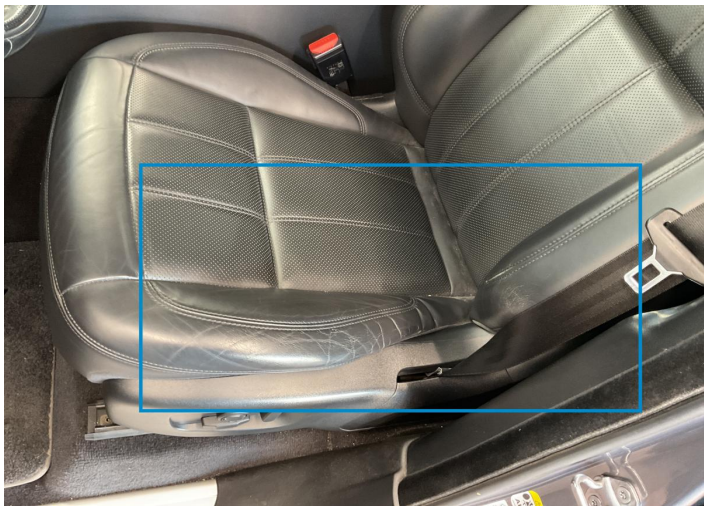
3. Seat / Front Left Interior / Scratched -

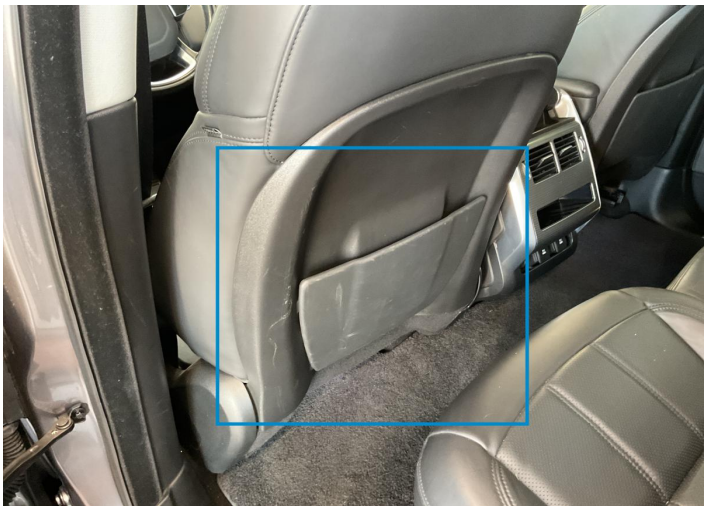
4. Seat / Front Left Interior / Scratched -

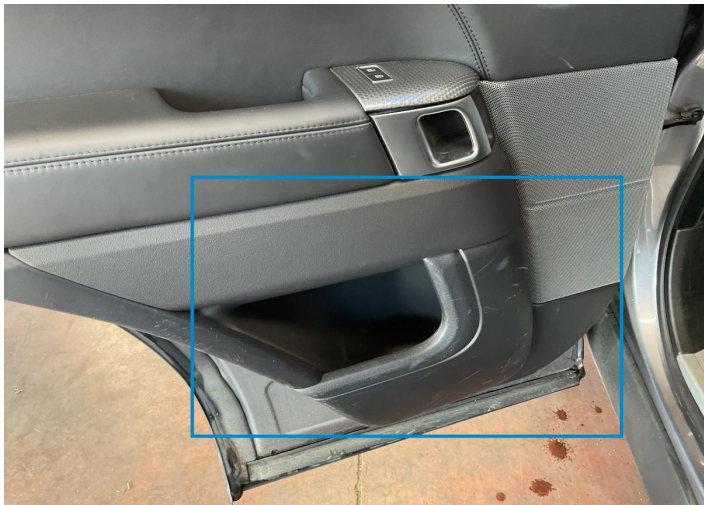
5. Panel Filling / Back Left Interior / Scratched -

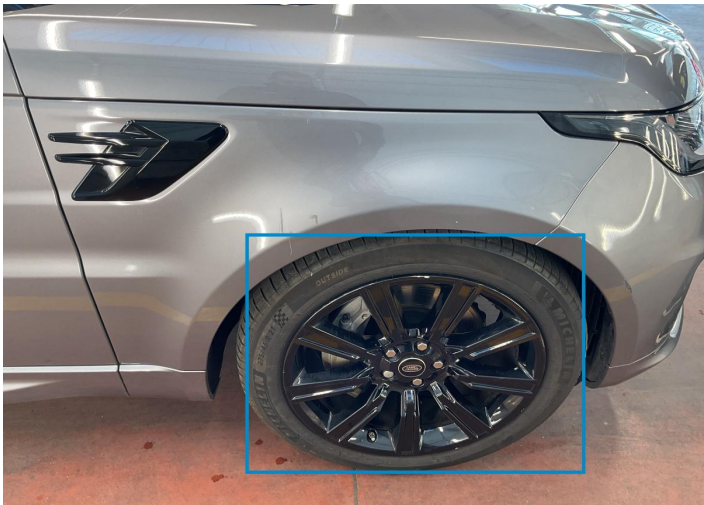
6. Rim / Front Right Out of Bodywork / Scratch -

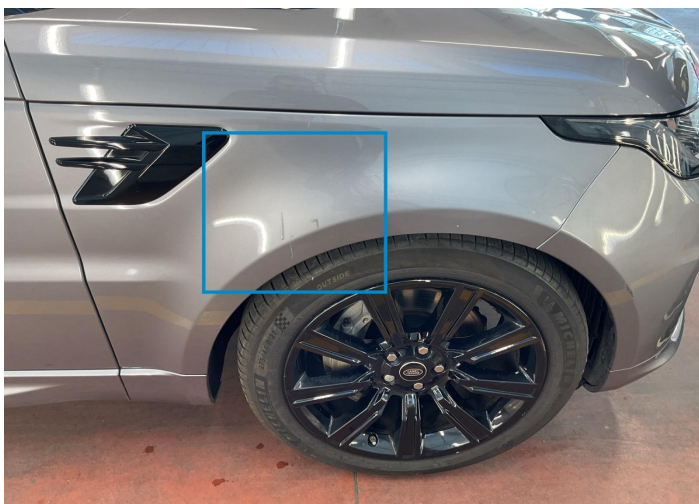
7. Fender / Front Right
Bodywork / Poor Previous Repair -

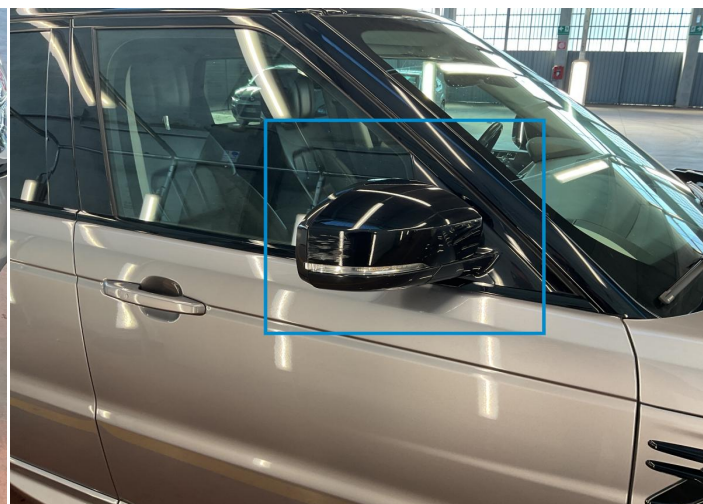
8. Mirror Shell / Front Right
Paint / Scratch / Line -

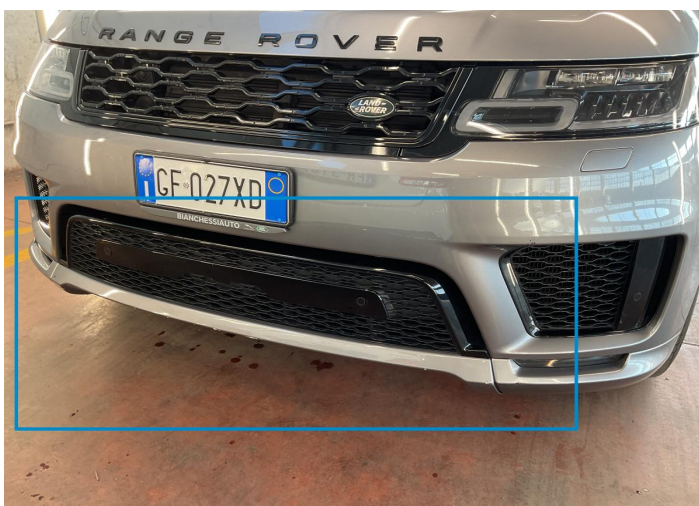
9. Bumper / Front
Paint / Scratch / Line -

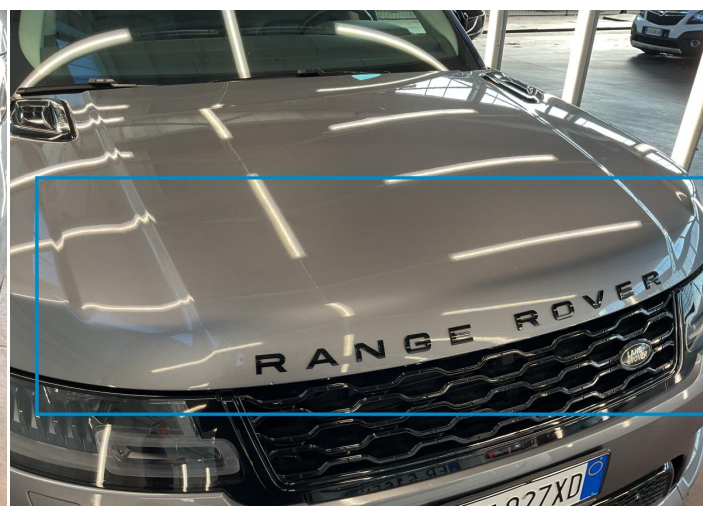
10. Hood
Paint / Chipping -

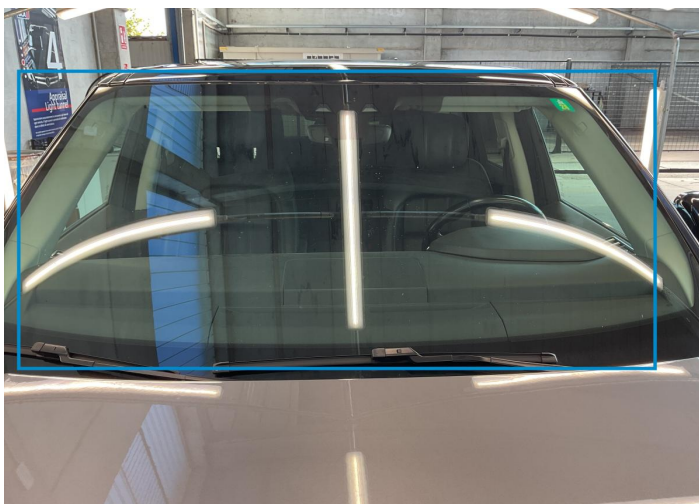
11. Windshield / Front
Glass Break / Impact -

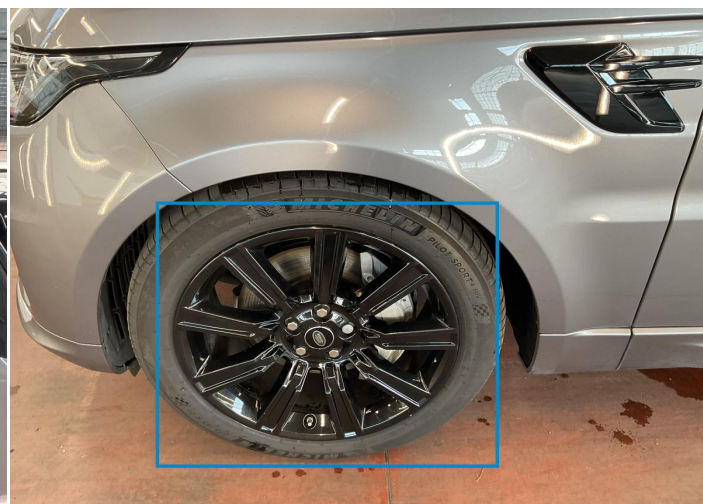
12. Rim / Front Left
Out of Bodywork / Scratch -

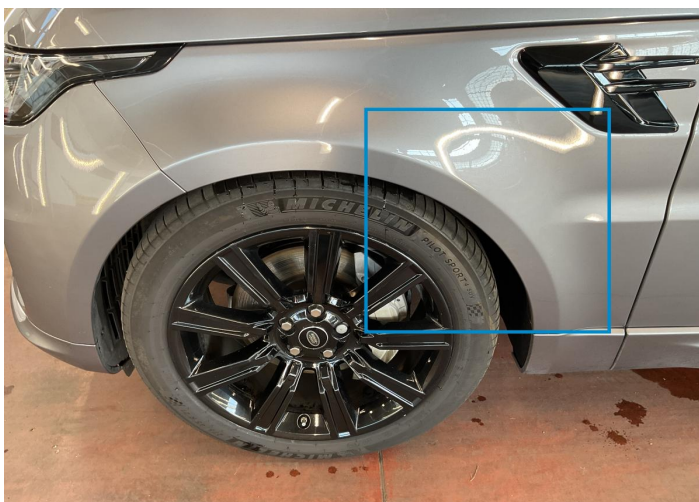
13. Fender / Front Left
Paint / Scratch / Line -

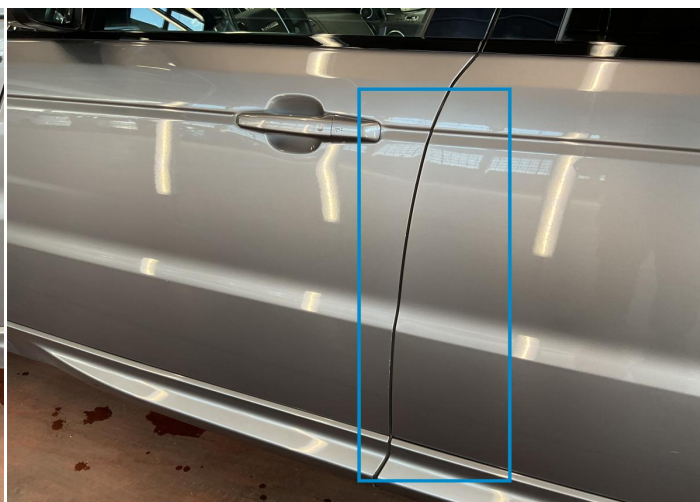
14. Door / Front Left
Paint / Scratch / Line -

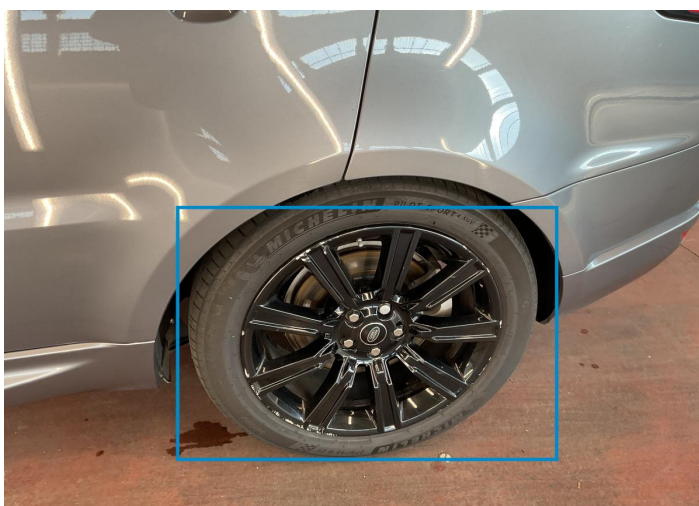
15. Rim / Back Left
Out of Bodywork / Scratch -

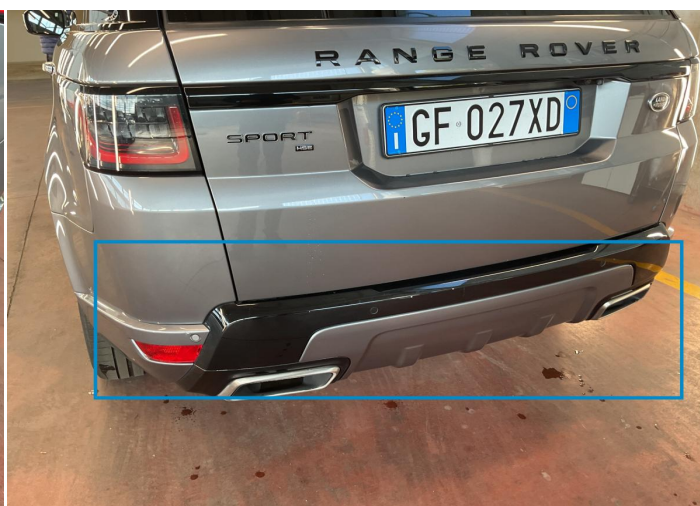
16. Bumper / Back
Bodywork / Dent -

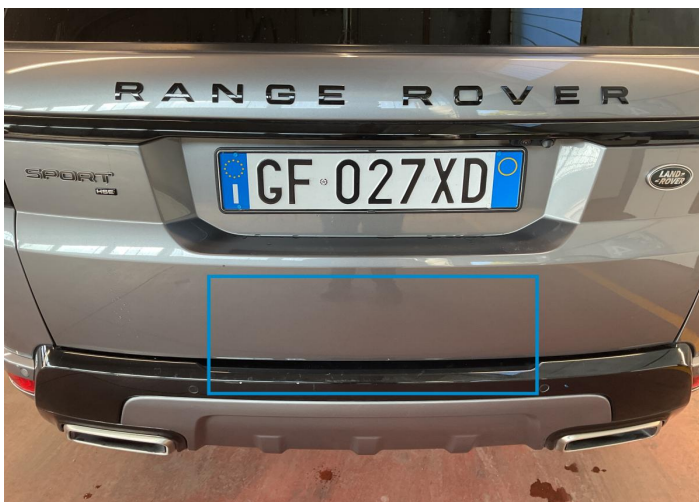
17. Tailgate
Paint / Chipping -

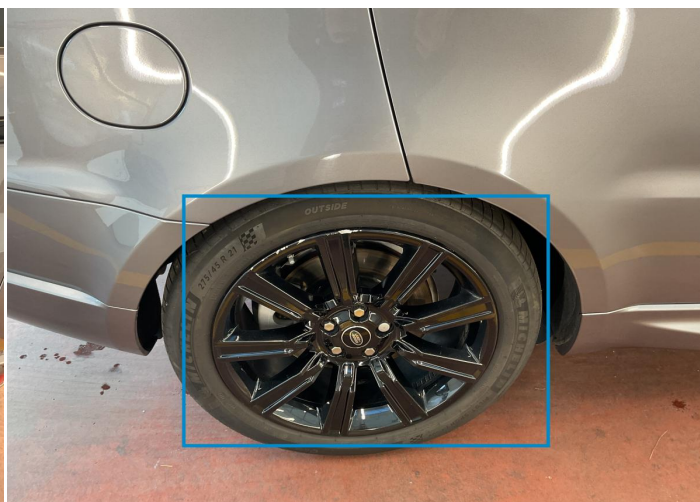
18. Rim / Back Right
Out of Bodywork / Scratch -

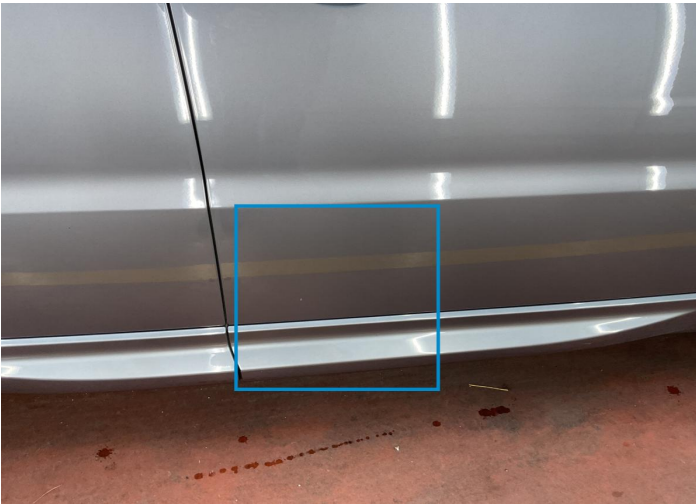
19. Door / Front Right
Paint / Chipping -

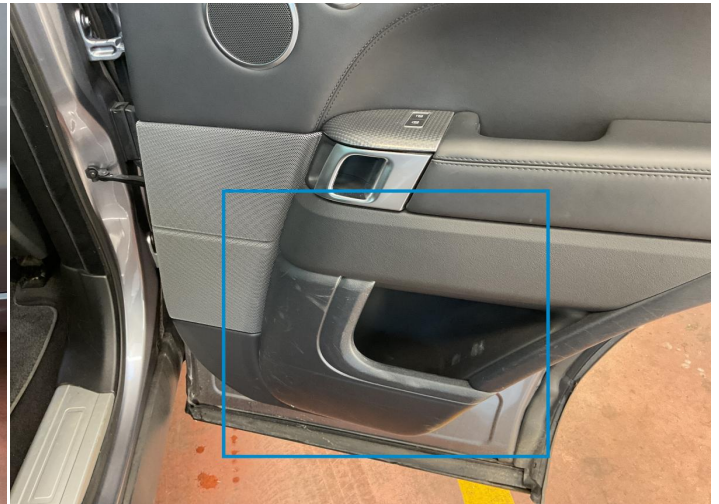
20. Panel Filling / Back Right
Interior / Scratched -

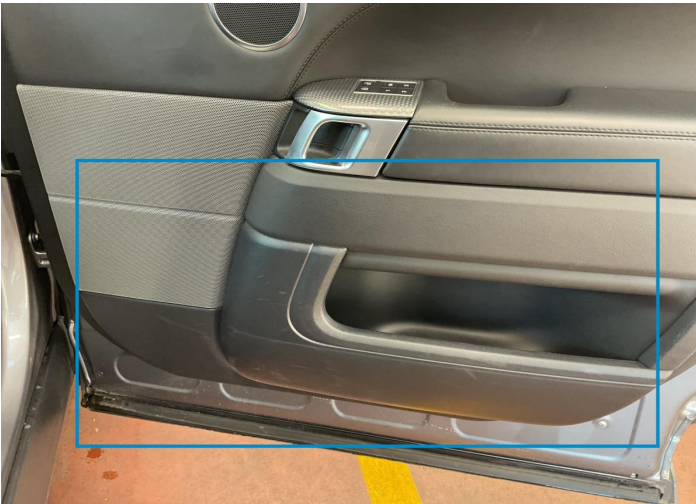
21. Panel Filling / Front Right
Interior / Scratched -
