## status report

#### Land Rover Range Rover Sport Autobiography Dynamic

| Vehicle identification number | <b>SALWA2JF9GA595692</b> | mileage read: | <b>150128 km</b> |

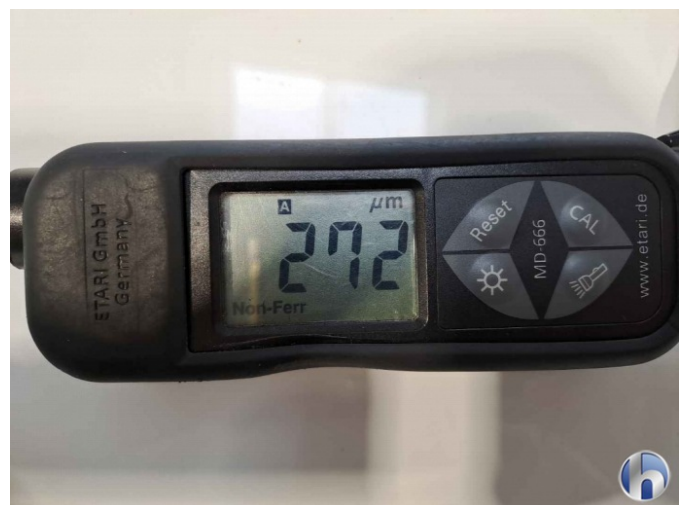
| component | Damage | Rep kind |
|---|---|---|
| 1. hood | Subsequently painted | acceptable |

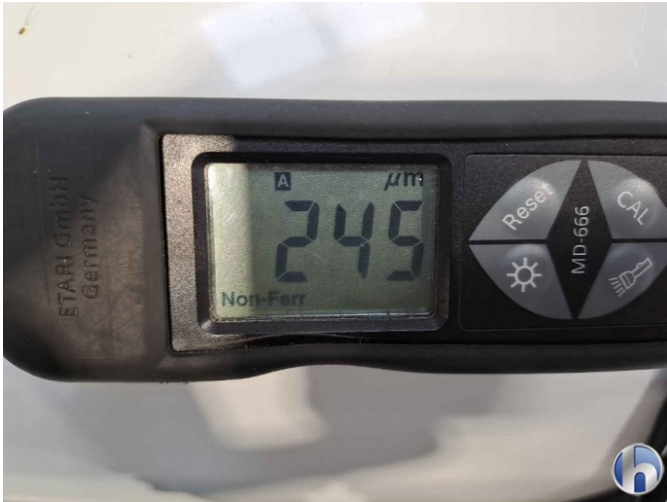
| component | Damage | Rep kind |
|---|---|---|
| 2. Front fender - right | Subsequently painted | acceptable |

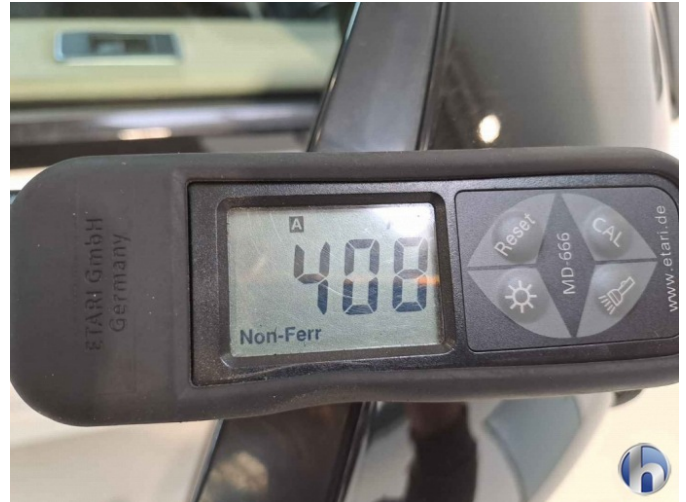
| component | Damage | Rep kind |
|---|---|---|
| 3. Front door - right | Subsequently painted | acceptable |

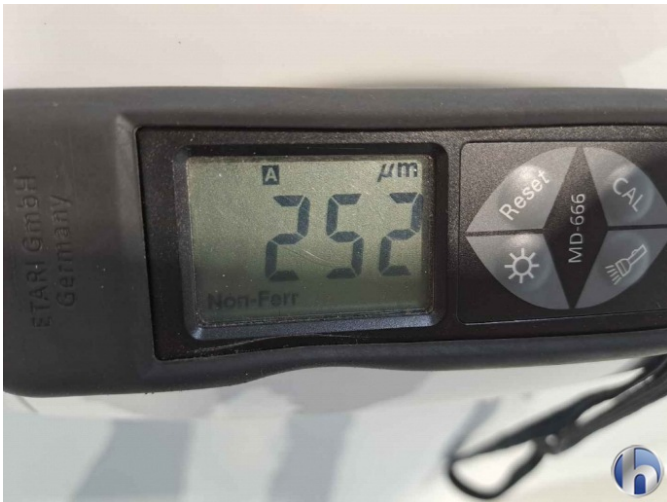
| component | Damage | Rep kind |
|---|---|---|
| 4. Door Rear - right | Subsequently painted | acceptable |

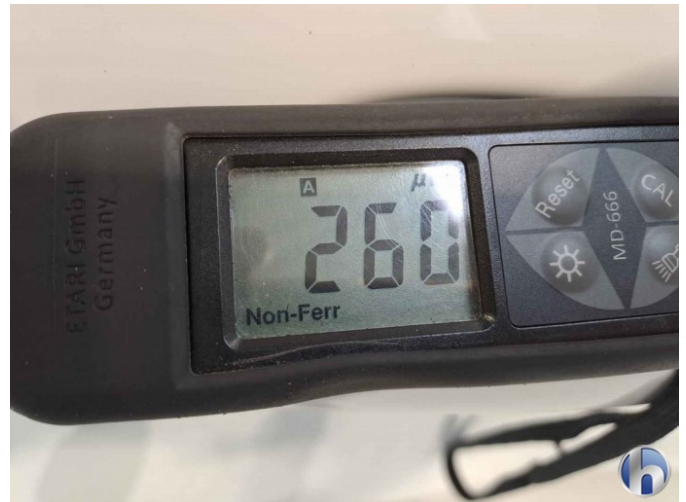
| component | Damage | Rep kind |
|---|---|---|
| 5. Sidewall - Rear - right | Subsequently painted | acceptable |

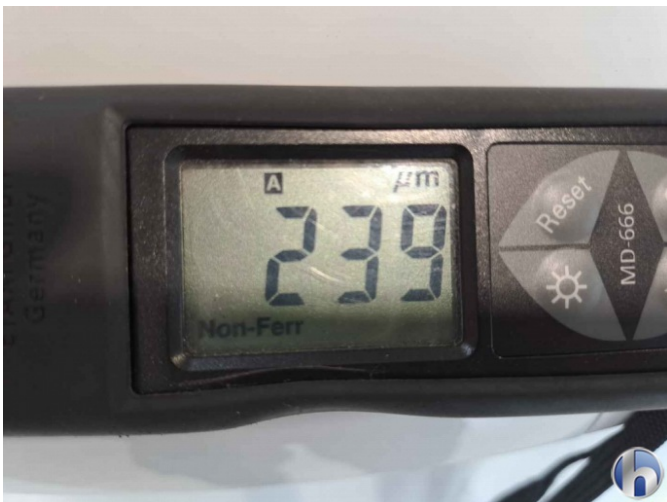
| component | Damage | Rep kind |
|---|---|---|
| 6. Sidewall - Rear - Left | Subsequently painted | acceptable |

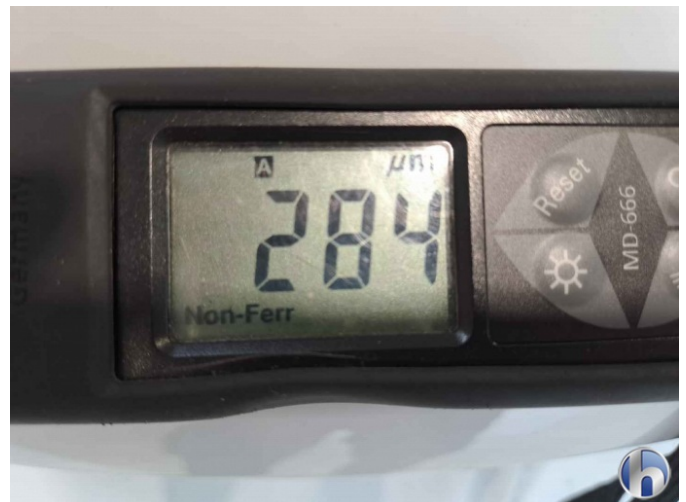
| component | Damage | Rep kind |
|---|---|---|
| 7. Rear door - left | Subsequently painted | acceptable |

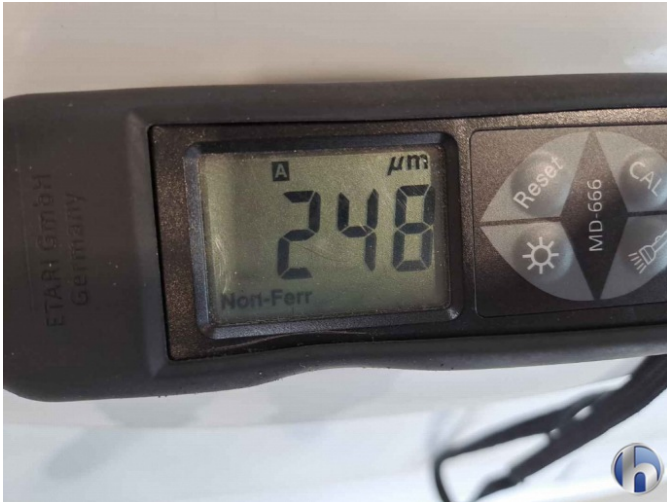
| component | Damage | Rep kind |
|---|---|---|
| 8. Front door - left | Subsequently painted | acceptable |

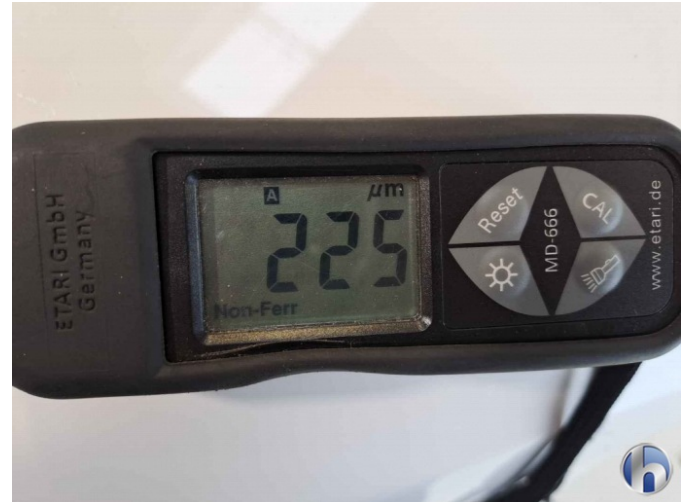
| component | Damage | Rep kind |
|---|---|---|
| 9. Front fender - left | Subsequently painted | acceptable |

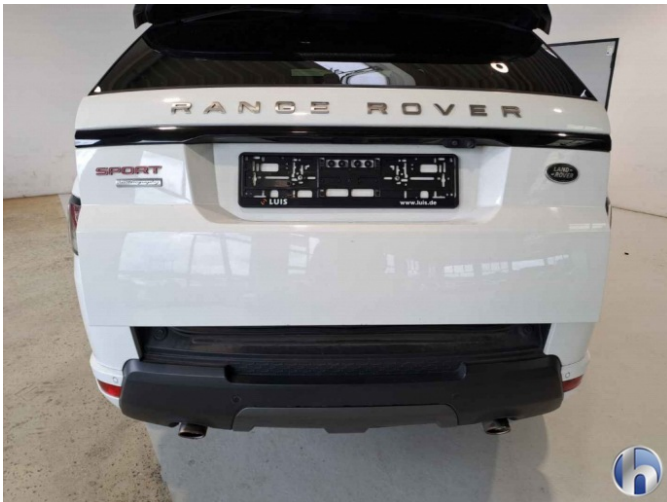
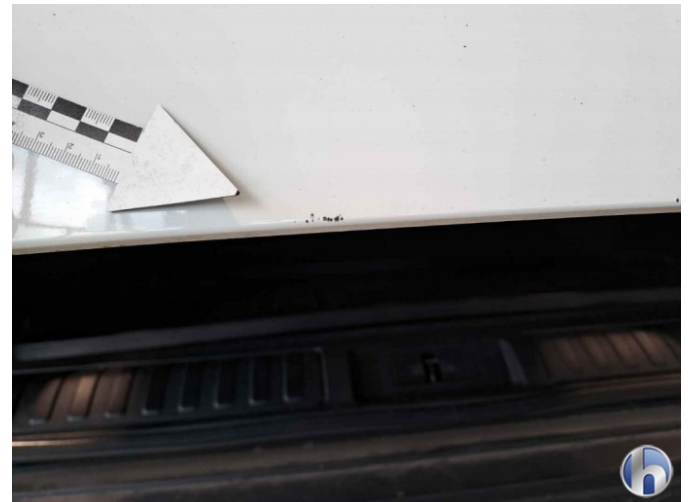
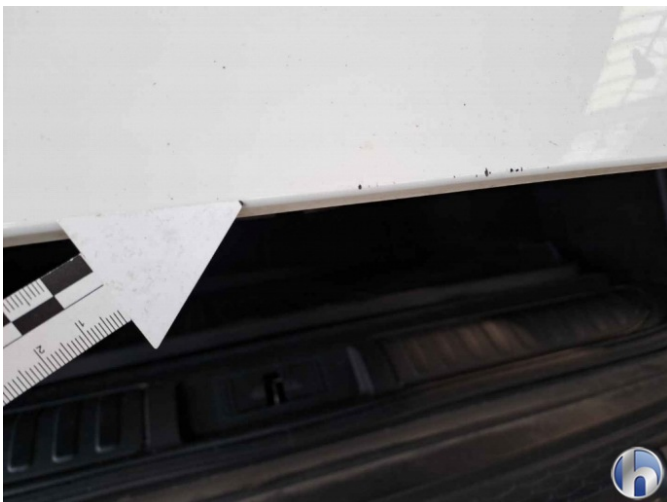
| component | Damage | Rep kind |
|---|---|---|
| 12. tailgate | Scrape | Smart repair |

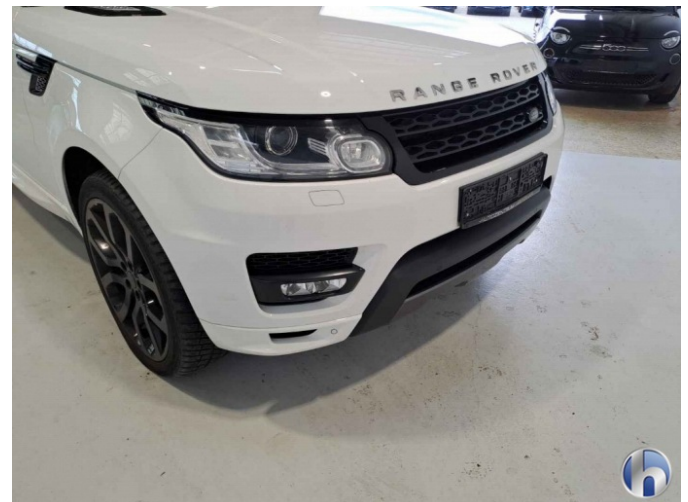
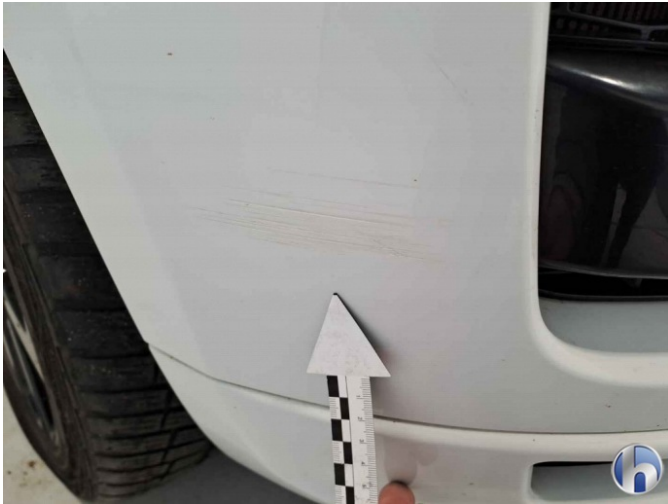
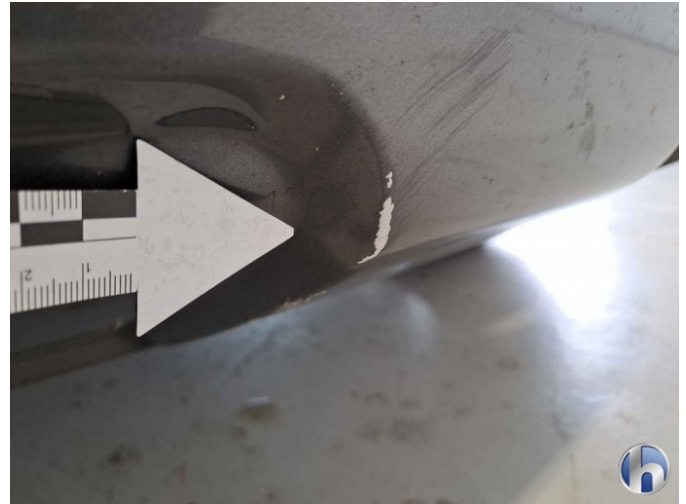
| component | Damage | Rep kind |
|---|---|---|
| 13. Front bumper | Scrape | Smart repair |

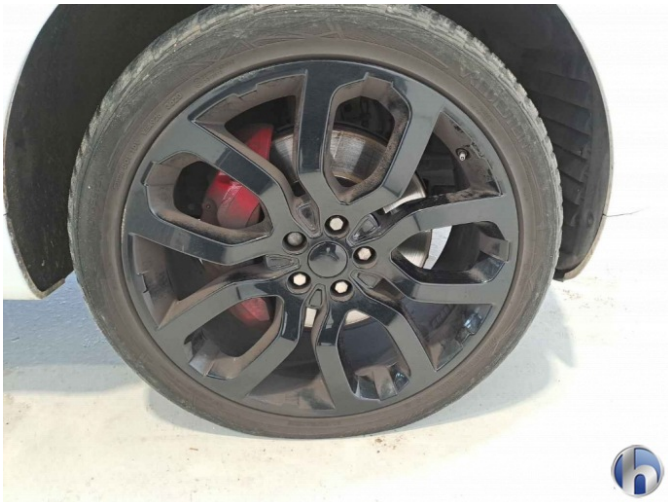
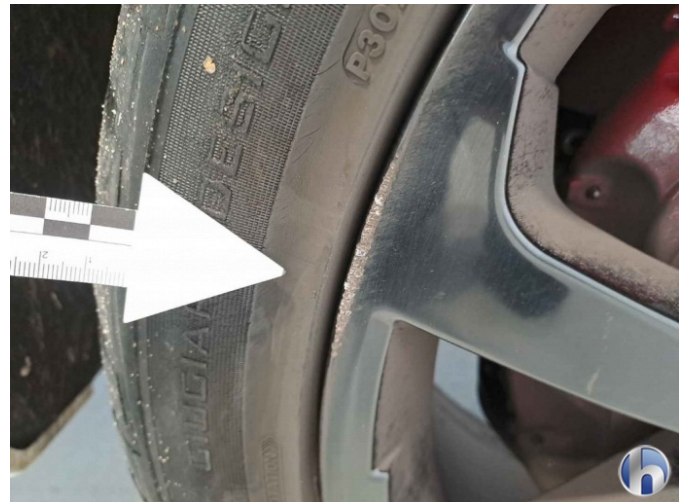
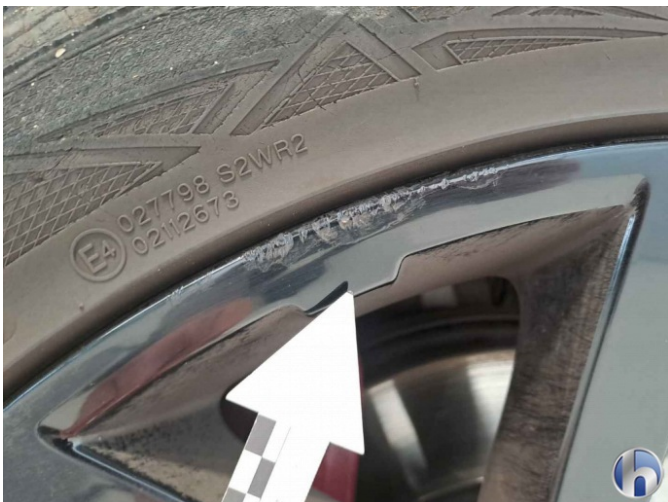
| component | Damage | Rep kind |
|---|---|---|
| 14. Rim front - right | Damaged | Replace |

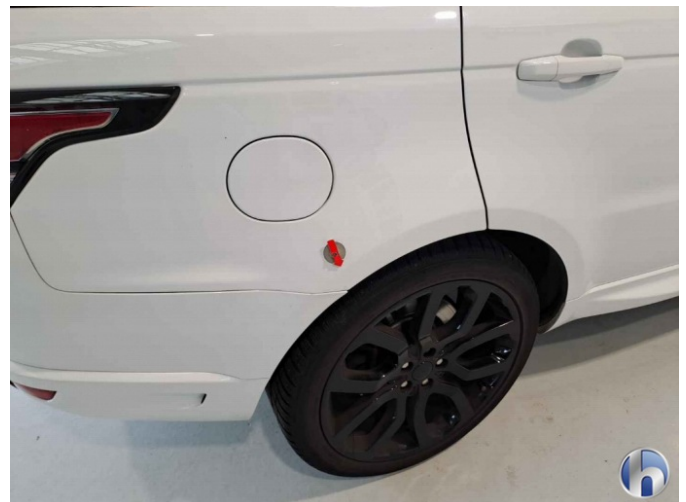
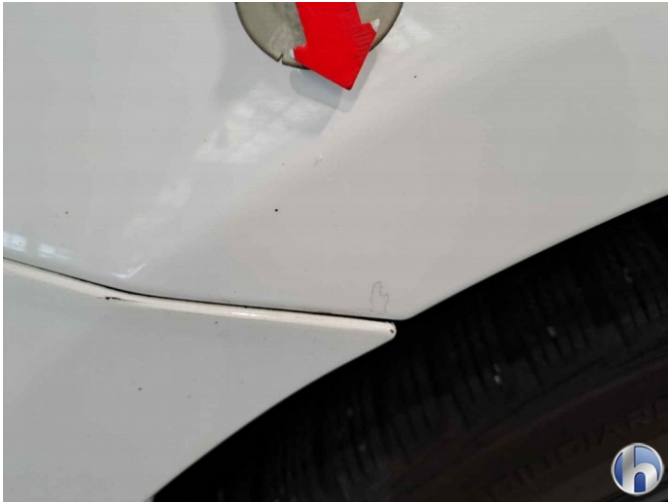
| component | Damage | Rep kind |
|---|---|---|
| 15. Sidewall - Rear - right | Damaged | Smart repair |

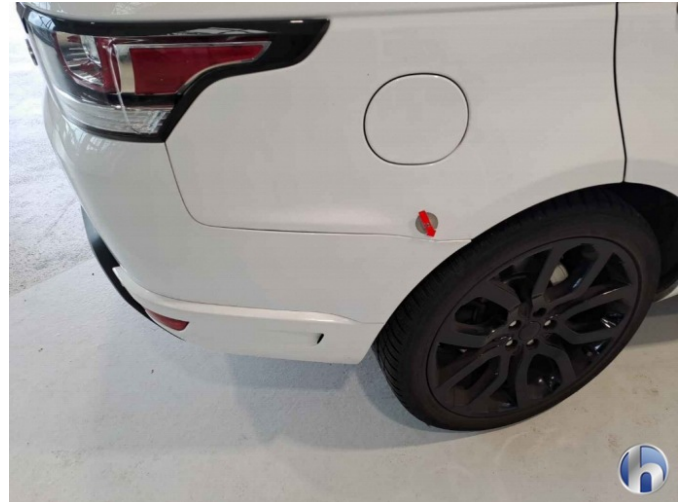
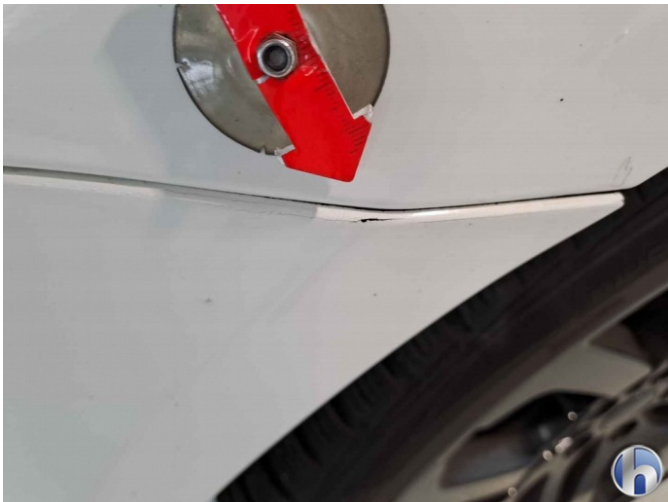
| component | Damage | Rep kind |
|---|---|---|
| 16. Rear bumper | Scrape | Smart repair |

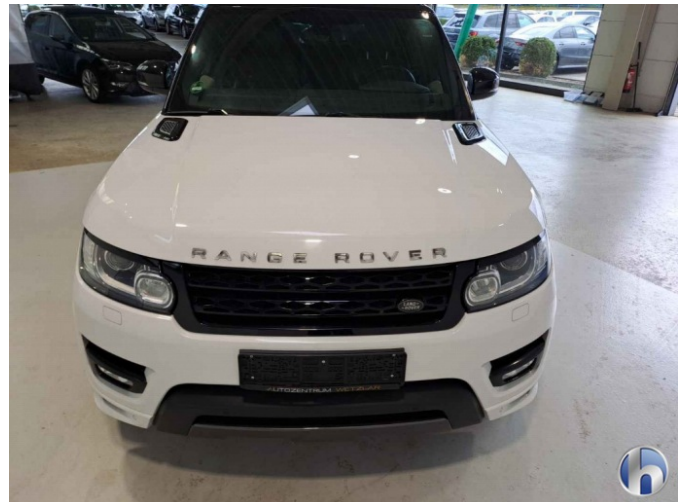
| component | Damage | Rep kind |
|---|---|---|
| 17. exterior body | Surface scratch(es) | |

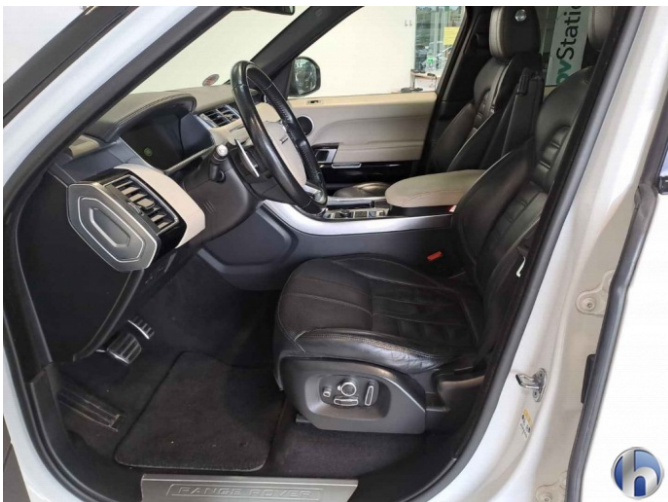
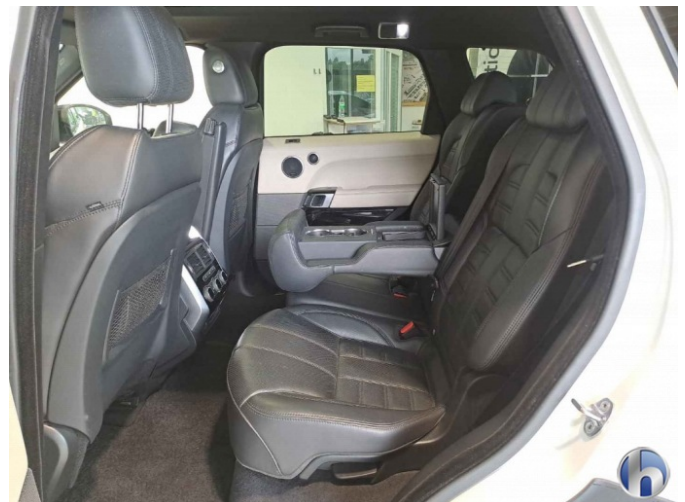
| component | Damage | Rep kind |
|---|---|---|
| 18. | Wear and tear | acceptable |

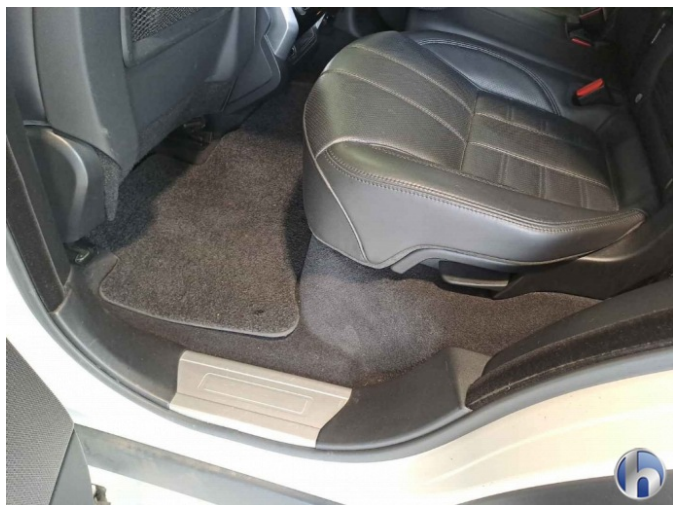
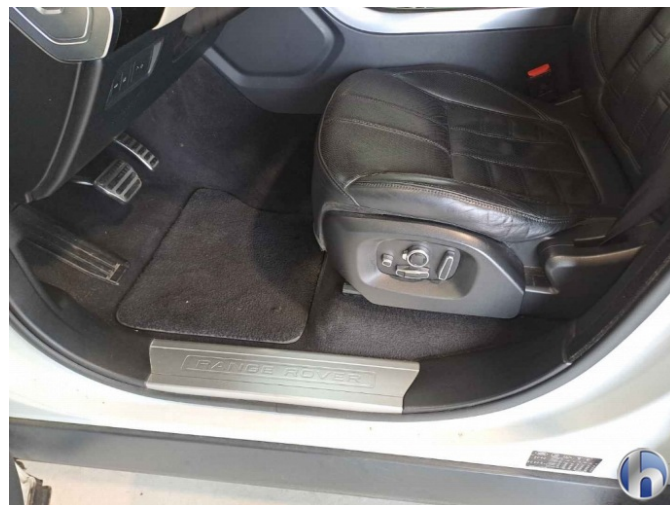
| component | Damage | Rep kind |
|---|---|---|
| 19. | Dirty | |

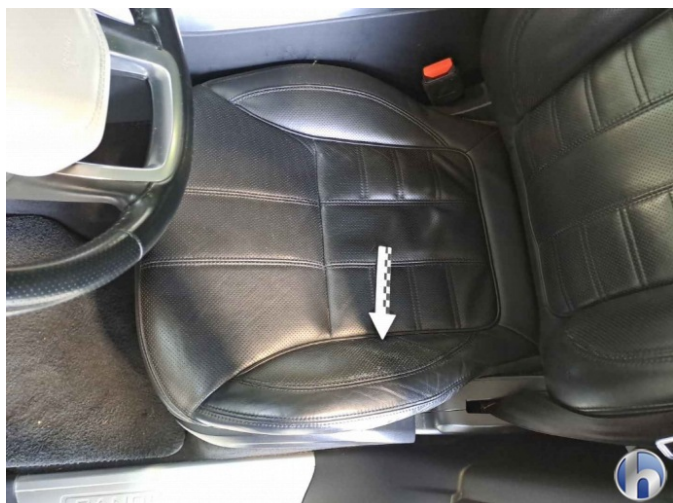
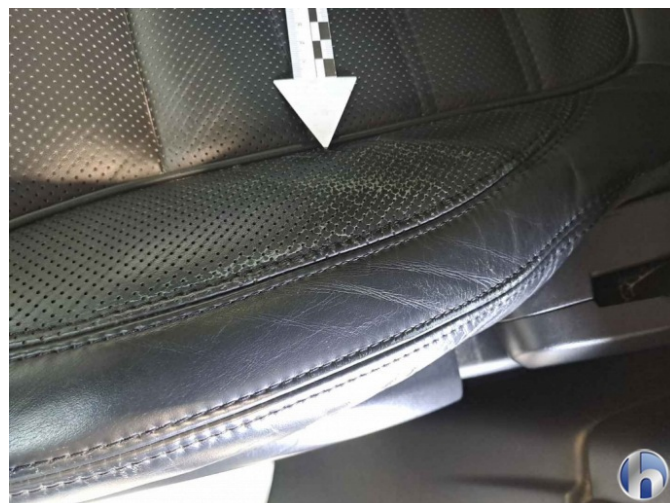
| component | Damage | Rep kind |
|---|---|---|
| 20. | Scrape | Replace |

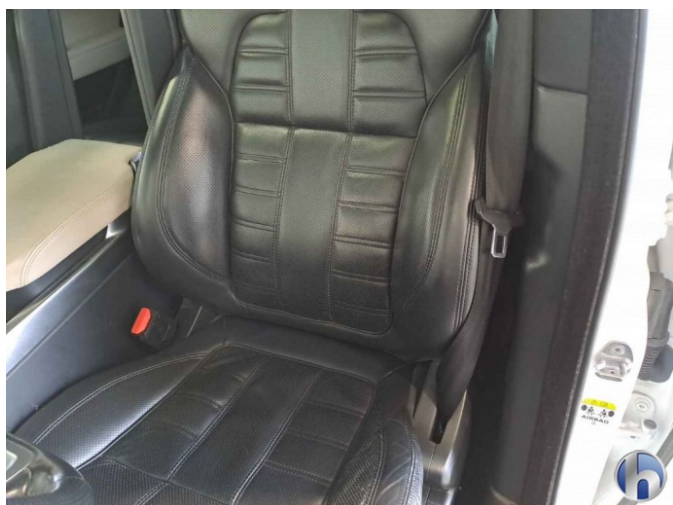
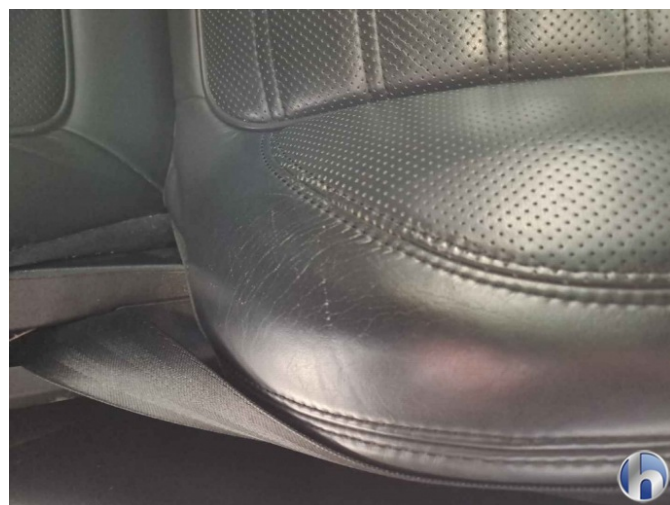
| component | Damage | Rep kind |
|---|---|---|
| 21. | Scrape | Replace |

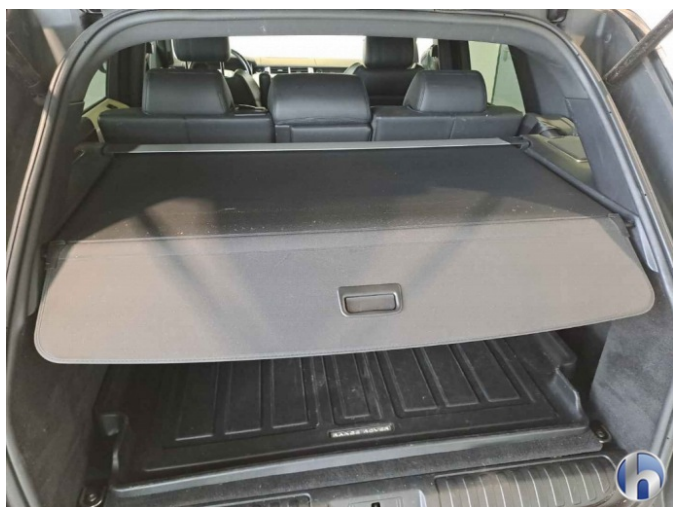
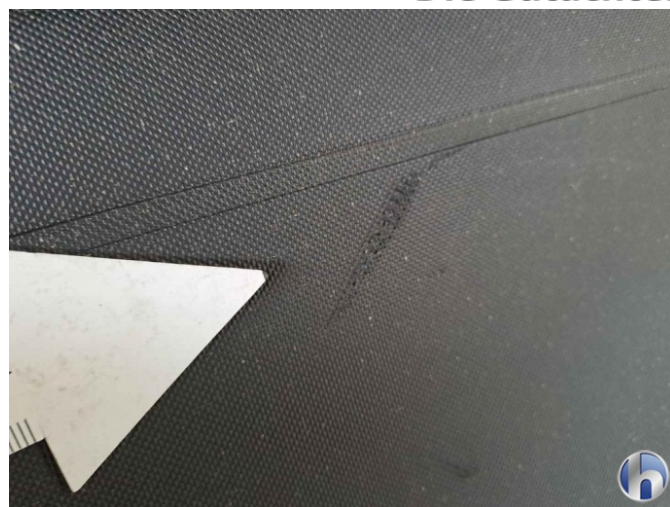
| component | Damage | Rep kind |
|---|---|---|
| 23. Cargo cover | Damaged | Replace |

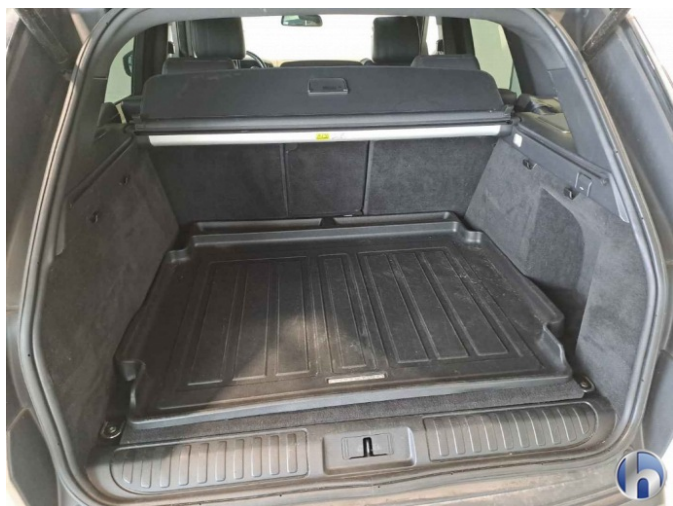
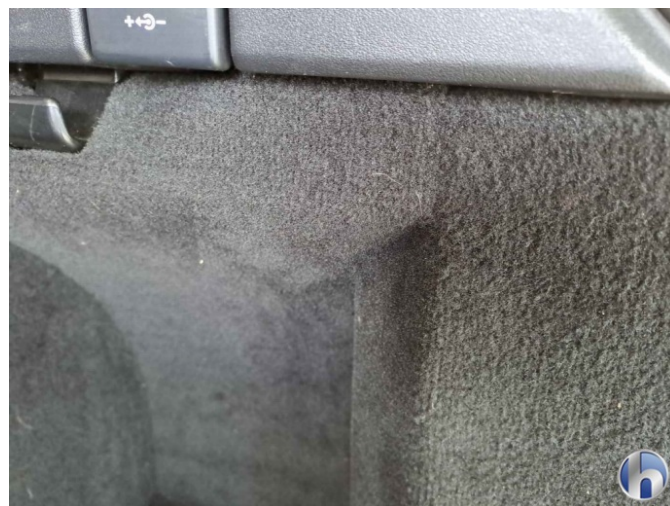
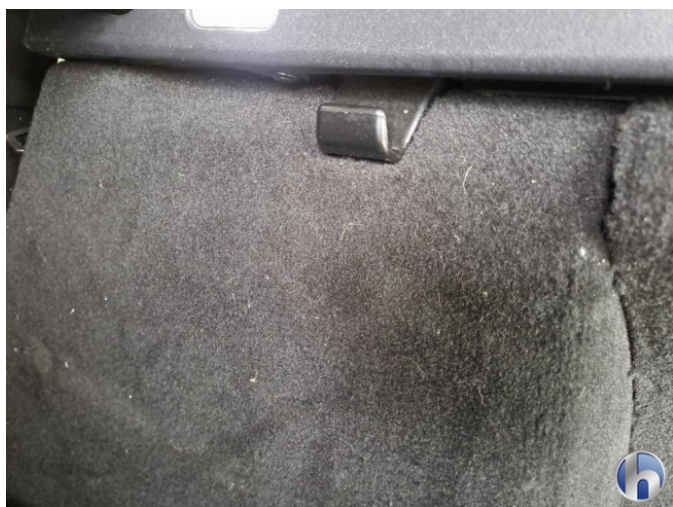
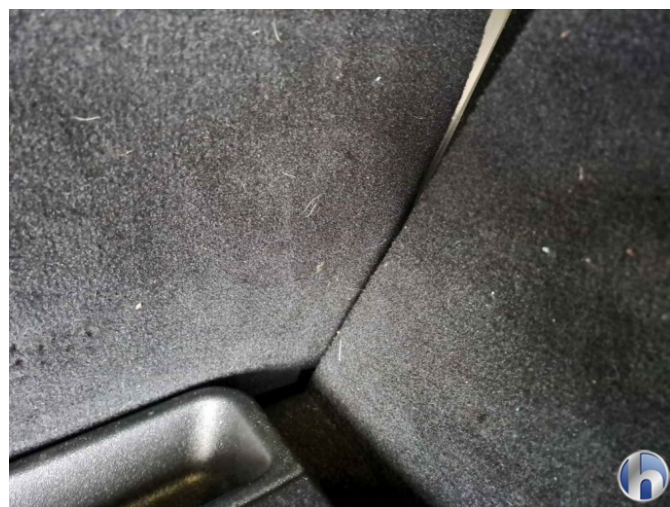
| component | Damage | Rep kind |
|---|---|---|
| 24. | Dirty (animal hair) | |

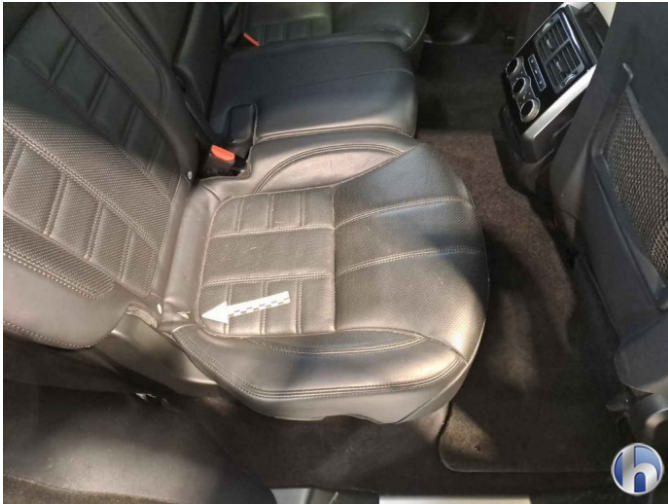
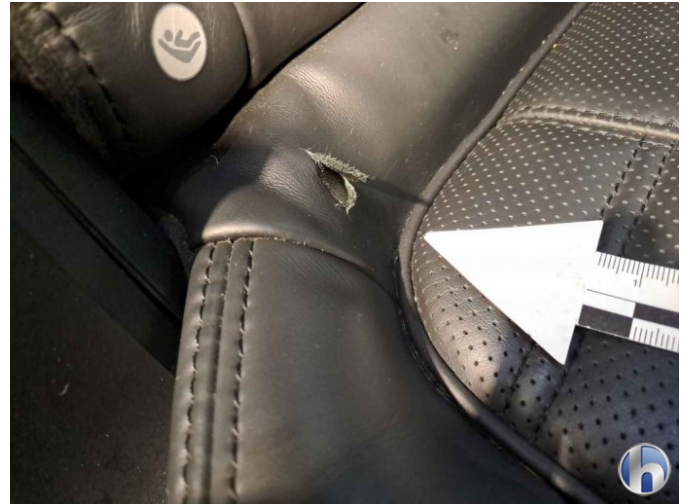
| component | Damage | Rep kind |
|---|---|---|
| 25. | Damaged | Replace |
