## status report

#### Land Rover Range Rover Velar R-Dynamic HSE

| Vehicle identification number | <b>SALYA2BK7LA243290</b> | mileage read: | <b>77891 km</b> |

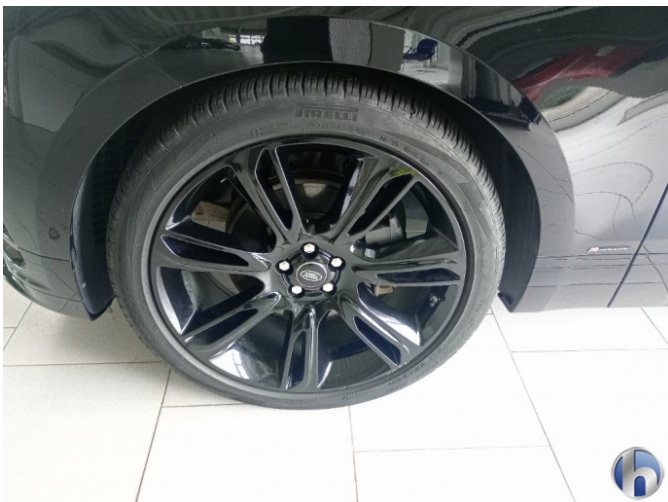
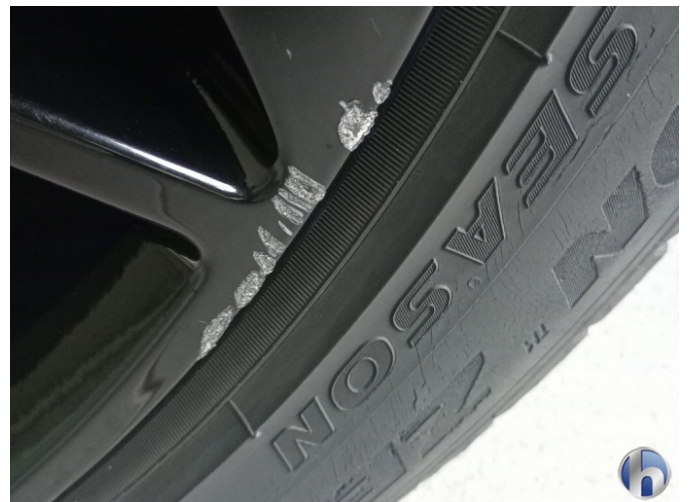
| component | Damage | Rep kind |
|---|---|---|
| 1. | Damaged | Paint |

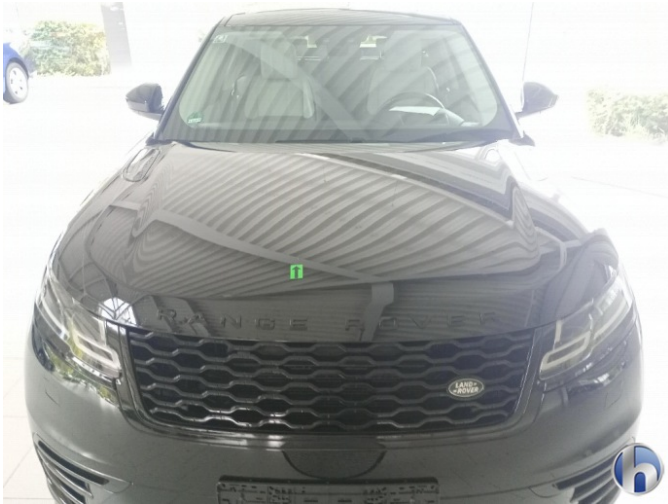
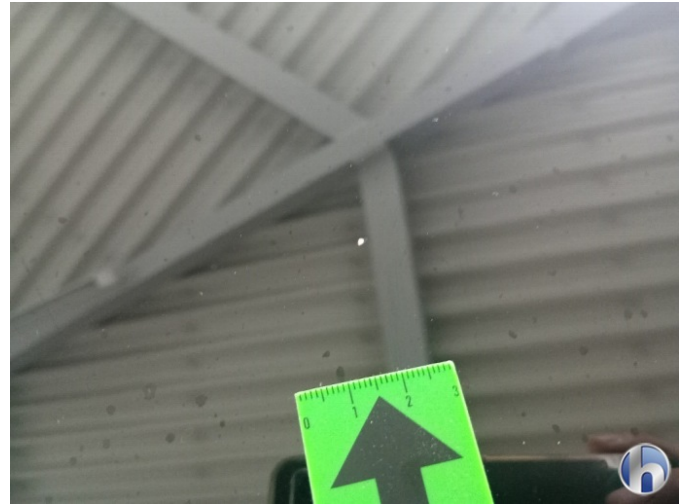
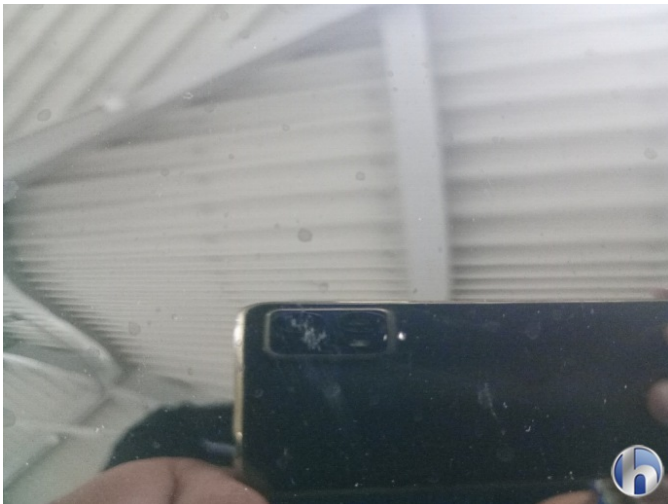
| component | Damage | Rep kind |
|---|---|---|
| 2. hood | Chipping from stones | Smart repair |

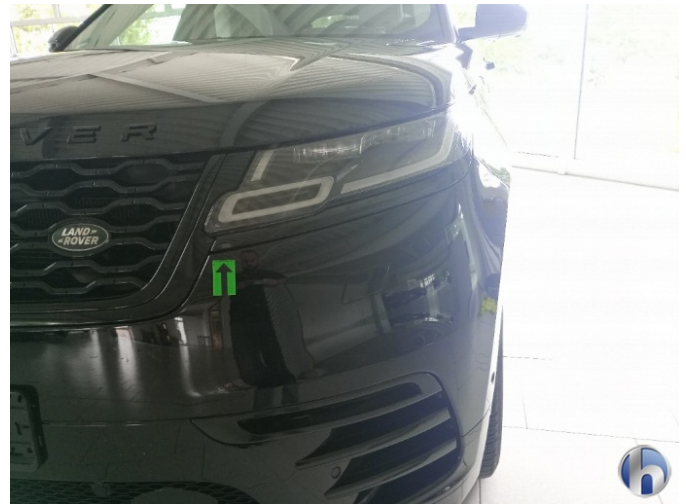
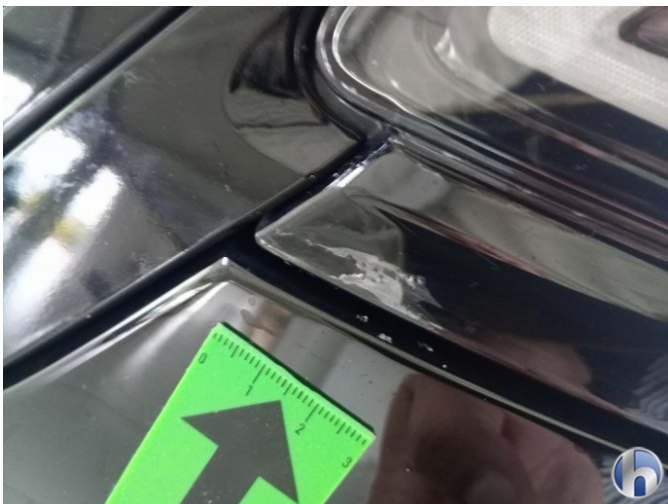
| component | Damage | Rep kind |
|---|---|---|
| 3. Halogen headlights - left | Damaged | Replace |

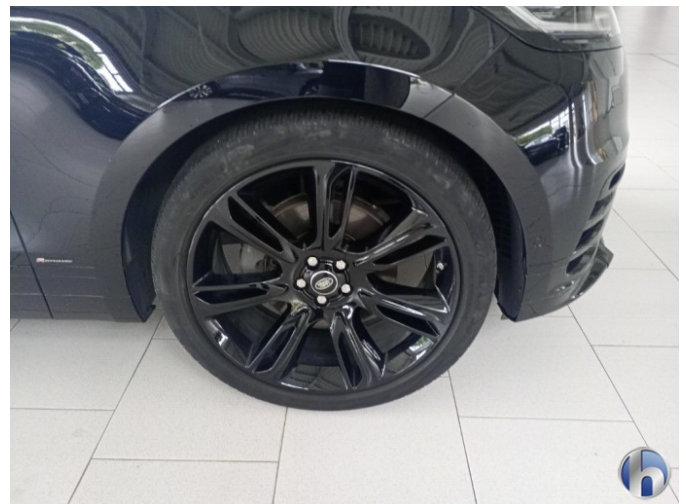
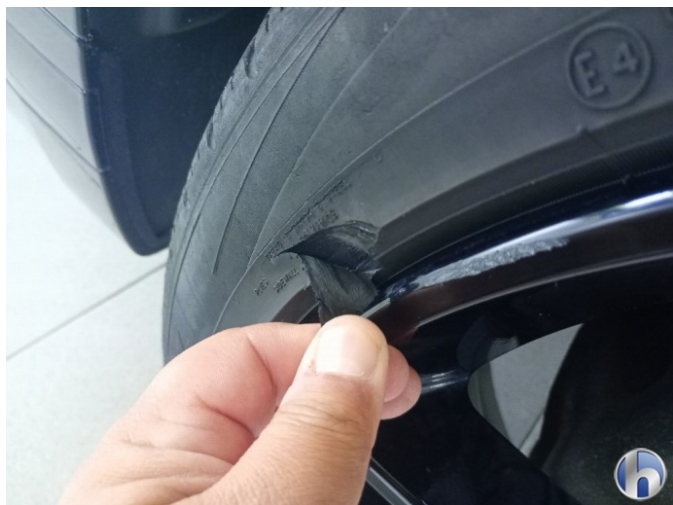
| component | Damage | Rep kind |
|---|---|---|
| 4. | Damaged | Replace |

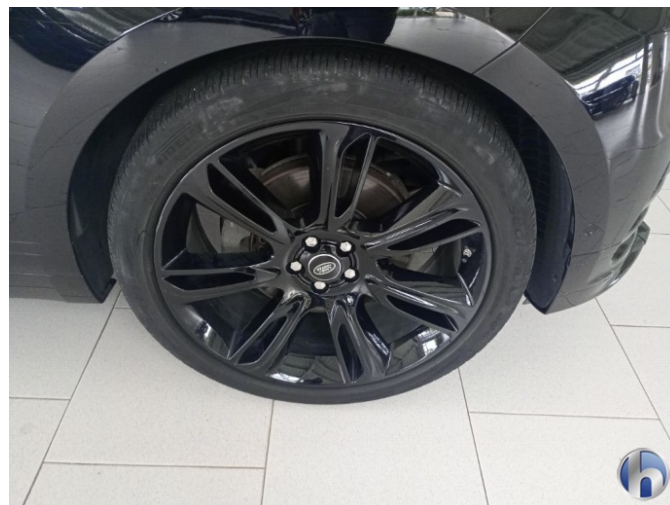
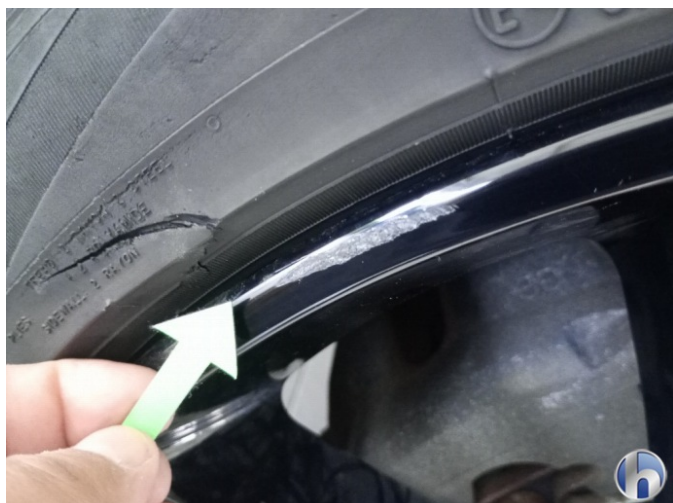
| component | Damage | Rep kind |
|---|---|---|
| 5. | Damaged | Smart repair |

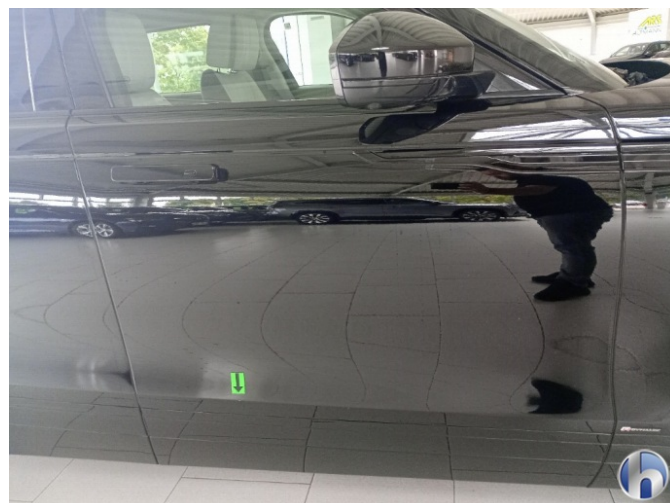
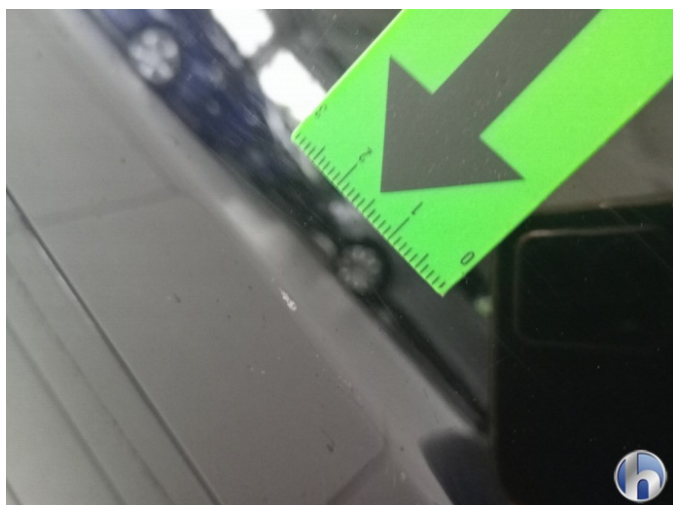
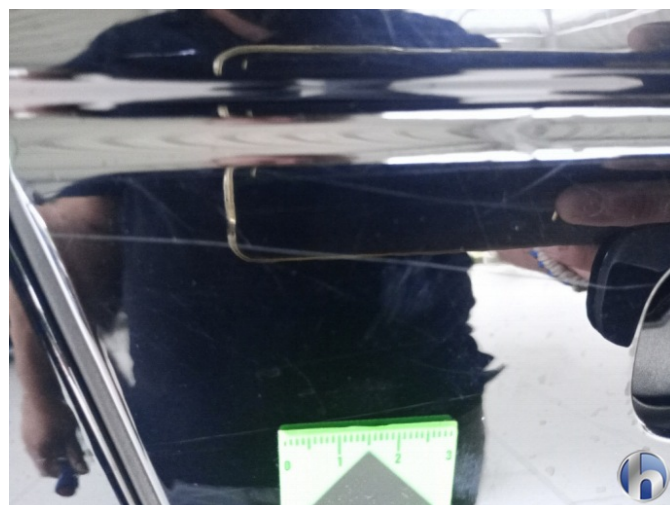
| component | Damage | Rep kind |
|---|---|---|
| 6. Front door - right | Scratch(es) | Smart repair |

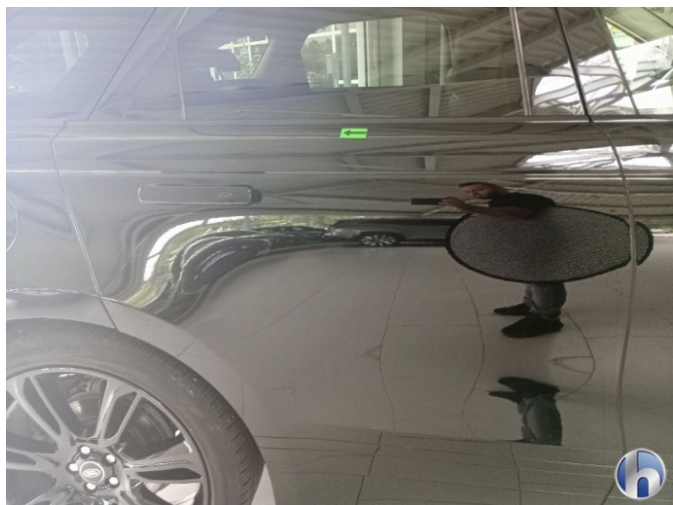
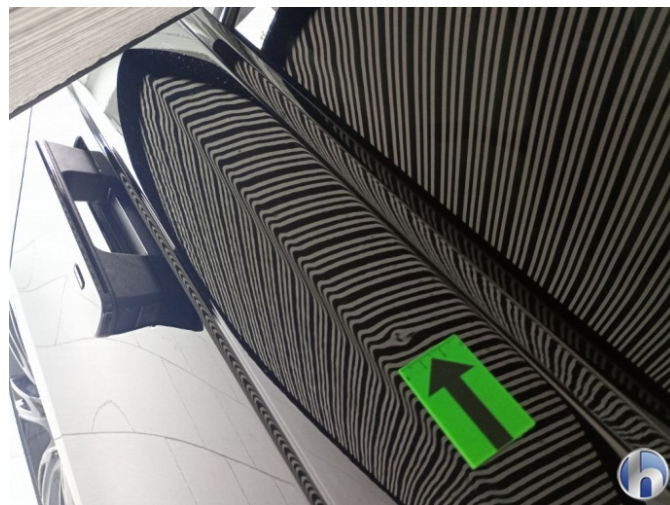
| component | Damage | Rep kind |
|---|---|---|
| 7. Door Rear - right | | Smart repair |

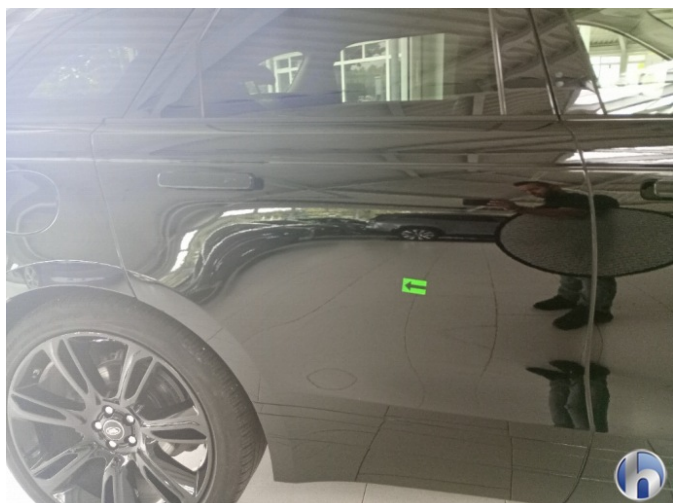
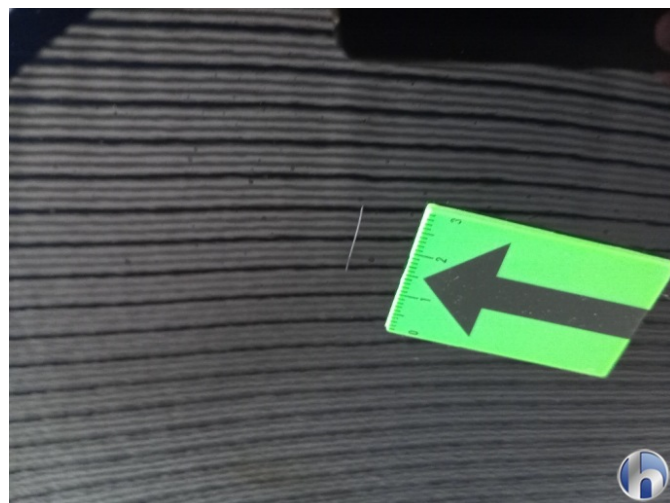
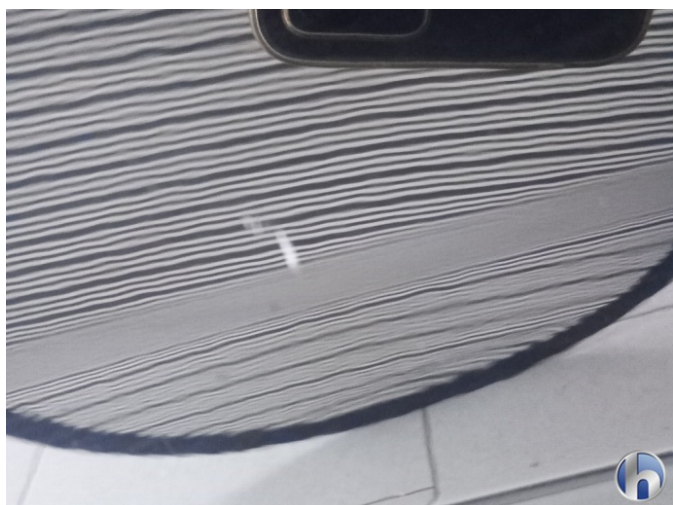
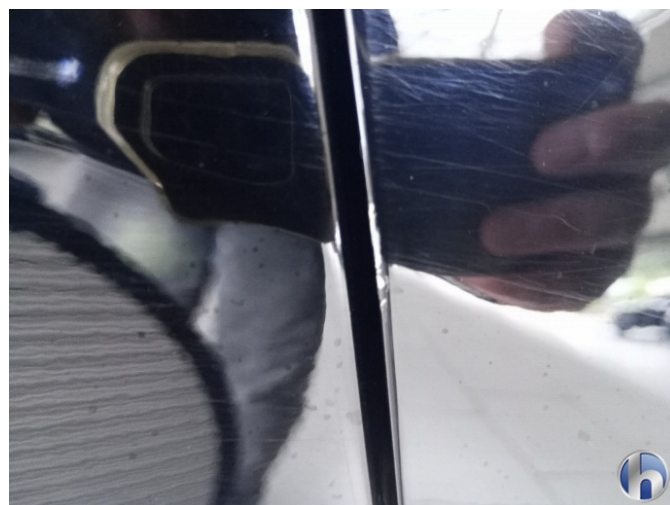
| component | Damage | Rep kind |
|---|---|---|
| 8. Door Rear - right | Scratch(es) | Smart repair |

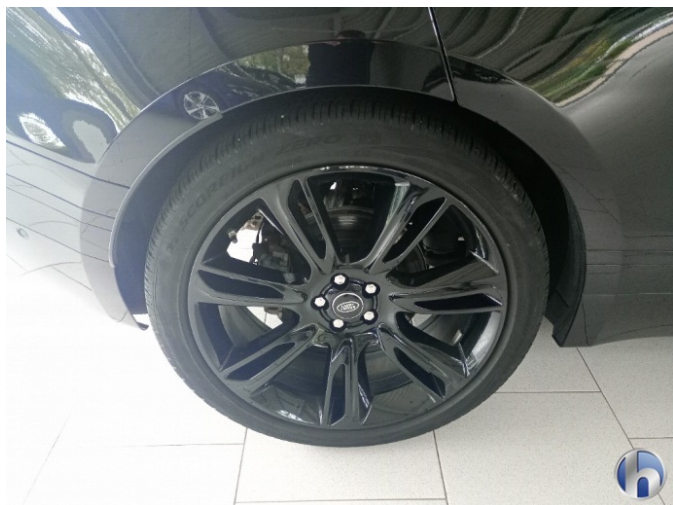
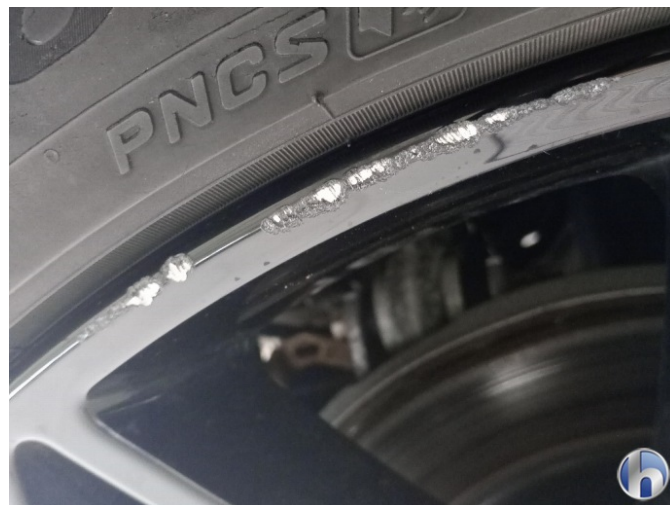
| component | Damage | Rep kind |
|---|---|---|
| 9. | Damaged | Paint |

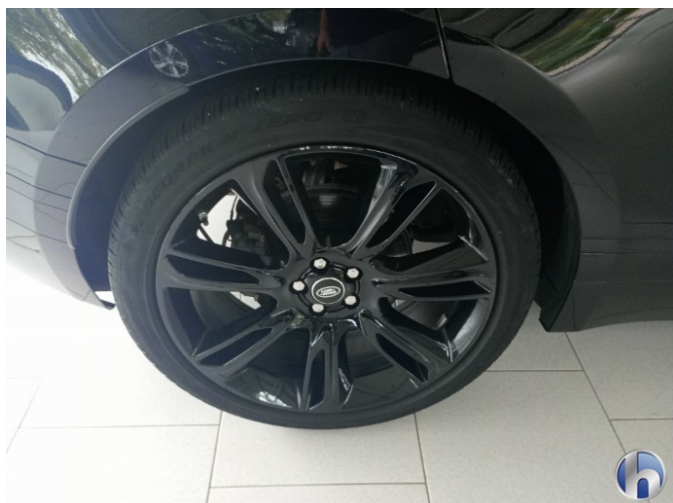
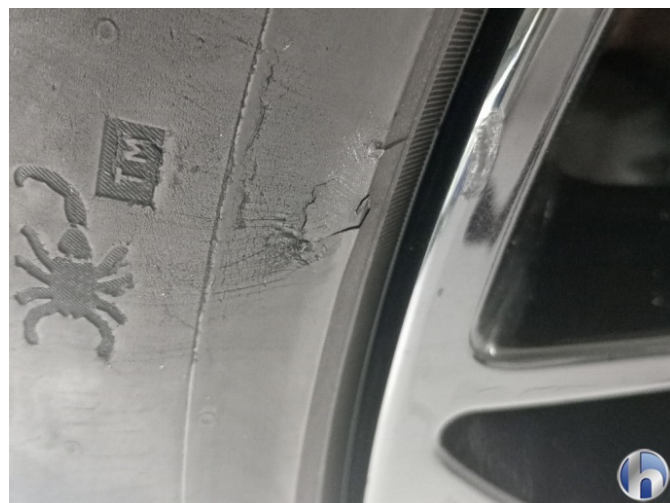
| component | Damage | Rep kind |
|---|---|---|
| 10. | Damaged | Replace |

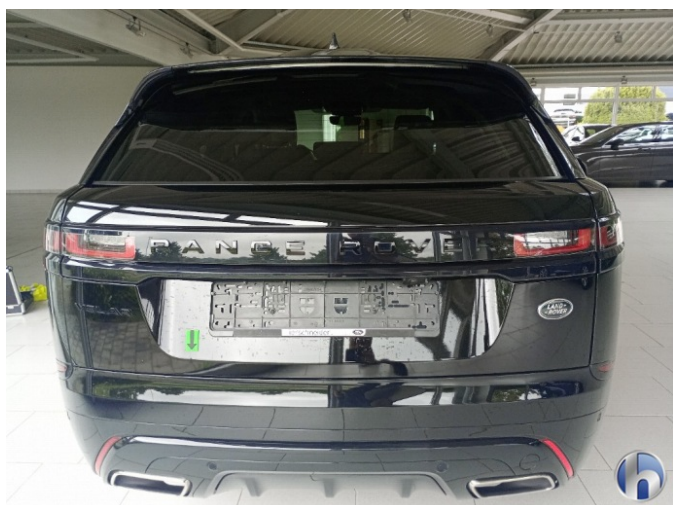
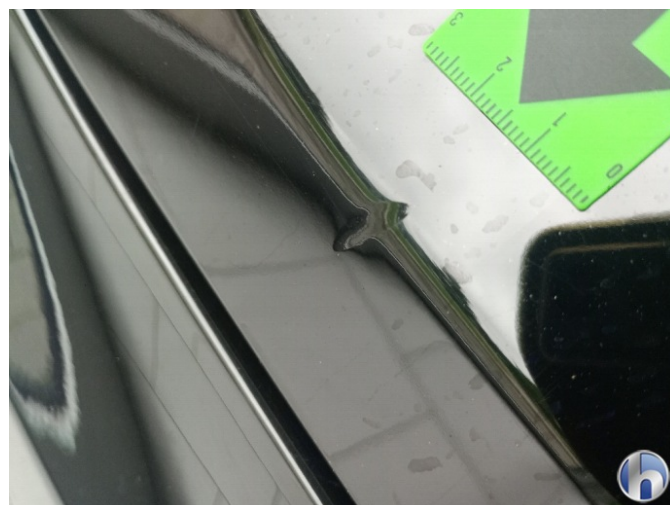
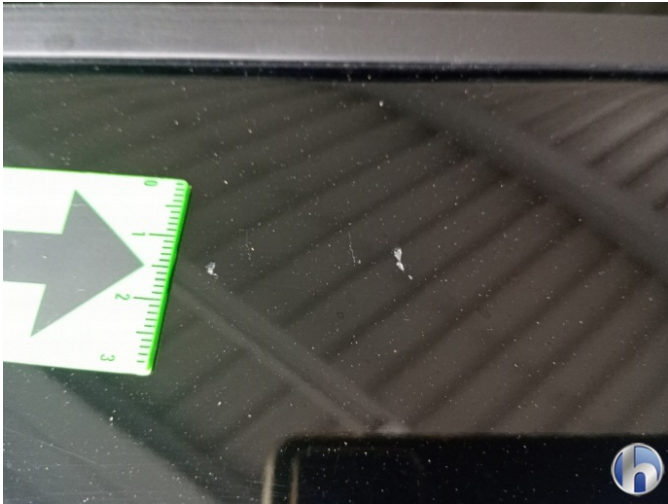
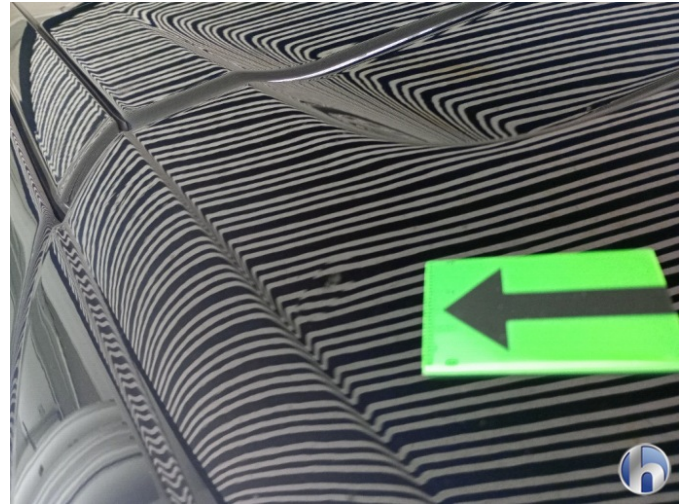
| component | Damage | Rep kind |
|---|---|---|
| 11. tailgate | Damaged | Smart repair |

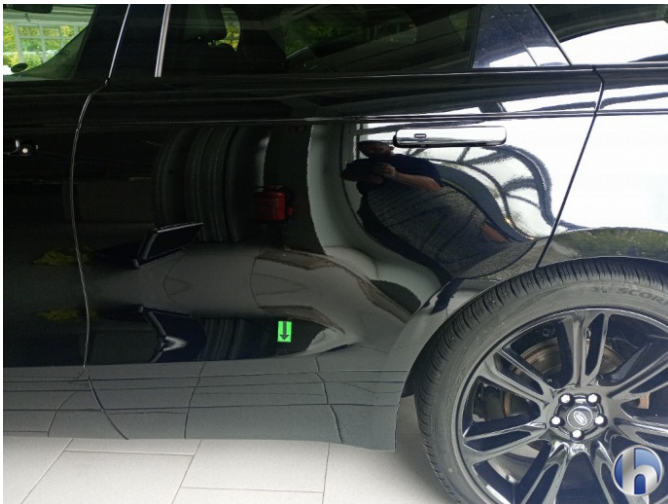
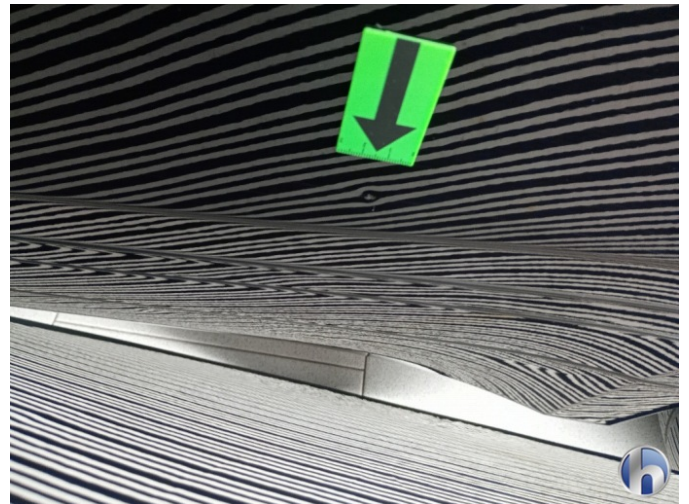
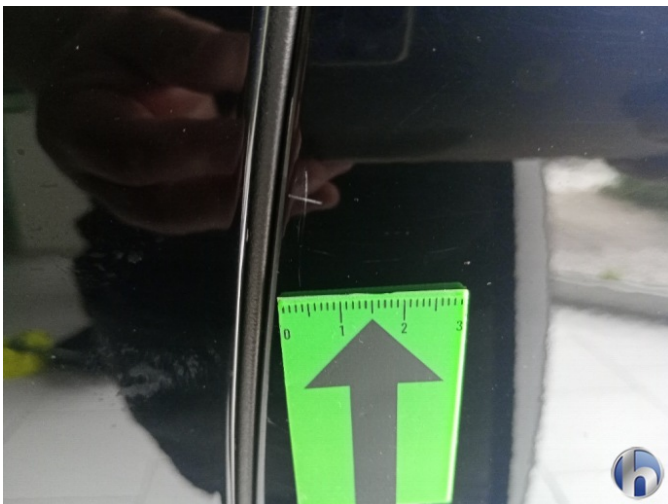
| component | Damage | Rep kind |
|---|---|---|
| 12. Rear door - left | | Smart repair |

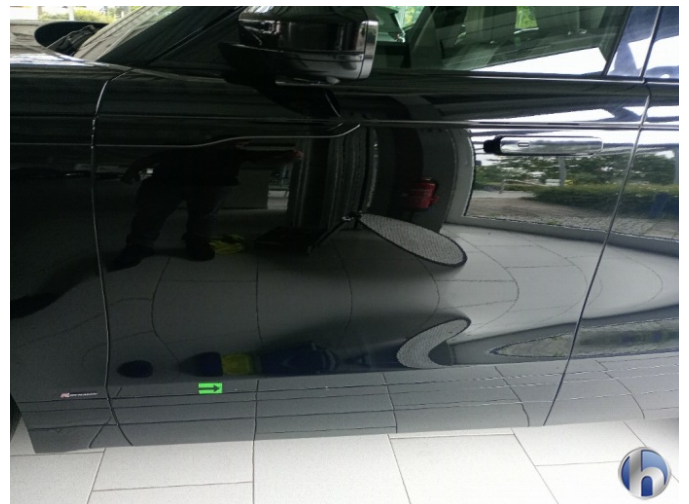
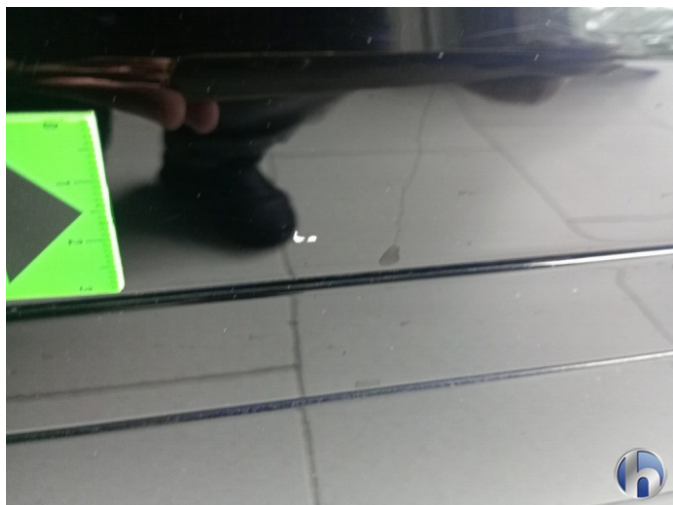
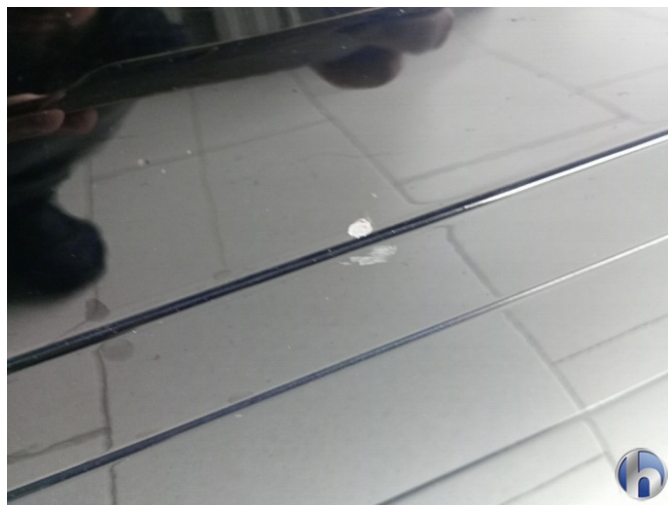
| component | Damage | Rep kind |
|---|---|---|
| 13. Front door - left | Scratch(es) | Smart repair |
