## status report

#### Land Rover Range Rover Velar R-Dynamic SE

| Vehicle identification number | <b>SALYA2BV8JA746205</b> | mileage read: | <b>106033 km</b> |

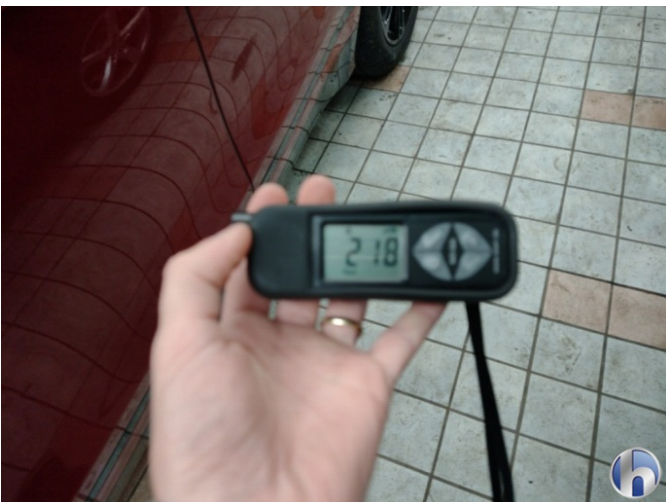
| component | Damage | Rep kind |
|---|---|---|
| 1. Front door - left | Subsequently painted | acceptable |

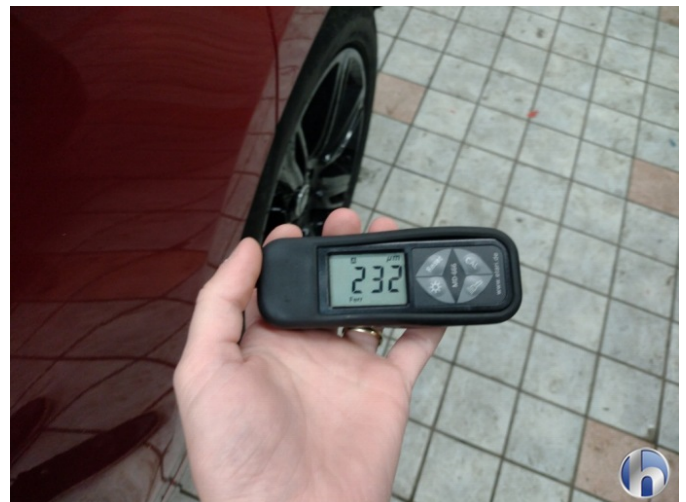
| component | Damage | Rep kind |
|---|---|---|
| 2. Rear door - left | Subsequently painted | acceptable |

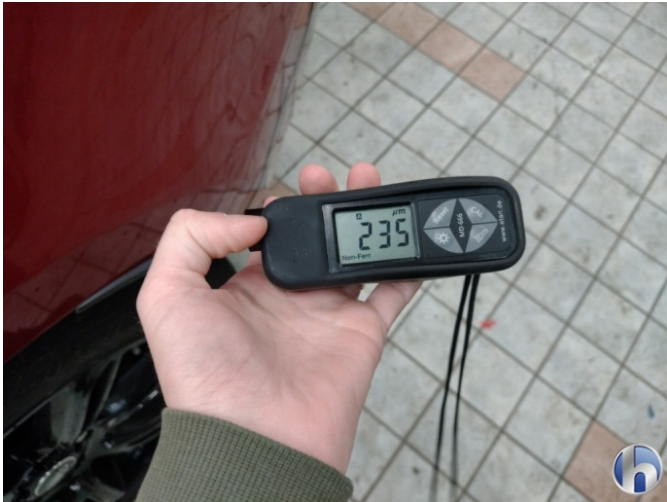
| component | Damage | Rep kind |
|---|---|---|
| 3. Sidewall - Rear - Left | Subsequently painted | acceptable |

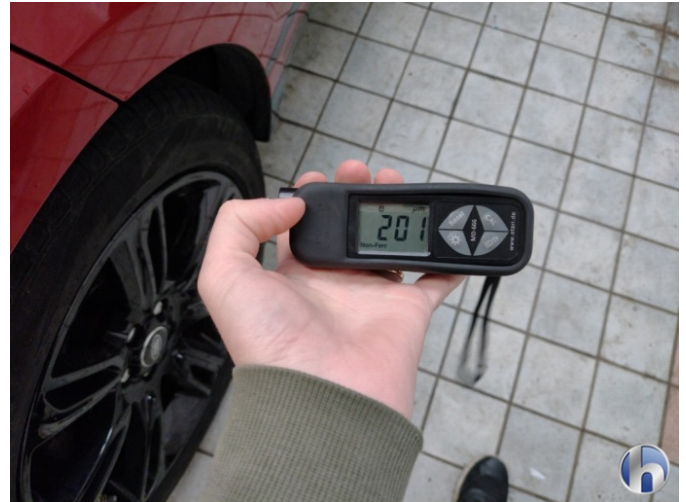
| component | Damage | Rep kind |
|---|---|---|
| 4. Sidewall - Rear - right | Subsequently painted | acceptable |

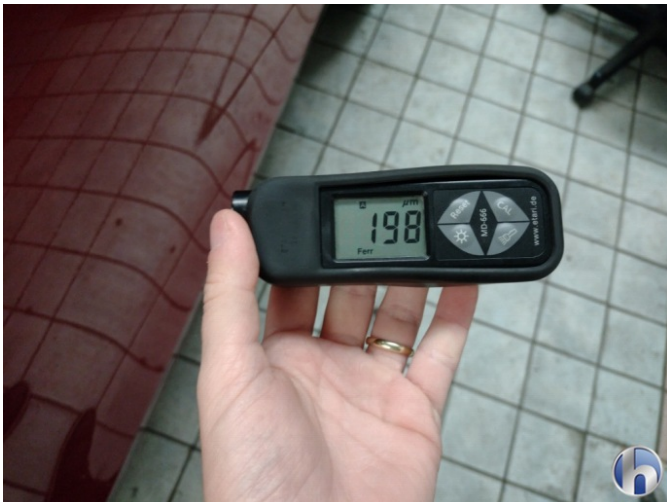
| component | Damage | Rep kind |
|---|---|---|
| 5. Front door - right | Subsequently painted | acceptable |

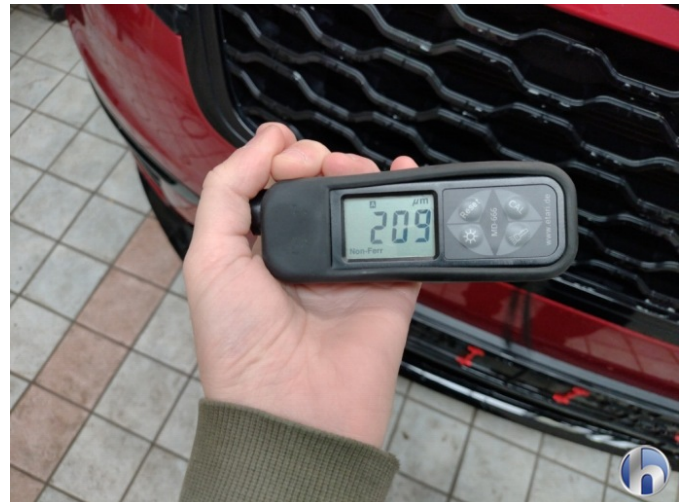
| component | Damage | Rep kind |
|---|---|---|
| 6. hood | Subsequently painted | acceptable |

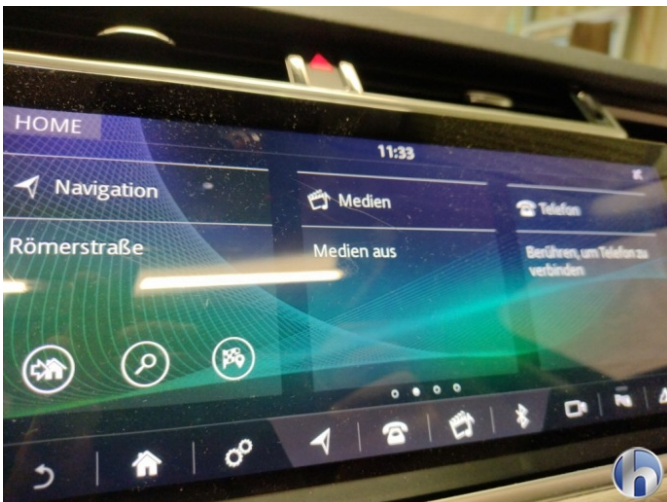
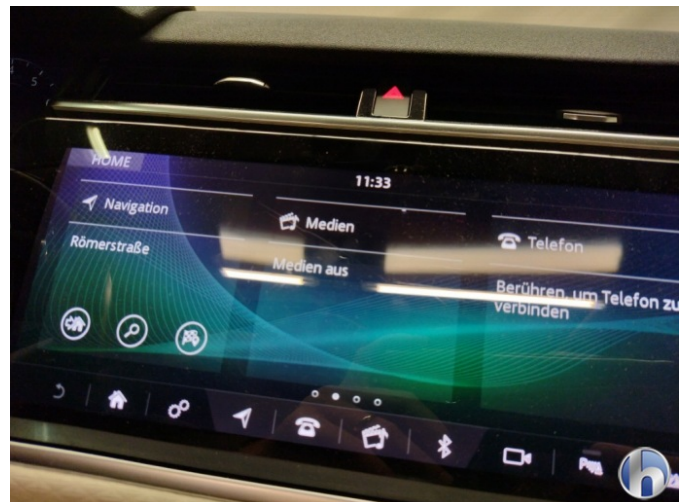
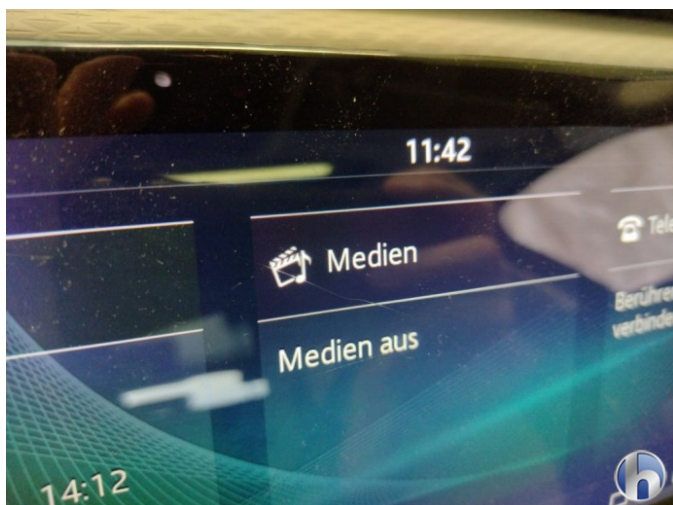
| component | Damage | Rep kind |
|---|---|---|
| 8. Multimedia Display | Scratch(es) | Replace |

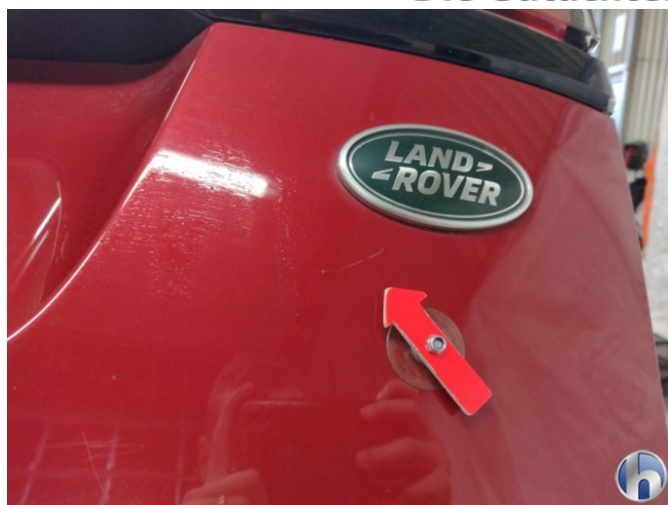
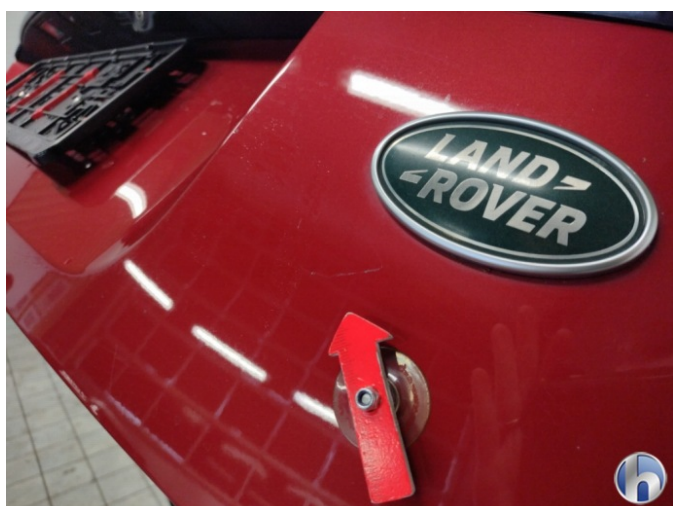
| component | Damage | Rep kind |
|---|---|---|
| 9. tailgate | Scratch(es) | Paint |
