## status report

| vehicle data | | | |
|---|---|---|---|
| <b>Land Rover Range Rover Evoque R-Dynamic SE</b> | | | |
| Vehicle identification number | <b>SALZA2BX4PH225570</b> | mileage read: | <b>17174 km</b> |
| First Registration / construction year: | <b>14.11.2023 / 2022</b> | Visit Date / place of birth: | <b>21.03.2025 Riedstadt-Goddelau</b> |

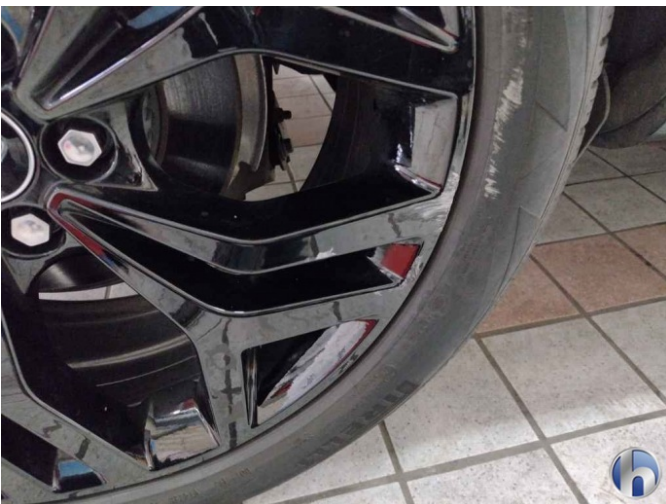
| component | Damage | Rep kind |
|---|---|---|
| 3. Rim rear - right | Scratch(es) | Replace |

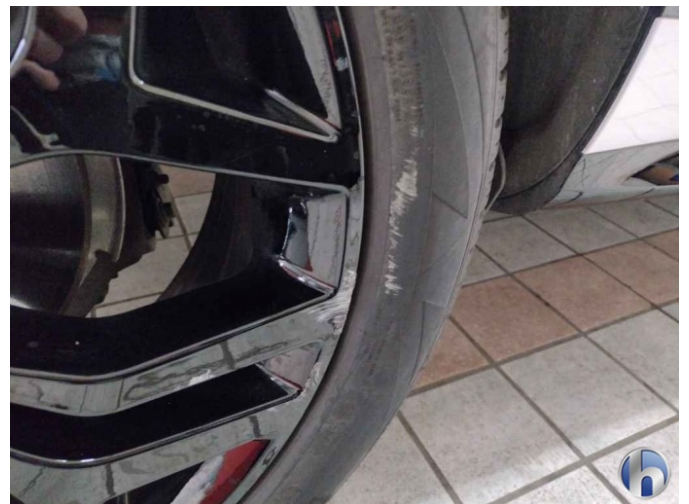
| component | Damage | Rep kind |
|---|---|---|
| 4. tire rear - right | Wear and tear | acceptable |

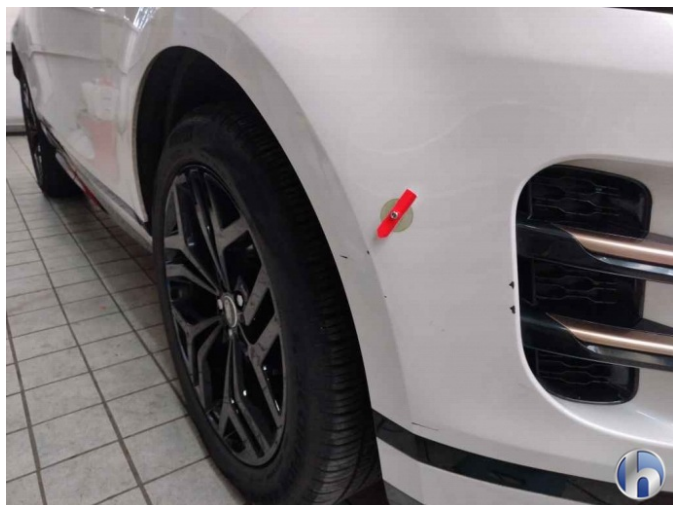
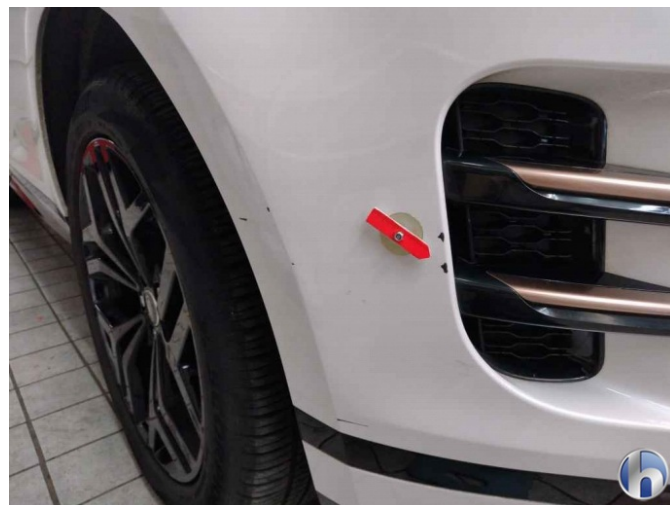
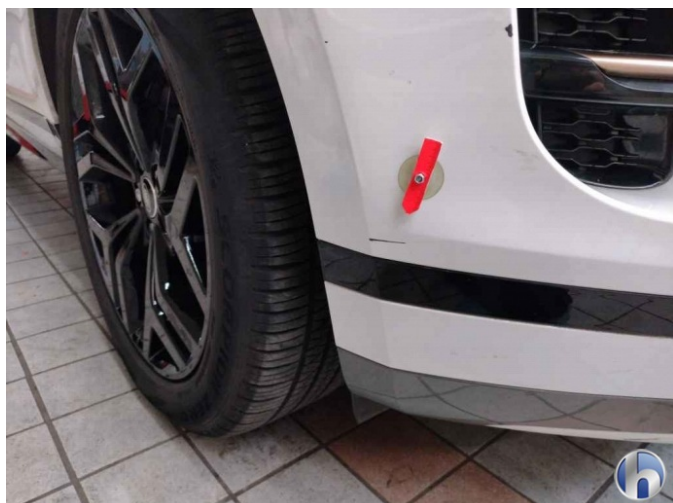
| component | Damage | Rep kind |
|---|---|---|
| 6. Front bumper | Scrape | Paint |

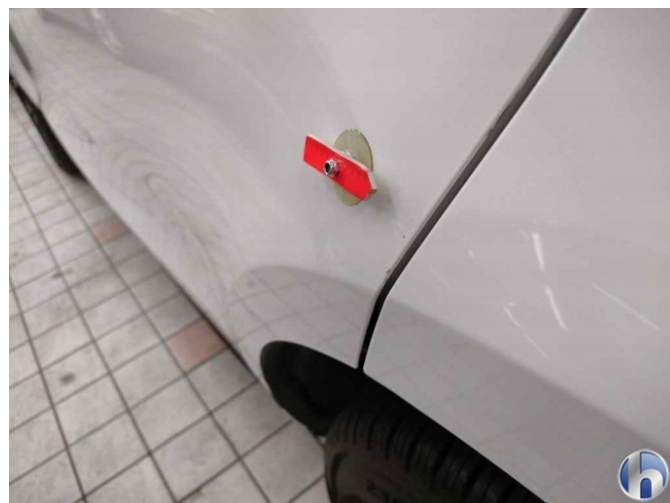
| component | Damage | Rep kind |
|---|---|---|
| 7. Rear door - left | Scratch(es) | Smart repair |

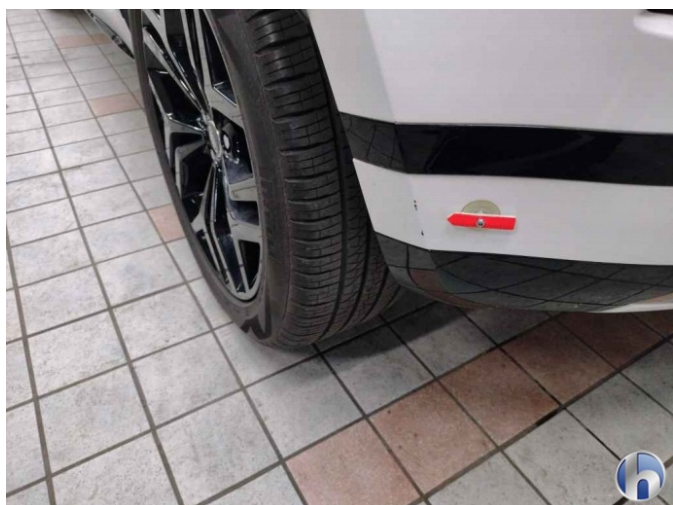
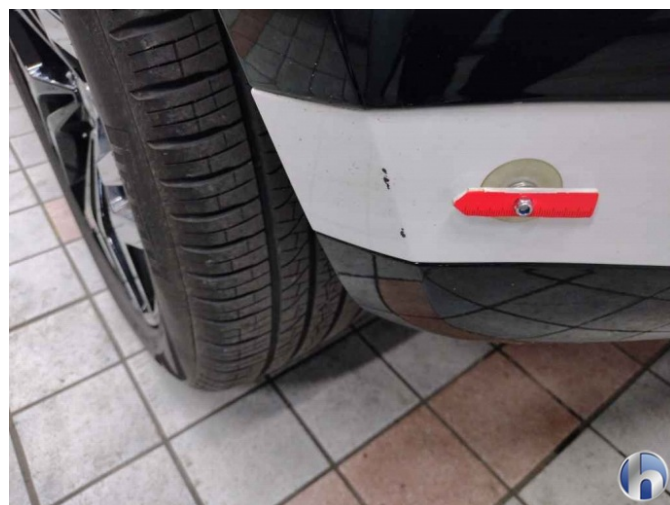
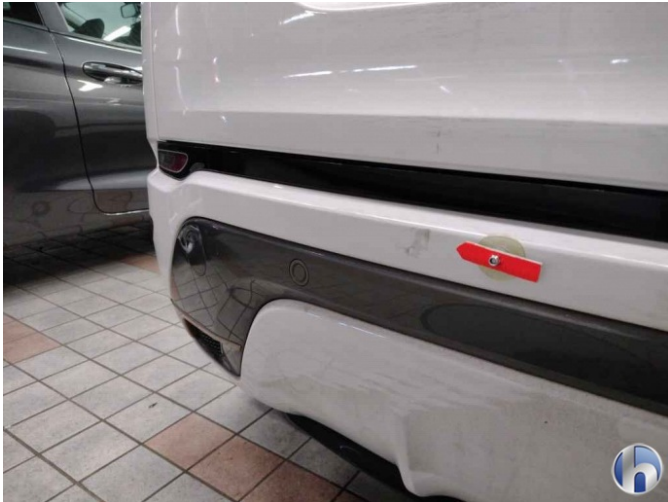
| component | Damage | Rep kind |
|---|---|---|
| 8. Rear bumper | Scrape | Paint |

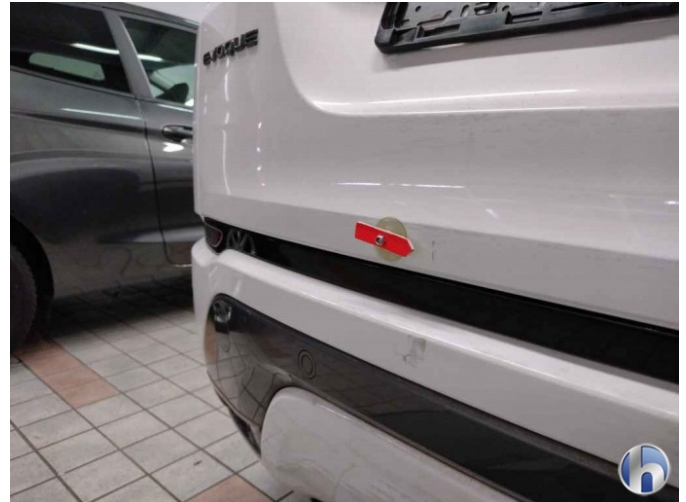
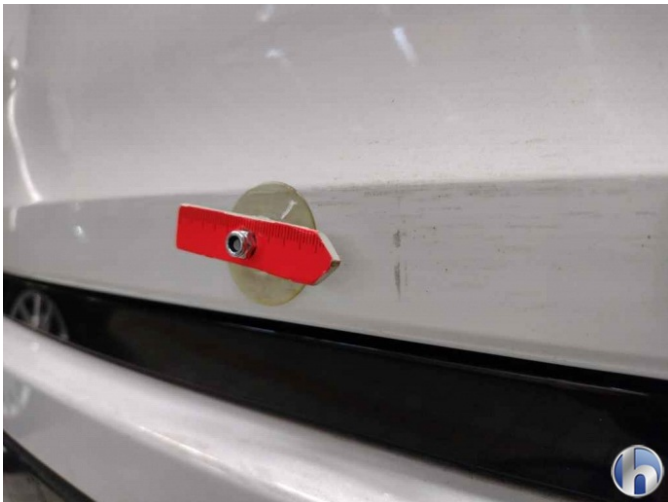
| component | Damage | Rep kind |
|---|---|---|
| 9. tailgate | Scratch(es) | |

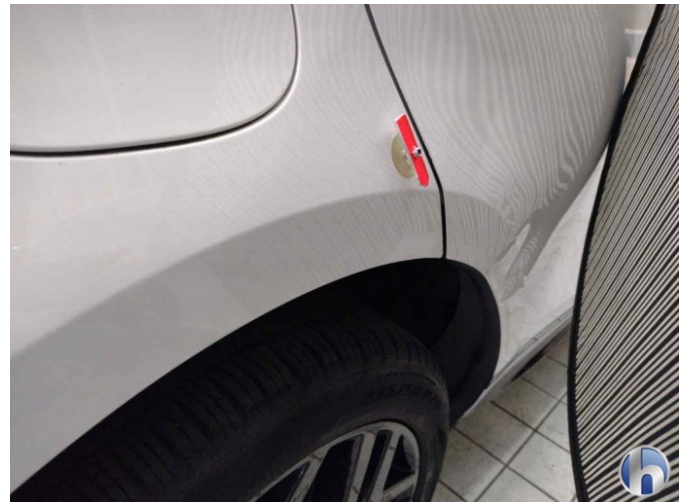
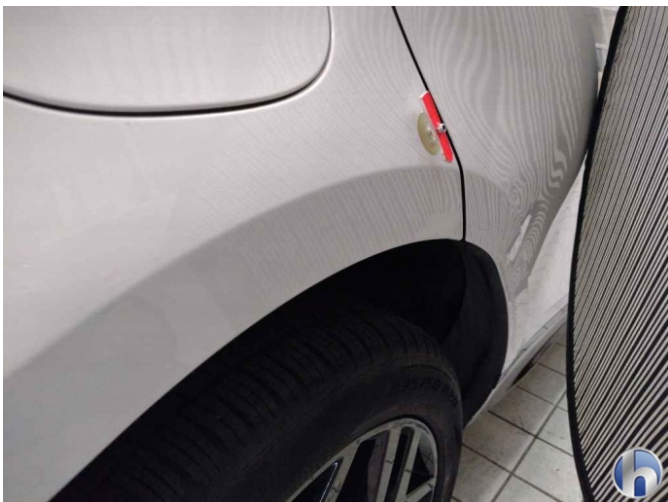
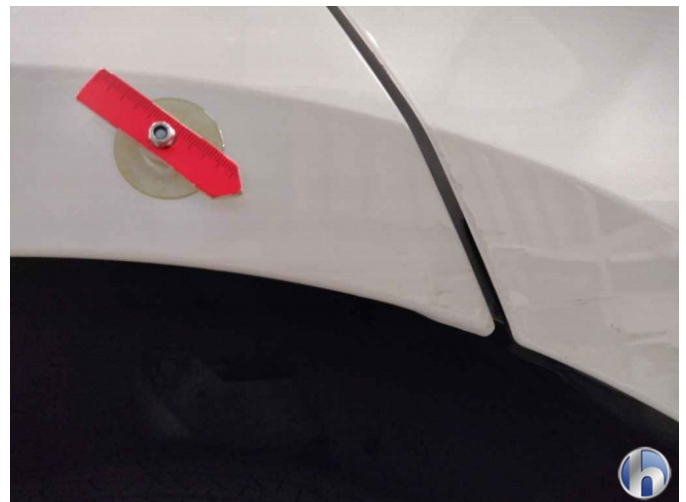
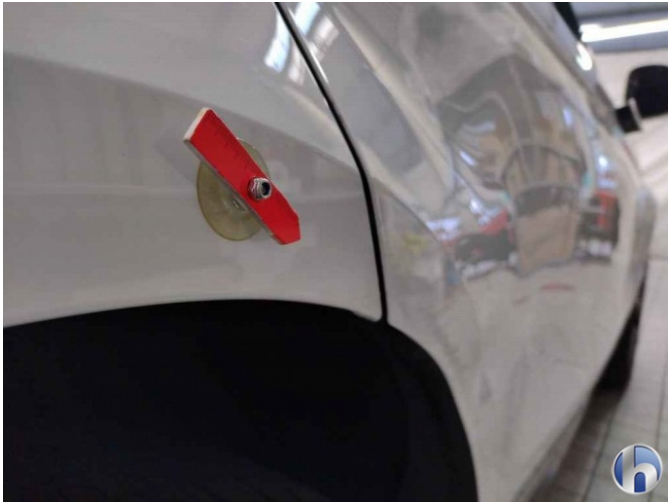
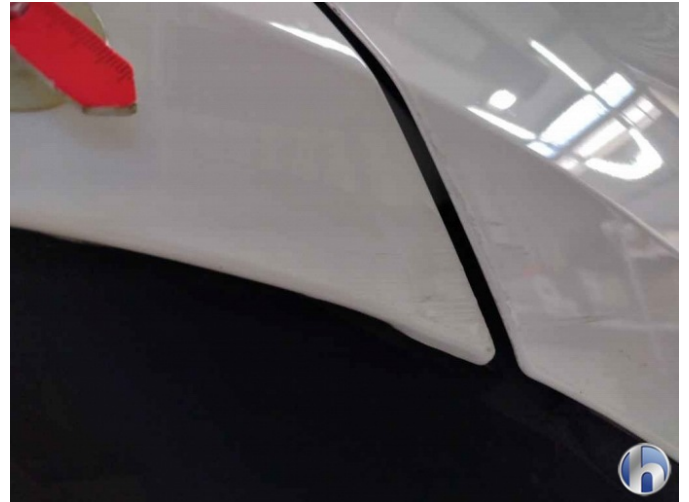
| component | Damage | Rep kind |
|---|---|---|
| 10. Sidewall - Rear - right | Deformed | Refurbish and paint |

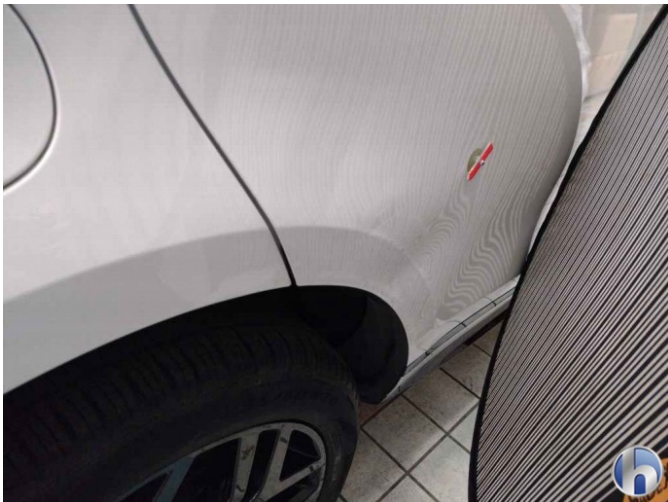
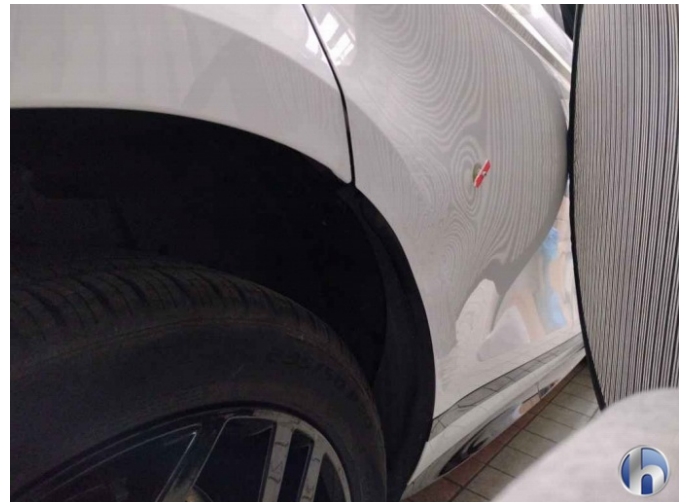
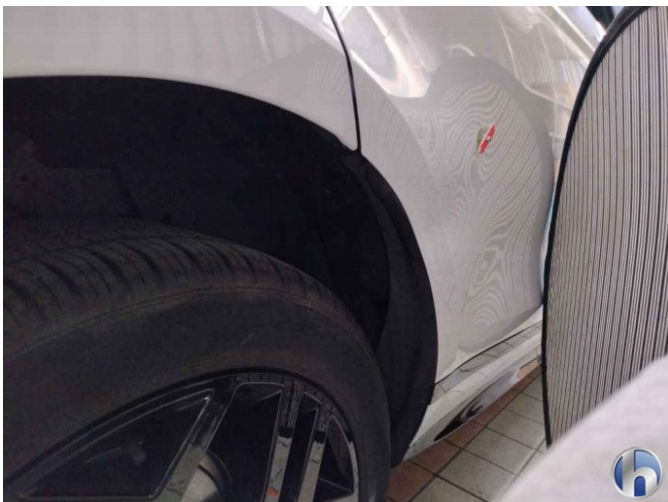
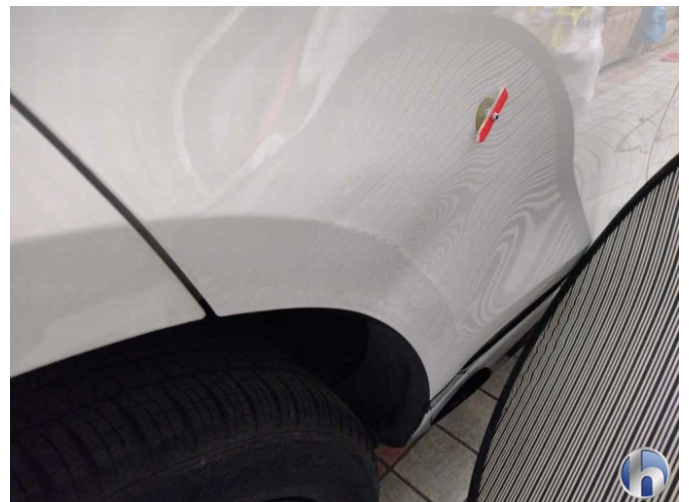
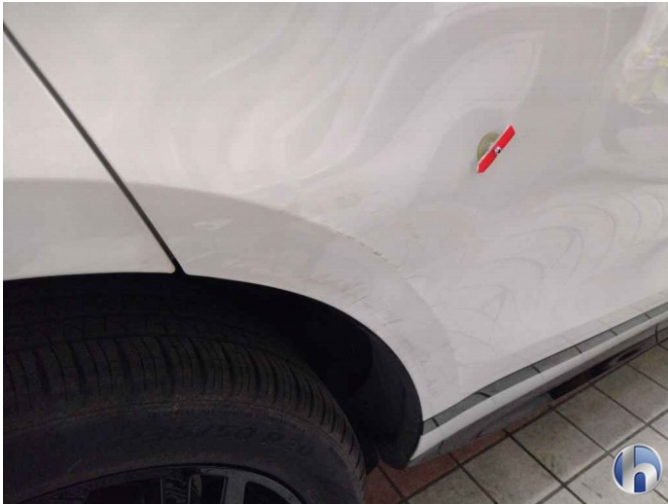
| component | Damage | Rep kind |
|---|---|---|
| 11. Door Rear - right | Deformed | Refurbish and paint |
