| TOYOTA COROLLA: 1YNJ638 | | | | |
| Vinnumber: | SB1K93BE80E144895 | Versionname: | 1.8 Hybrid Dynamic Plus e-CVT | |

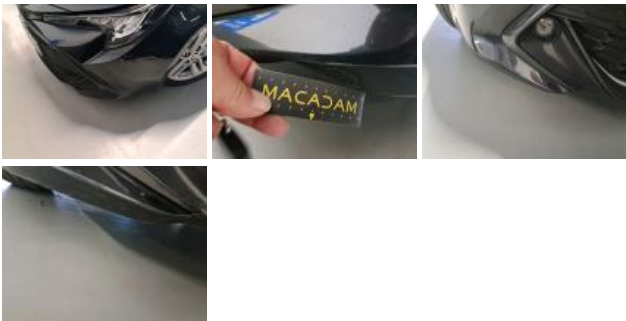
| Bumper F, Scratch(es), Acceptable | | 0,00 | | |
