NISSAN Qashqai +2 Diesel  
qashqai+2 2.0 dci n-tec Dpf

VIN NO SJNJDAJ10U6016673

Registration Number DT071VV

Inspection Report Summary

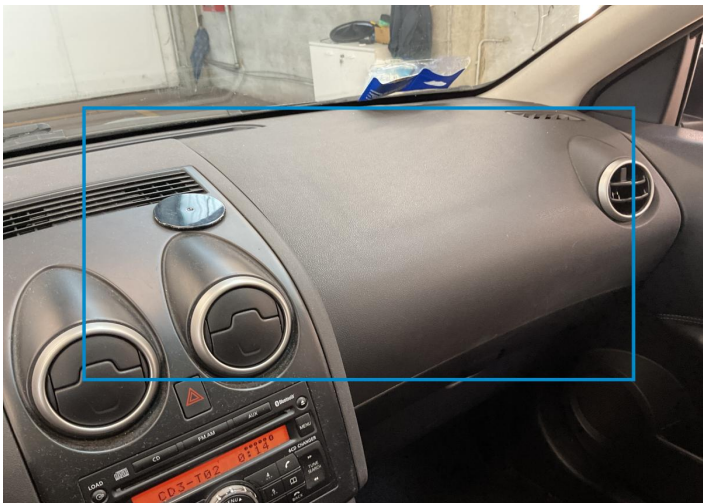
1. Dashboard / Front Interior / Worn - out -

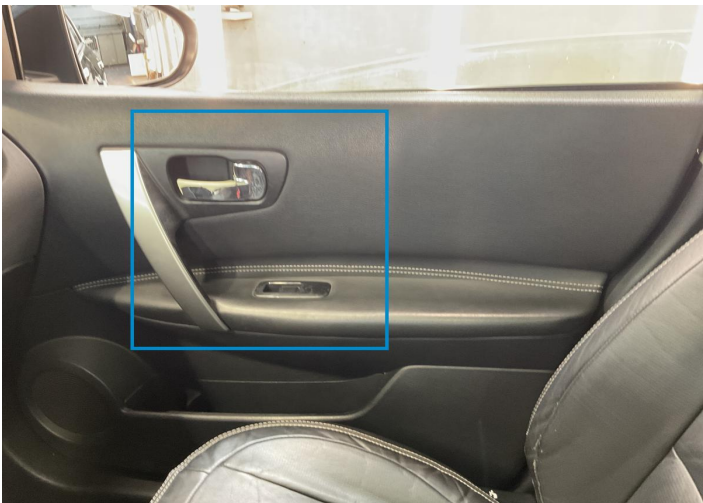
2. Panel Filling / Front Right Interior / Worn - out -

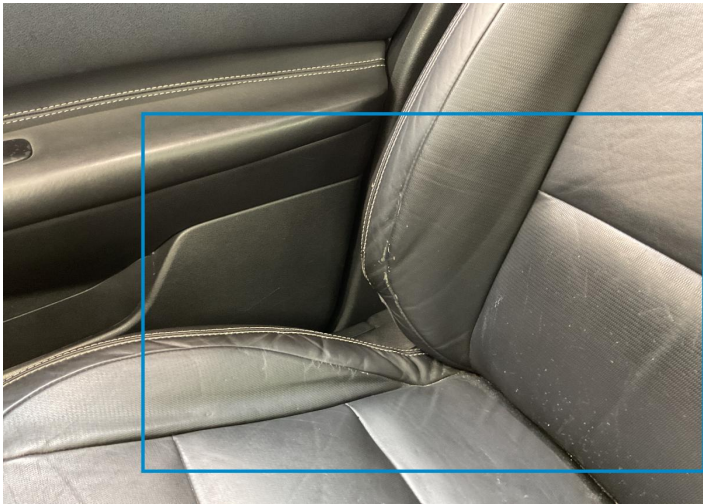
3. Seat / Front Right Interior / Worn - out -

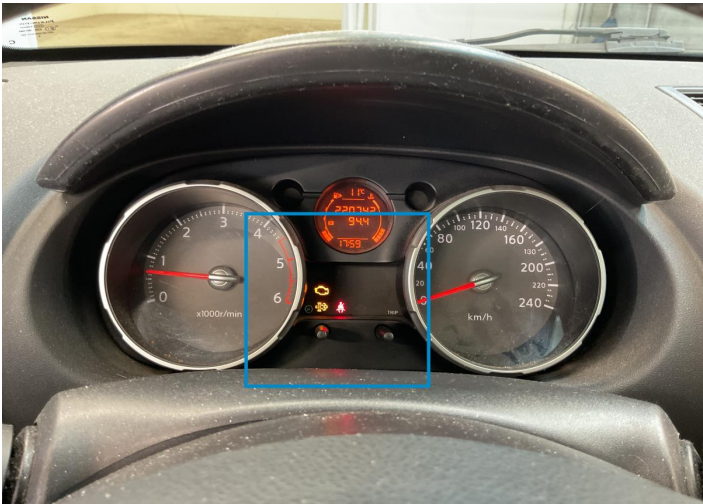
4. Dashboard / Front Interior / Warning Light ON -

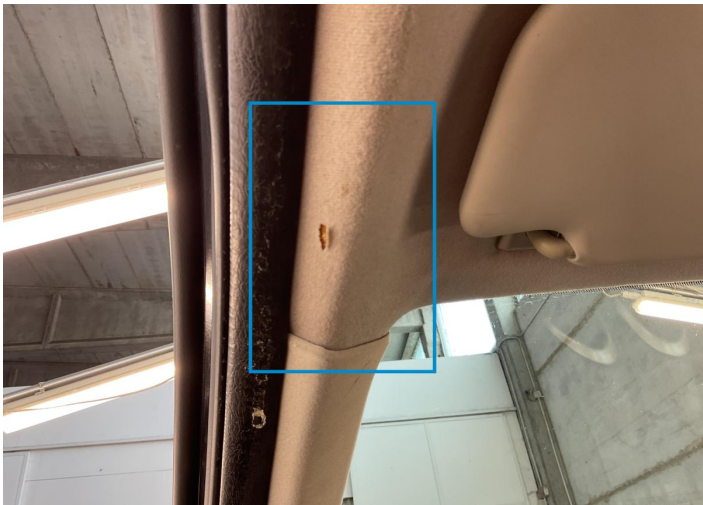
5. Roof Upholstery Interior / Ripped -

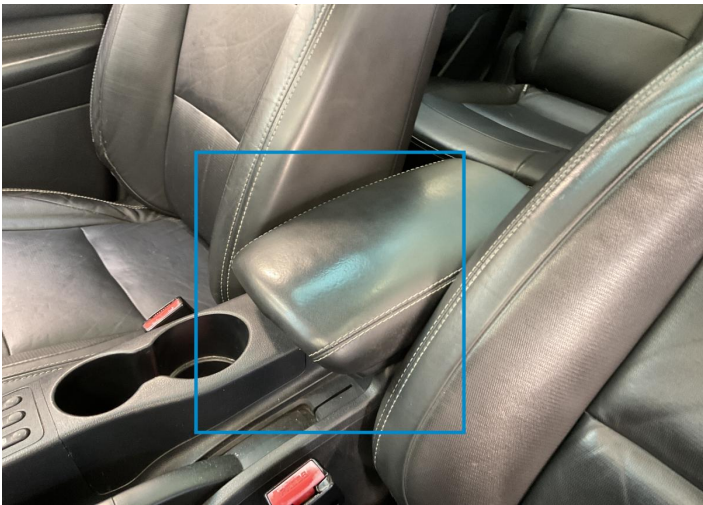
6. Center Console Interior / Broken -

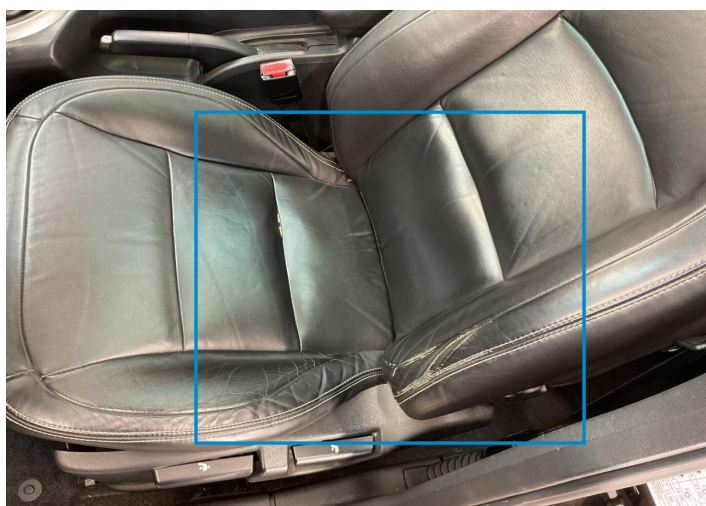
7. Seat / Front Left  
Interior / Ripped -

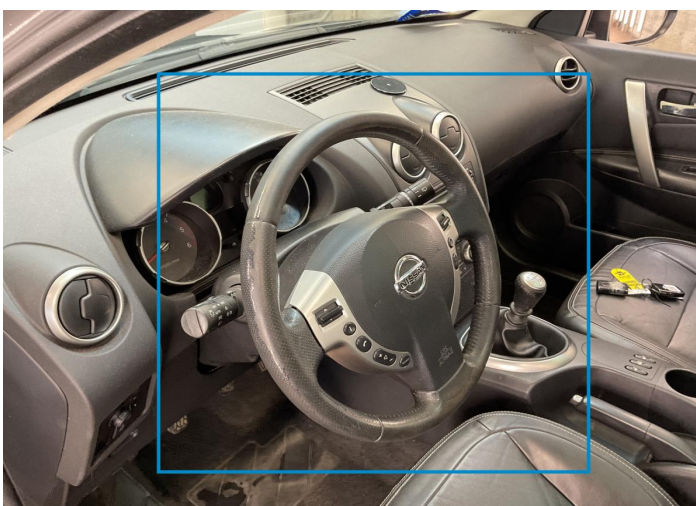
8. Steering Wheel / Front  
Interior / Worn - out -

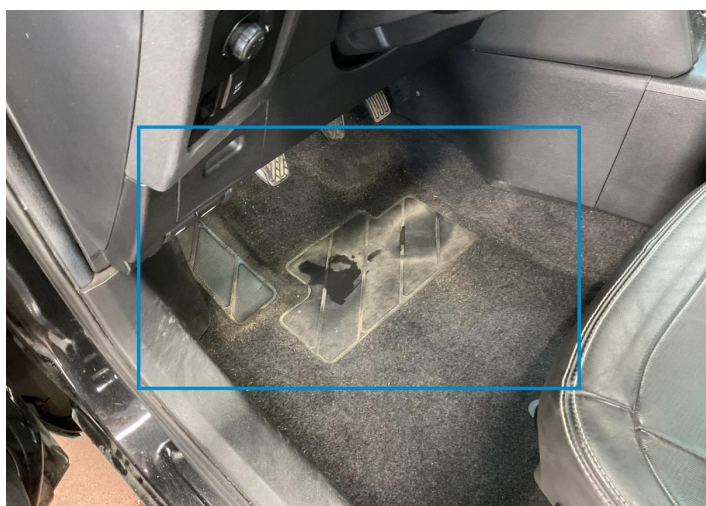
9. Floor Carpet  
Interior / Worn - out -

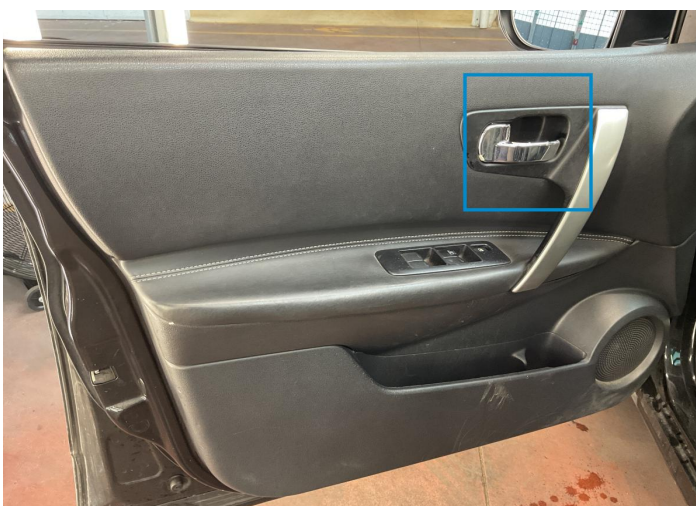
10. Interior door handle Front left  
Interior / Worn - out -

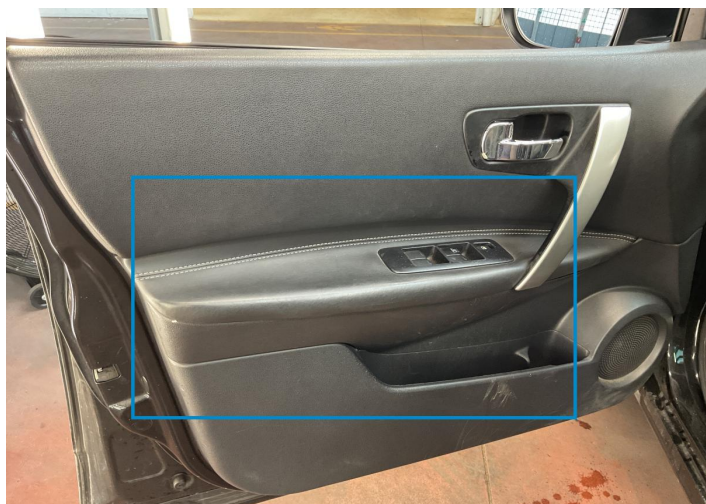
11. Panel Filling / Front Left  
Interior / Worn - out -

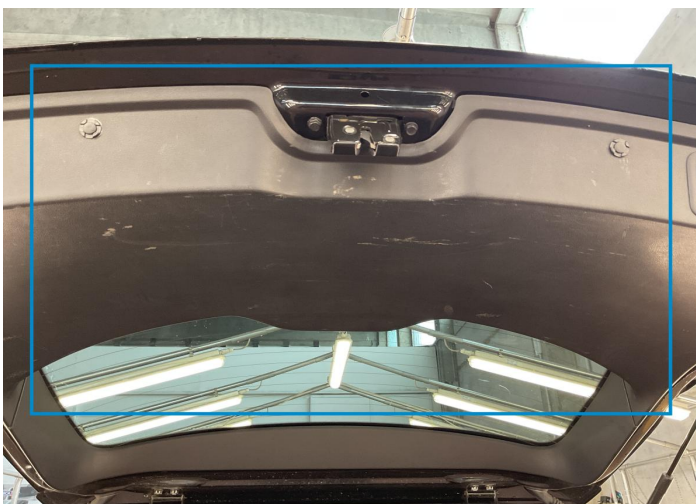
12. Tailgate Upholstery / Back  
Interior / Scratched -

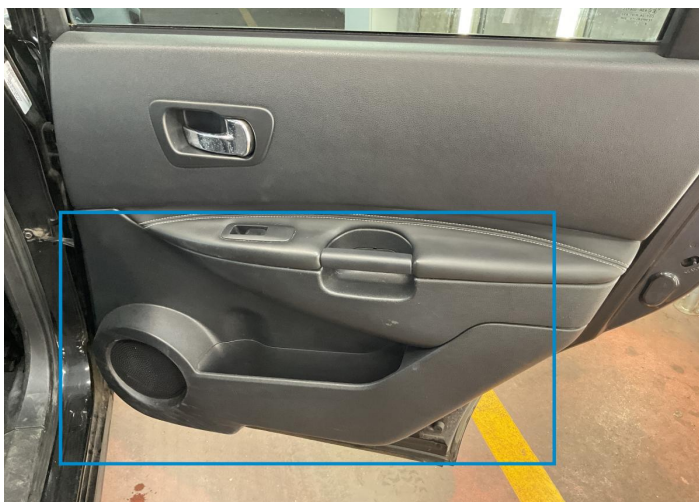
| 13 | Panel Filling / Back Right | Interior / Scratched |

13. Panel Filling / Back Right  
Interior / Scratched -

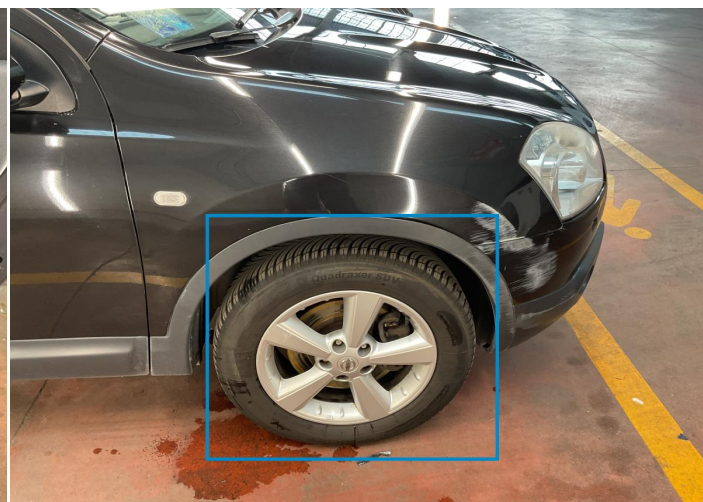
| 14 | Rim / Front Right | Out of Bodywork / Scratch |

14. Rim / Front Right  
Out of Bodywork / Scratch -

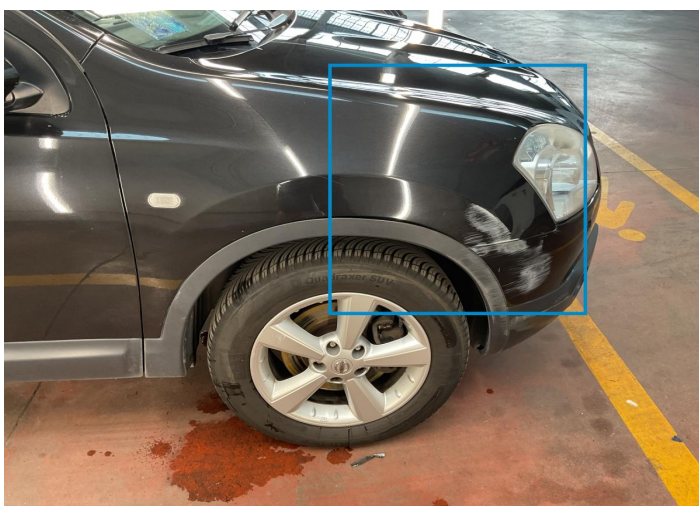
| 15 | Fender / Front Right | Bodywork / Dent |

15. Fender / Front Right  
Bodywork / Dent -

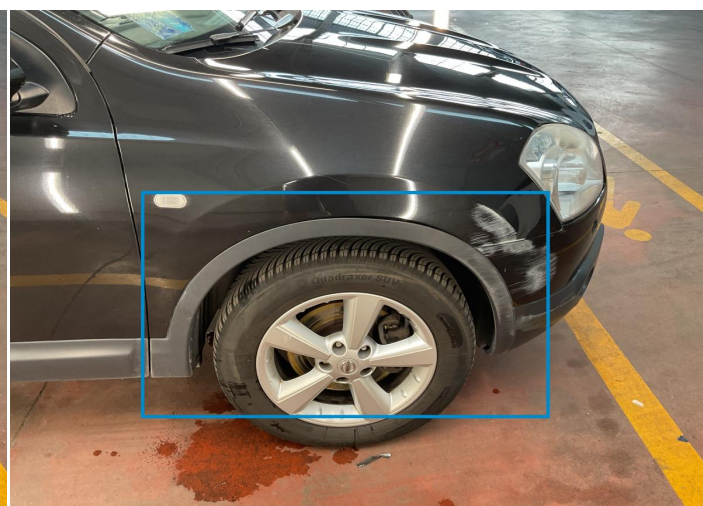
| 16 | Wing Expander / Front Right | Paint / Scratch / Line |

16. Wing Expander / Front Right  
Paint / Scratch / Line -

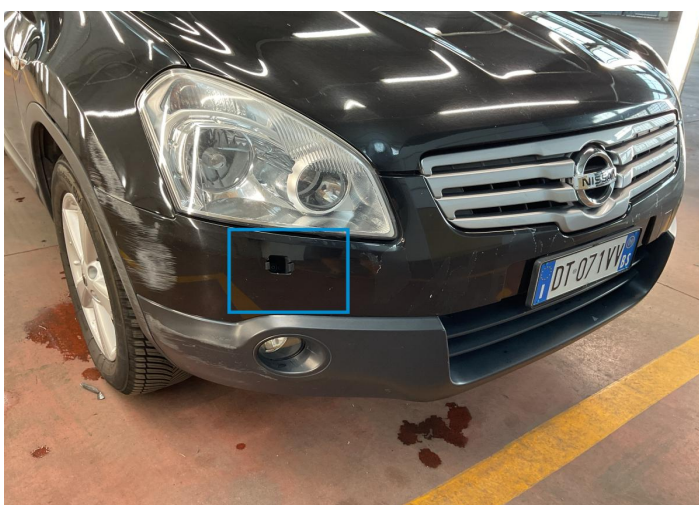
| 17 | Headlight Nozzle / Front Right | Missing Part |

17. Headlight Nozzle / Front Right  
Missing Part -

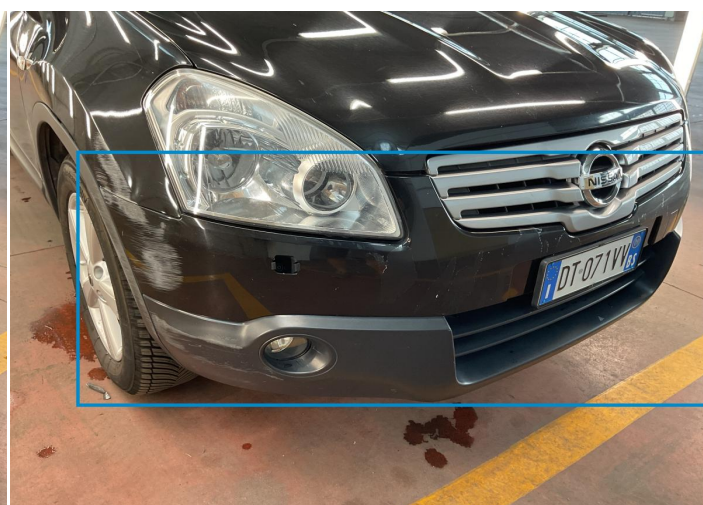
| 18 | Bumper / Front | Bodywork / Dent |

18. Bumper / Front  
Bodywork / Dent -

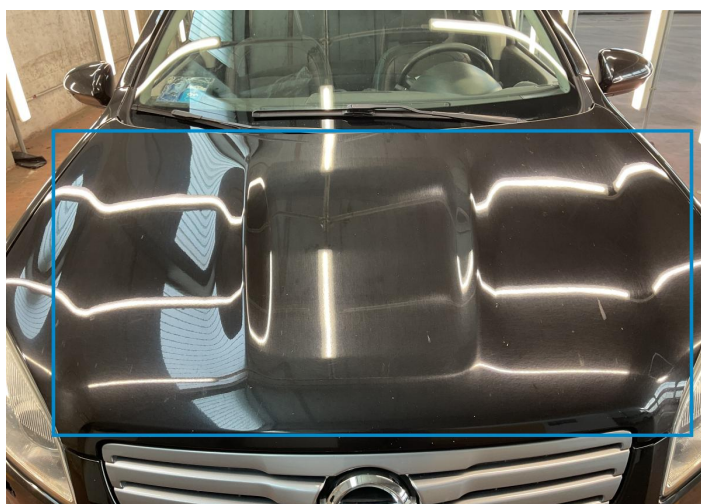
| 19 | Hood | Paint / Chipping |

19. Hood  
Paint / Chipping -

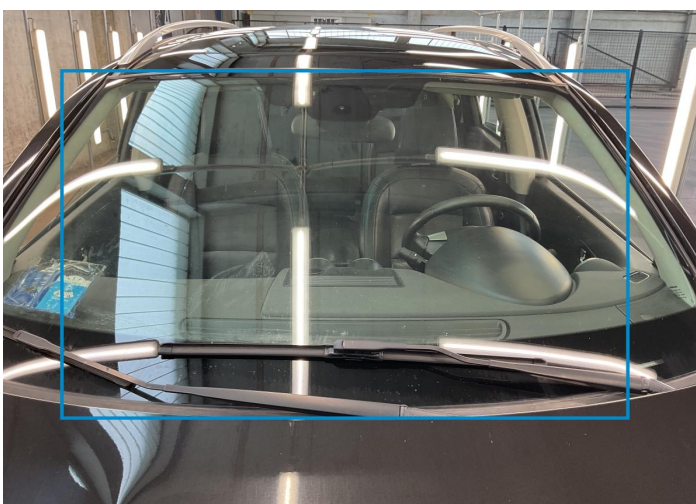
| 20 | Windshield / Front | Glass Break / Impact |

20. Windshield / Front  
Glass Break / Impact -

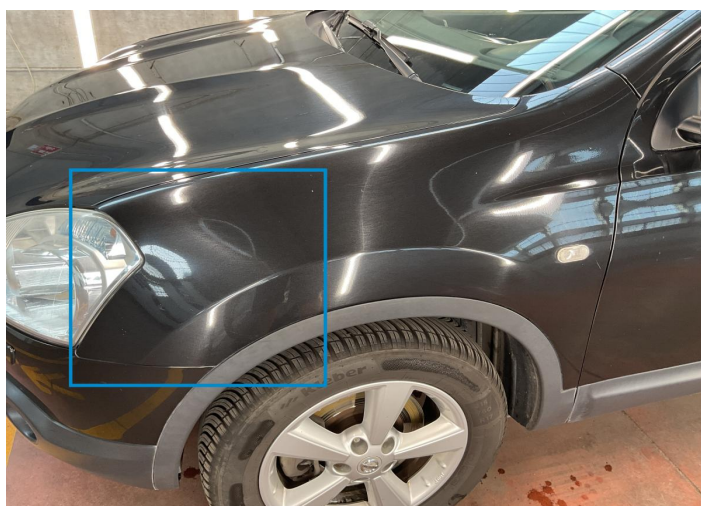
| 21 | Fender / Front Left | Paint / Chipping |

21. Fender / Front Left  
Paint / Chipping -

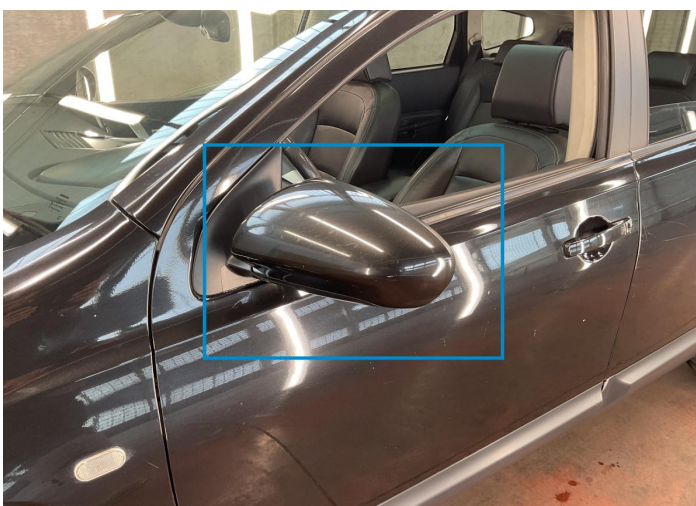
| 22 | Mirror Shell / Front Left | Paint / Scratch / Line |

22. Mirror Shell / Front Left  
Paint / Scratch / Line -

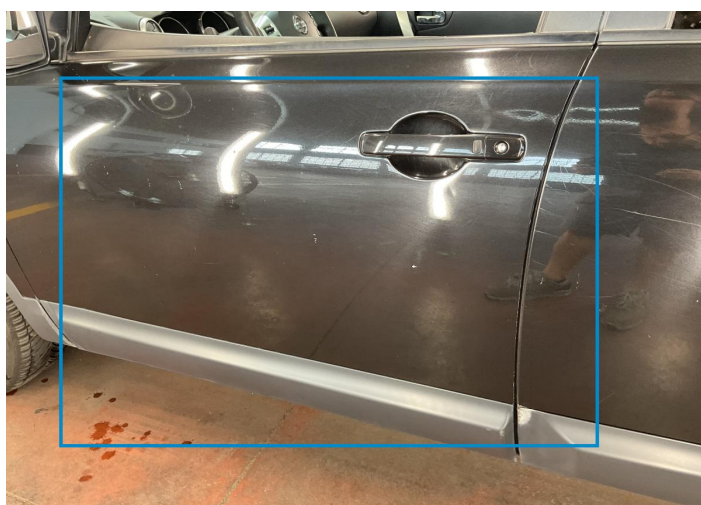
| 23 | Door / Front Left | Paint / Scratch / Line |

23. Door / Front Left  
Paint / Scratch / Line -

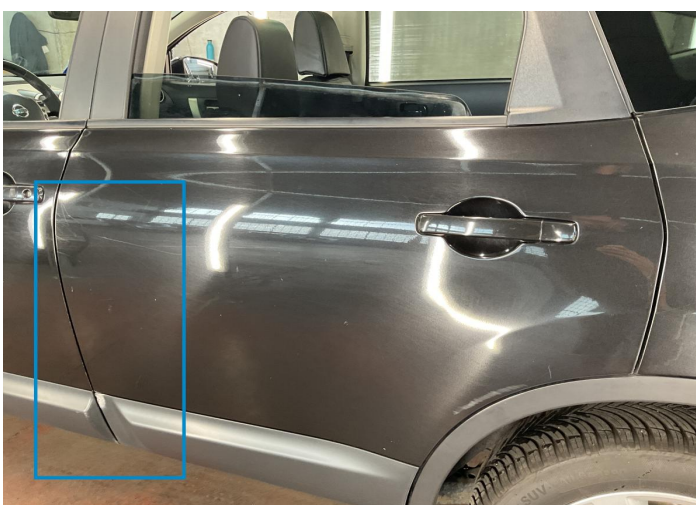
| 24 | Door / Back Left | Bodywork / Dent |

24. Door / Back Left  
Bodywork / Dent -

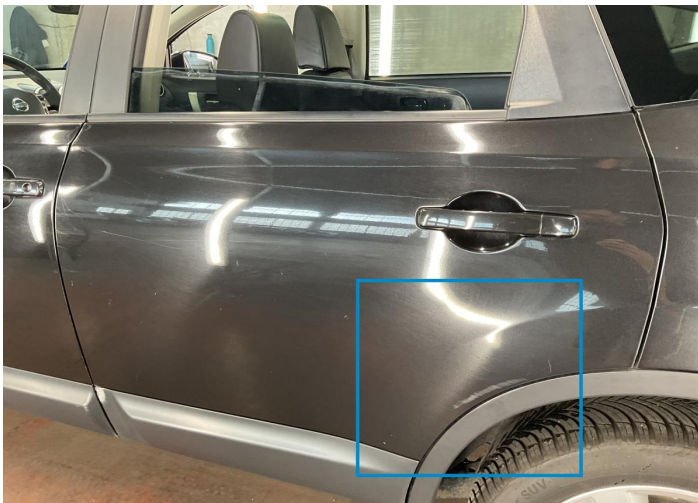
| 25 | Door / Back Left | Bodywork / Dent |

25. Door / Back Left  
Bodywork / Dent -

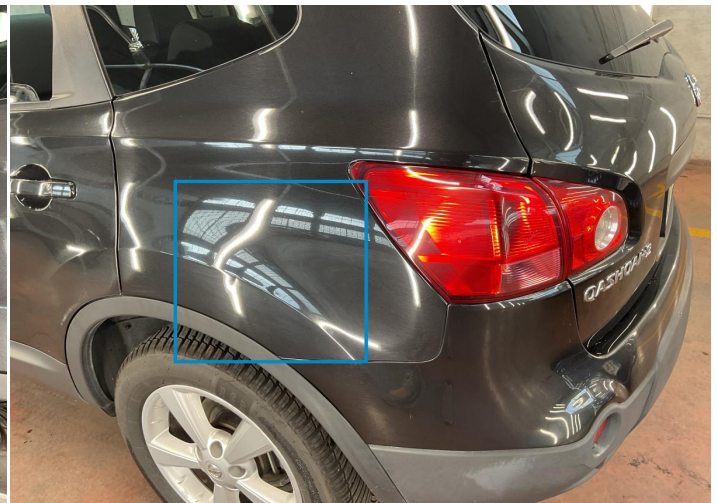
| 26 | Fender / Back Left | Bodywork / Dent |

26. Fender / Back Left  
Bodywork / Dent -

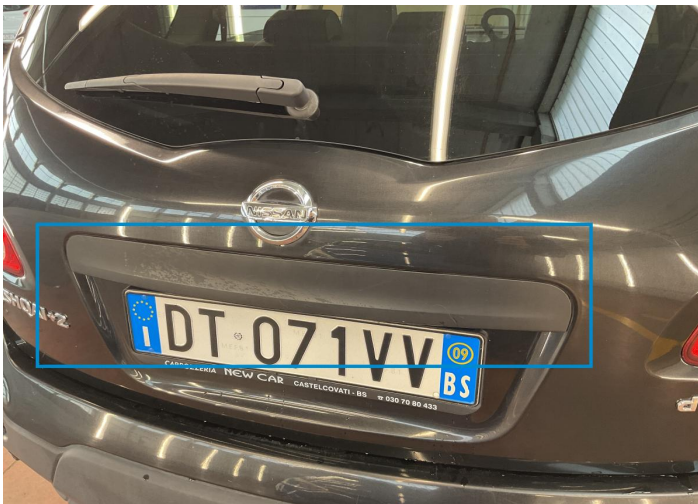
| 27 | Trunk Tailgate Handle / Back | Bodywork / Breakage |

27. Trunk Tailgate Handle / Back  
Bodywork / Breakage -

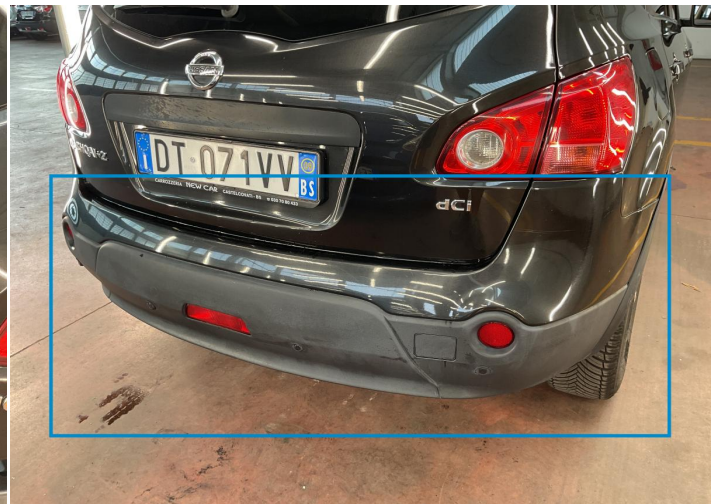
| 28 | Bumper / Back | Bodywork / Dent |

28. Bumper / Back  
Bodywork / Dent -

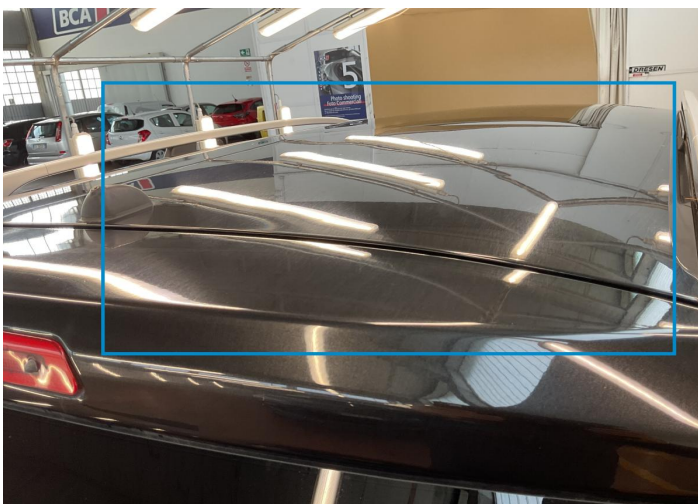
| 29 | Roof | Bodywork / Dent / Hail Area |

29. Roof  
Bodywork / Dent / Hail Area -

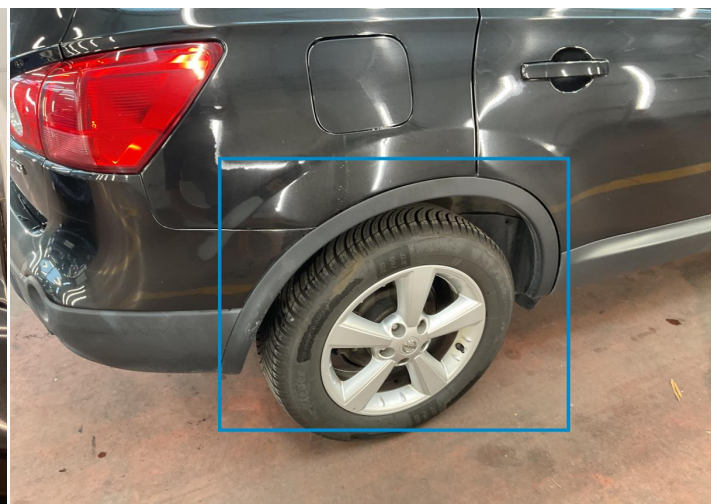
| 30 | Wing Expander / Back Right | Bodywork / Breakage |

30. Wing Expander / Back Right  
Bodywork / Breakage -

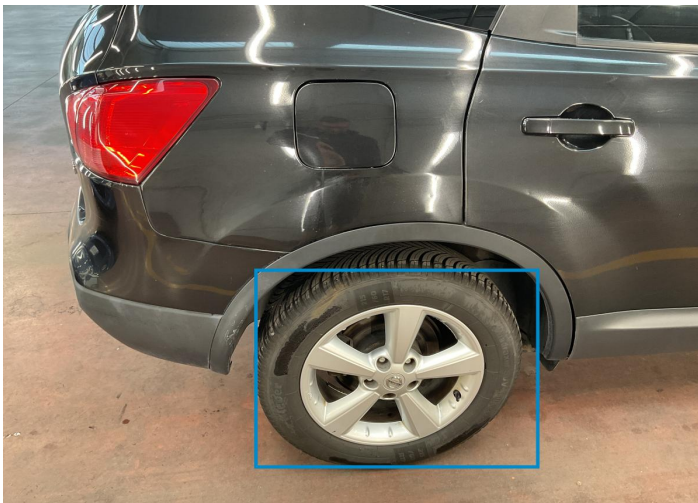
| 31 | Rim / Back Right | Out of Bodywork / Scratch |

31. Rim / Back Right  
Out of Bodywork / Scratch -

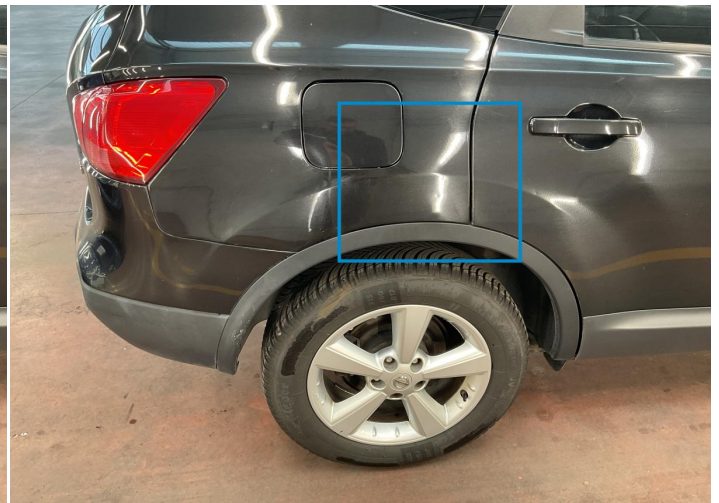
| 32 | Fender / Back Right | Bodywork / Dent |

32. Fender / Back Right  
Bodywork / Dent -

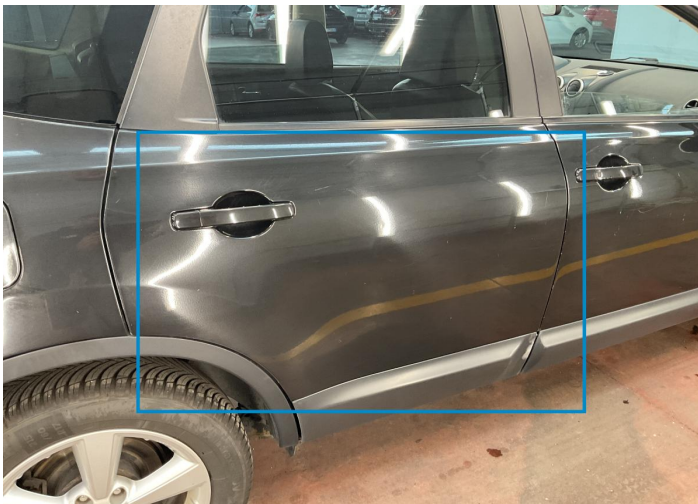
| 33 | Door / Back Right | Bodywork / Poor Previous Repair |

33. Door / Back Right  
Bodywork / Poor Previous Repair -

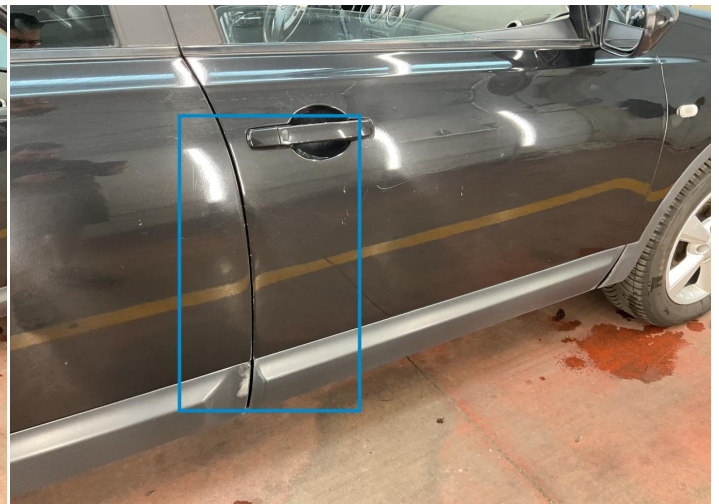
| 34 | Door / Front Right | Bodywork / Dent |

34. Door / Front Right  
Bodywork / Dent -

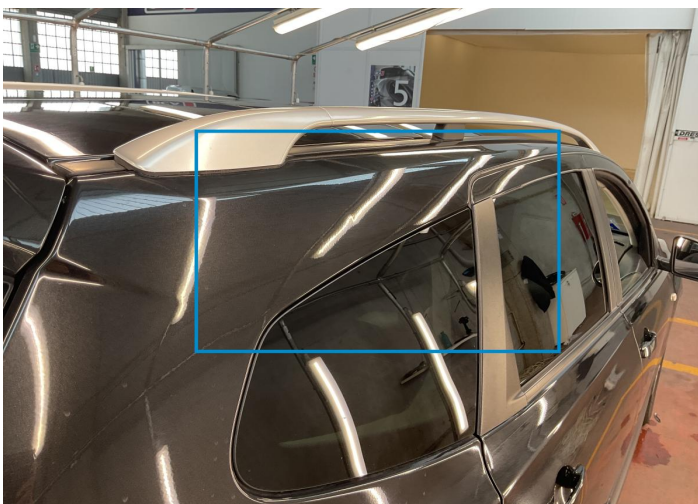
| 35 | Pillar / Front Right | Bodywork / Dent / Hail Area |

35. Pillar / Front Right  
Bodywork / Dent / Hail Area -
